## **NATIONAL TRANSPORTATION SAFETY BOARD**

### **AIRFRAME & ENGINE EXAMINATION SUMMARY**

**WPR21FA270**

| Aircraft: | Cessna 421C, N687SW |

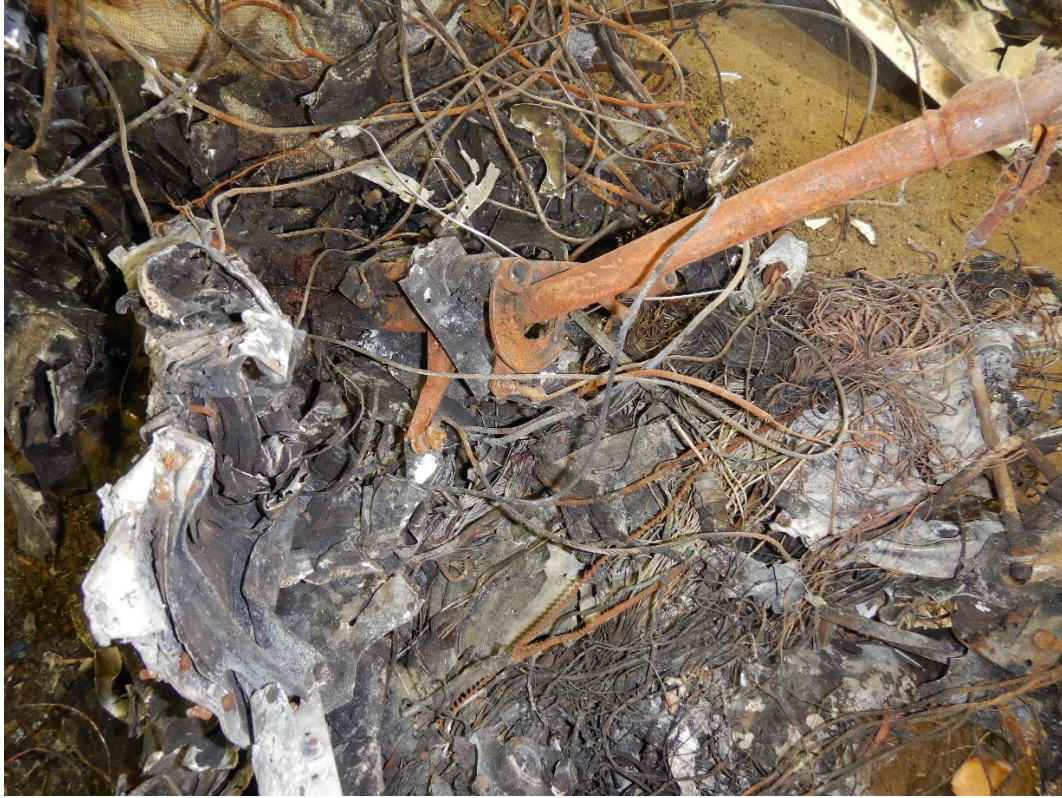
Flight control continuity was unable to be established due to multiple separations, impact and thermal damage. The cockpit flight controls were separated and exhibited thermal and impact damage throughout. The rudder pedals were observed in the cockpit area with heavy impact and thermal damage. All areas of separation were consistent with overload or were cut by recovery personnel.

Figure 1: View of airplane cockpit area with impact and thermal damage. (Photo courtesy of Textron Aviation)

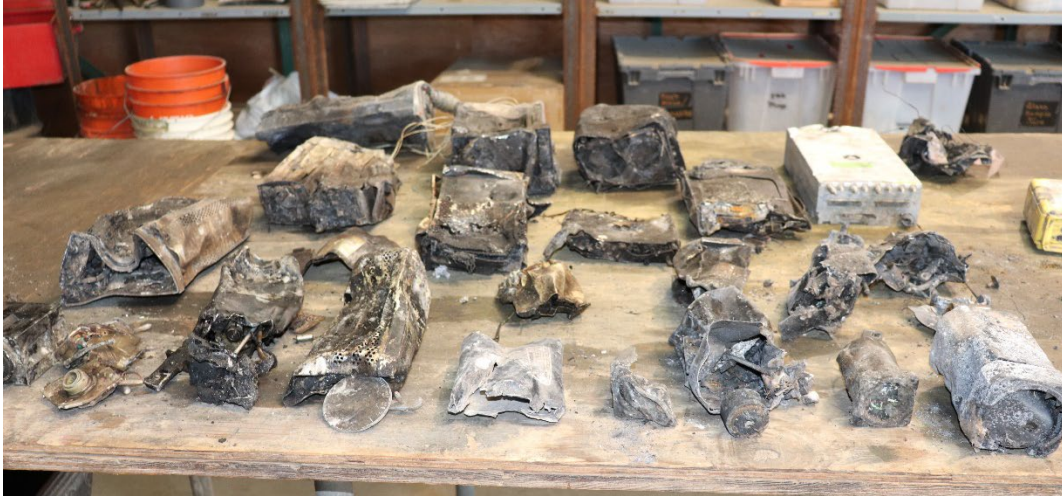
Figure 2: View of various airplane instruments with impact and thermal damage. (Photo courtesy of the NTSB)

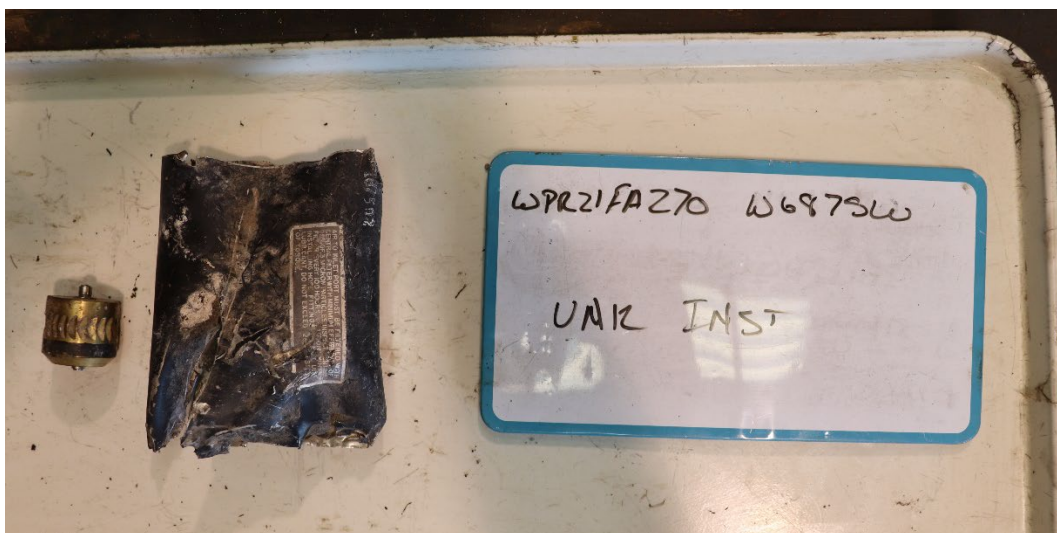
Figure 3: View of unknown instrument with impact and thermal damage. (Photo courtesy of the NTSB)

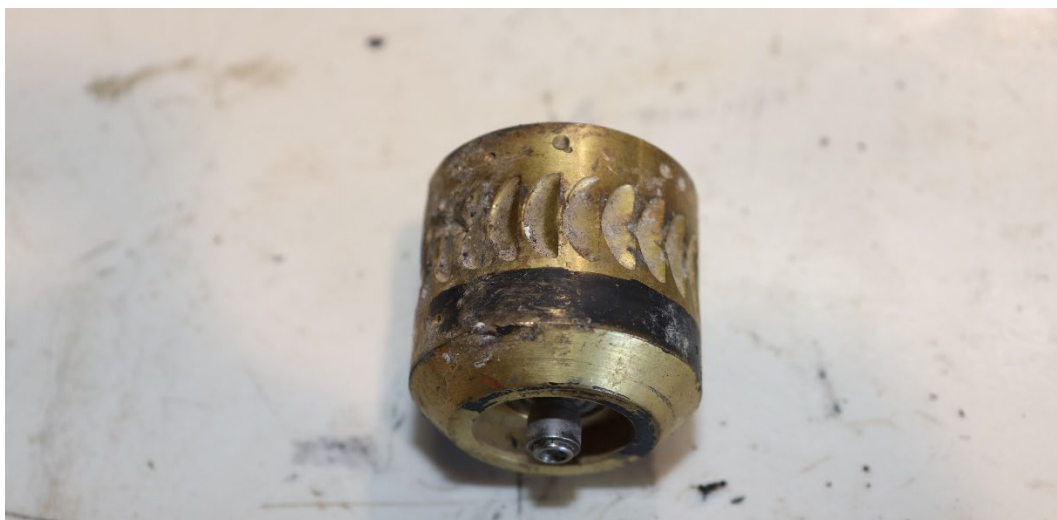
Examination of the recovered wreckage revealed that the cockpit, fuselage structure was mostly destroyed by thermal and impact damage. Both engines, engine mounts, engine nacelles, nose landing gear, instrument panel, cockpit, flight controls, and seats were separated, exhibited thermal and impact damaged throughout. Multiple instruments were separated from the instrument panel and exhibited thermal and impact damaged. One instrument, which was heavily impact damaged, contained a gyro gimble. Rotational scoring and impact damage was observed on the gimble.

Figure 4: View of unknown instrument gyro gimble with rotational scoring and impact damage. (Photo courtesy of the NTSB)

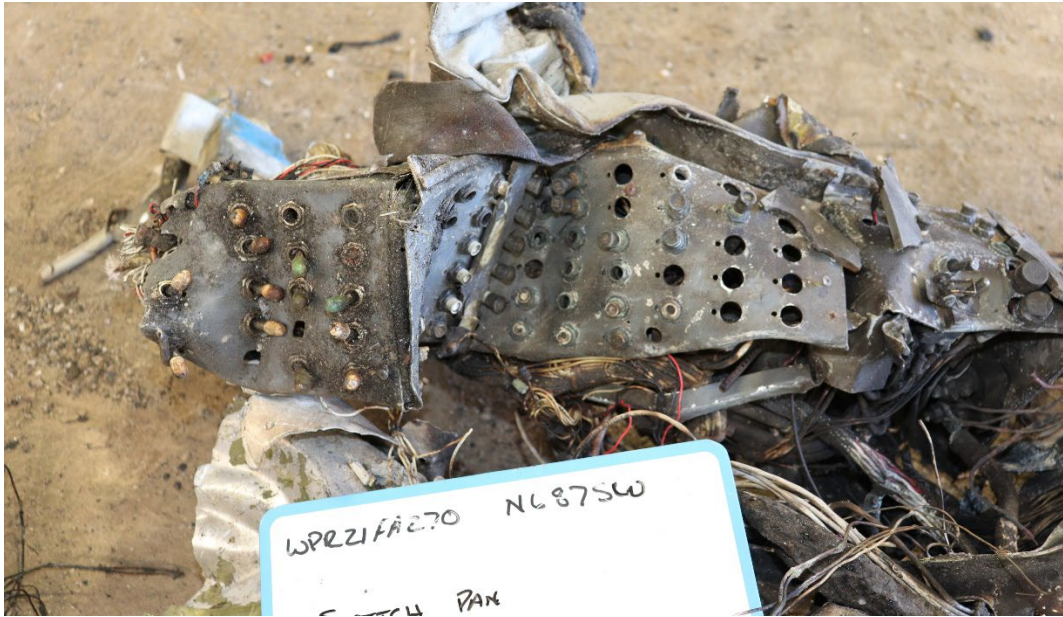
The cockpit switch/circuit breaker panel was separated and exhibited thermal and impact damage.

**Figure 5: View of airplane cockpit switch/circuit breaker panel with impact and thermal damage. (Photo courtesy of the NTSB)**

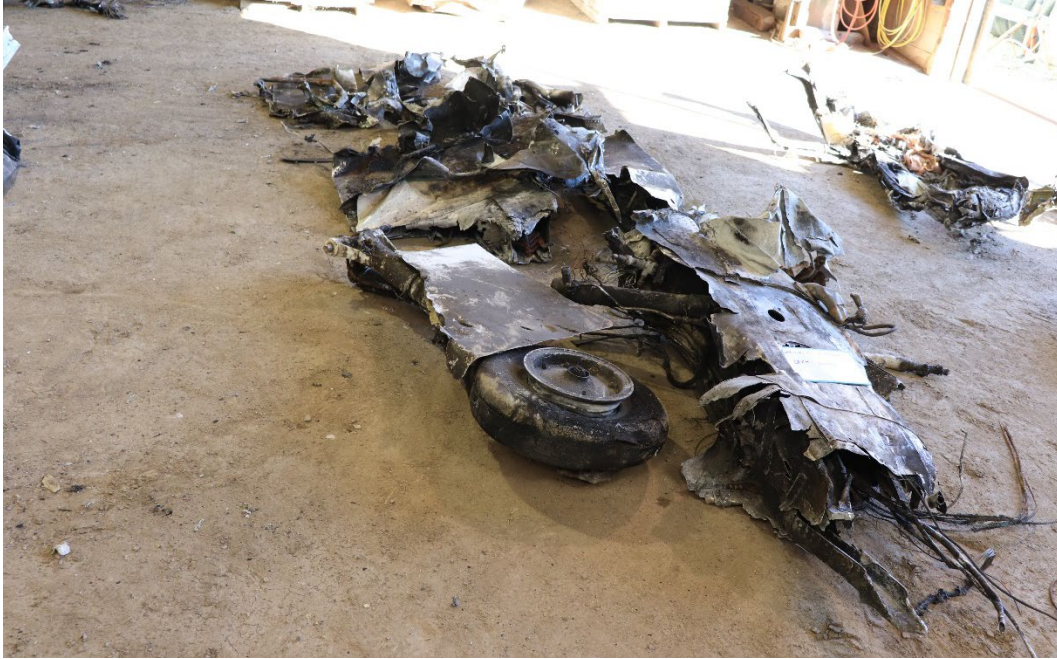
The left wing was separated from the fuselage at the wing root. The left wing was fragmented into multiple pieces with varying degrees of thermal and impact damage. The outboard section of the left wing was mostly destroyed. An approximate 3 ft section of leading edge, with fuel cap attached exhibited thermal damage. The portion that remained attached to the center section was bent, buckled, and torn throughout. The left aileron and outboard portion of the wing structure were separated. The left wing flap remained partially attached via their mounts, thermal and impact damaged was observed throughout. The left main landing gear was separated from the wing attachment point. The landing gear actuator remained attached via its mount.

**Figure 6: View of left wing with impact and thermal damage. (Photo courtesy of the NTSB)**

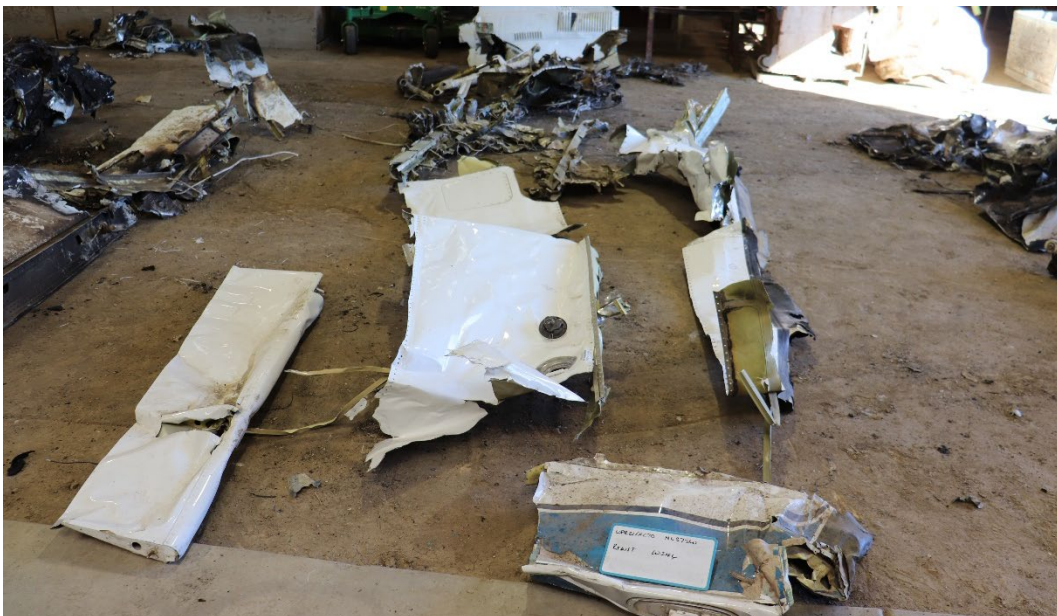
The right wing separated from the fuselage at the wing root. The right wing had various portions of the wing structure separated and exhibited thermal and impact damage throughout. An approximate 5 ft section of leading edge with fuel cap attached exhibited impact damage. The portion that remained attached to the center section was thermal damaged, bent, buckled, and torn throughout. The right aileron was separated and was mostly intact, however, bent and buckled throughout. The right flap separated, had thermal damage about mid span, was bent and buckled throughout. The right main landing gear was separated from the wing attachment points.

**Figure 7: View of right wing with impact and thermal damage. (Photo courtesy of the NTSB)**

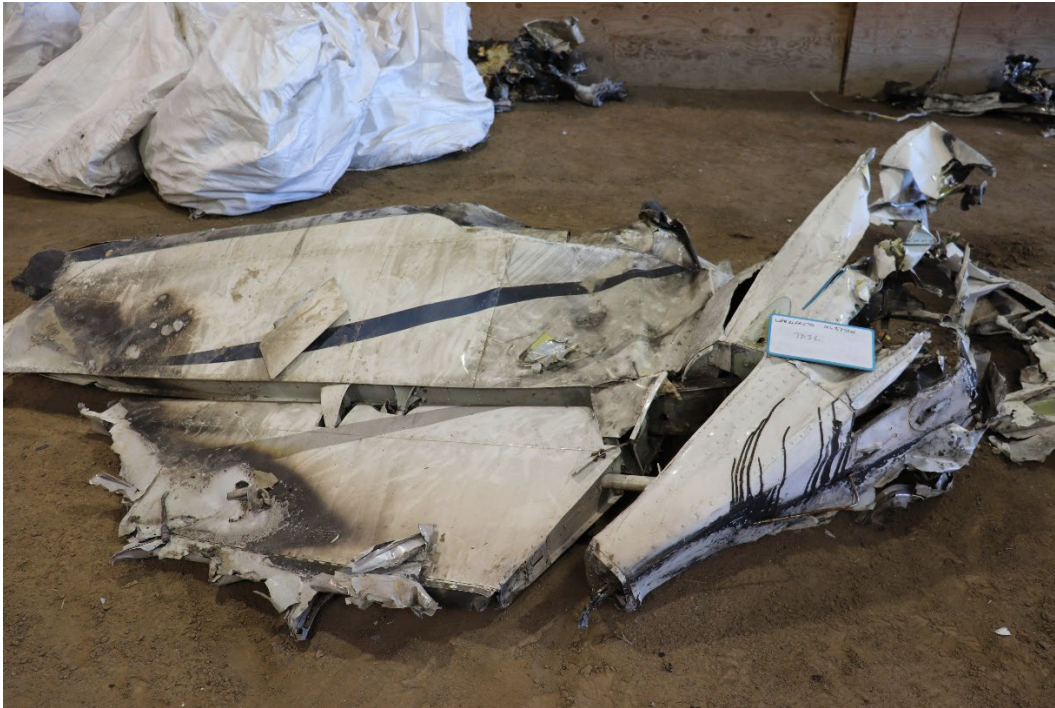
The empennage was separated from the fuselage. The vertical stabilizer was separated from the empennage, exhibited thermal damage, crushing and bending throughout. The rudder remained attached to the vertical stabilizer via its attachment points and exhibited thermal damage, crushing, and bending throughout. The left and right horizontal stabilizers were separated from the empennage and mostly destroyed. The left and right elevators were separated from the horizontal stabilizers and mostly destroyed.

**Figure 8: View of empennage with impact and thermal damage. (Photo courtesy of the NTSB)**

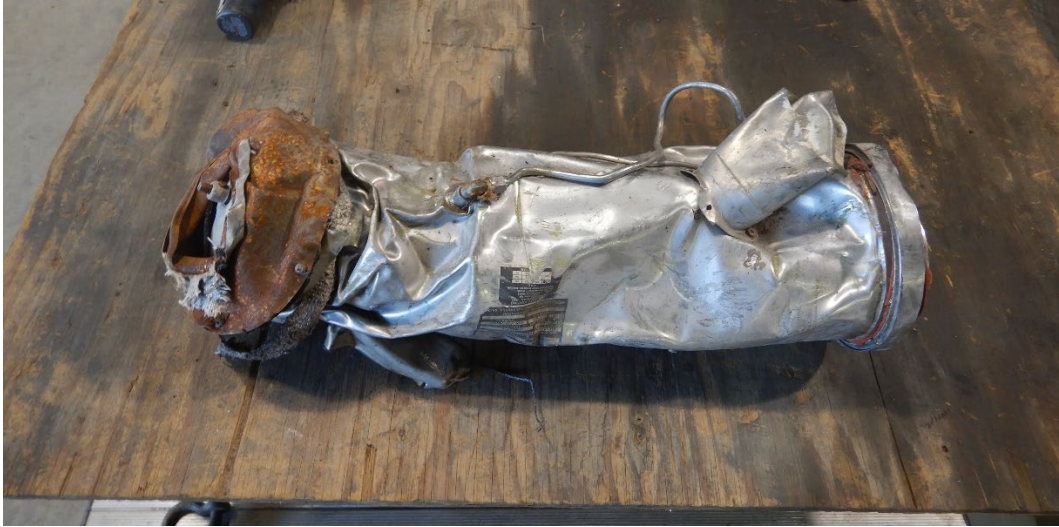
The cabin heater assembly was separated and exhibited impact damage to the external casing. Using a lighted borescope, the heater assembly was examined internally. No evidence of any soot or discoloration was observed internally.

Figure 9: View of airplane heater assembly with impact and thermal damage. (Photo courtesy of Textron Aviation)

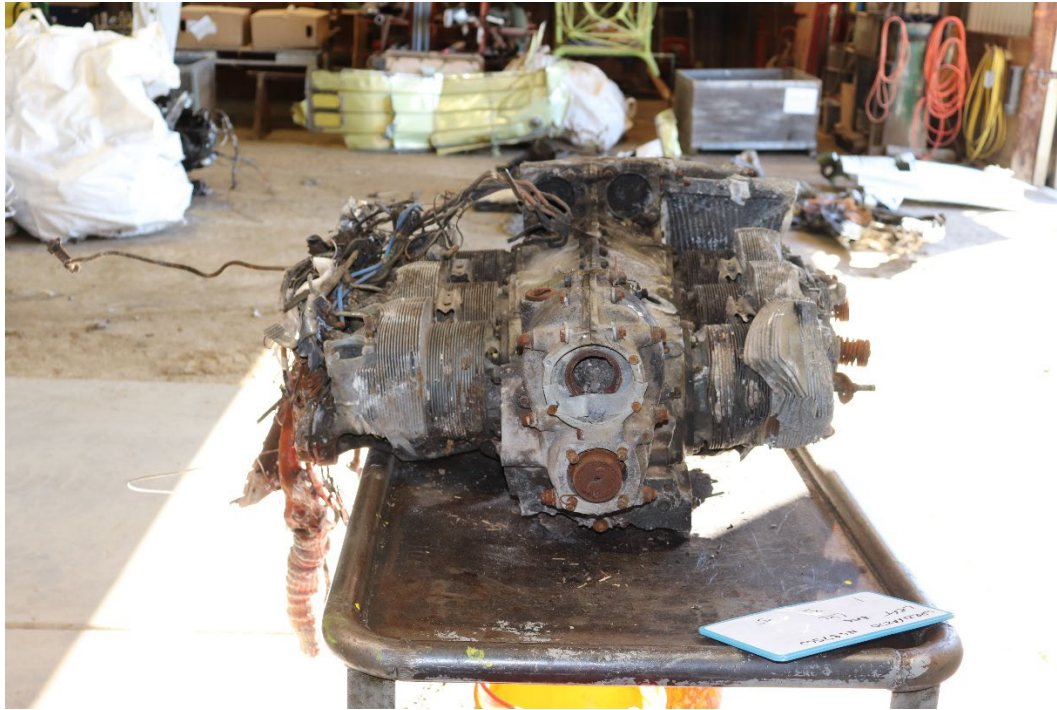
Examination of the recovered engine revealed that the engine was separated from the engine mount, impact and thermal damage was observed throughout. The propeller and propeller flange separated from the quill shaft. The intake and exhaust were separated. The intercooler was separated and impact damaged. The oil sump was mostly separated and not completely observed within the recovered wreckage.

**Figure 10: Front view of left engine with impact and thermal damage. (Photo courtesy of the NTSB)**

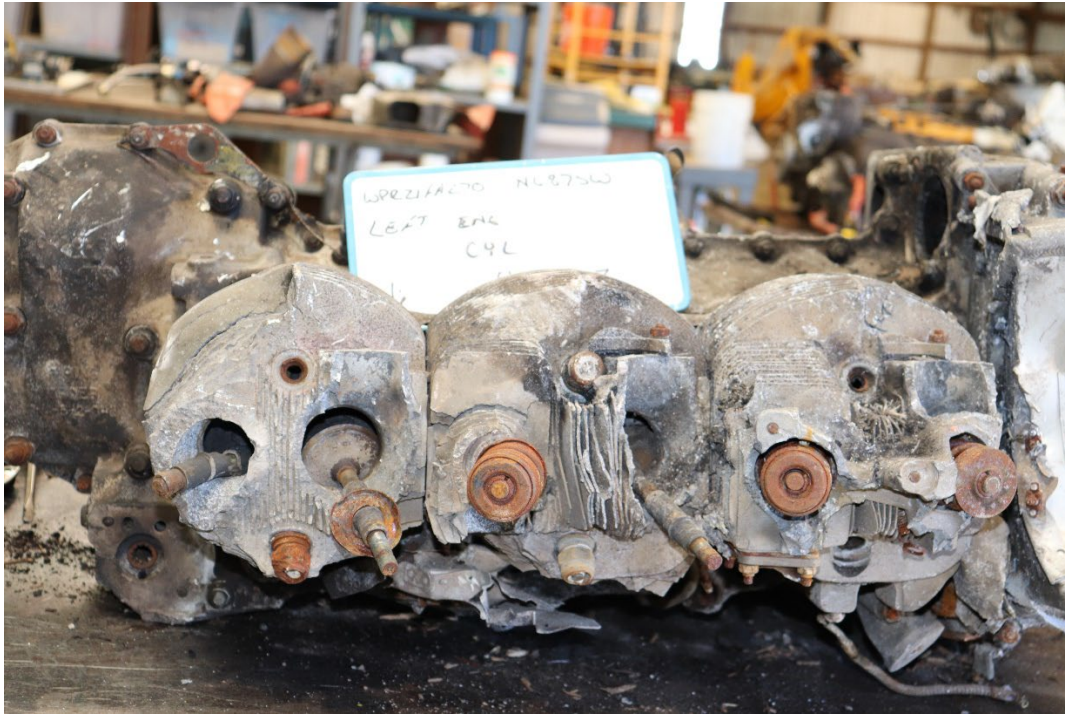
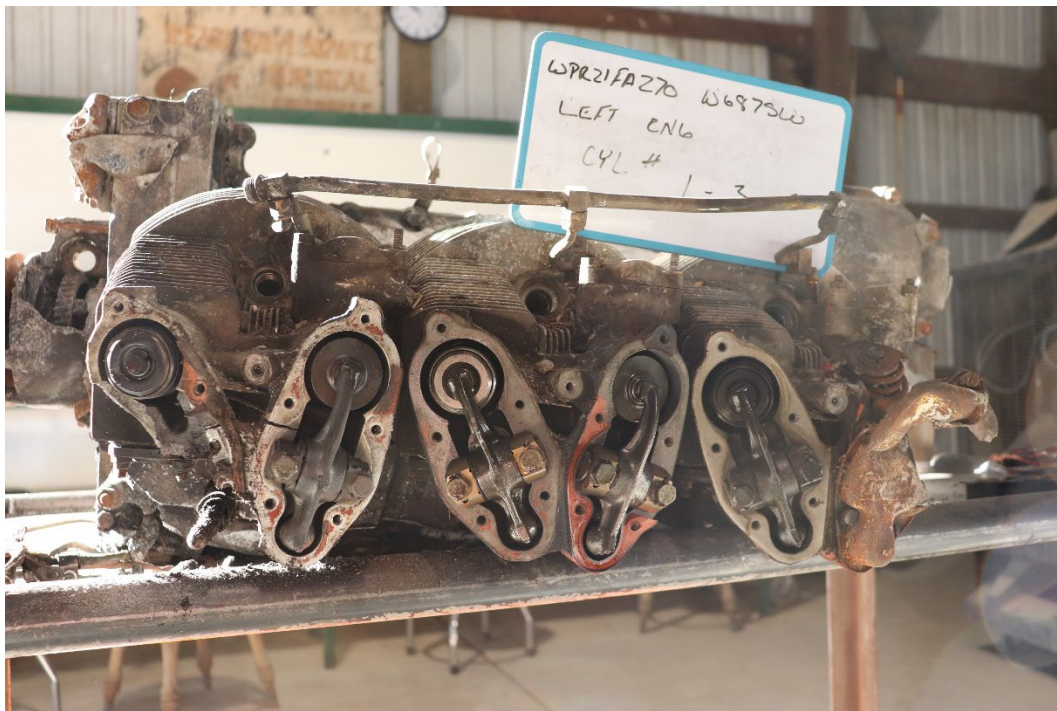
All six cylinders remained attached and exhibited varying degrees of impact and thermal damage. The exhaust rocker box covers, rocker arms, and portions of the cylinder heads were separated from the No. 2, 4, and 6 cylinders. The exhaust rocker box cover, rocker arm, and portions of the cylinder head were separated from the No. 1 cylinder. The intake rocker box cover, rocker arm, and portions of the cylinder head were separated from the No. 5 cylinder. The No. 2, 4 and 6 cylinder exhaust and intake valves springs were separated. The rocker box covers were removed from the No. 1, 3 and 5 cylinders, the intake and exhaust rocker arms were intact and oil coated. The push rod tubes and push rods were separated from the No. 1, 2, 4, and 6 cylinders. The upper spark plugs were removed, and all six cylinders were examined internally using a lighted borescope. The No. 3 cylinder was filled dirt and debris, the remaining cylinders exhibited a normal amount of combustion deposits was observed within the combustion dome of each cylinder and piston face. The crankshaft was rotated by hand using a hand tool connected to the starter adapter. Rotational continuity was established throughout the engine and valve train. Due to the extensive damage to all cylinders, thumb compression and suction was not obtained.

Figure 11: View of left engine cylinders 2, 4, and 6. (Photo courtesy of the NTSB)

Figure 12: View of left engine cylinders 1, 3, and 5. (Photo courtesy of the NTSB)

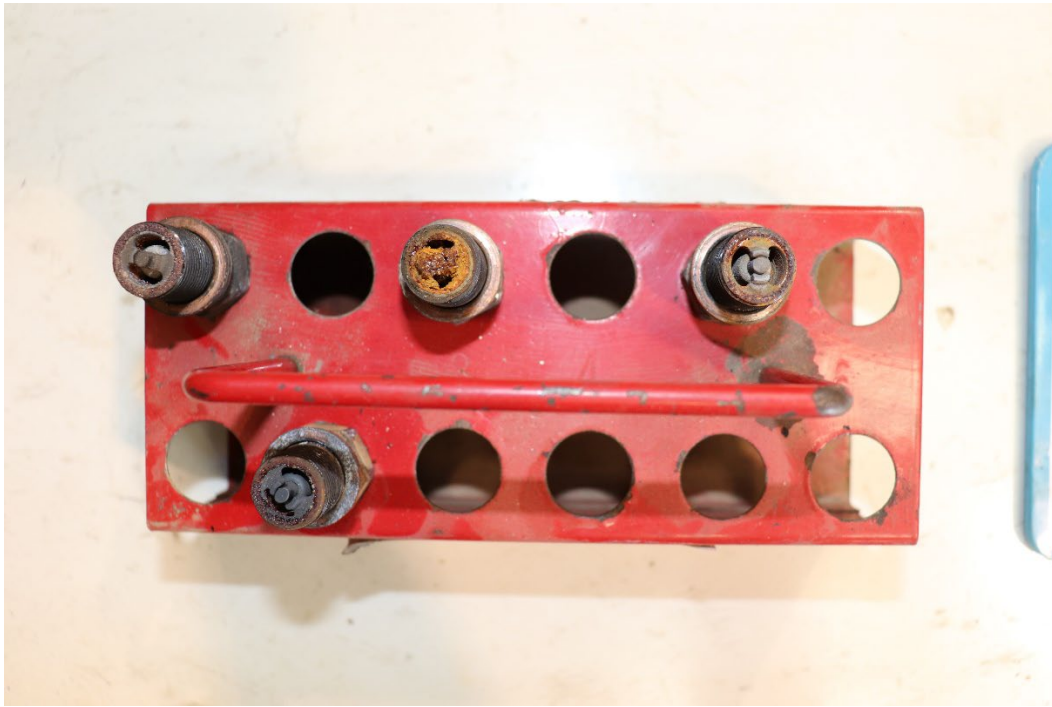
The top spark plugs were removed from the 1, 3 and 5 cylinders. The bottom spark plug was removed from the No. 2 cylinder. All spark plugs were massive electrode type. All sparkplugs had a debris and

corrosion within electrode area. All of spark plugs exhibited signatures consistent with worn-normal when compared to the Champion Check-A-Plug comparison chart.

**Figure 13: View of left engine spark plugs. (Photo courtesy of the NTSB)**

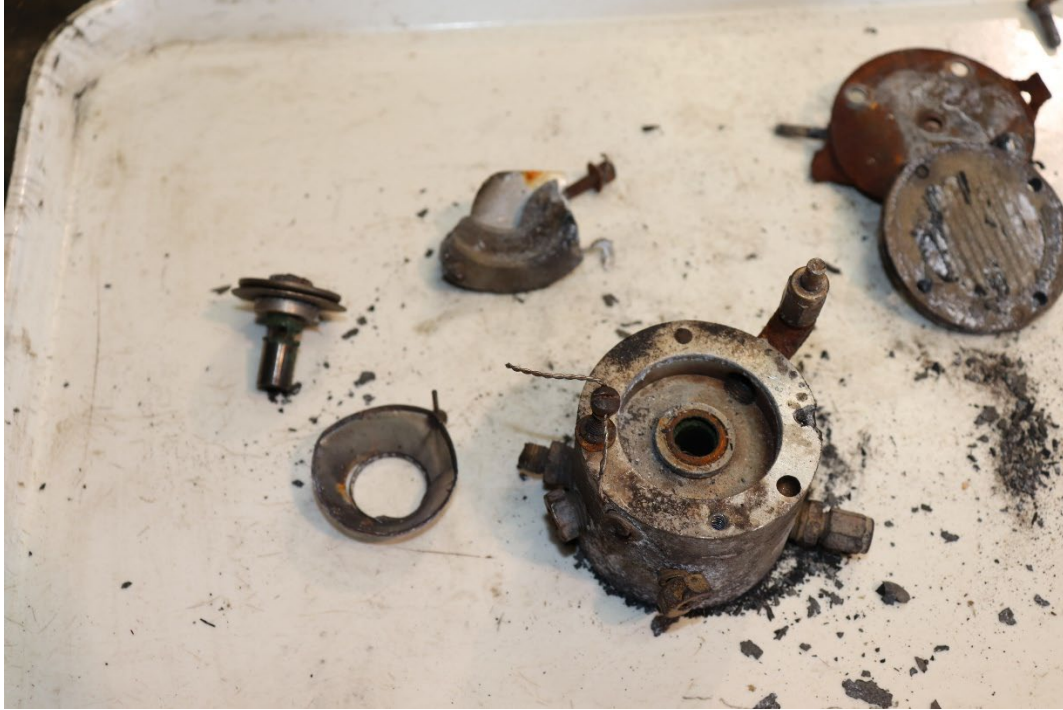
The fuel manifold valve was separated and exhibited impact damage. All fuel injector lines exhibited impact damage. The fuel manifold valve was disassembled. The internal spring and diaphragm were intact. Various amounts of debris and corrosion was observed within the fuel screen and plunger.

Figure 14: View of left engine fuel manifold valve. (Photo courtesy of the NTSB)

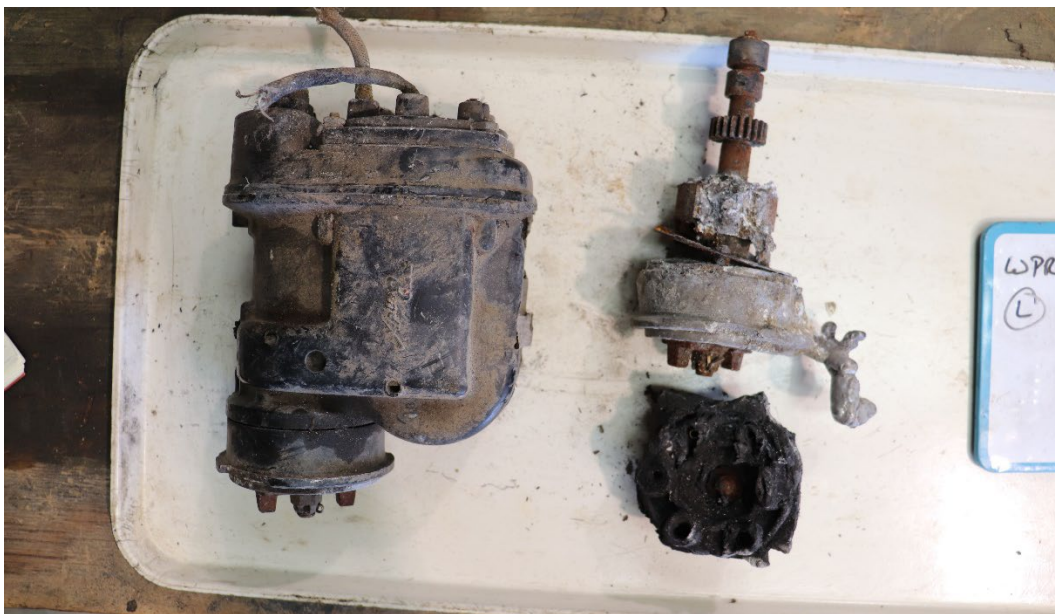
The left and right magnetos were separated. Due to impact damage a functional test was not able to be conducted.

Figure 15: View of left engine magnetos. (Photo courtesy of the NTSB)

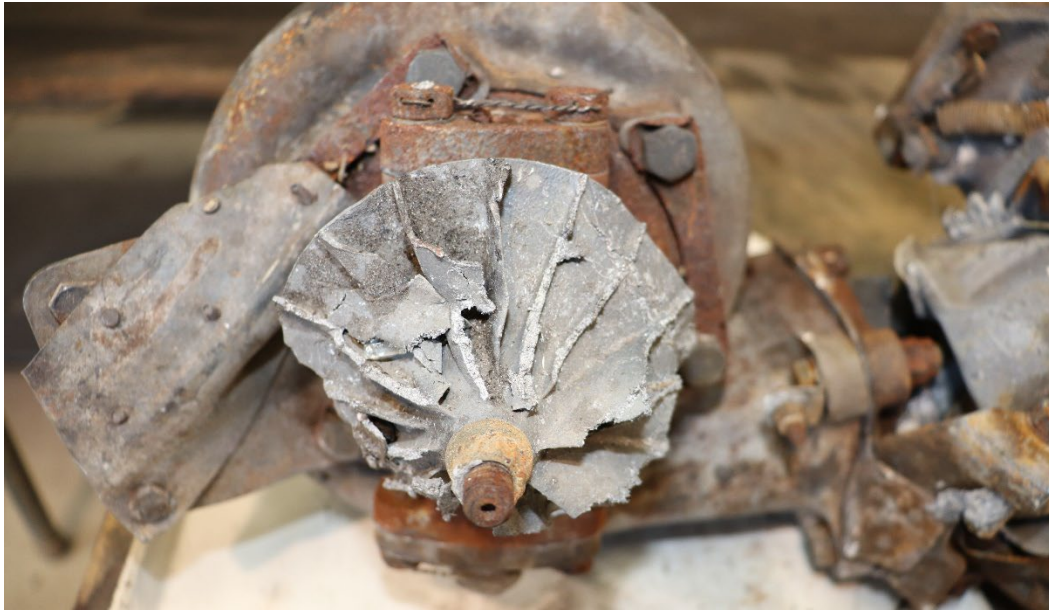
The left engine turbo was separated, exhibited impact and thermal damage. The impeller blades on the turbine and compressor side were impact and thermal damaged. The turbo would not rotate, impact damage and corrosion were observed within the impeller.

Figure 16: View of left engine turbo. (Photo courtesy of the NTSB)

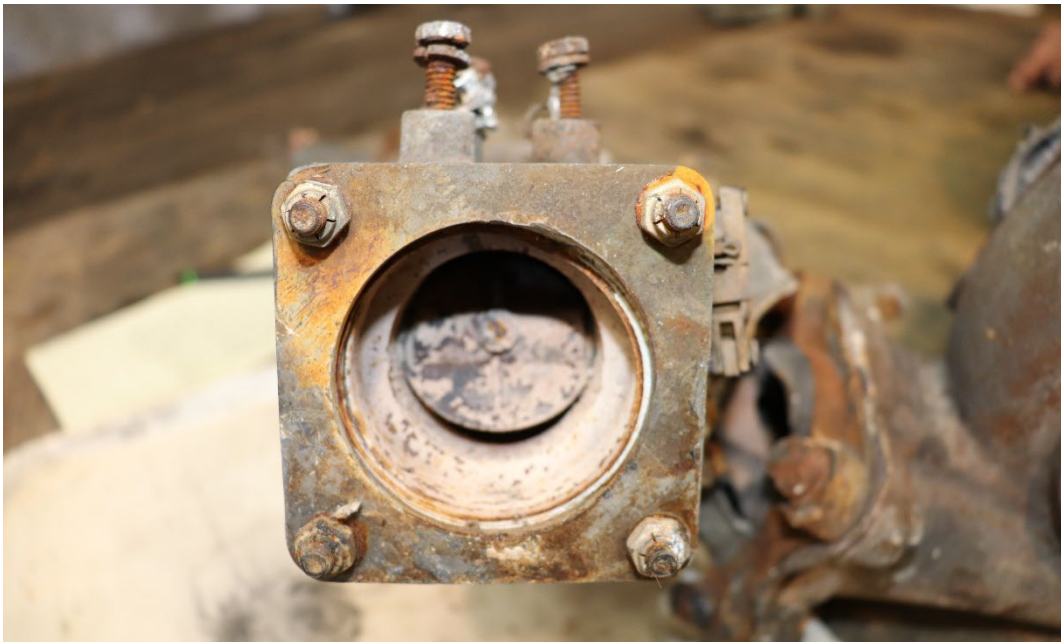
The waste gate remained attached to the turbo assembly and exhibited impact damage. The waste gate valve moved freely when rotated by hand using a handtool.

Figure 17: View of left engine waste gate. (Photo courtesy of the NTSB)

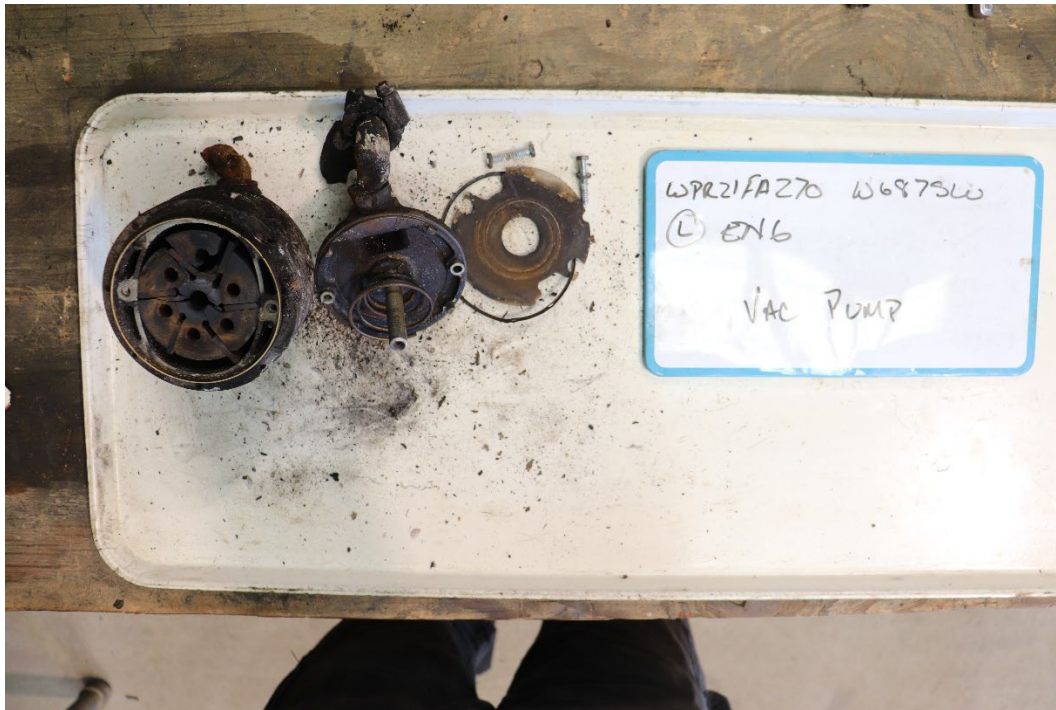
The left engine vacuum pump was separated, exhibited impact and thermal damage. The vacuum pump was disassembled. The rotor and veins were fragmented. The vacuum pump drive was impact damaged. The vacuum drive shaft was intact and undamaged.

Figure 18: View of left engine vacuum pump. (Photo courtesy of the NTSB)

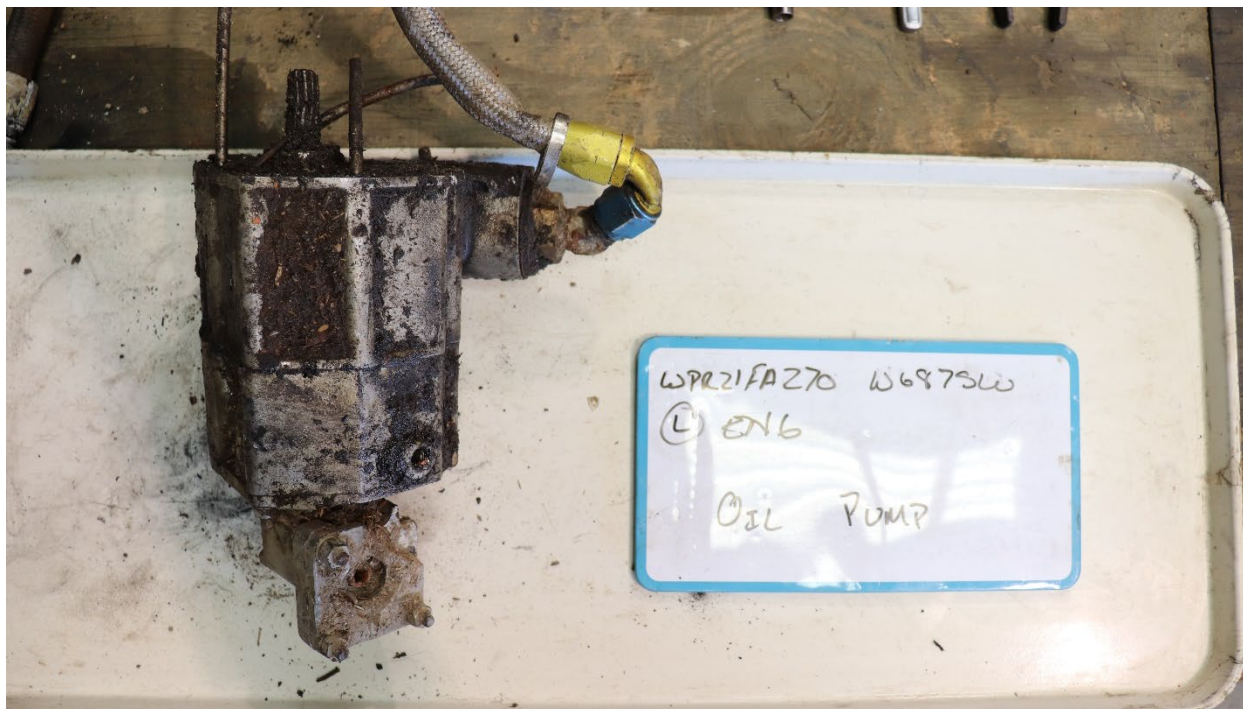
The left engine oil pump was separated, exhibited impact and thermal damage. The oil pump was disassembled and free of debris. The oil pump drive shaft rotated freely when rotated by hand.

Figure 19: View of left engine oil pump. (Photo courtesy of the NTSB)

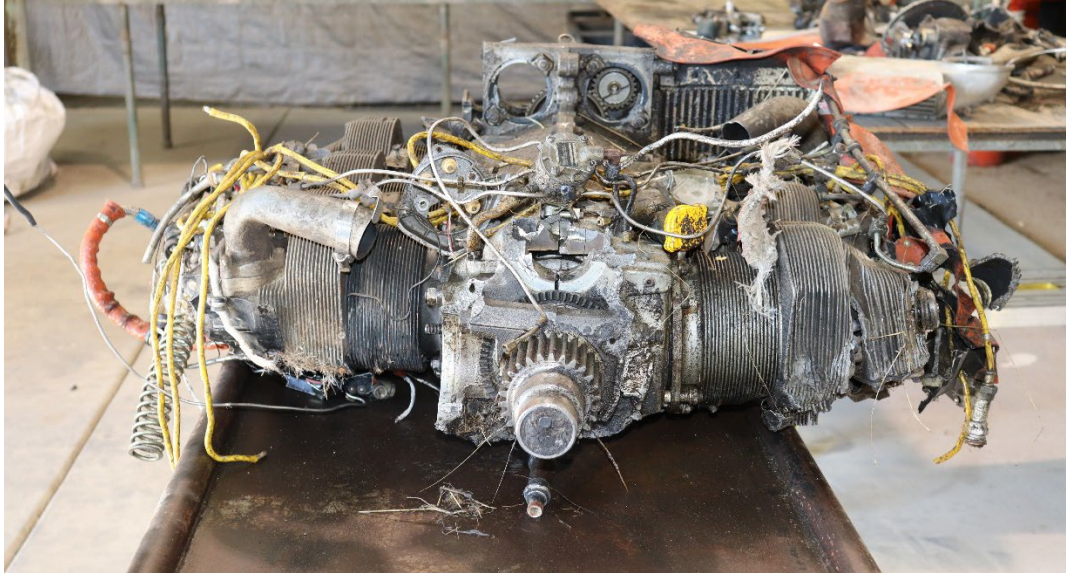
Examination of the recovered engine revealed that the engine was separated from the engine mount, impact and thermal damage was observed throughout. The quill shaft along with a section of the crank and crank case separated from the engine. The intake separated and fragmented. The intercooler was separated, exhibited impact damage throughout. The oil sump was separated and not observed within the recovered wreckage.

**Figure 20: Front view of right engine with impact damage. (Photo courtesy of the NTSB)**

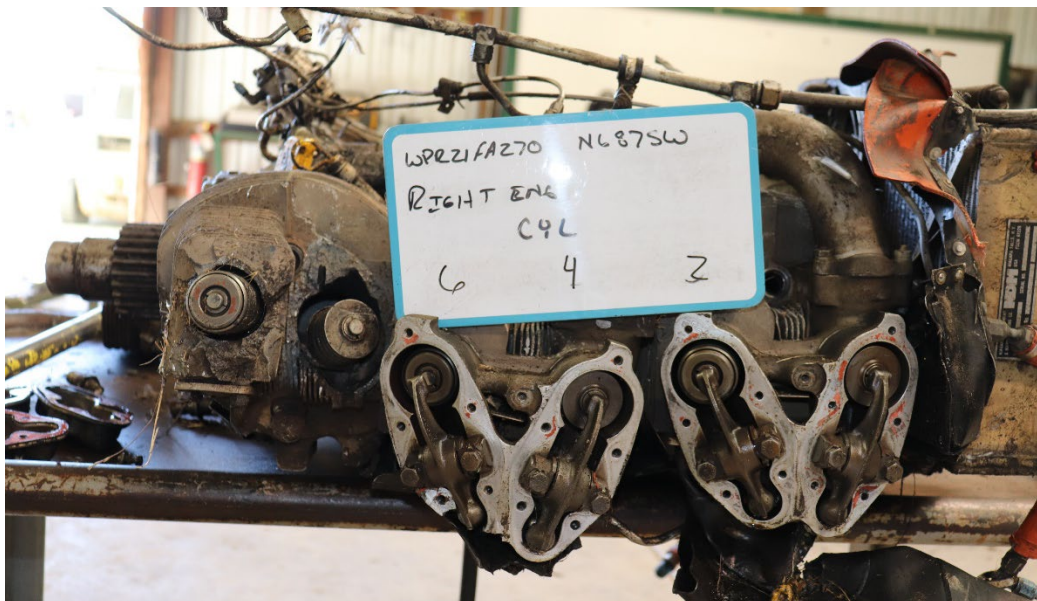
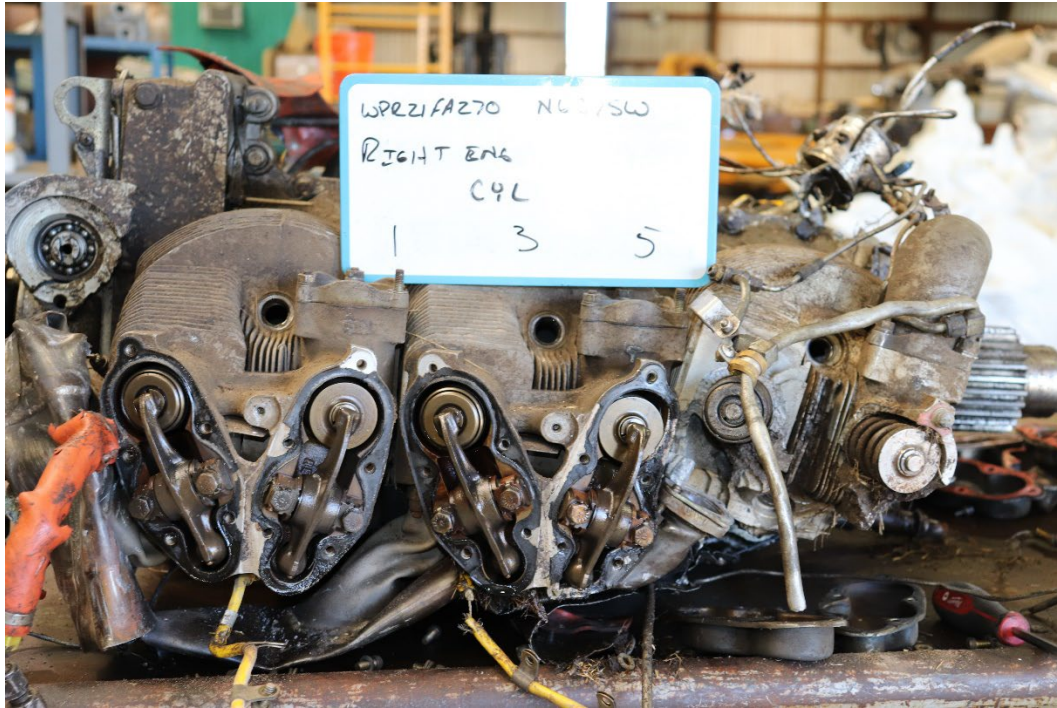
All six cylinders remained attached and exhibited varying degrees of impact and thermal damage. The exhaust rocker box covers, and rocker arms were separated from the No. 5 and 6 cylinders. The rocker box covers were removed from remaining cylinders, the intake and exhaust rocker arms were intact and oil coated. The upper spark plugs were removed, and all six cylinders were examined internally using a lighted borescope. All cylinders exhibited a normal amount of combustion deposits was observed within the combustion dome of each cylinder and piston face. The crankshaft was rotated by hand using a hand tool connected to the crank shaft. Rotational continuity was established throughout the engine and valve train. Due to the damage to the cylinders, thumb compression and suction was not obtained.

**Figure 21: View of right engine cylinders 6, 4, and 2. (Photo courtesy of the NTSB)**

Figure 22: View of right engine cylinders 1, 3, and 5. (Photo courtesy of the NTSB)

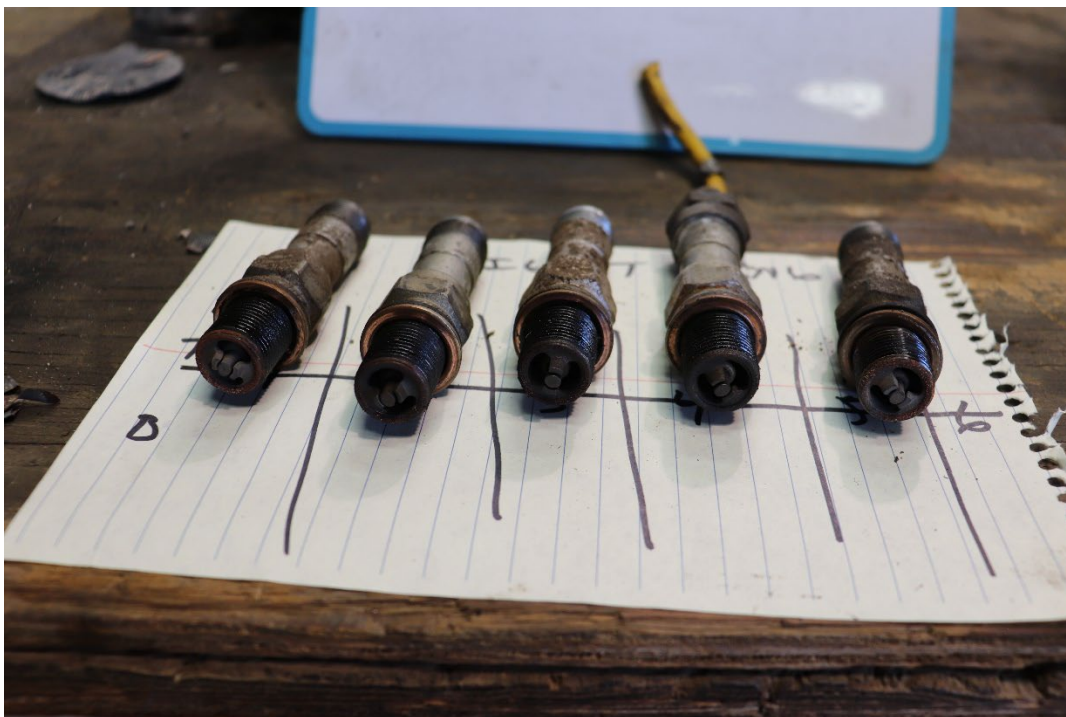
The top spark plugs were removed from the engine, and they were the massive electrode type. All sparkplugs had a grey deposits within the electrode area. All of spark plugs exhibited signatures consistent with worn-normal when compared to the Champion Check-A-Plug comparison chart.

Figure 23: View of right engine spark plugs. (Photo courtesy of the NTSB)

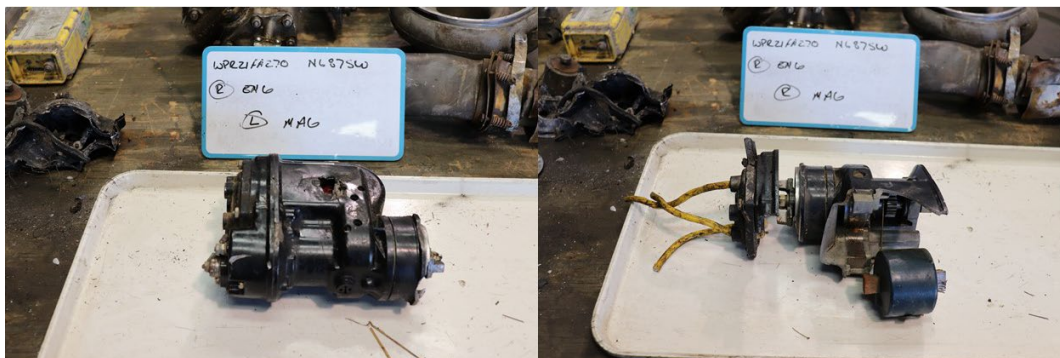
The left and right magnetos were separated. Due to impact damage a functional test was not able to be conducted.

Figure 24: View of right engine magnetos. (Photo courtesy of the NTSB)

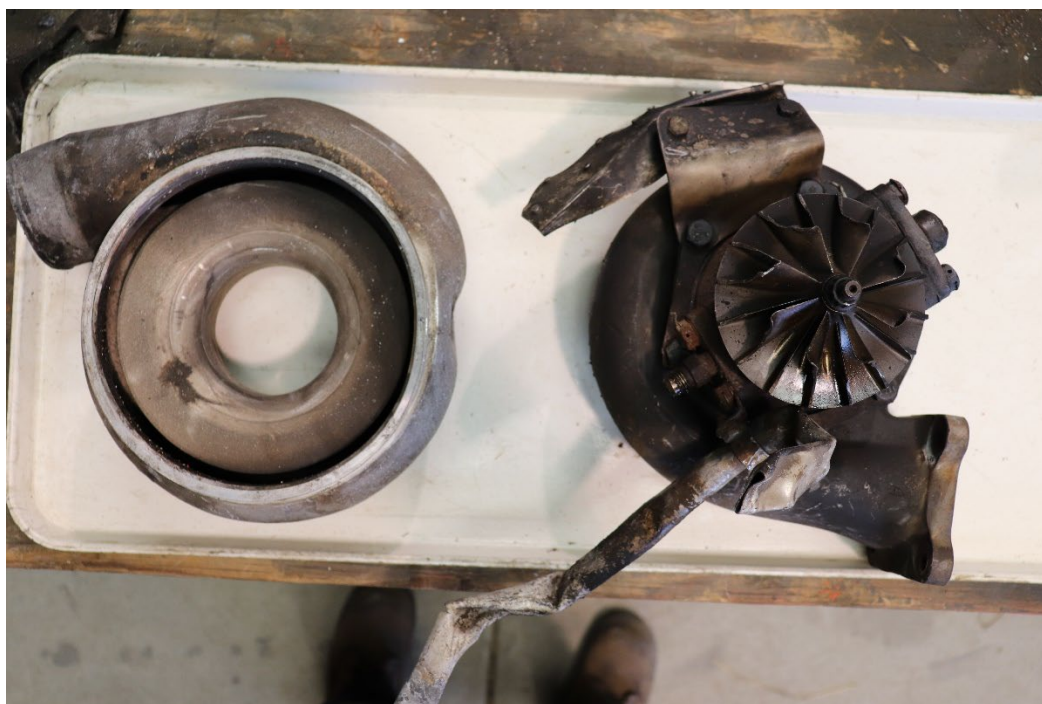
The right engine turbo was separated, exhibited impact damage. The impeller blades on the turbine side were impact damaged. The impeller blades on the compressor side were intact and undamaged. The turbo rotated freely by hand.

Figure 25: View of right engine turbo. (Photo courtesy of the NTSB)

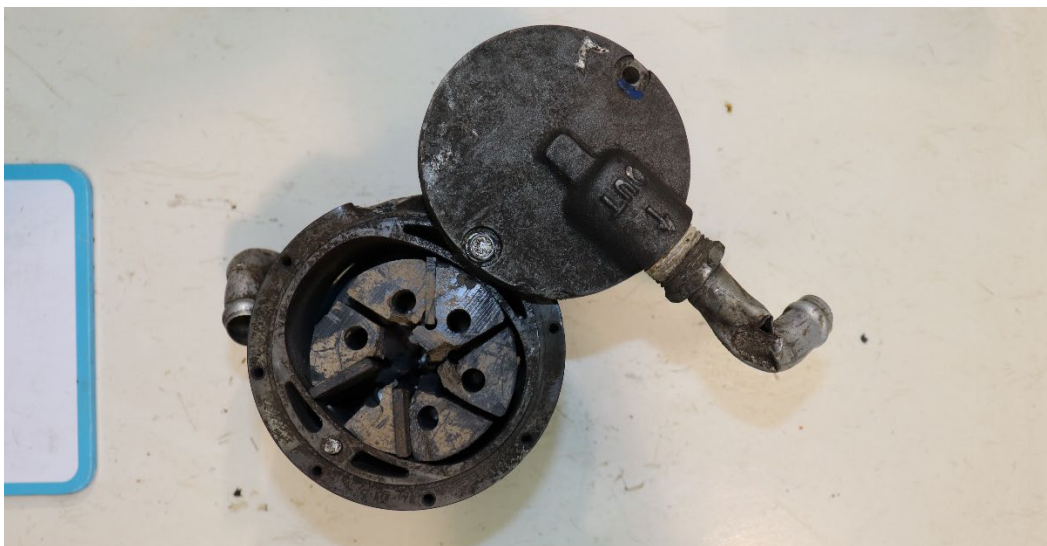
The right engine vacuum pump was separated and exhibited impact and thermal damage. The cap was partially separated. The rotor and veins were fragmented. The vacuum pump drive was separated. The drive pins were intact and undamaged.

Figure 26: View of right engine vacuum pump. (Photo courtesy of the NTSB)

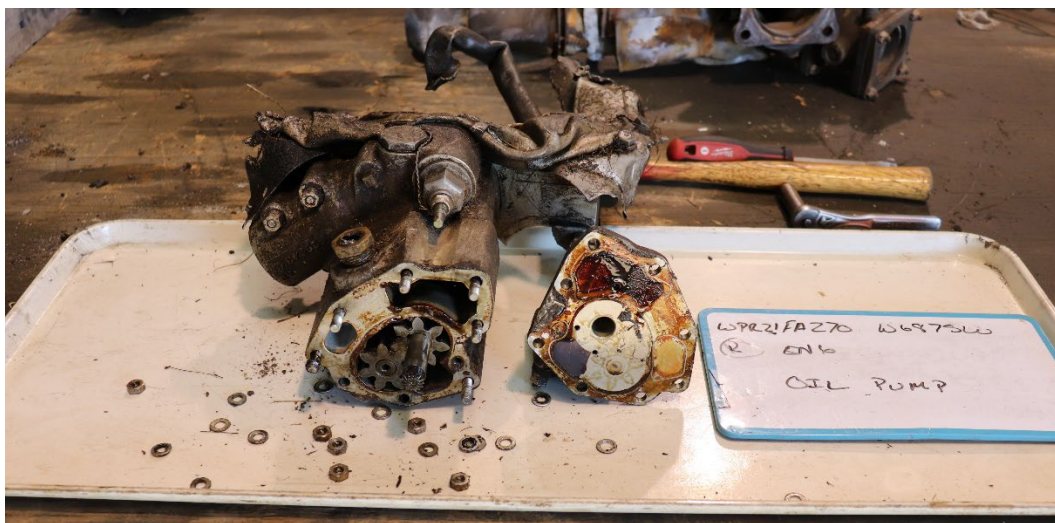
The right engine oil pump was separated, exhibited impact and thermal damage. The oil pump was disassembled and free of debris. The oil pump drive shaft rotated freely when rotated by hand.

Figure 27: View of right engine oil pump. (Photo courtesy of the NTSB)
