## **NATIONAL TRANSPORTATION SAFETY BOARD**

### **Specialist's Factual Report**

# **METEOROLOGY**

WPR21FA270

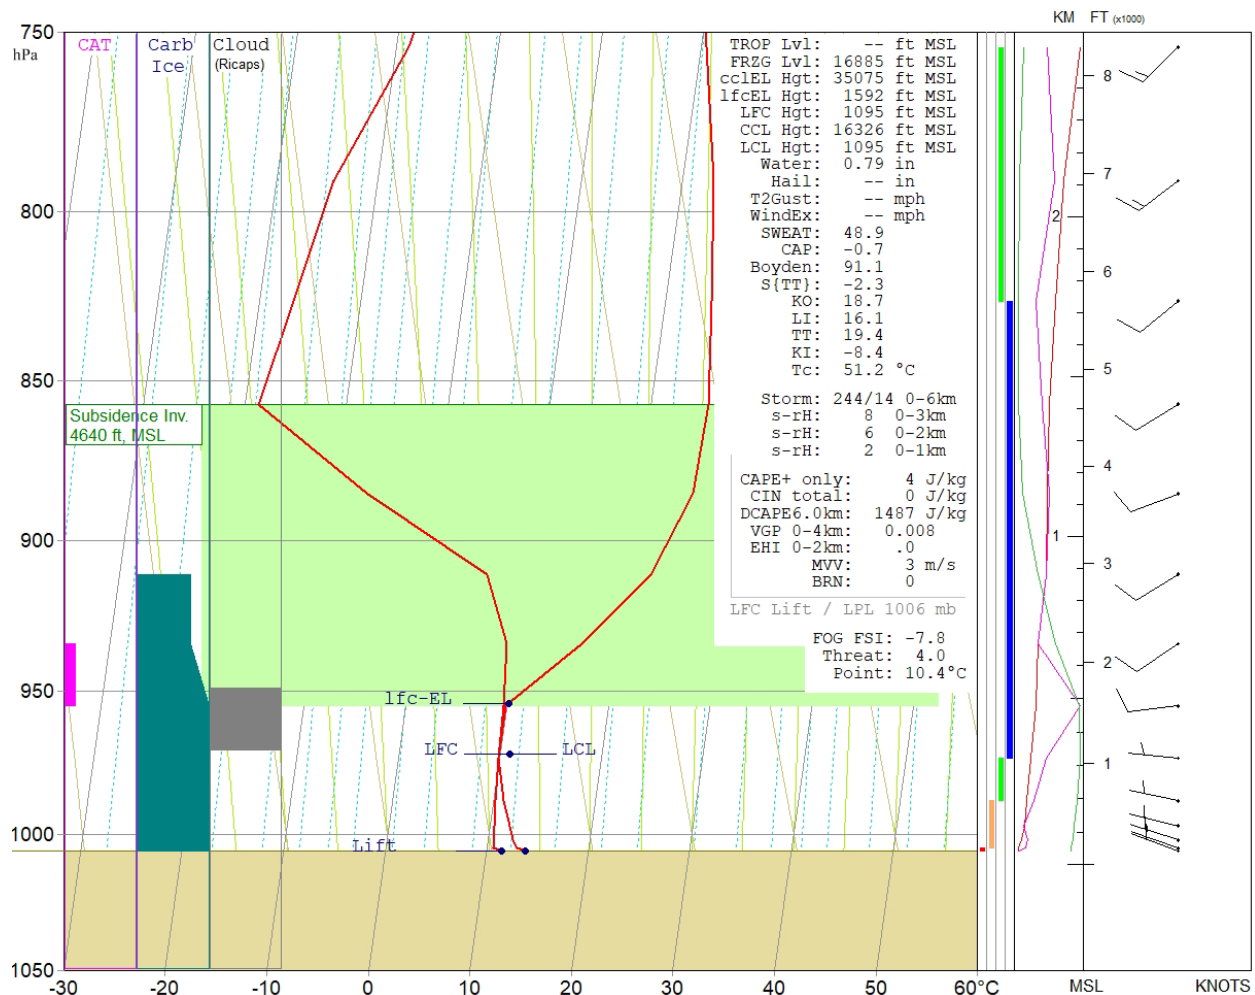
A High-Resolution Rapid Refresh (HRRR) model<sup>4</sup> sounding (figure 1) for near the accident site<sup>5</sup> at 1100 using an elevation of 140 feet was retrieved from the National Oceanic and Atmospheric Administration's Air Resources Laboratory and analyzed by the RAwinsonde OBservation (RAOB) program. Cloudy conditions were identified by RAOB from about 1,100 to 1,700 feet. The freezing level was noted at about 17,000 feet. The wind below 2,000 feet was from the west at magnitudes less than 10 knots. A temperature inversion was noted between 1,600 and 4,600 feet.

**Figure 1** – HRRR model sounding data in SkewT/LogP format for 1100 near the accident site, surface to 750 hPa.

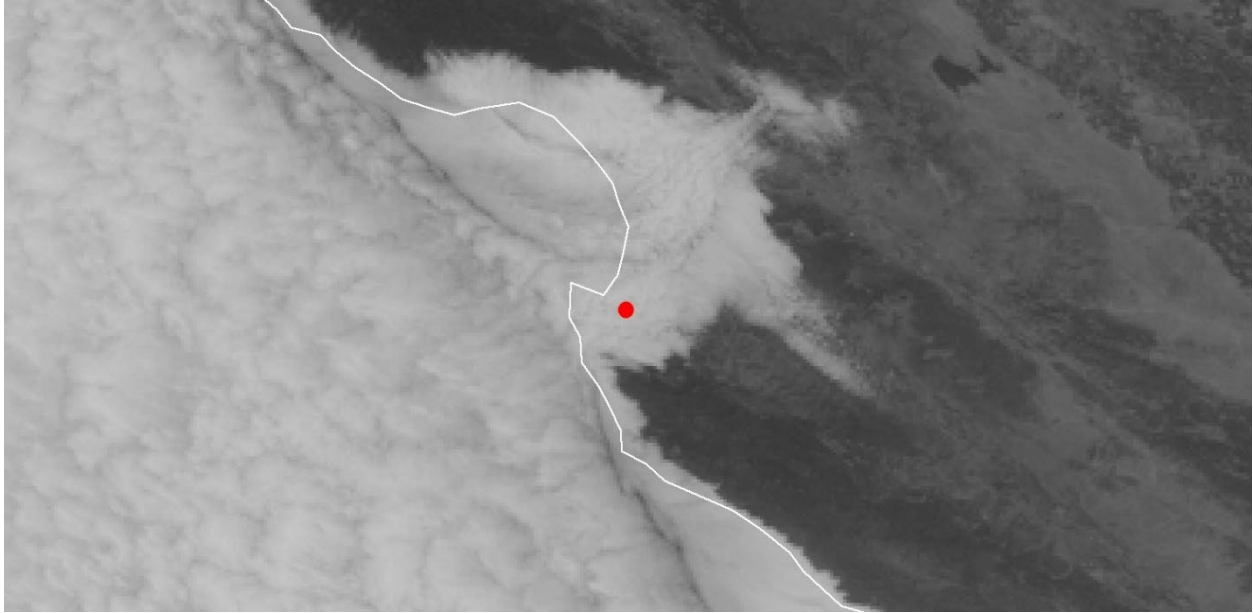
Geostationary Operational Environmental Satellite (GOES)-17 visible (0.64 $\mu$ m) and infrared (10.3 $\mu$ m) data were obtained from an archive at the Space Science Engineering Center at the University of Wisconsin-Madison. Images from 1041 are presented in figures 2 and 3. The GOES-17 visible imagery depicted cloudy conditions over the accident region. Infrared cloud-top temperatures over the accident site were about 9°C, which, when considering the 1100 HRRR sounding, corresponded to cloud top heights of about 2,200 feet.<sup>6</sup>

**Figure 2** – GOES-17 visible imagery from 1041. Accident location denoted by the red dot. Image is not corrected for parallax error.

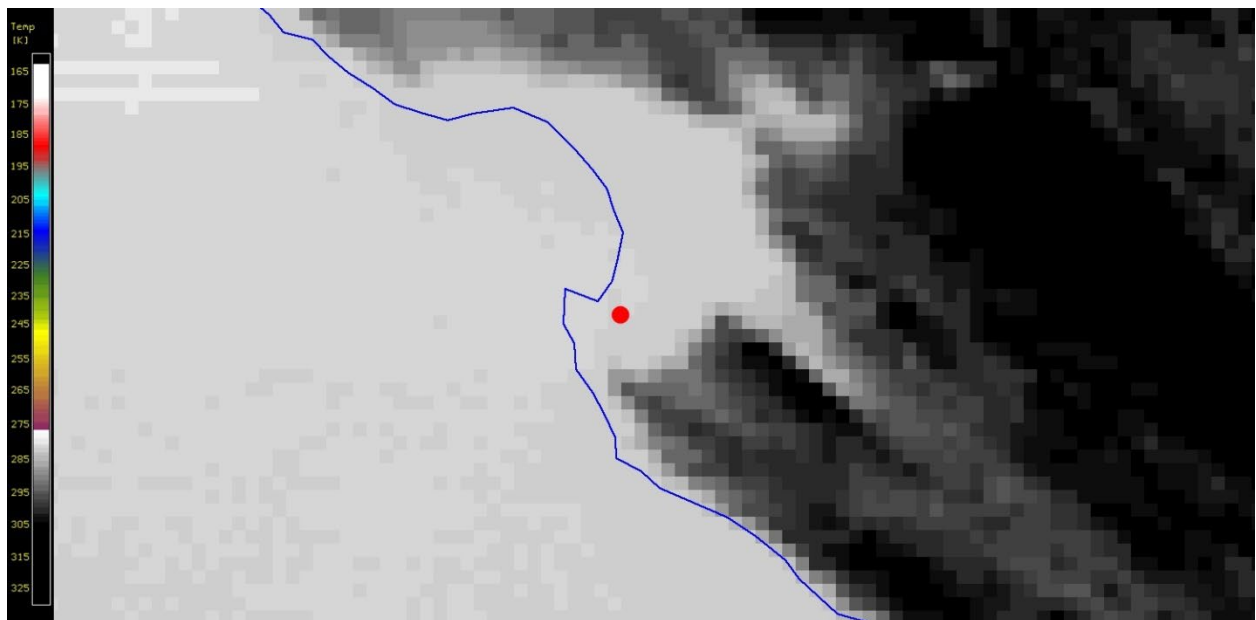
**Figure 3** – GOES-17 infrared brightness temperature imagery from 1041. Accident location is denoted by the red dot. This image has not been corrected for any parallax error.

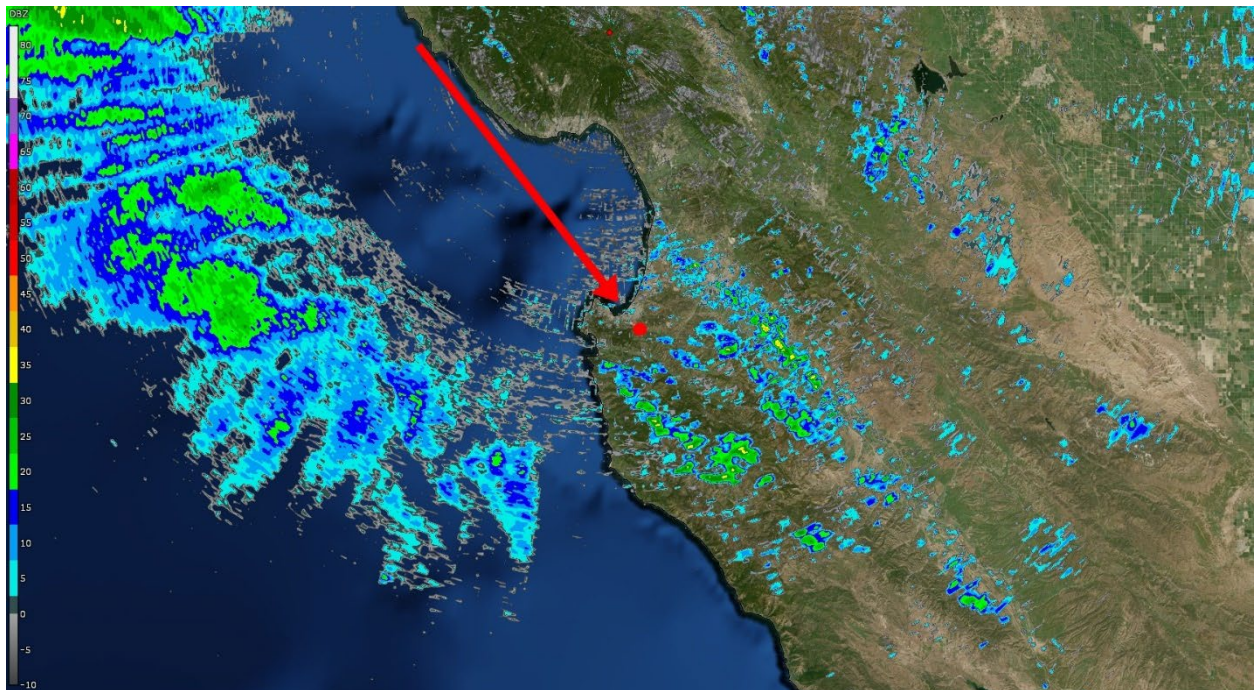
WSR-88D<sup>7</sup> Level-II base reflectivity weather radar imagery from near Santa Cruz, California, site (KMUX) is presented in figure 4. KMUX was located about 35 miles north of the accident location at an elevation of about 3,550 feet. Assuming standard refraction and considering the 0.95° beam width<sup>8</sup> for the WSR-88D radar beam, the KMUX -0.044° tilt would have “seen” altitudes over the accident location of between about 2,400 and 6,000 feet.

**Figure 4** – KMUX -0.044° Level-II base reflectivity product from a sweep initiated at 1047:57. Accident location denoted by the red circle.
