## **NATIONAL TRANSPORTATION SAFETY BOARD**

# **ACCIDENT SITE EXAMINATION SUMMARY**

**WPR21FA270**

Location: Monterey, California  
Date: July 13, 2021  
Aircraft: Cessna, 421C, N678SW  
NTSB Investigator-in-Charge: Eric M. Gutierrez

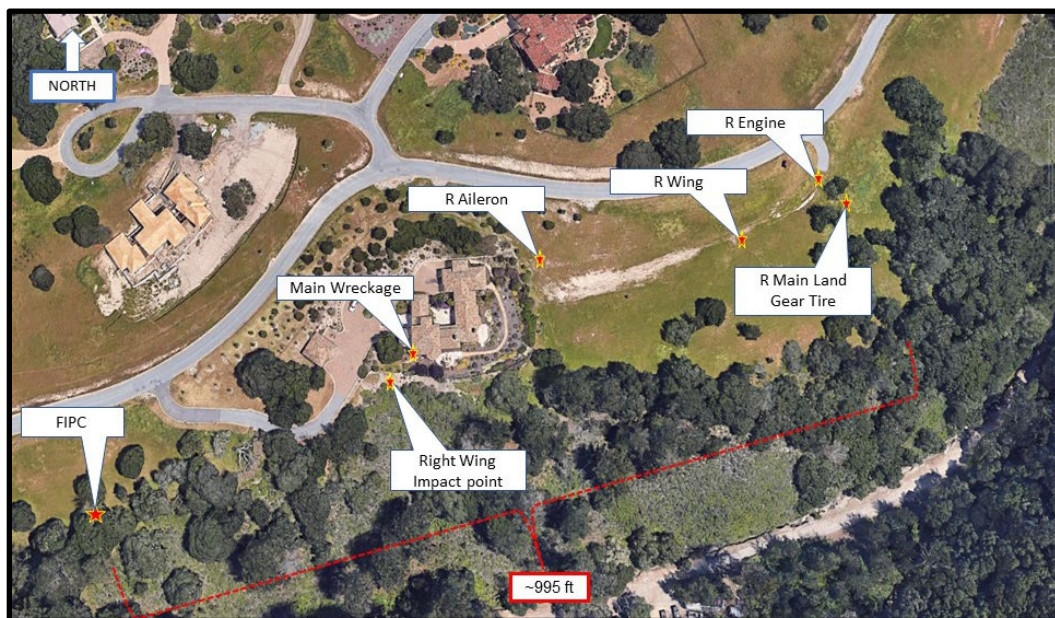
Examination of the accident site revealed that the airplane impacted trees about 1 mile south of the departure end of runway 10R. The first identifiable point of contact (FIPC) was a 50 to 75 ft tall tree that had damaged limbs near the top of the tree. The debris path was oriented on a heading of about 067° and was about 995 ft in length from the FIPC to right engine. The main wreckage was located about 405 ft from the FIPC. Throughout the debris path, various portions of aluminum wing skin, right wing, flap, aileron, engine, propeller blades, and propeller hub were observed. Additionally, several trees were damaged throughout the debris path. Within the damaged trees, about 95 ft prior to the main wreckage, fragments of a green navigational lens were observed. The fuselage came to rest upright against a residential structure on a heading of about 045° magnetic at an elevation of 447 ft msl. The wreckage was recovered to a secure location for further examination.

Figure 1: View of accident site diagram (photo courtesy of the NTSB)

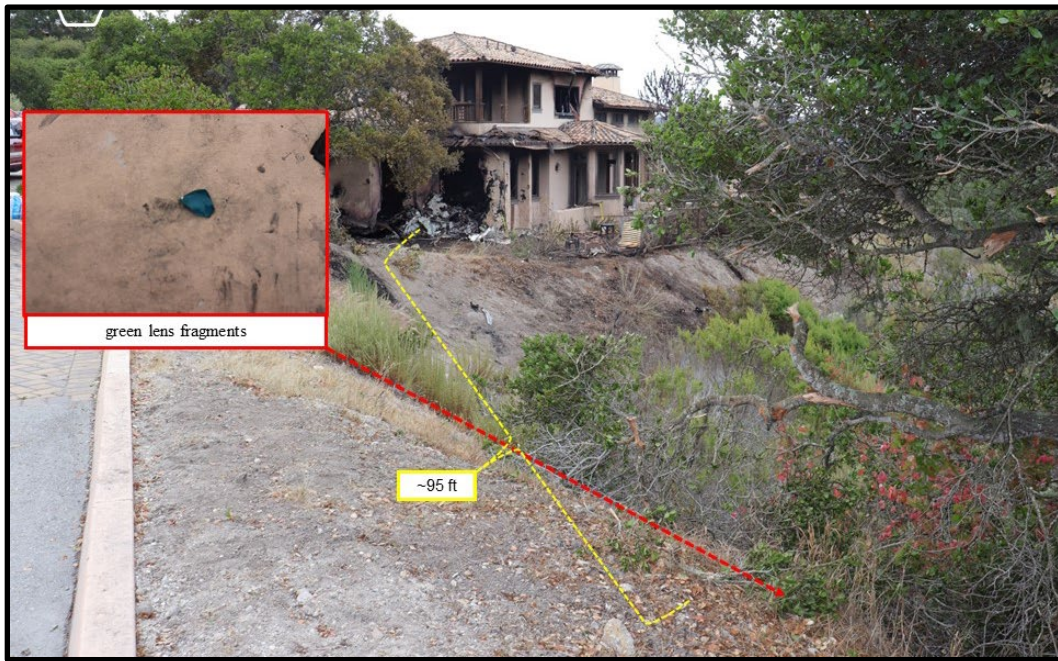
Figure 2: View of green navigational lens (photo courtesy of the NTSB)

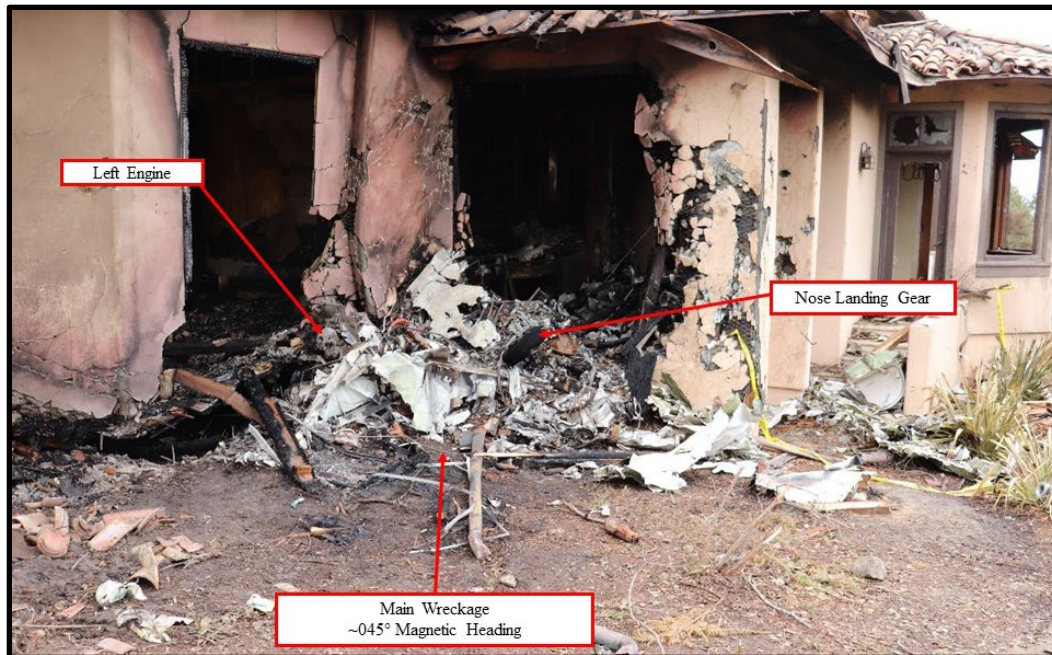
Examination of the fuselage revealed that it was mostly destroyed by thermal and impact damage. Both wings, center section, left and right horizontal, elevators, vertical stabilizer, and rudder were separated. The fuselage came to rest upright against a residential structure on a heading of about 045° magnetic. The instrument panel was thermal and impact damaged with instruments separated. The nose landing gear was separated from the fuselage in the retracted position.

Figure 3: View of main wreckage (photo courtesy of the NTSB)

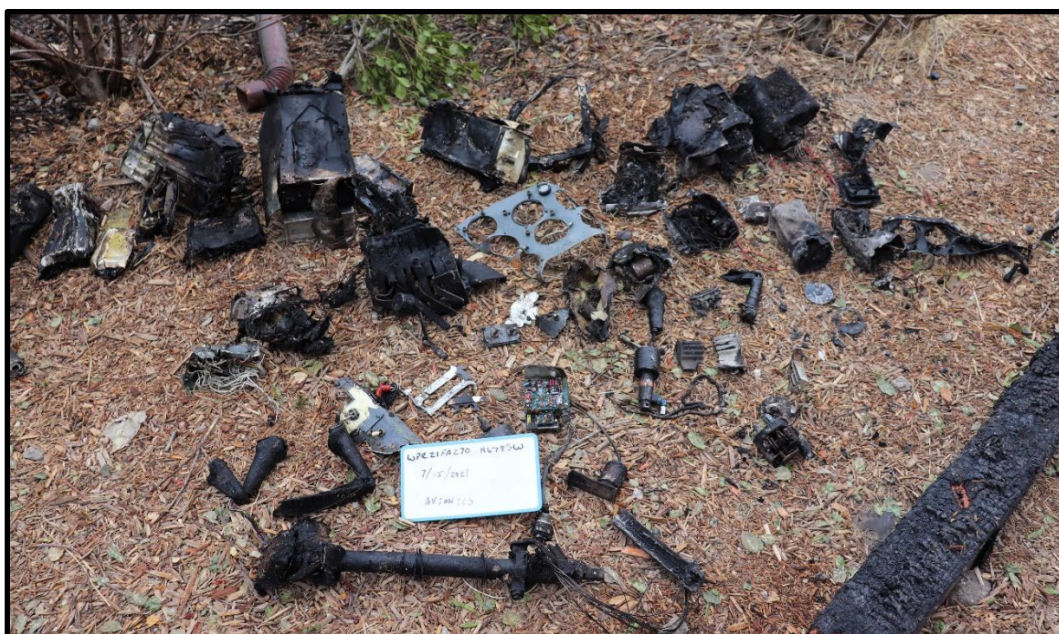
Figure 4: View of airplane instruments (photo courtesy of the NTSB)

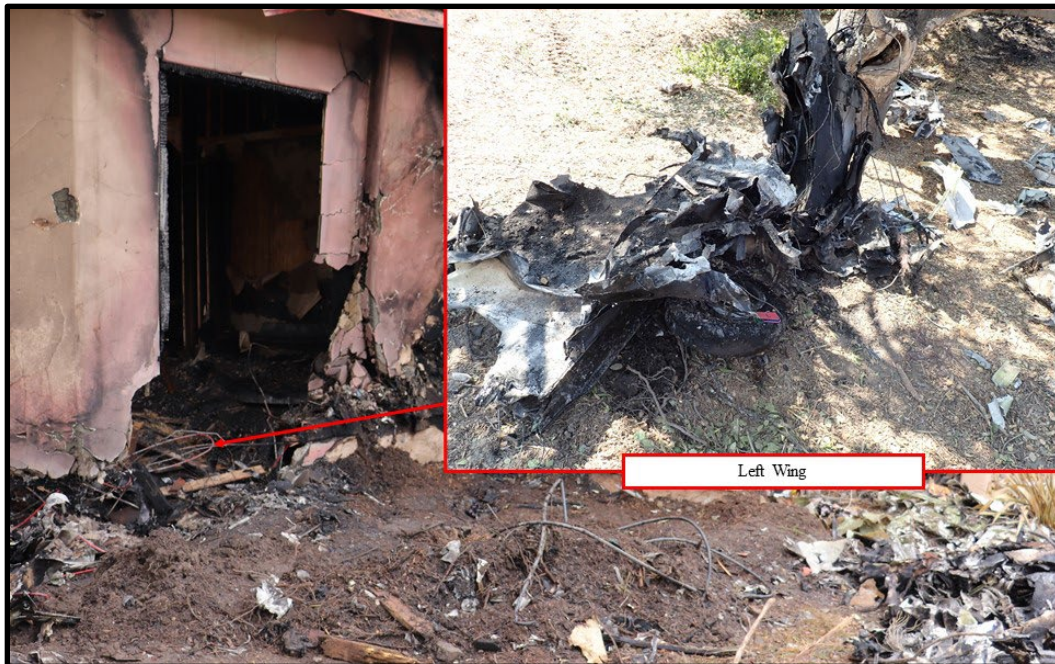
The left wing was separated at the wing root and came to rest under the southeast corner of the residence. The left wing had various portions of the wing structure separated. The outboard section of the left wing was mostly destroyed. A section of about 3 ft leading edge with fuel cap attached exhibited thermal damage. The portion that remained attached to the center section was bent, buckled, and torn throughout. The left flap, aileron, outboard portion of the wing structure were separated. A 15-inch section of outboard left aileron and a 3 ft section of aileron trim hinge (full pin length) had thermal and impact damage. Sections of the left lower wing skin were

Figure 5: View of left wing location (photo courtesy of the NTSB)

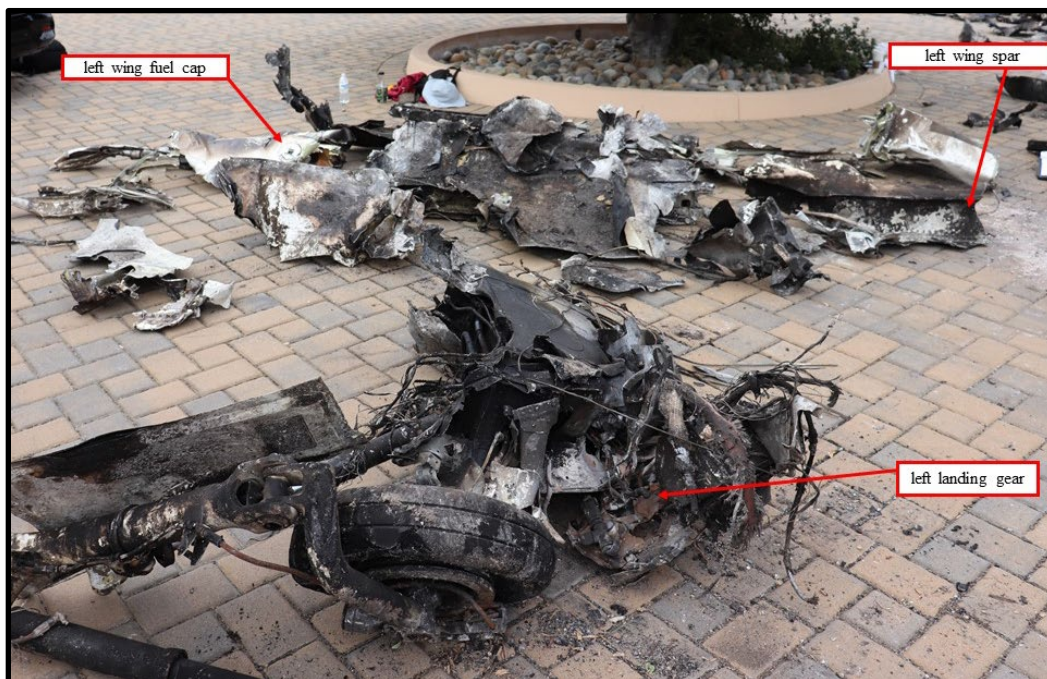
identified by fuel panels. A 2 ft section of leading edge exhibited extensive compression damage consistent with tree impact. The left main landing gear was separated from the wing attachment points, was in the retracted position and thermal damaged. While the landing gear was being recovered from under the residence, it was extended.

Figure 6: View of left wing (photo courtesy of the NTSB)

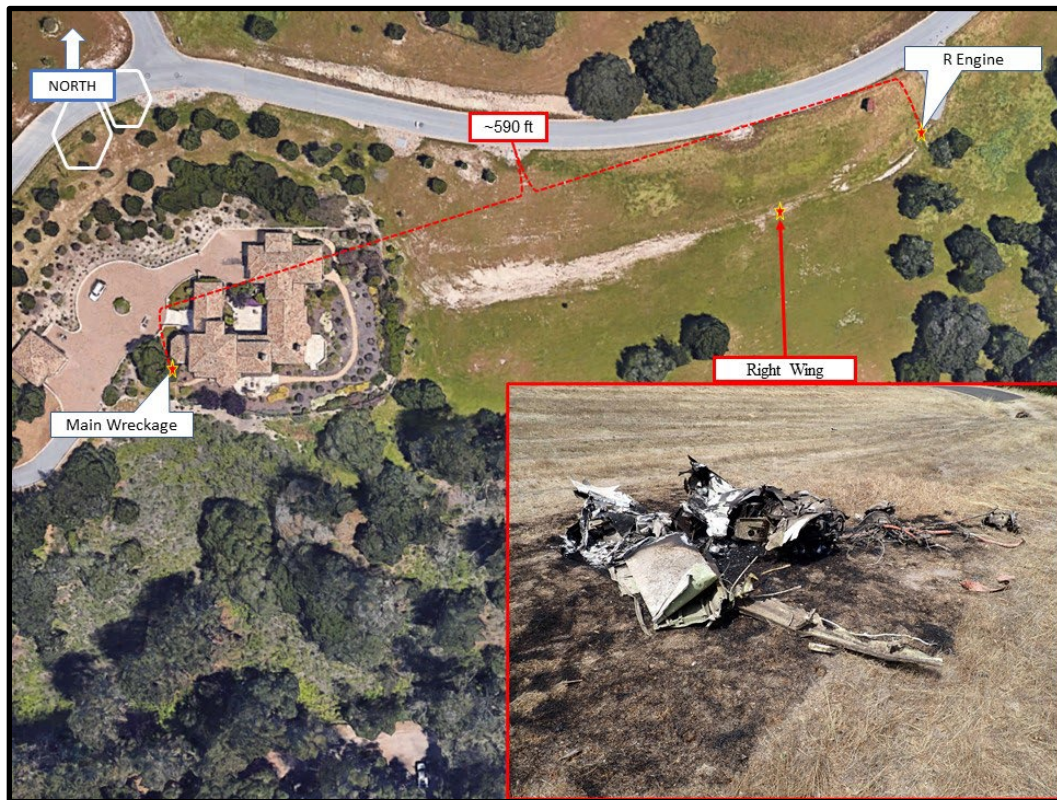
The right wing was separated at the wing root and came to rest in a field about 460 ft northeast of the main wreckage. The right wing had various portions of the wing structure separated. A section of about 5 ft leading edge with fuel cap attached exhibited impact damage. The portion that remained attached to the center section was thermal damaged, bent, buckled, and torn throughout. The right aileron separated and was mostly intact, however, bent and buckled throughout. The right flap separated, had thermal damage about mid span, was bent and buckled throughout. The right main landing gear was separated from the wing attachment points and was in the retracted position.

Figure 7: View of right wing in field (photo courtesy of the NTSB)

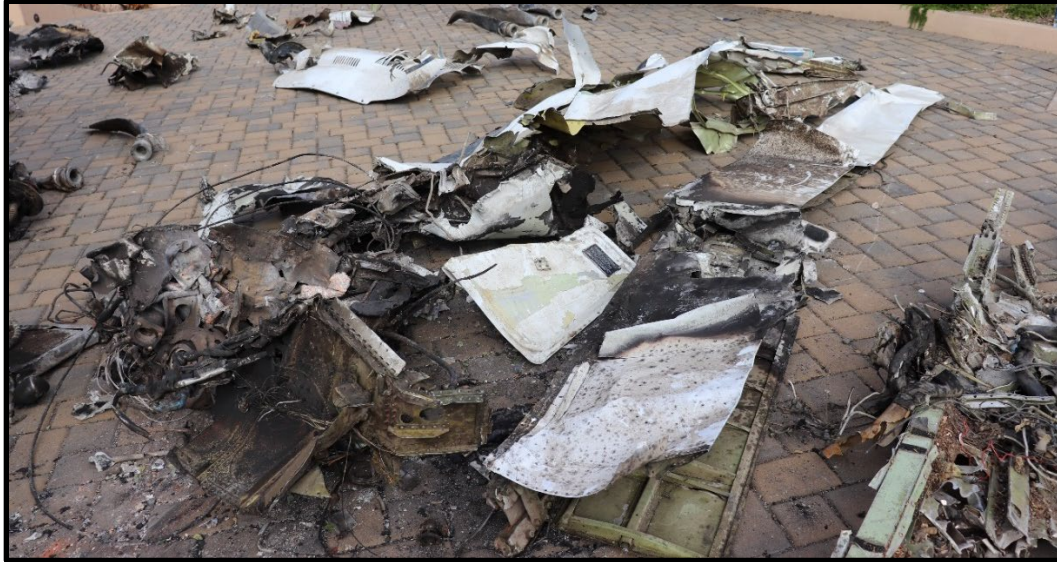
Figure 8: View of right wing (photo courtesy of the NTSB)

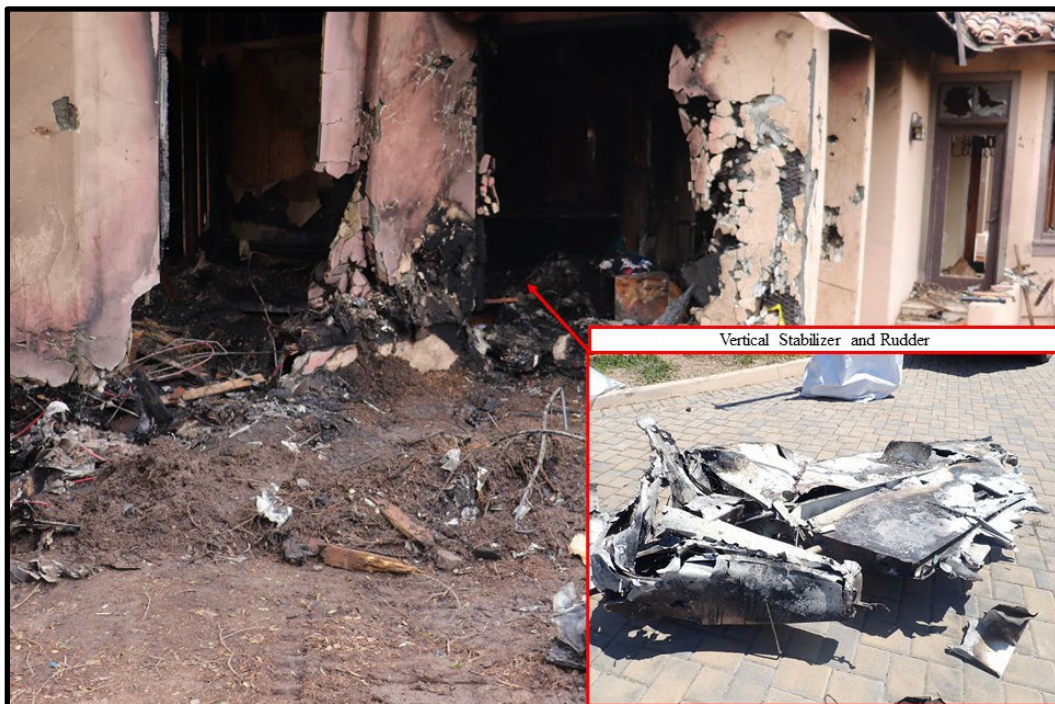
The empennage was separated from the fuselage and came to rest in room on the southeast corner of the residence. The vertical stabilizer was separated from the empennage, exhibited thermal damage, crushing and bending throughout. The rudder remained attached to the vertical stabilizer buy the attachment points and exhibited thermal damage, crushing, and bending throughout. The left and right horizontal stabilizers were separated from the empennage and mostly destroyed. The left and right elevators were separated from the horizontal stabilizers and mostly destroyed.

Figure 9: View of empennage location (photo courtesy of the NTSB)

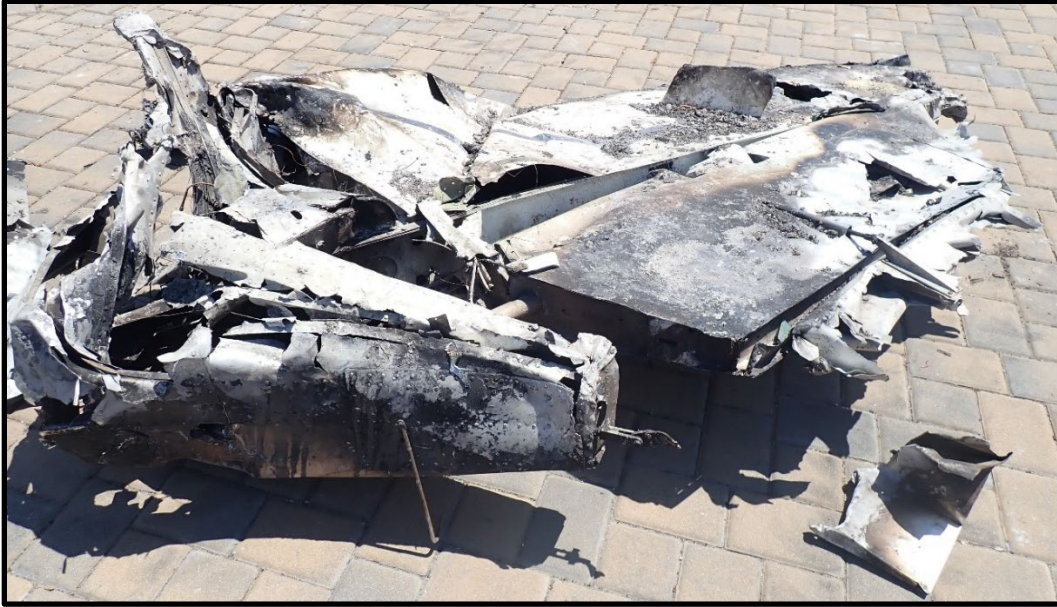
Figure 10: View of vertical stabilizer and rudder (photo courtesy of the NTSB)

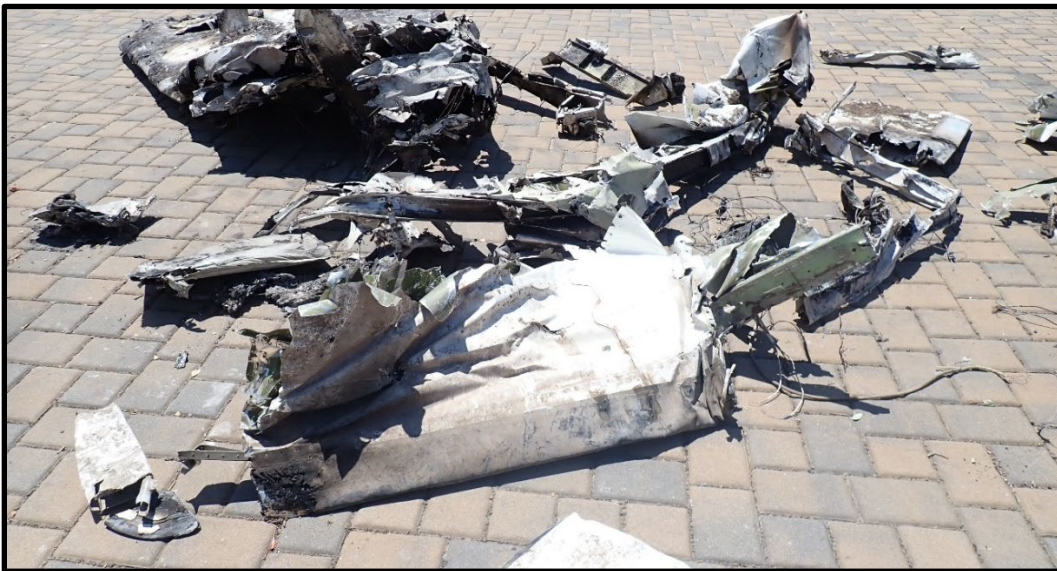
Figure 11: View of horizontal stabilizer and elevator (photo courtesy of the NTSB)

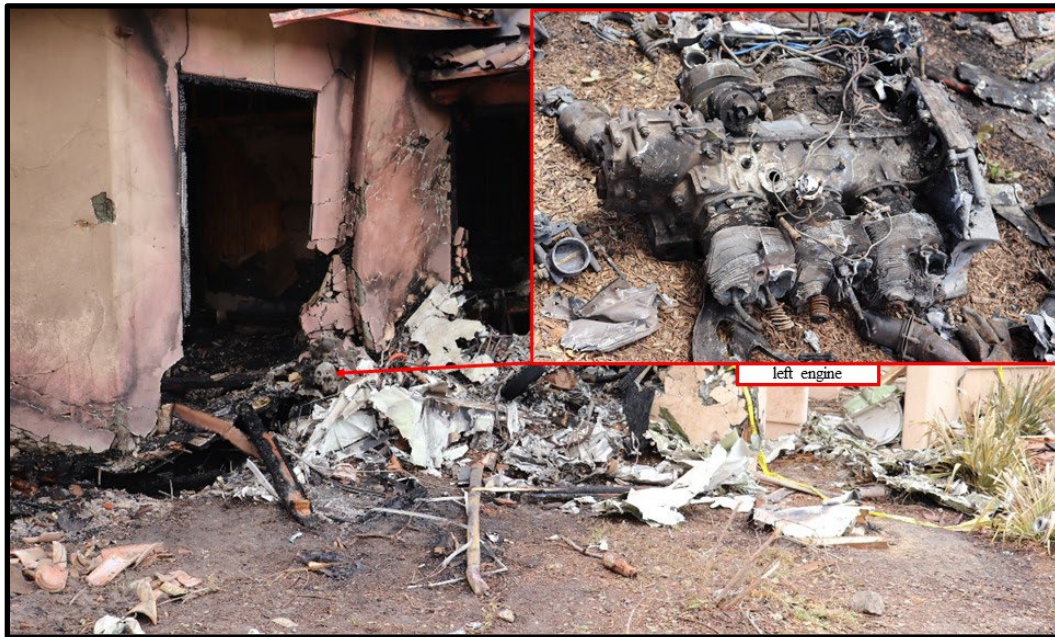
The left engine was separated from the wing and came to rest adjacent to the main wreckage. All four engine mounts had fracture separated. All six cylinders remained attached, exhibited thermal and impact damage. All engine accessories, both magnetos, fuel manifold valve, intake and exhaust were separated, exhibited thermal and impact damage. The fuel manifold valve was observed in the closed position. The propeller hub and reduction gearbox were separated from the engine.

Figure 12: View of the left engine location (photo courtesy of the NTSB)

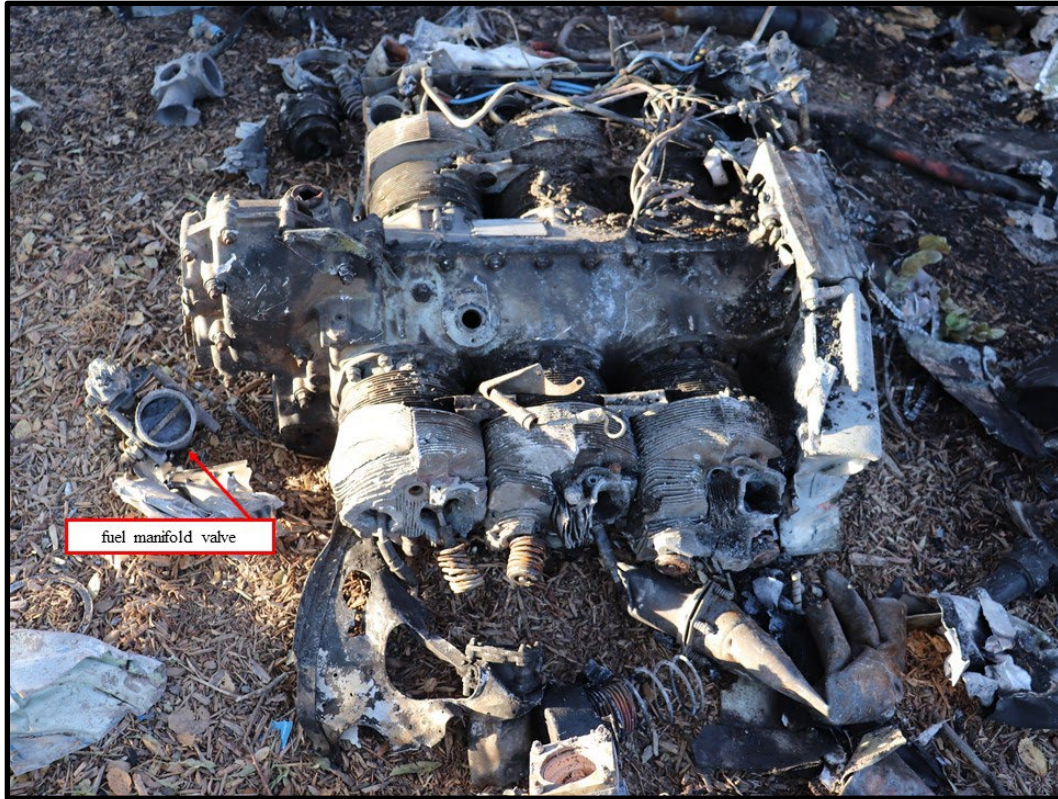
Figure 13: View of left engine (photo courtesy of the NTSB)

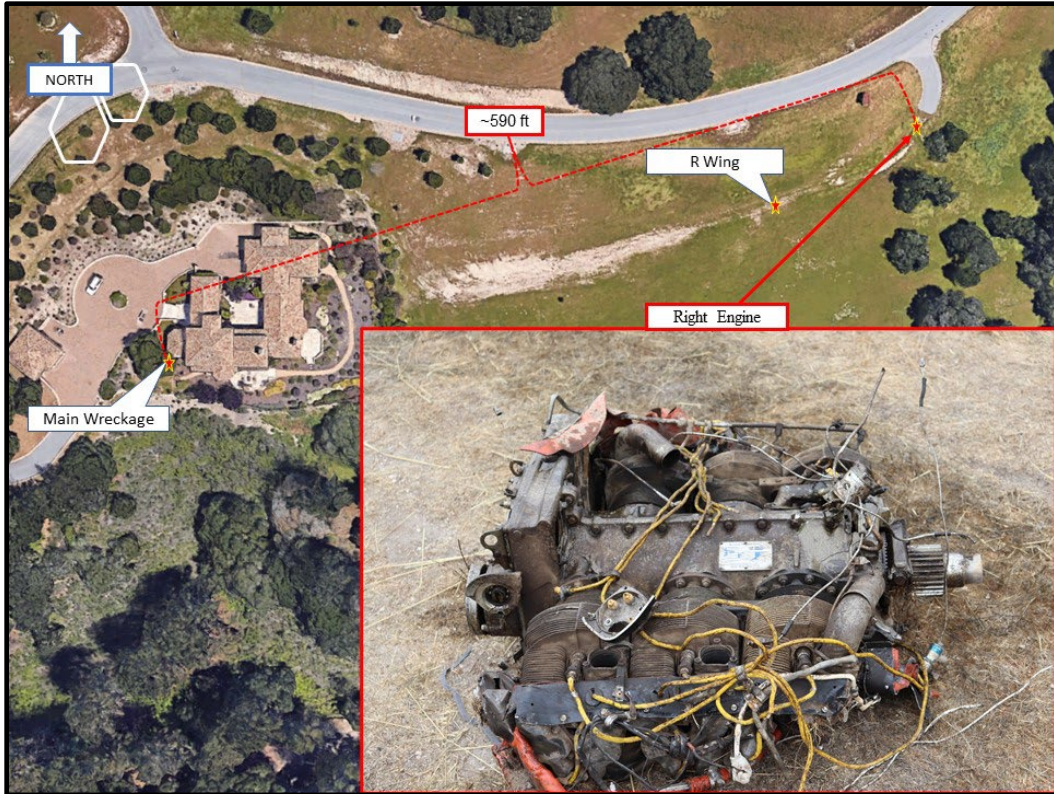
The right engine was separated from the wing and came to rest in a field about 590 ft northeast of the main wreckage. All six cylinders remained attached, exhibited thermal and impact damage. All engine accessories, both magnetos, fuel manifold valve, intake and exhaust were separated, exhibited thermal and impact damage. The fuel manifold valve was intact and observed in the open position. The propeller hub and reduction gearbox were separated from the engine.

Figure 14: View of right engine location (photo courtesy of the NTSB)

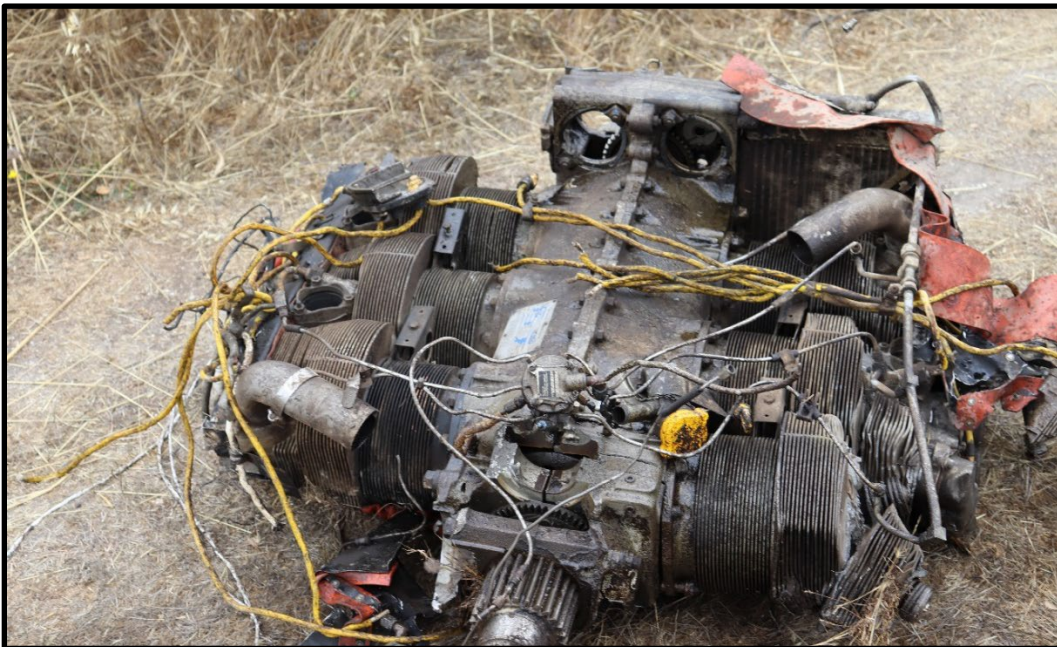
Figure 15: View of right engine (photo courtesy of the NTSB)

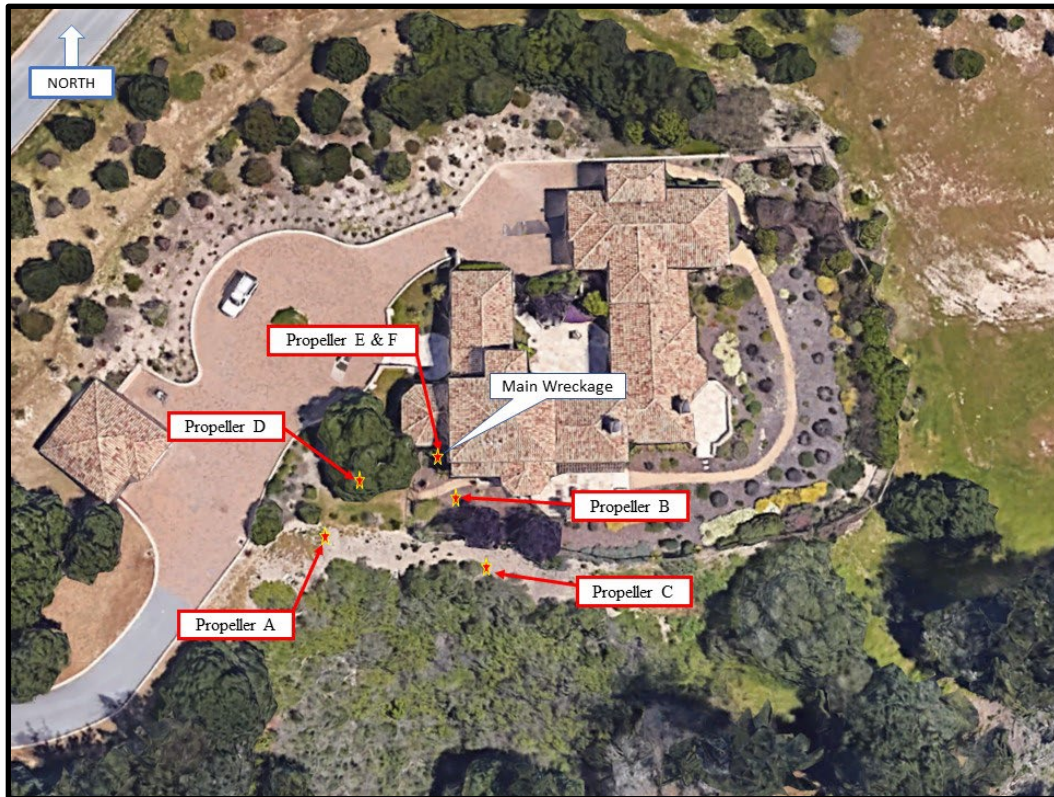
maintenance records could not establish positive confirmation. Propeller blade A (sr# K133404), separated from the propeller hub and came to rest about 45 ft southwest of the main wreckage. Propeller blade B (sr# K133386), separated from the propeller hub and came to rest about 10 ft south of the main wreckage. Propeller blade C (sr# K rest unreadable), separated from the propeller hub and came to rest about 30 ft southeast of the main wreckage. Propeller blade D (sr# CB 163), separated from the propeller hub and came to rest about 10 ft west of the main wreckage. Propeller blade E (sr# unknown), remained attached to the propeller hub (sr# 001202) and came to rest adjacent to the main wreckage. Propeller blade F (sr# CB 268), separated from the and came to rest adjacent to the main wreckage.

Figure 16: View of propeller locations (photo courtesy of the NTSB)

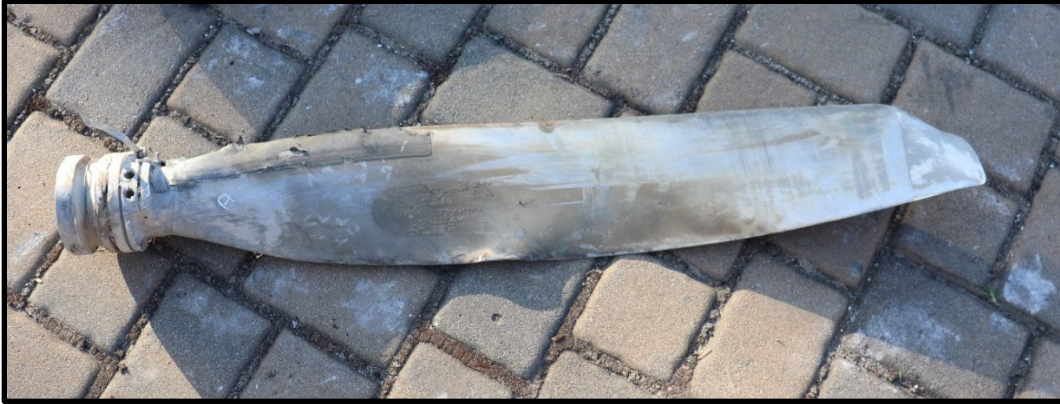
Propeller blade A exhibited bending aft near the tip, with polishing of the blade face along with chordwise striations on the cambered side of the blade. Propeller blade B exhibited bending aft about mid span with polishing of the blade face along with unidirectional striations on the cambered side of the blade. Propeller blade C exhibited bending aft near the tip, with polishing of the blade face along with chordwise striations on the cambered side of the blade. Propeller blade D exhibited impact damage on the trailing edge near mid span, with aft bending near the tip and polishing of the blade face along with chordwise striations on the cambered side of the blade. Propeller blade E remained attached to the propeller hub, exhibited S bending about mid span with polishing of the blade face along with unidirectional striations on the cambered side of the blade. Propeller blade F exhibited bending aft about mid span with polishing of the blade face along with unidirectional striations on the cambered side of the blade.

**Figure 17: View of propeller blade A (photo courtesy of the NTSB)**

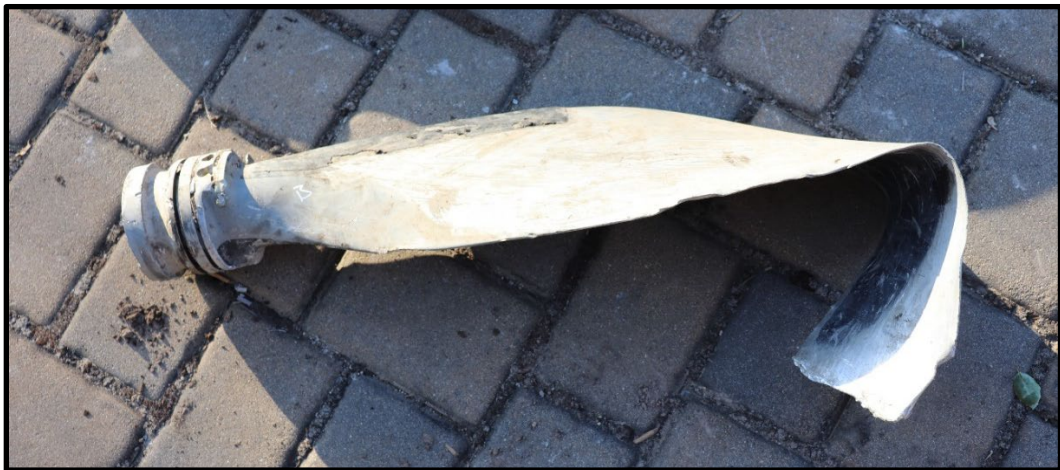
**Figure 18: View of propeller blade B (photo courtesy of the NTSB)**

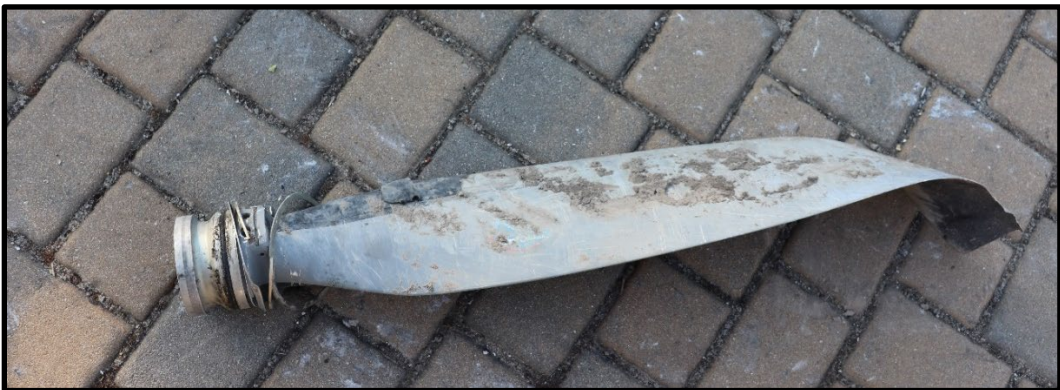
**Figure 19: View of propeller blade C (photo courtesy of the NTSB)**

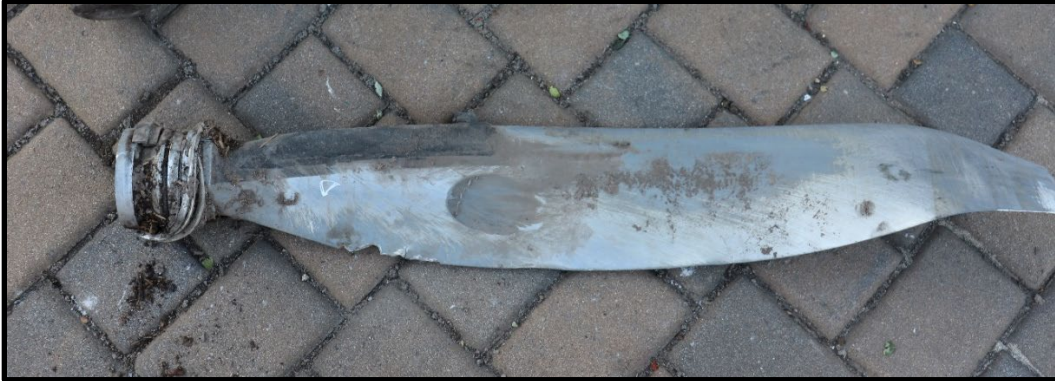
Figure 20: View of propeller blade D (photo courtesy of the NTSB)

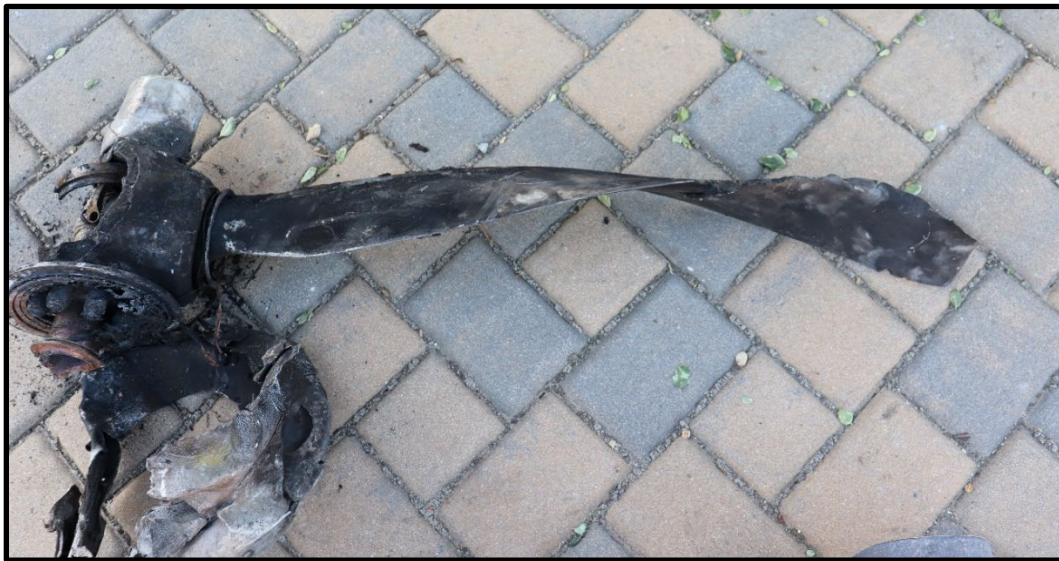
Figure 21: View of propeller blade E (photo courtesy of the NTSB)

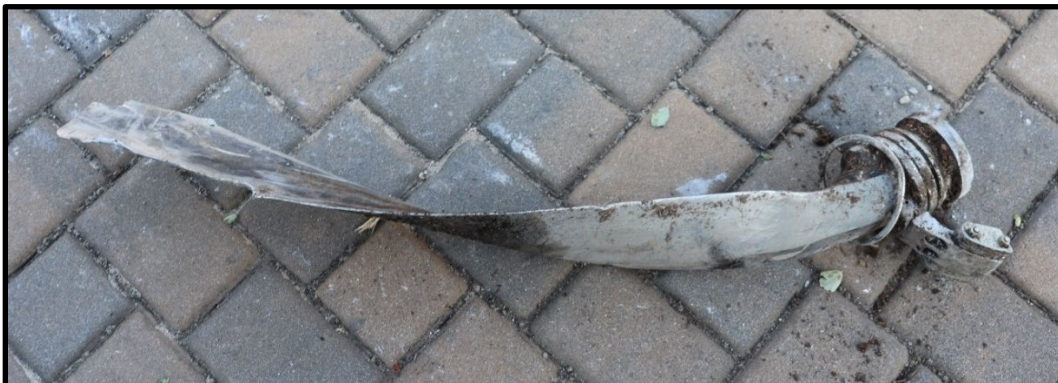
Figure 22: View of propeller blade F (photo courtesy of the NTSB)
