# **NATIONAL TRANSPORTATION SAFETY BOARD**

## **Airworthiness Group Chairman's Factual Report**

### **A. ACCIDENT      WPR21FA286**

Location:              Truckee, California  
Date:                    July 26, 2021  
Time:                    About 1318 Local Time  
Aircraft:                Bombardier Inc., CL-600-2B16 (604 Variant), N605TR

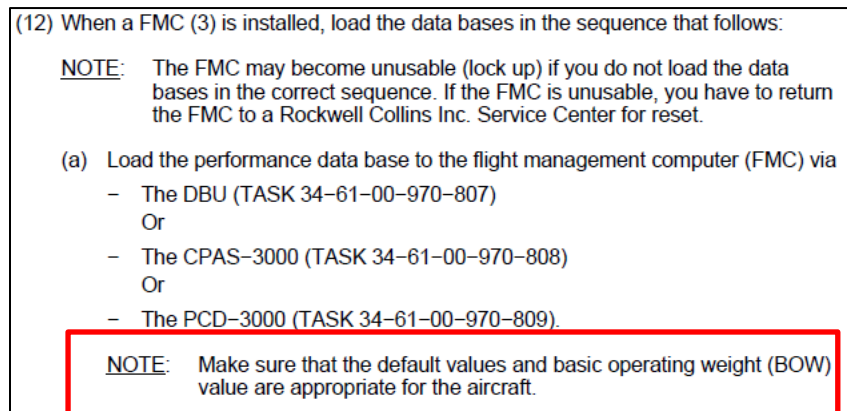
3. **TASK 22-12-16-400-801**, "Installation of the Flight Management Computer", details the re-installation of the FMC(s) into the airplane. After the FMC is re-installed into the IAPS Cage, it is necessary to restore information into its memory; the appropriate databases need to be re-installed. Procedure Step E. (12) of the task lists all the databases that are required to be loaded into each FMC following installation. In addition, at the bottom of Page 407 is the following note: "Make sure that the default values and basic operating weight (BOW) value are appropriate for the aircraft." See excerpt below, Figure 1.

Figure 1 - Excerpt from Maintenance Task, With Basic Operating Weight Note in Red Box (Courtesy of Bombardier Aircraft)

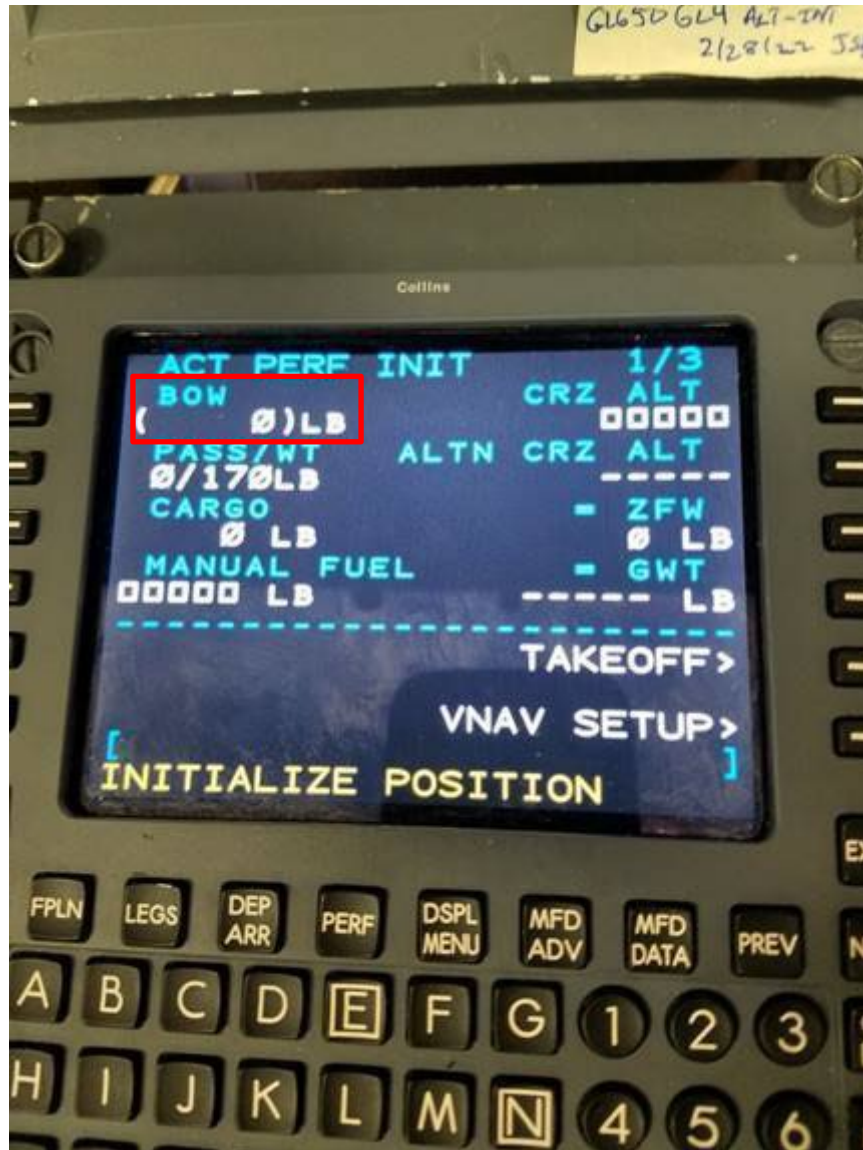
Collins Aerospace conducted a test using their FMC-6000 and CDU Test Bench and Simulator. First, after installing an FMC-6000 card into the simulator, they simulated a removal of the battery by clearing all information from the FMC card. Checking the weight entry on the ACFT PERF INIT page of the FMC, Collins confirmed that, after clearing the FMC memory, the BOW is cleared (zero weight). See Figure 2.

Figure 2 - After clearing the FMC the BOW is cleared as shown. BOW value is boxed in red.  
(Photograph courtesy of Collins Aerospace)

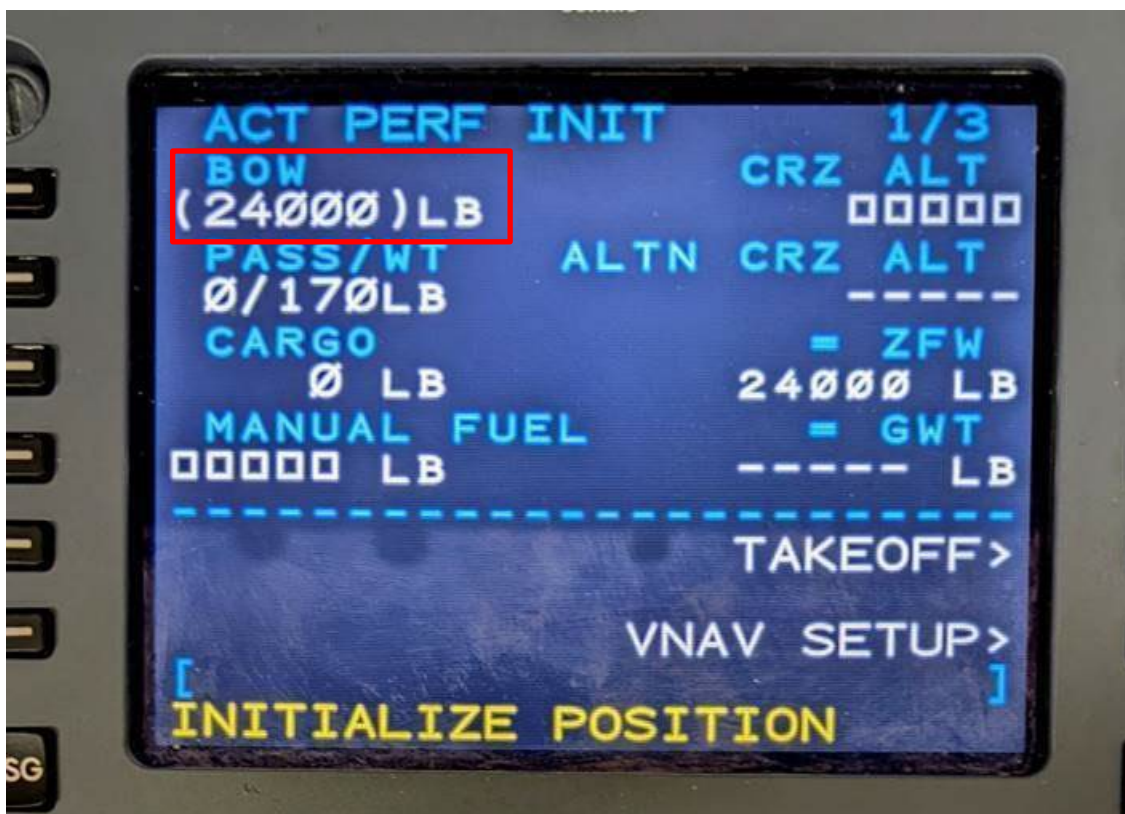
After re-installing the appropriate performance databases, and without any additional weight entries by the user, Collins confirmed that the BOW reverted to 24,000 pounds. See Figure 3.

Figure 3 - After re-installing the performance databases, the default BOW is 24,000 pounds, as shown in red box. (Photograph courtesy of Collins Aerospace)
