## **NATIONAL TRANSPORTATION SAFETY BOARD**

### **ONSITE EXAMINATION NOTES**

**WPR21FA288**

Location: Tucson, AZ  
Date: July 27, 2021  
Aircraft: N966EZ  
NTSB IIC: Albert Nixon

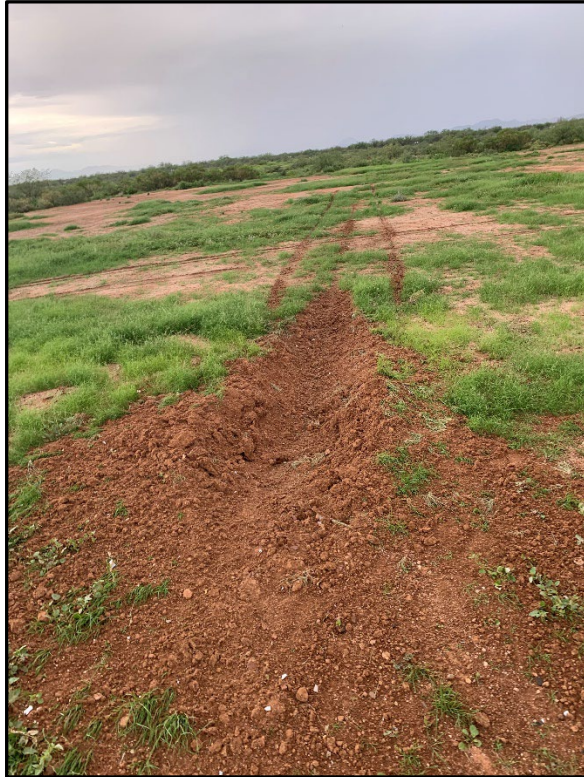
Examination of the accident site revealed that the airplane impacted terrain about 500 ft short of runway 06R on the extended centerline, at an elevation of about 2,390 ft. All major components of the airplane were contained within the main wreckage site. Only small pieces of wreckage debris were scattered about 200 ft from the main wreckage. The first identified point of contact was a ground scar from the left landing gear; it was followed shortly by the right landing gear and then the nose wheel. Subsequently, a large area of disturbed dirt, about 17 ft by 3 ft in size and about 12 inches deep, about 43 ft from the main wreckage. The airplane came to rest inverted in the middle of a field. There was no post impact fire.

**Figure 1: Ground Scars at the Accident Site.**

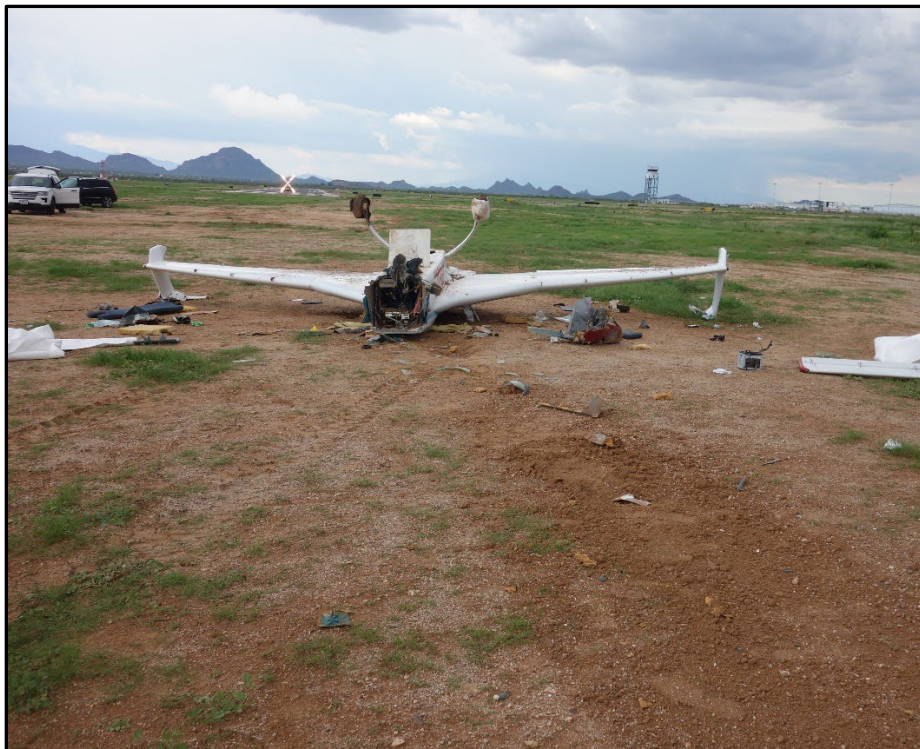
**Figure 2: Airplane Wreckage Inverted as Viewed from the Front Side.**

The fuselage came to rest on a heading of about 250° magnetic. The wings remained attached. The front portion of the fuselage, including the canards, was separated from the fuselage just in front of the rear seat. Flight control continuity was established from the rudder and ailerons to the control sticks. Both tires tracked dirt. The speed brake on the bottom of the airplane was extended.

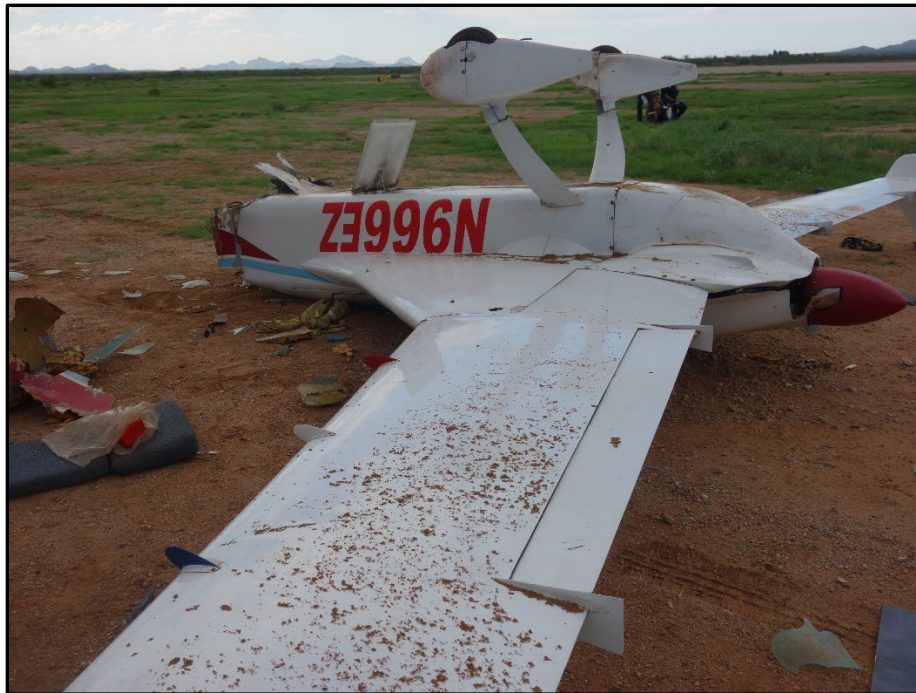
The left wing's vertical stabilizer and rudder were bent inwards about 90°. The right wing's vertical stabilizer and rudder sustained damage to the top portion.

The canopy rail remained attached and was observed to be in the latched position. However, the canopy was totally shattered into small fragments.

Figure 3: Airplane Wreckage Inverted as Viewed from the Right Side.
