## **NATIONAL TRANSPORTATION SAFETY BOARD**

# **AIRFRAME AND ENGINE EXAMINATION SUMMARY**

**WPR21FA288**

Location: Tucson, AZ  
Date: July 27, 2021  
Aircraft: N966EZ  
NTSB IIC: Albert Nixon

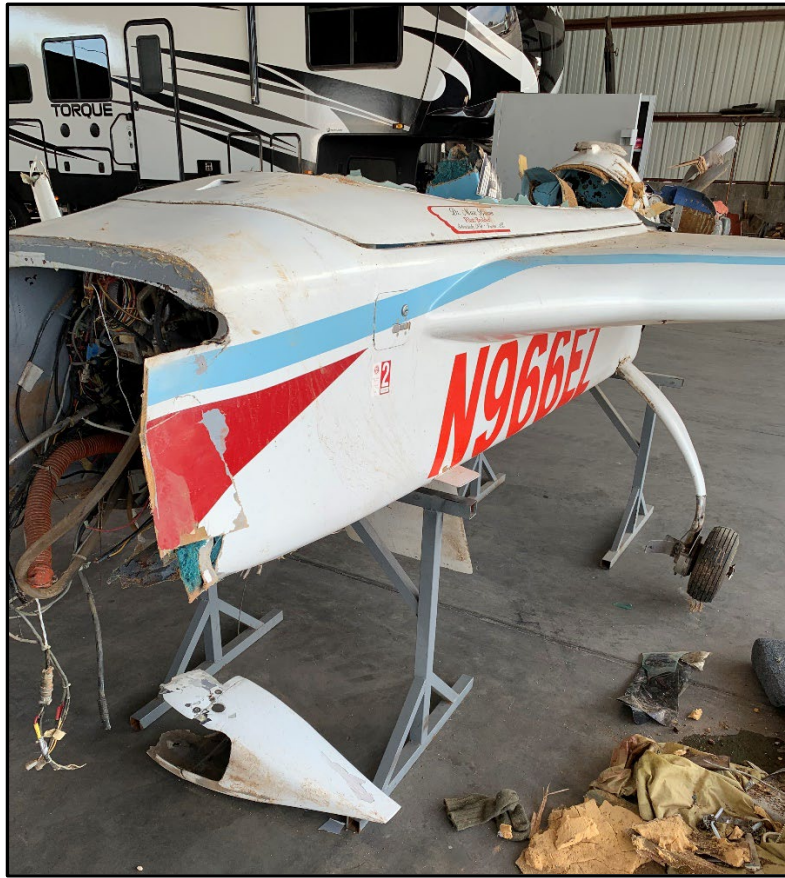
Flight control continuity was established from the rudders and ailerons to the flight control sticks. The rudders and ailerons moved freely and were attached at all their respective attach points. The canard was separated from the fuselage. Elevator continuity was established from the cockpit control sticks to the breakage in the push/pull rod at the front of the fuselage. The fracture surfaces were consistent with overload. The elevator push rod that attached to the canard was separated, however, movement of remaining portion of the flight control tube resulted in appropriate deflection of the elevator. The elevator was attached to the canard at all the respective attachment points. On the canard, the trim continuity was established. The trim

Figure 1: Airplane wreckage as viewed from the front left side.

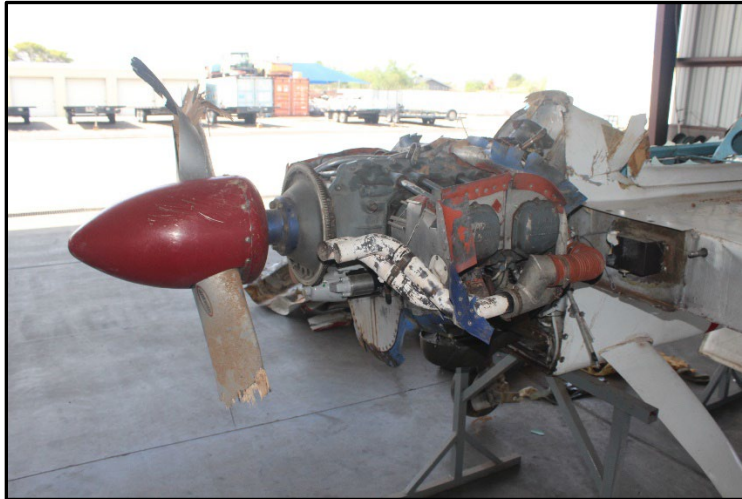
The Lycoming O-320-E2G engine was attached to the fuselage by the engine mount assembly. The airplane type had the engine installed with the engine crankshaft facing aft in a “pusher” style set up. No damage or anomalies were observed on the exterior examination of the engine.

Figure 2: The engine as viewed from the right side of the airplane during the examination.
