## Memorandum for Record

**NTSB Accident Number: WPR21FA298**  
**Aircraft Registration & Make/Model: N8520G / Cessna 150**  
**Accident Location: Banning, California**  
**Accident Date: July 30, 2021**

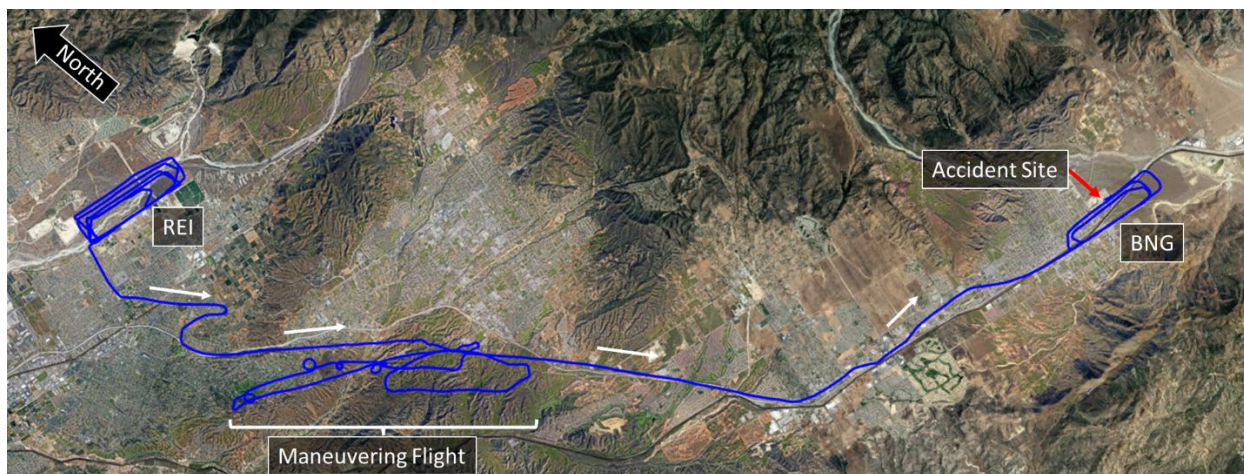
Figure 1. Image of the entire flight route.

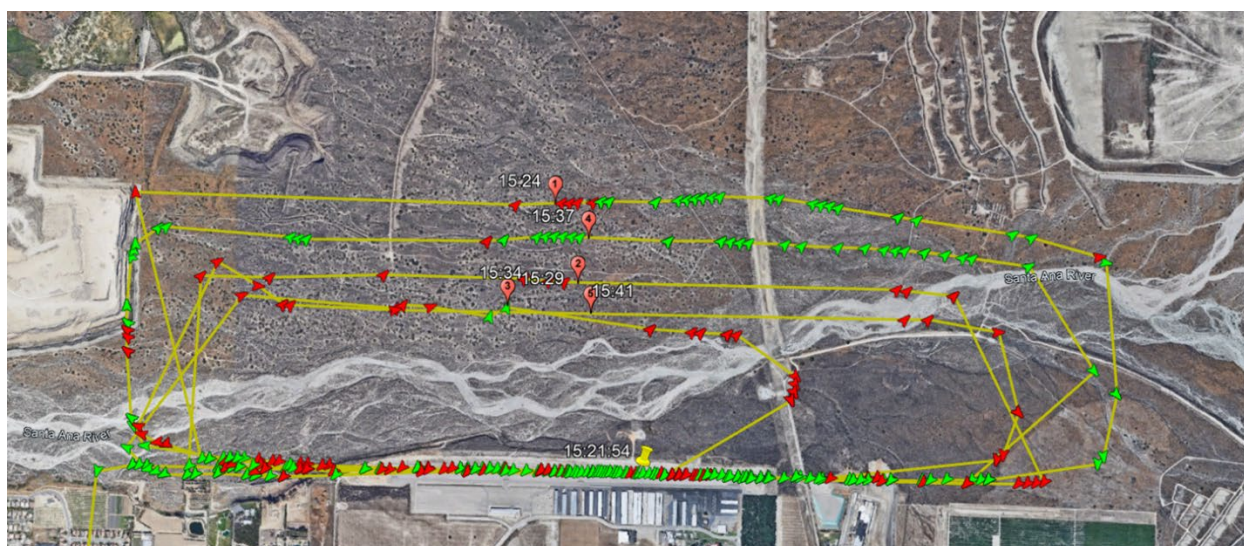
- Crossed the threshold four times and once beyond the threshold (#3)
  1. 15:26, 1,550 ft
  2. 15:31, 1,525 ft
  3. 15:35, 1,400ft
  4. 15:39, 1,500 ft
  5. 15:43, 1,500 ft

Figure 2. Image of the five traffic pattern flights at REI. The numbers identify the order of the traffic patterns.

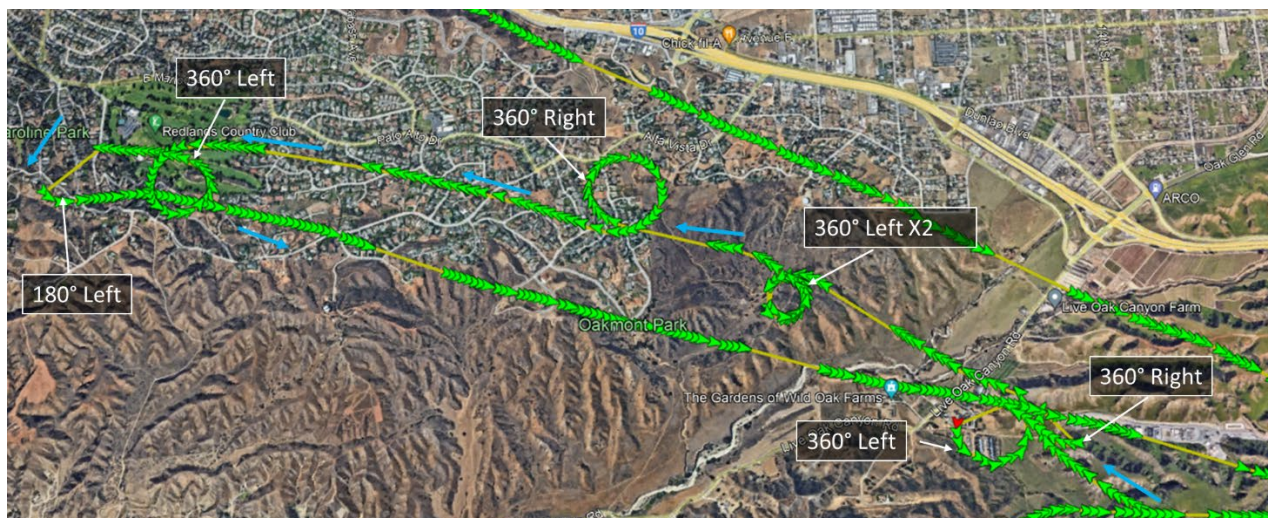
Figure 3. Image of the western half of the maneuvering flight portion of the flight.

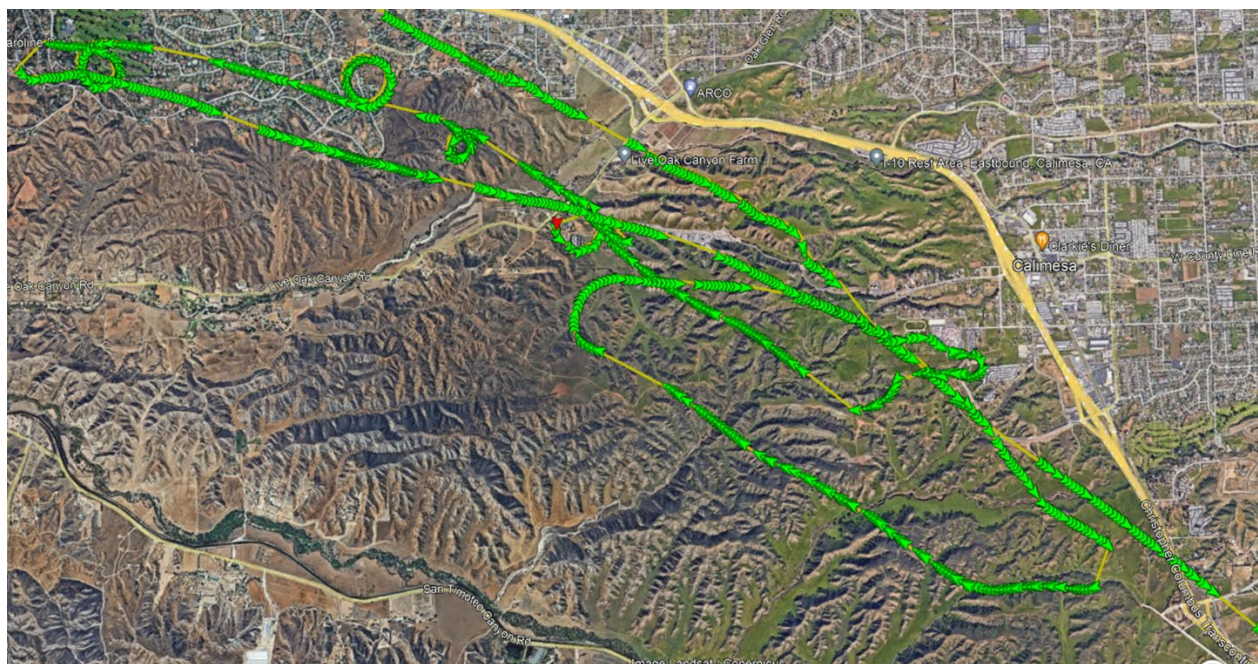
Figure 4. Image of the entire maneuvering flight portion of the flight.

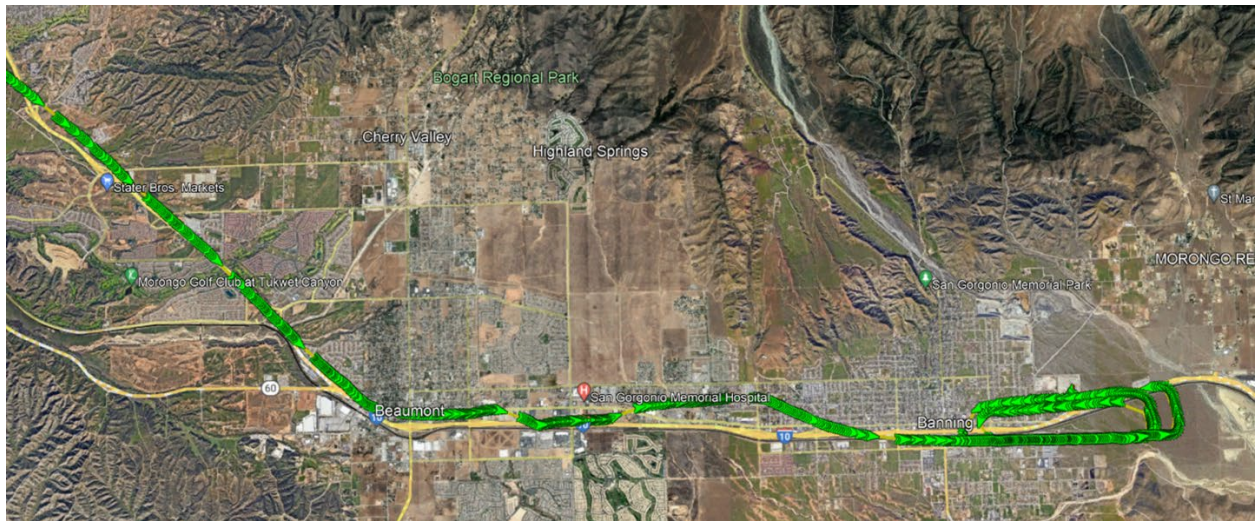
- Travelled southeast about 6 miles.
- 16:05 turned right 180°
- Travelled northwest for about 3 miles.
- 16:07, turned right 180°, travelled southeast, over the freeway to the Banning Municipal Airport, (BNG), Banning, California

Figure 5. Image showing the transition over Interstate 10 freeway to BNG.

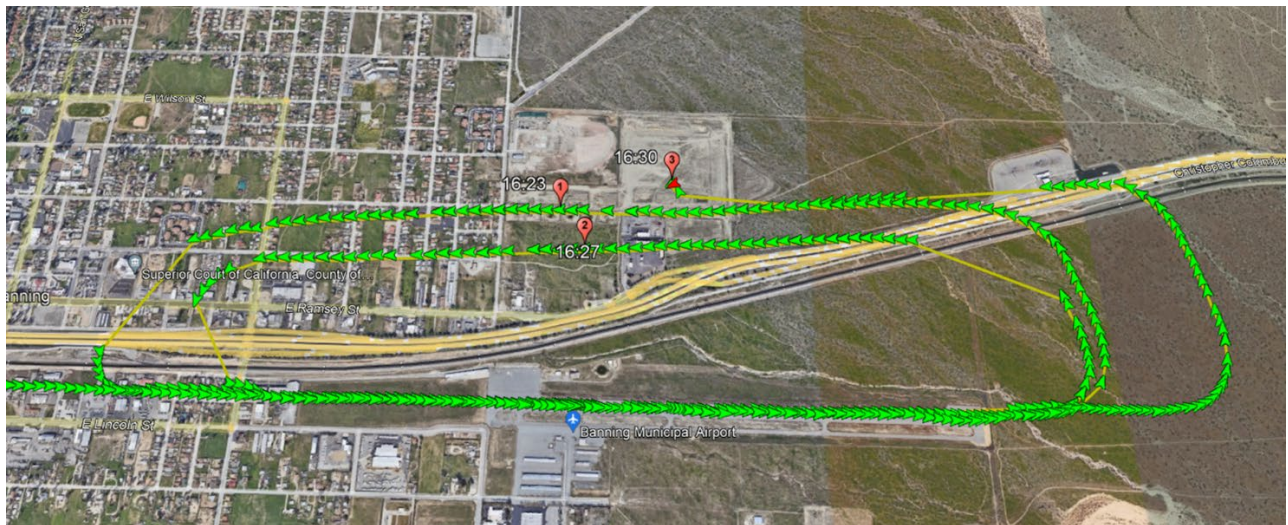
- 4<sup>th</sup> from last data point: 16:30:23, at 2,500 ft
- 3<sup>rd</sup> from last data point: 16:30:36, at 2,500 ft
- 2<sup>nd</sup> from last data plot: 16:30:38, at 2,300 ft

- Last data point: 16:30:39, at 2,200 ft. Google elevation for the accident site was 2,252 ft

Figure 6. Image showing the traffic patterns at BNG. The number 3 icon points to the accident site.
