## **NATIONAL TRANSPORTATION SAFETY BOARD**

# **AIRFRAME AND ENGINE EXAMINATION**

**WPR21FA298**

Location: Banning, California  
Date: July 30, 2021  
Aircraft: Cessna 150  
NTSB IIC: Fabian Salazar

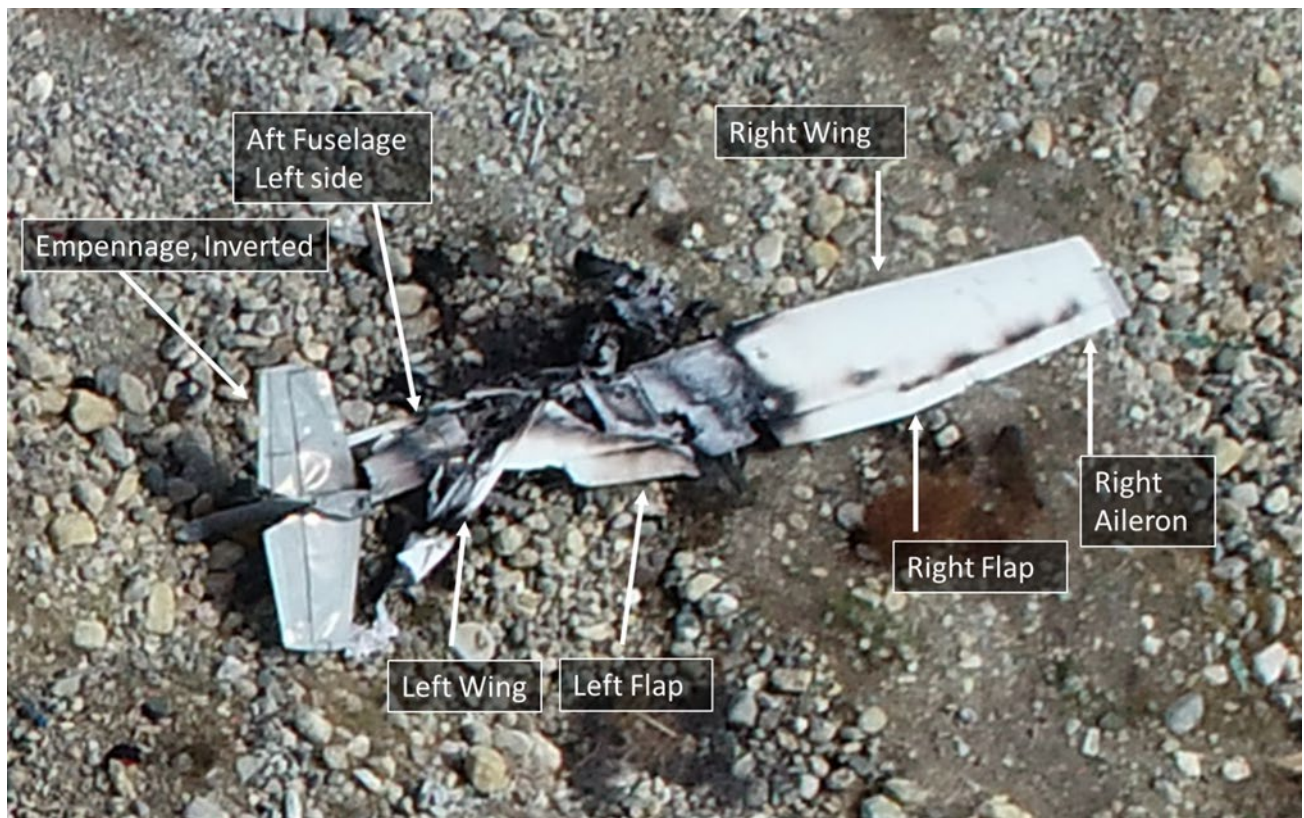
The airplane came to rest in an open rocky field, on a heading of about 045° magnetic, at an elevation of about 2,253 ft mean sea level (msl). Coordinates: 33° 55.762N 116° 51.197 W. The site was a dumping area for rocks and boulders, which varied in size from fist-size rocks to beach ball size boulders. A debris path extended away from the wreckage about 70 feet, on a bearing of about 020° magnetic. Fragments of sheet metal, engine components, left main landing gear components, and left-wing tip fragments were distributed throughout the debris path. All major components of the airplane were located with the wreckage. A post-impact fire thermally damaged the cabin area, and the right and left wings.

Figure 1. Overheard view looking north.

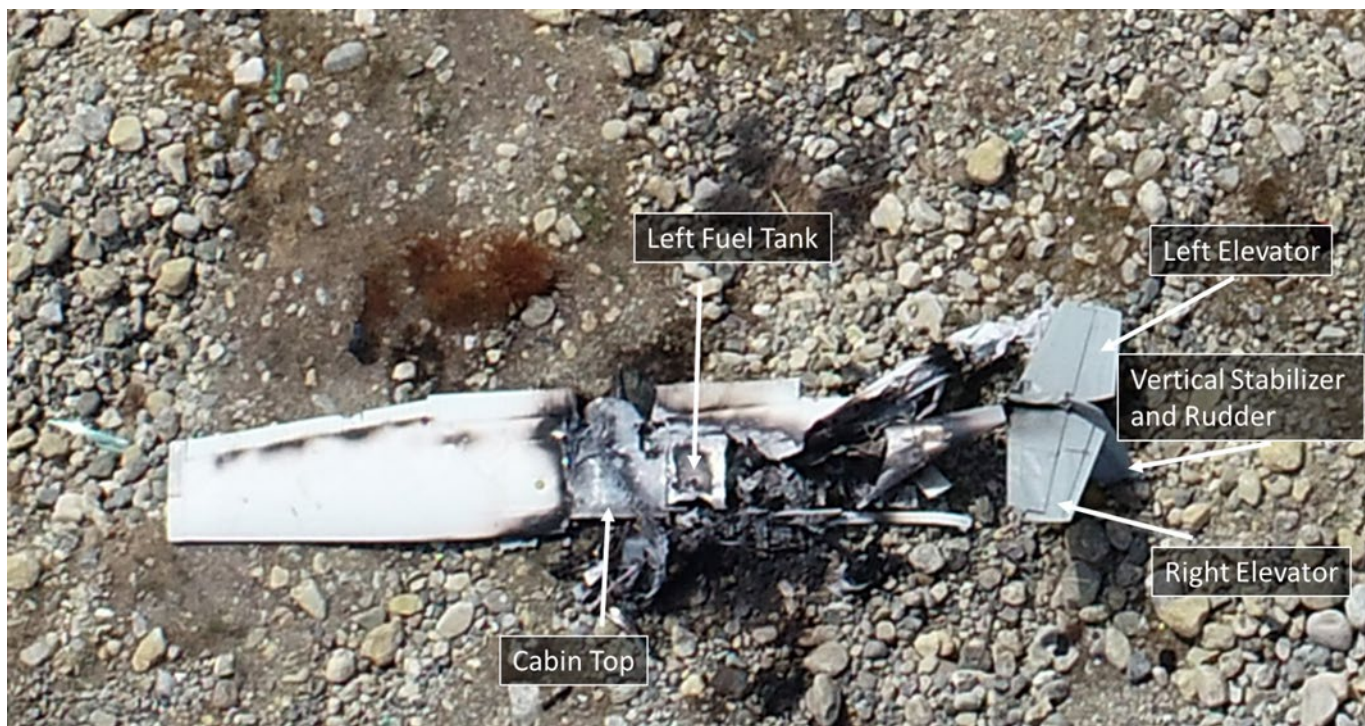
Figure 2. Overhead view looking south.

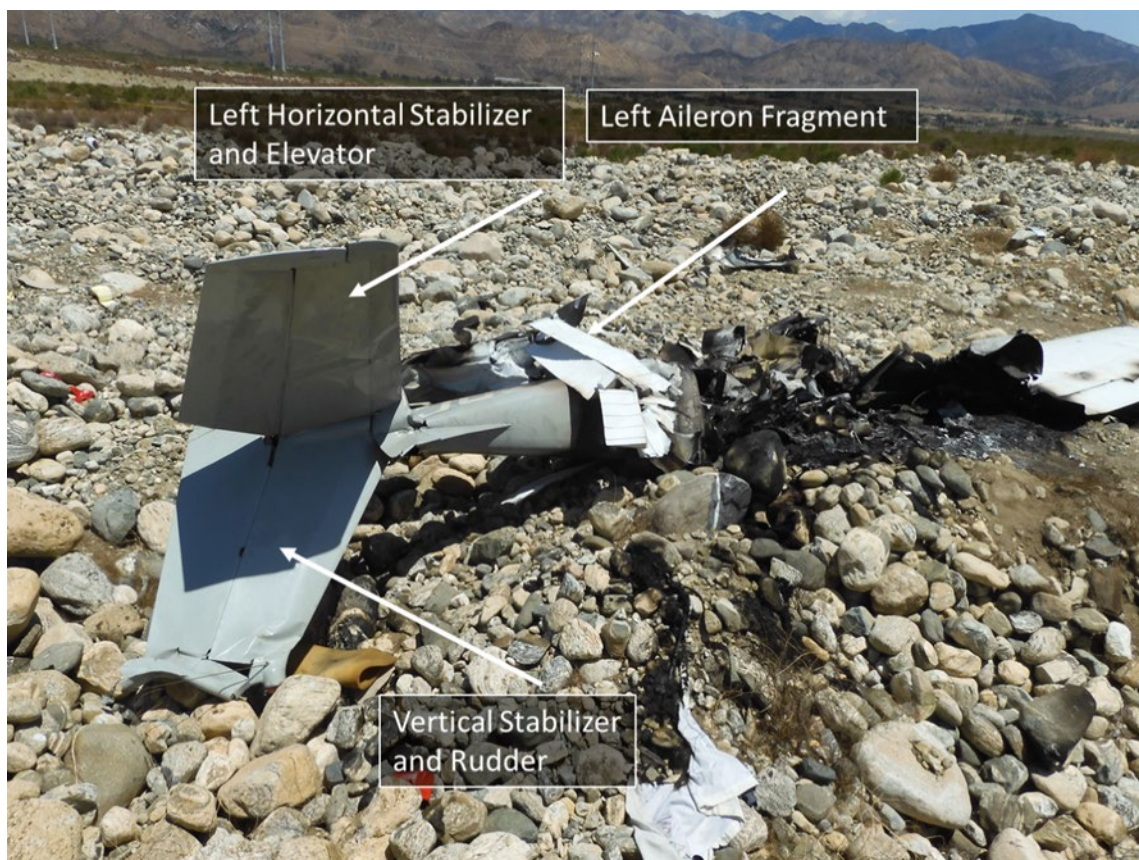
The wings partially separated from the fuselage as a unit and rotated counterclockwise about 90° so that the left wing was displaced over the aft fuselage. The left wing, near the root was thermally damaged. The left fuel tank was located almost over the cabin area and was thermally damaged. The root area of the left wing was thermally damaged. The left wing exhibited heavy aft crushing, displacing the leading edge aft about 45°. The composite left-wing tip was located at the beginning of the debris area, with the trailing edge to the left-wing tip being one of the first items in the debris area. The left fuel cap remained secured to the fuel port and was thermally damaged. The thermally damaged seal remained secured to the cap. The left aileron was fractured into multiple pieces, and partially separated from the left wing. The left flap fractured in two, with the outboard half separated and the inboard half remaining attached to the wing. The left-wing strut separated from the wing and the fuselage.

Figure 3. Empennage and left wing.

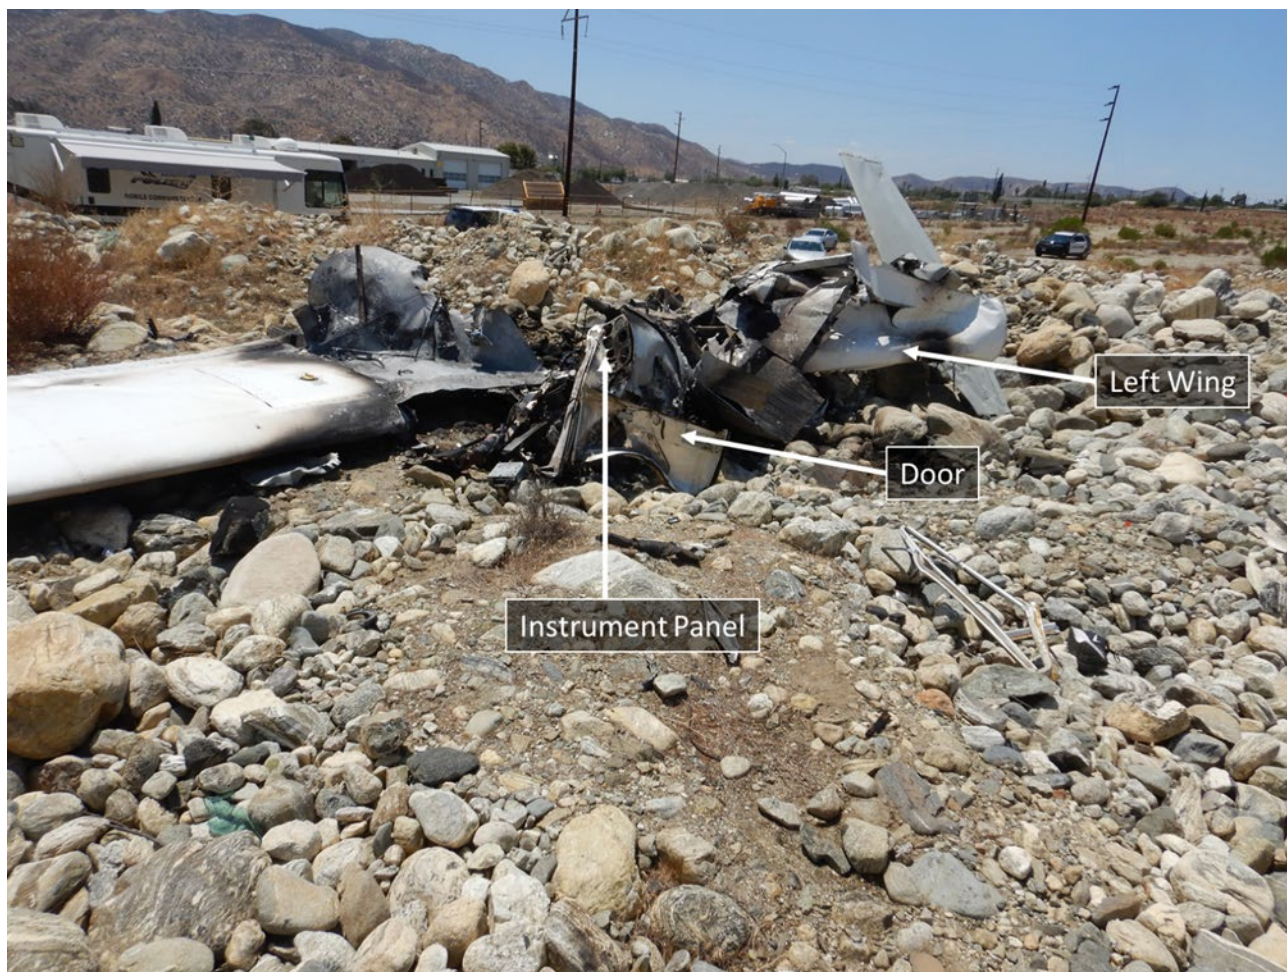
The instrument panel was thermally damaged and all instruments, except the airspeed indicator were separated from the instrument panel.

Figure 4. Instrument panel, door, and left wing.

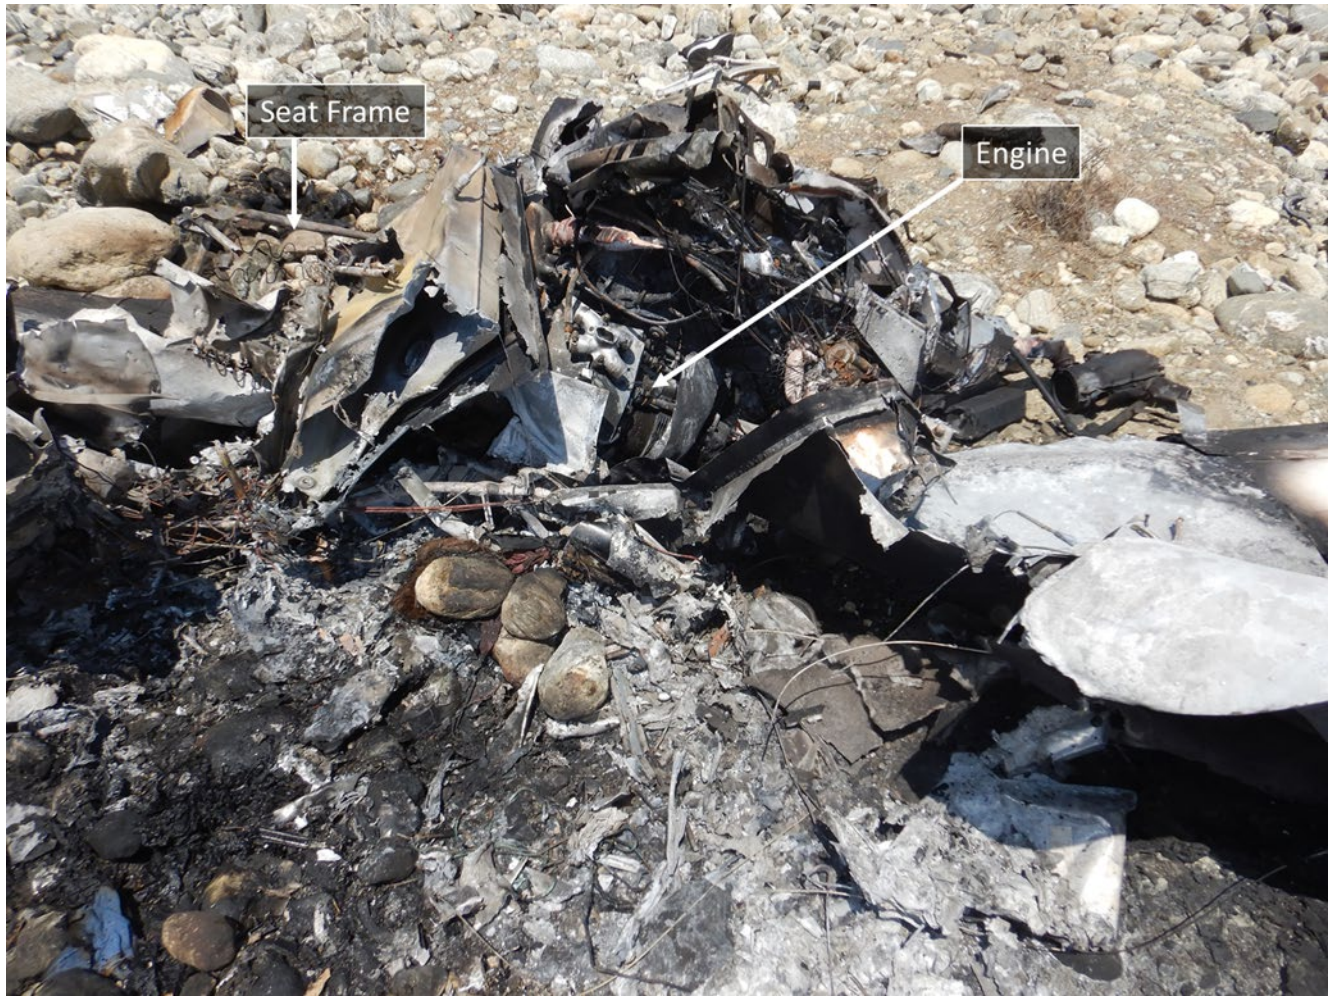
The seats separated from their tracks. All fabric was thermally consumed, leaving only the metal frames. The seatbelts were cut during recovery but both buckles appeared to be latched with the shoulder straps connected to the buckles.

Figure 5. Engine and seat frame.

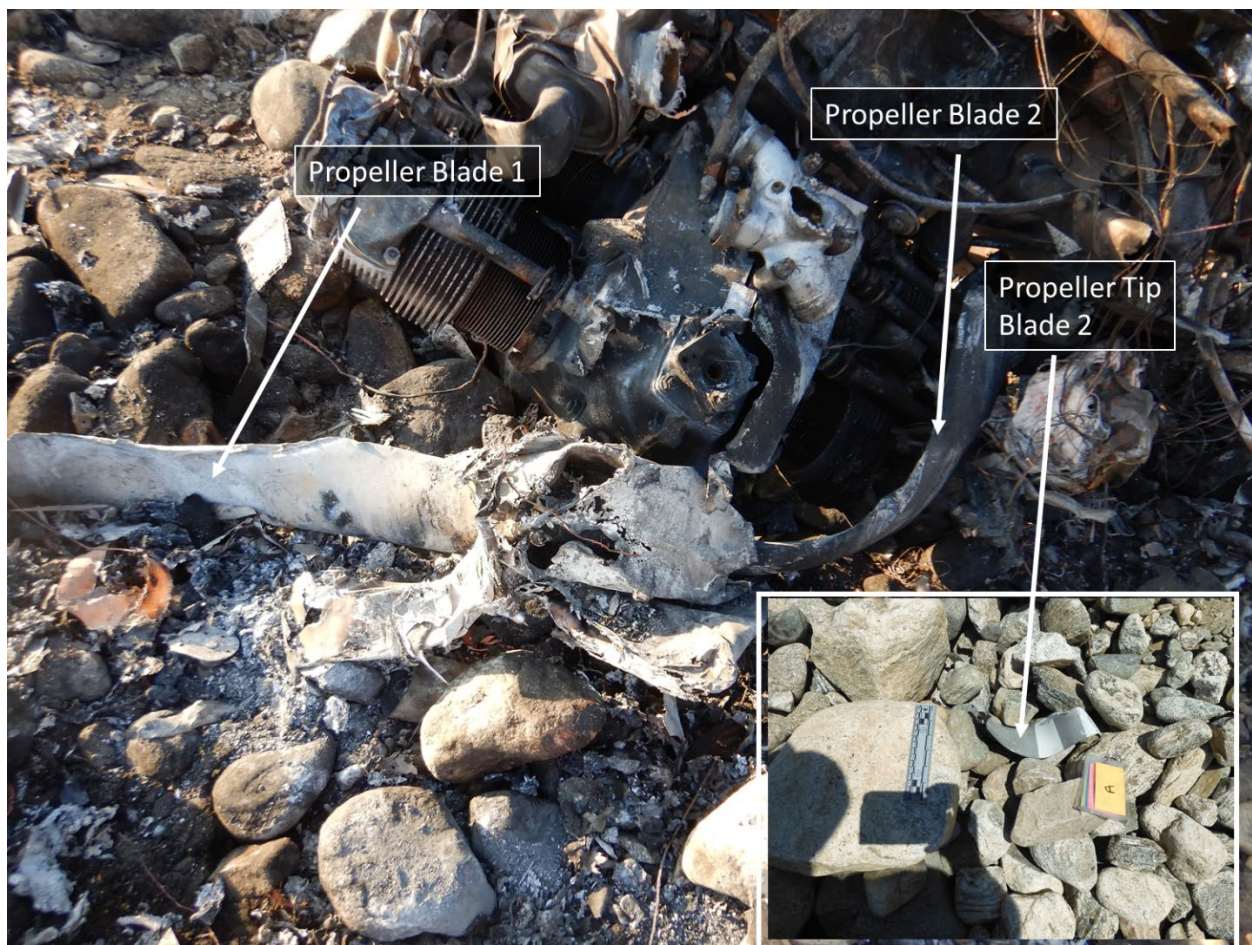
The propeller remained attached to the propeller flange and was damaged. One blade remained mostly intact and exhibited thermal damage about mid-span to the leading edge and the trailing edge. The tip was present. There was some leading-edge gouging present. The other blade was damaged and bent about 90° aft. The tip was located early in the debris field. There was heavy gouging along the leading edge, and a tear in the trailing edge, at the bend. The spinner was crushed inwards.

Figure 6. Propeller.

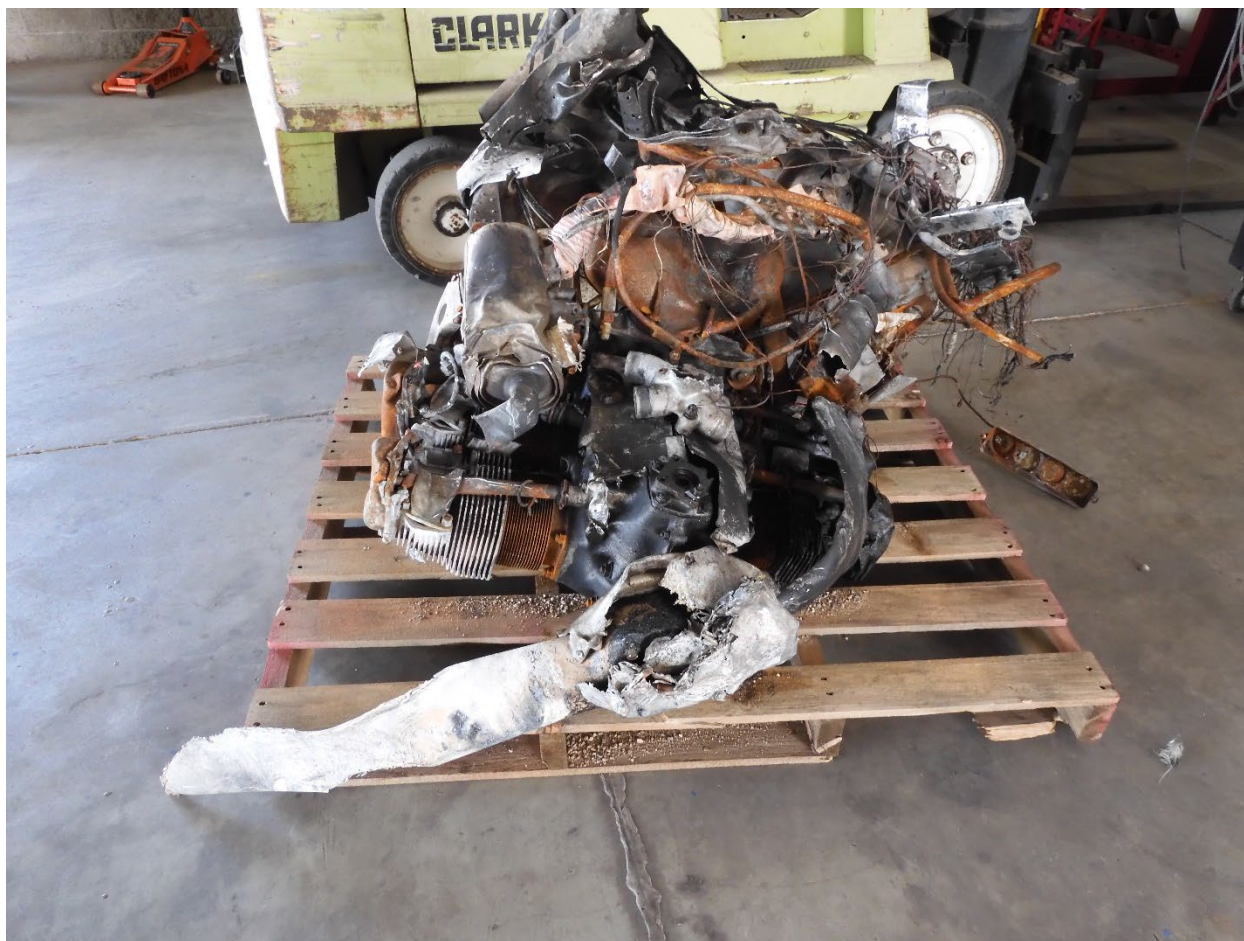
The engine remained partially attached to the fuselage at the engine mount and was in the main wreckage. The engine was inverted with the fractured intake manifold pointing upwards. The carburetor was separated and remained partially attached to the wreckage by the throttle and mixture cables. Segments of the intake tubes and some push rods with associated tubes, were located throughout the debris field. The four cylinders remained attached to the case. One cylinder exhibited impact damage to the front of the cylinder and head. The engine was shipped to a secure facility for further examination.

Figure 7. Engine at recovery facility.

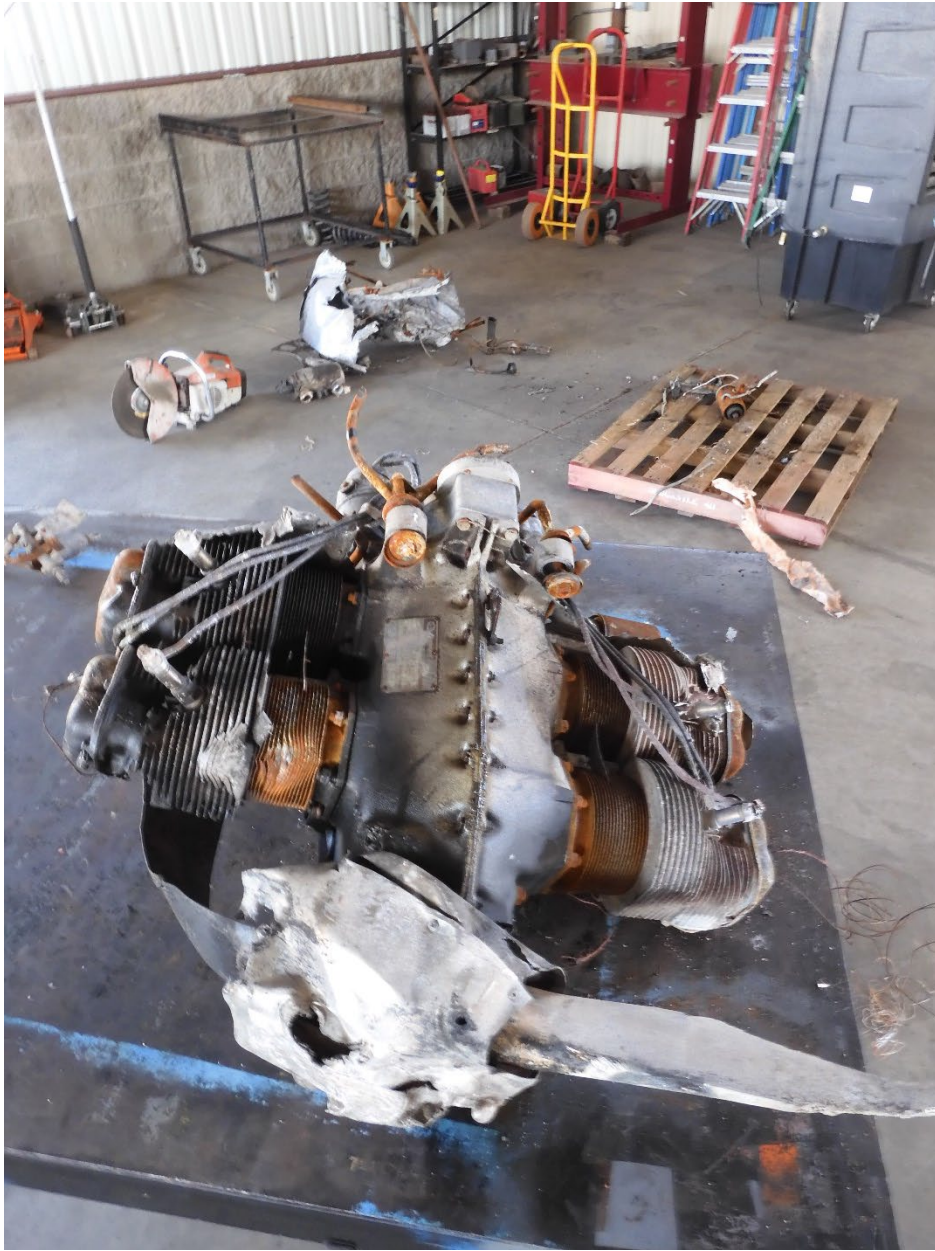
The engine Model O-200-A, Serial Number: 5721-8-A-R. The engine had been in storage upside down. The engine was removed from the airframe by cutting the engine mounts. The gascolator was removed from the firewall and examined. The gascolator was thermally damaged. The bowl contained soot consistent with burned fuel on the inside. The screen was black, and see-through, with no clogs. The end of the fuel hose was attached to the gascolator, and the opposite end held the nipple to the carburetor.

Figure 8. Engine prior to examination.

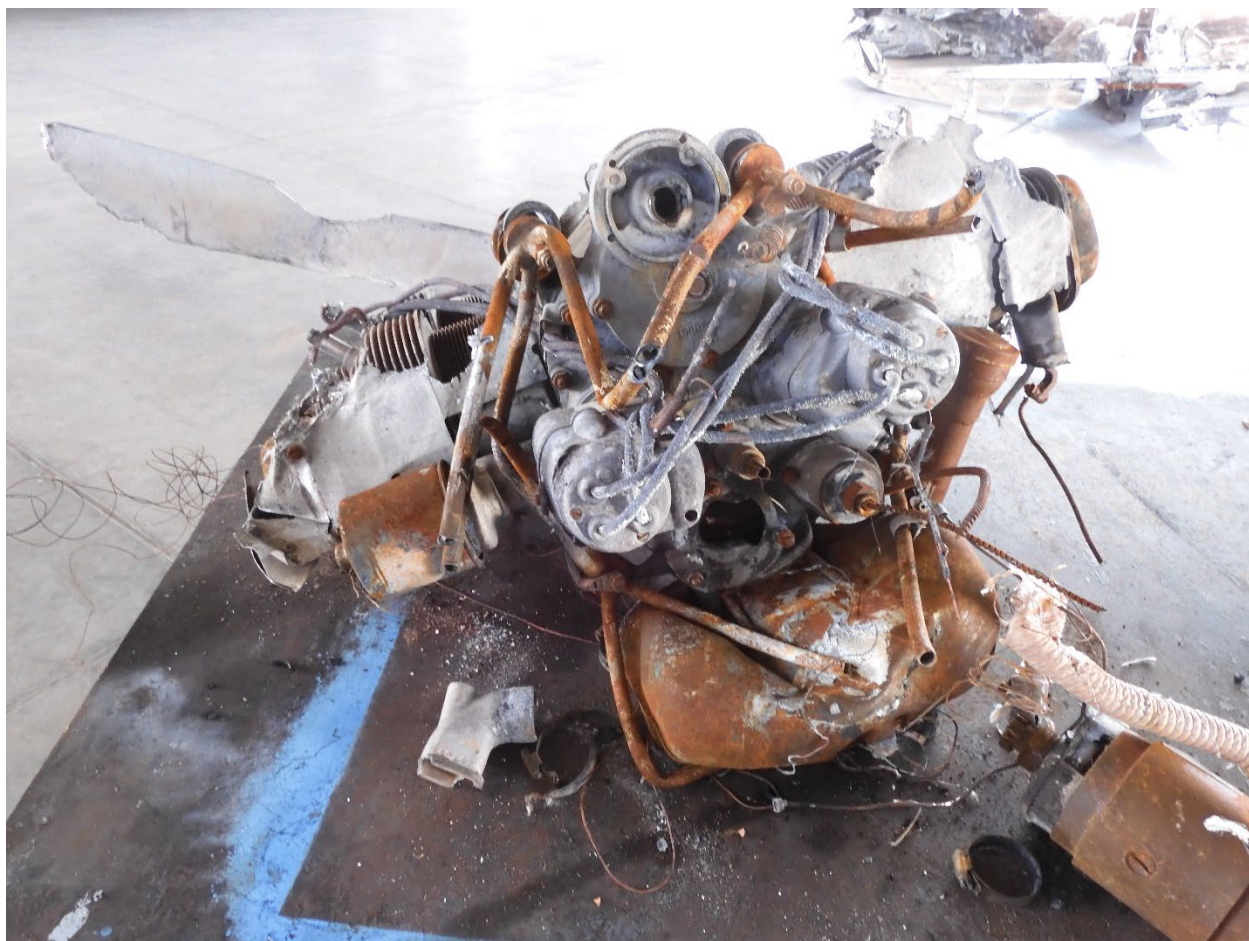
Once the rods were removed, the engine rotated freely. The cam appeared undamaged, and all lobes were normal in appearance. All gears at the rear of the engine retained their teeth and meshed easily. The engine drive train timing was established.

Figure 9. Rear view of the engine.

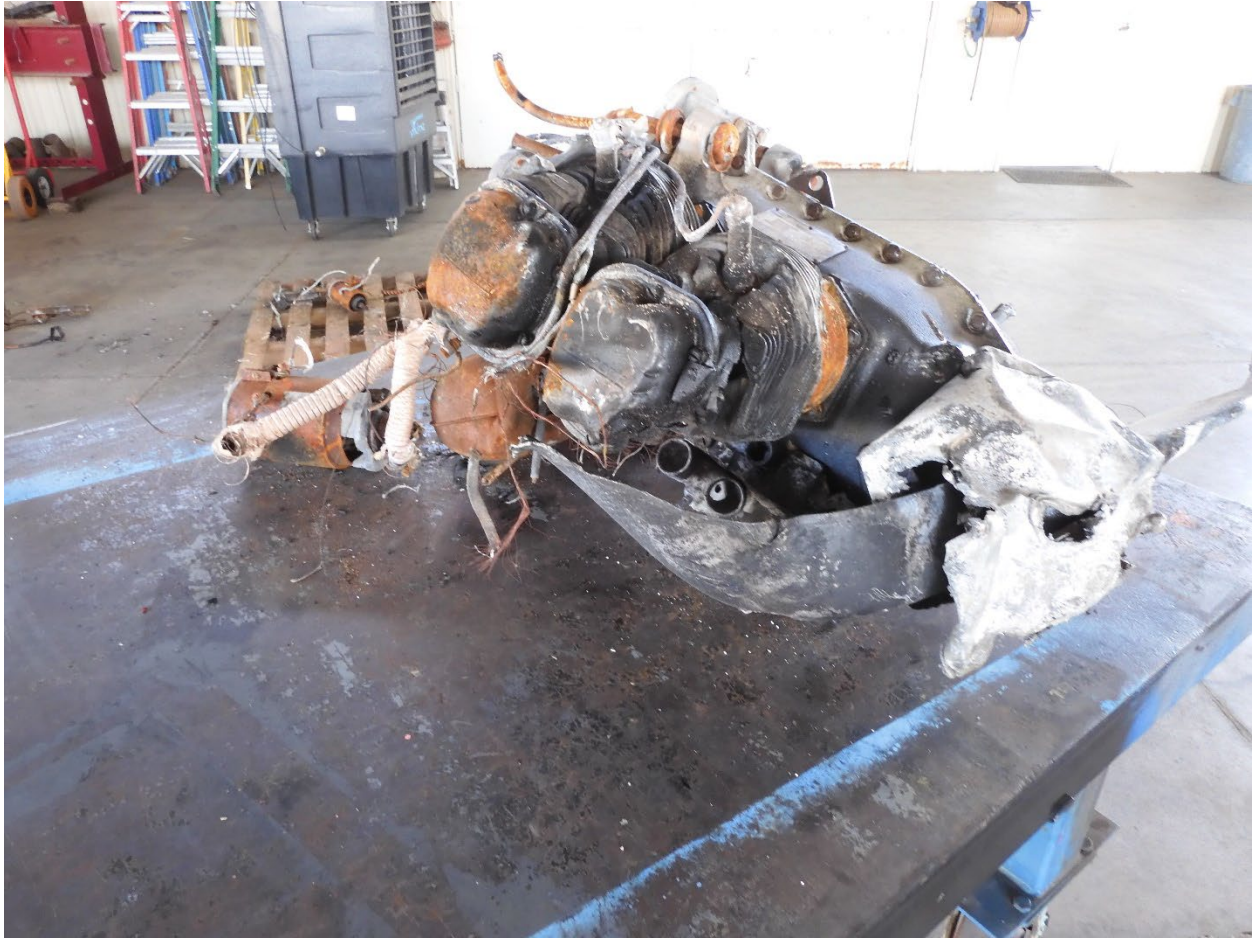
Figure 10. Right-side view of engine.

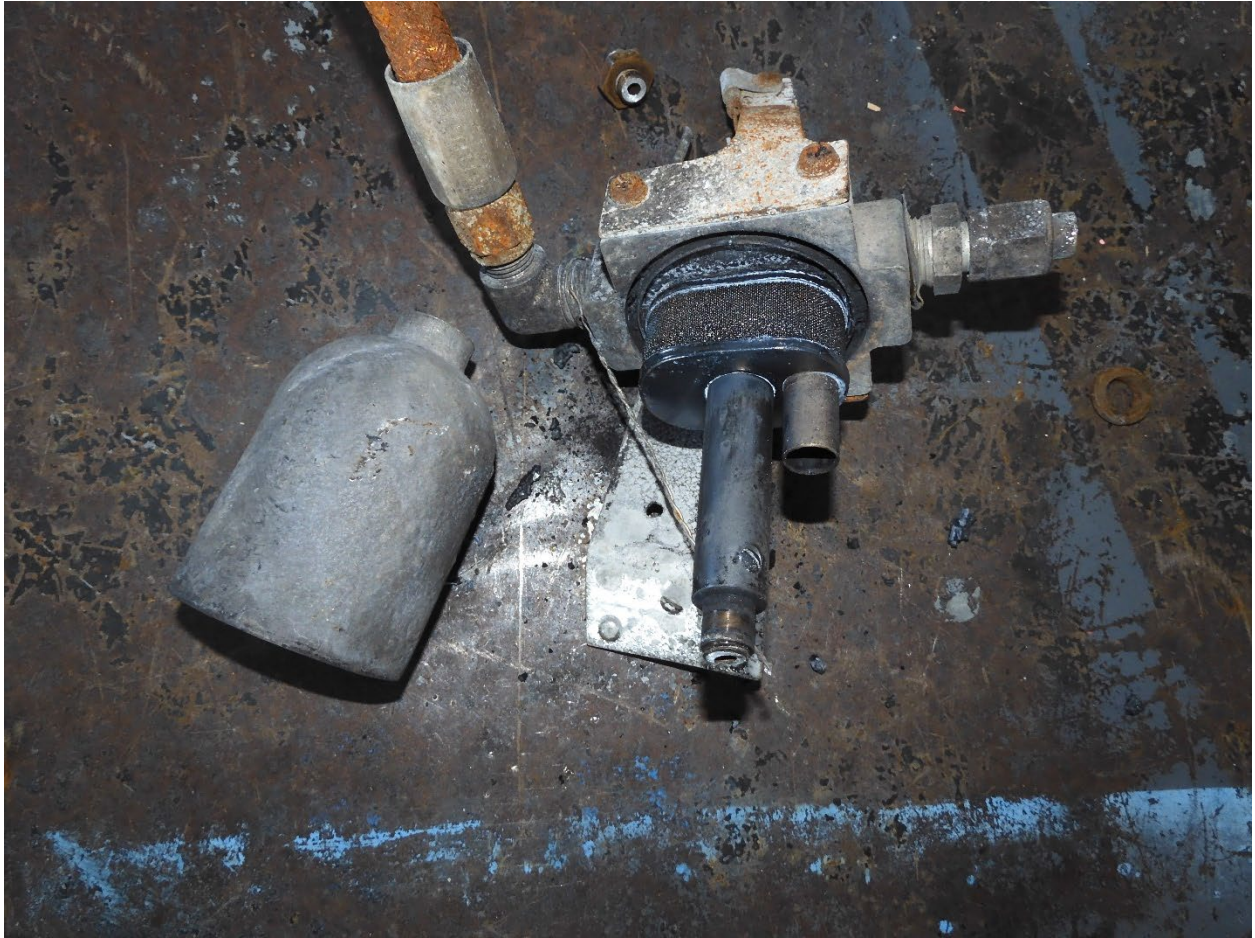
Figure 11. Gascolator.

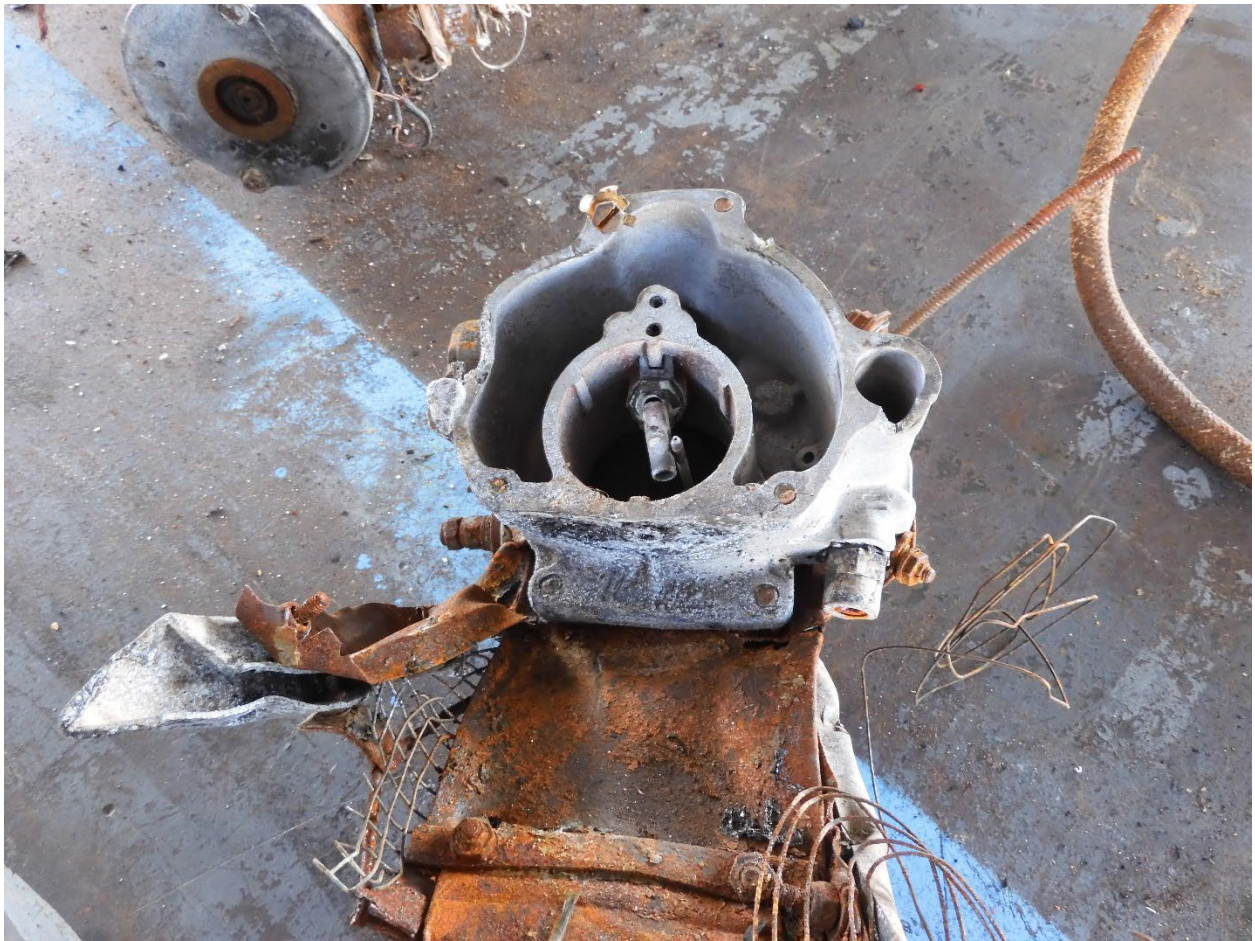
Carburetor. The bowl of the carburetor was separated from the rest of the carburetor, and the rest of the carburetor was not present. The bowl was without the floats, and thermally damaged.

Figure 12. Carburetor bowl.

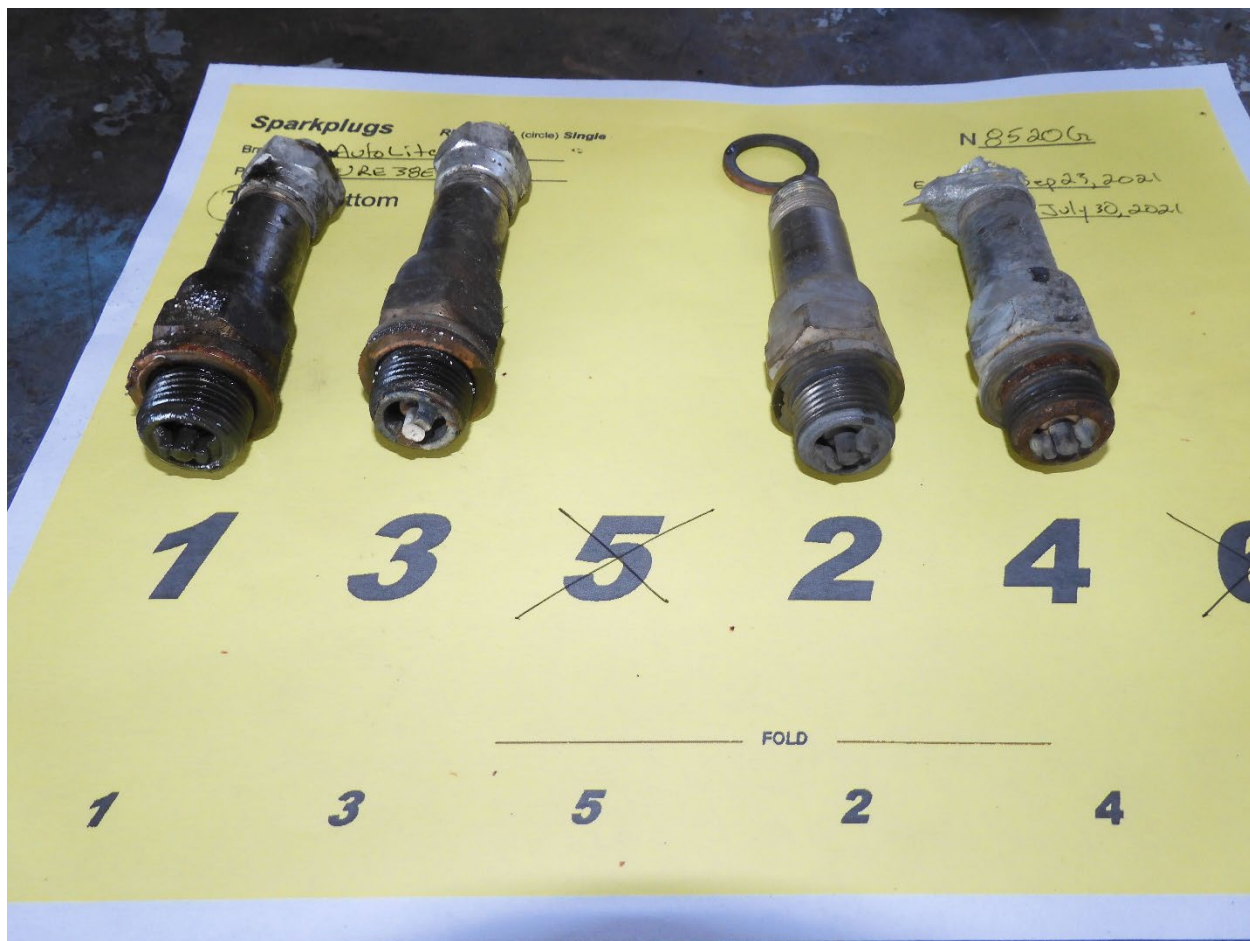
- #1. Oil soaked, dark color.
- #2. Dry and light gray, the porcelain is also gray.
- #3. Dry and gray with a white electrode.
- #4. Dry and gray electrode, porcelain near white.

Figure 13. Top sparkplugs.

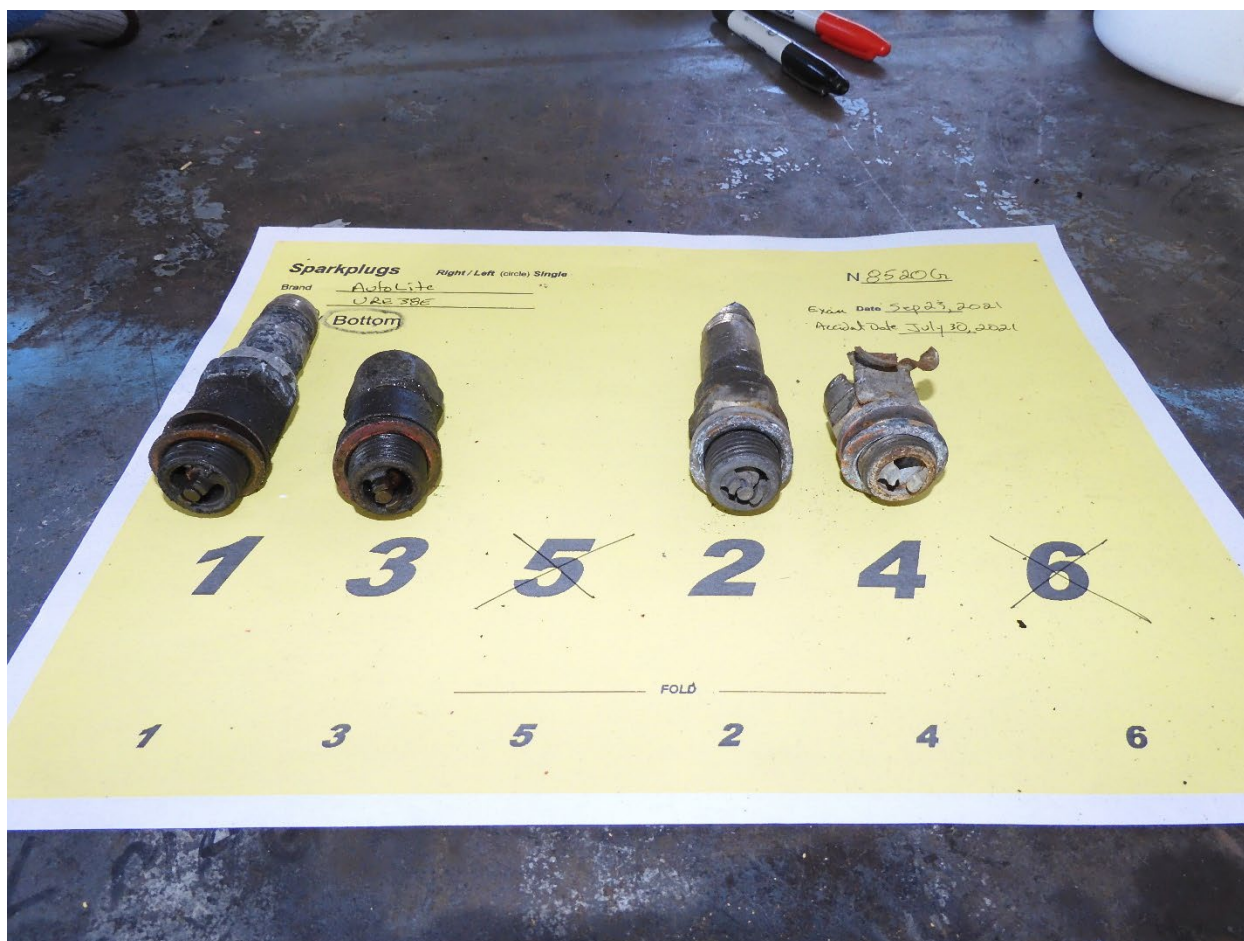
- #1. Wet but not oil soaked, dark gray.
- #2. Dry, light gray, porcelain also light gray.
- #3. Wet and dark gray, with the top section fractured and absent.

#4. Dry with corrosion. No electrode present. The top section was fractured and absent.

Figure 14. Bottom sparkplugs.

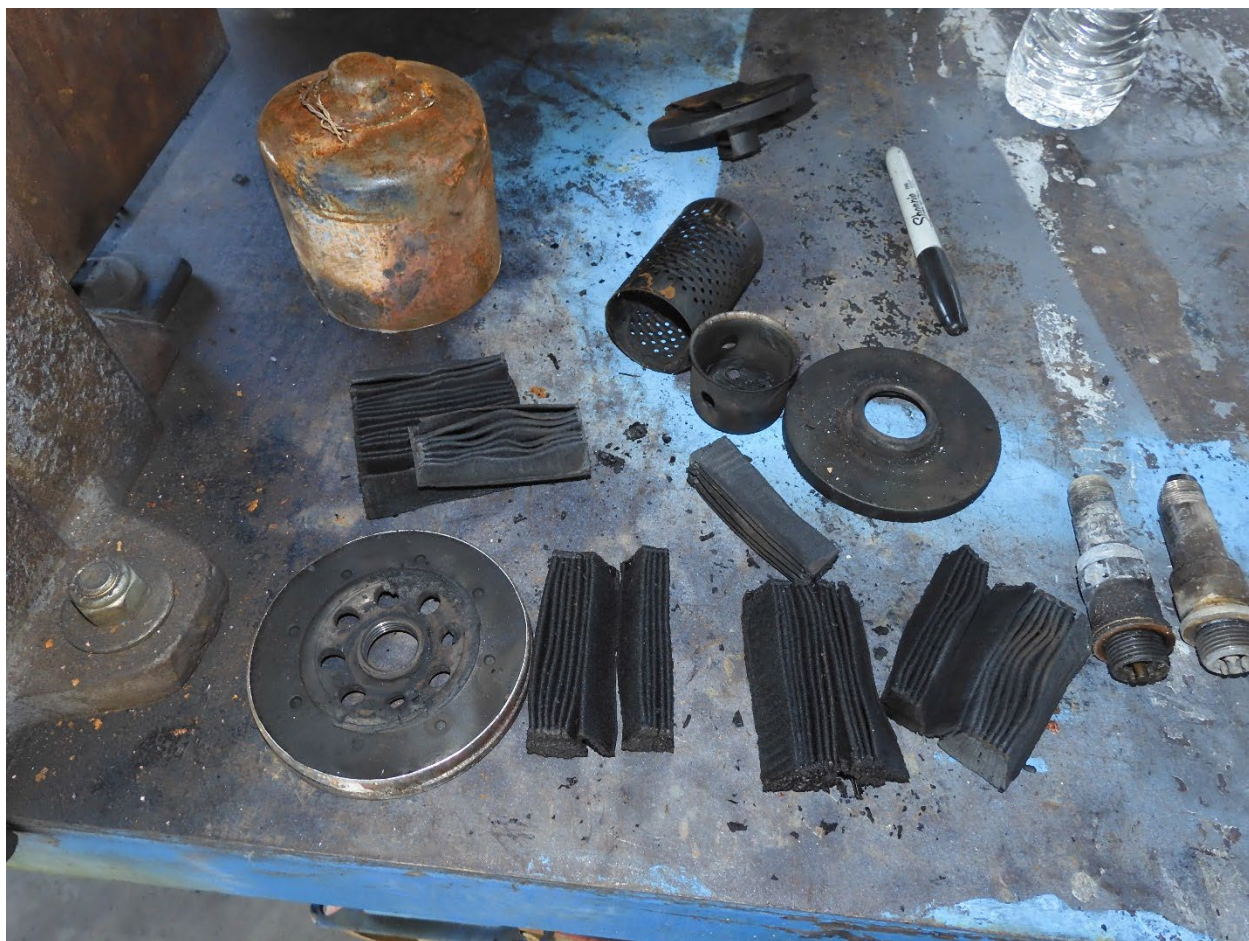
The oil system was examined. The oil reservoir remained attached to the bottom of the engine and was thermally damaged. The cap and dipstick remained fastened and secure. There was no oil in the reservoir. The oil filter was removed and examined. The filter was cut open and revealed thermal damaged. The pleats were dry and near charred but exhibited no metal. The oil pump was removed and appeared dry due to thermal exposure. No other damage was noted.

Figure 15. Oil filter.

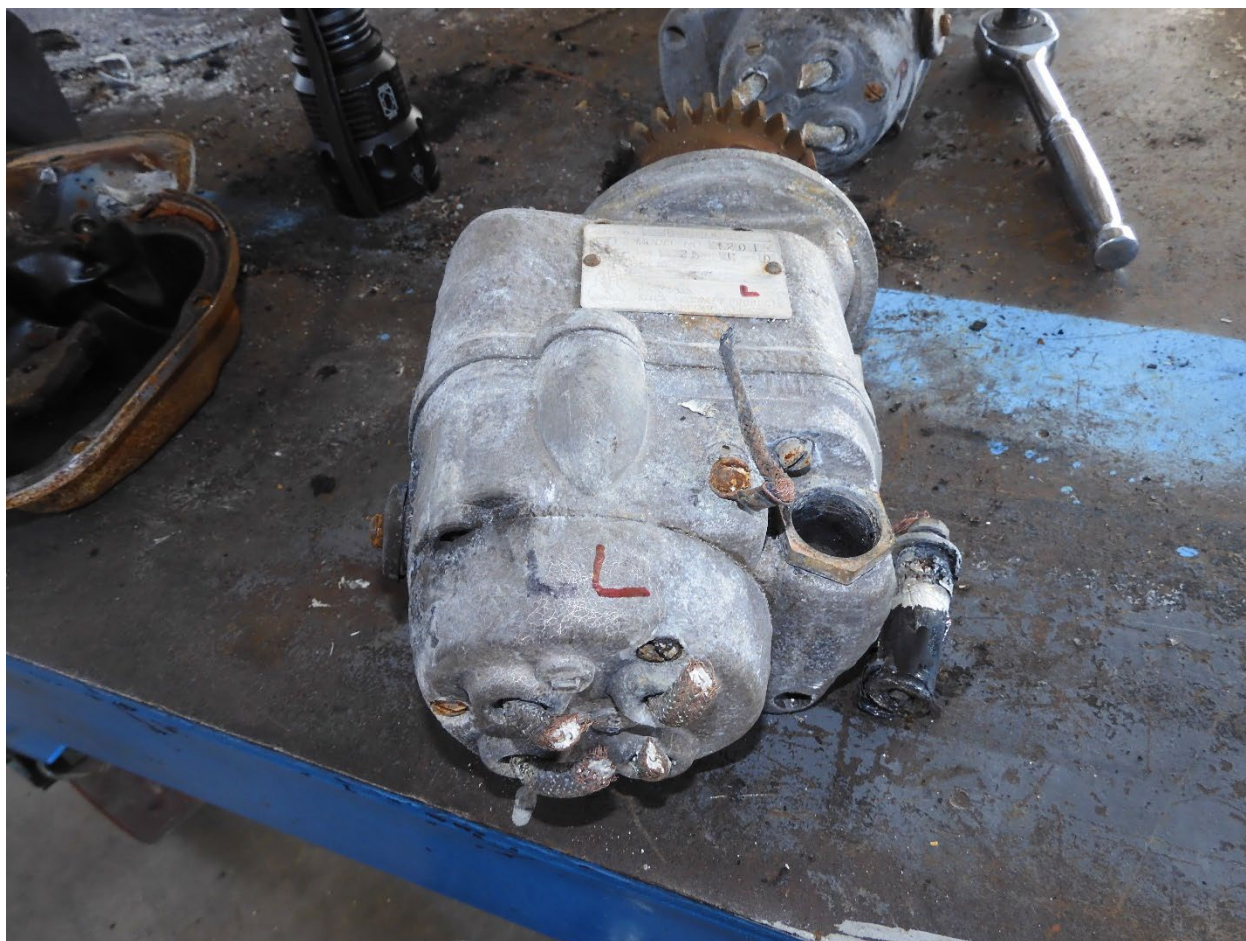
The magnetos were identified as left magneto, and right magneto. Both magnetos were model number 4201. The left magneto, Serial number: 88080025, LAG: 25, ROT: L, REV: D, remained attached at the mount, was thermally damaged and would not rotate. The spark plug leads were thermally damaged and disintegrated when manipulated by hand.

Figure 16. Left magneto.

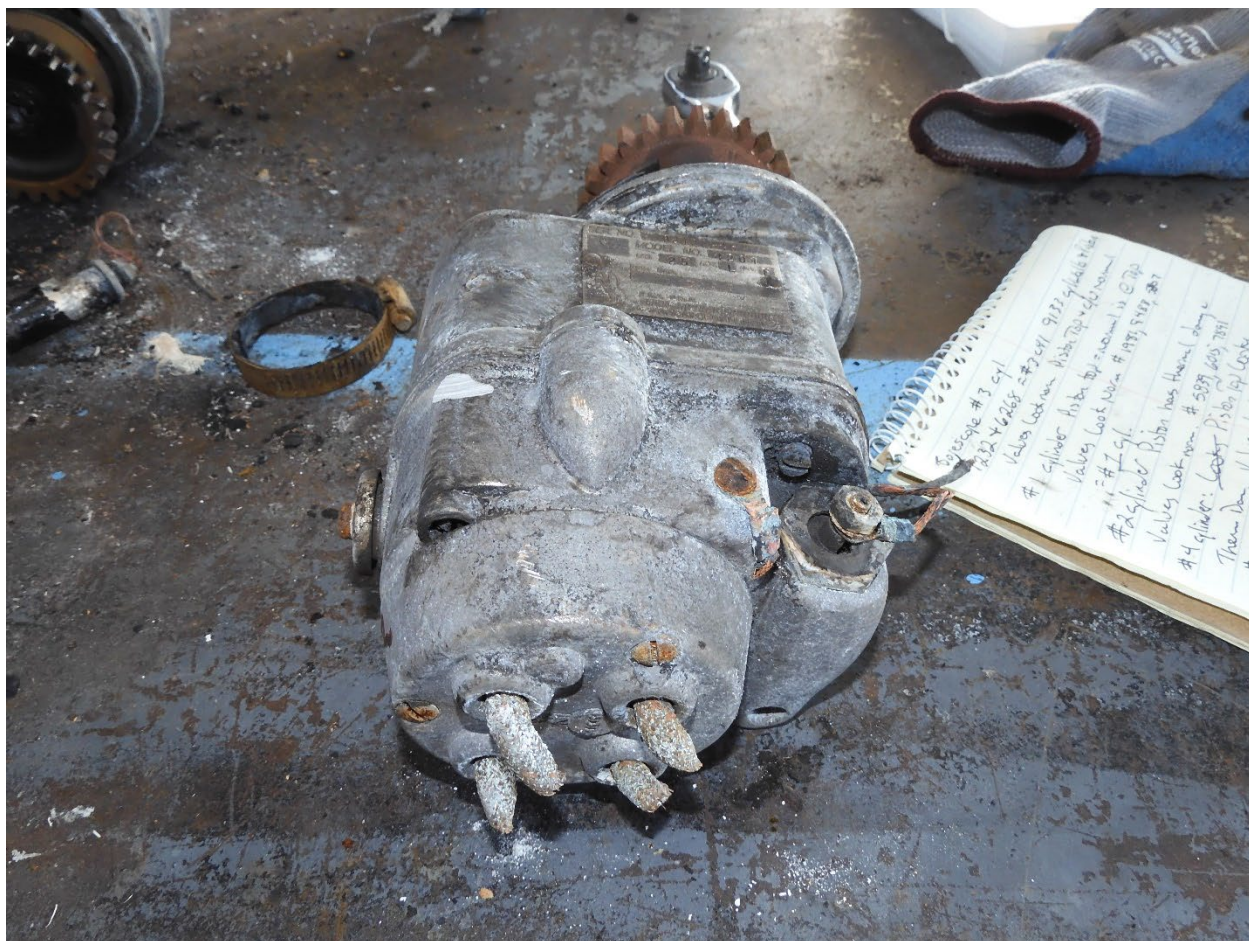
The right magneto, serial number 88120045, LAG: 25, ROT: L, REV: E, remained attached to the mount, was thermally damaged and would not rotate. The spark plug leads were thermally damaged and disintegrated when manipulated by hand.

Figure 17. Right Magneto.

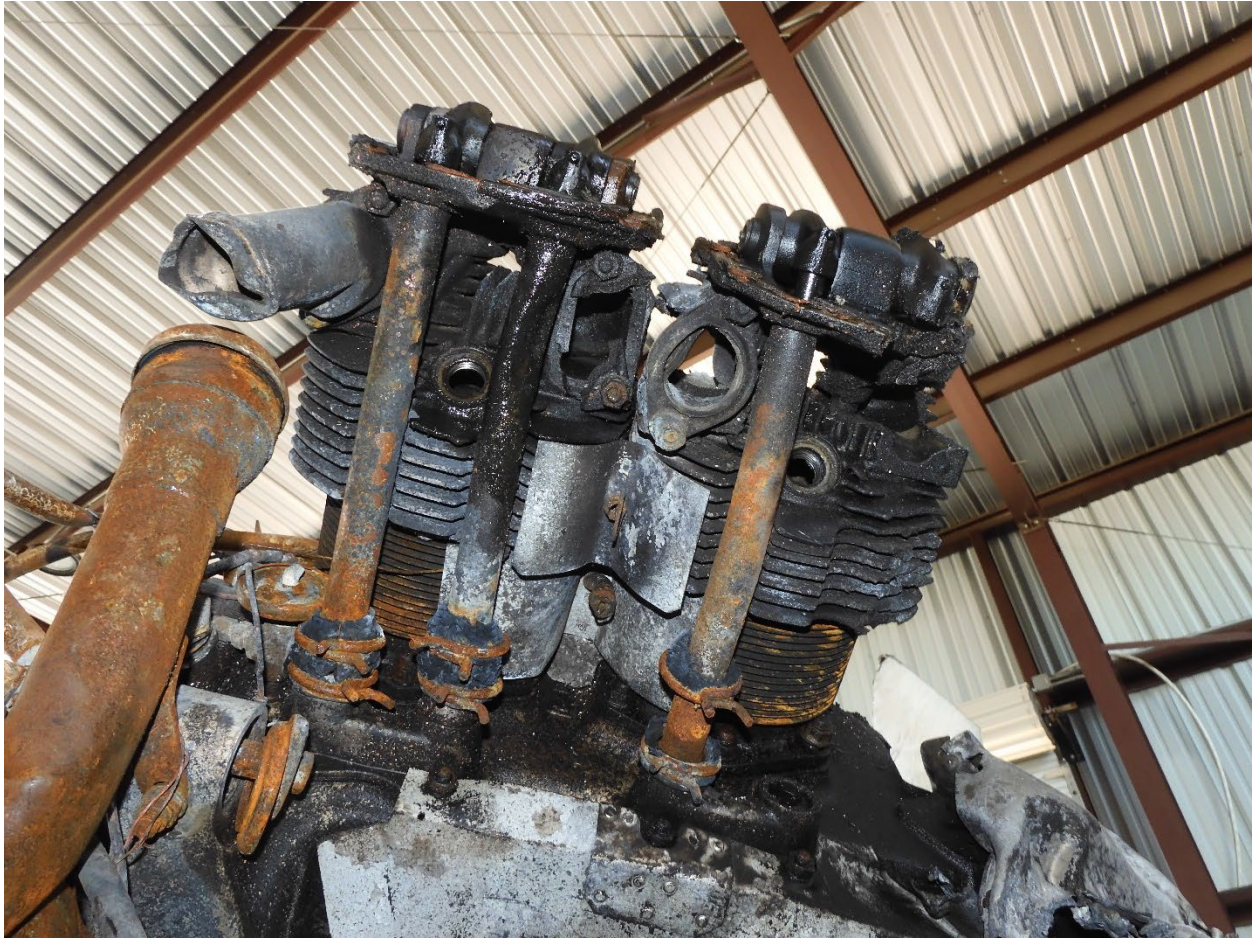
The number 1-cylinder head revealed a wet valve assembly interior. The rocker arms remained in place and the two valve assemblies appeared intact. The intake push rod and pushrod tube were dented and displaced aft. The exhaust push rod remained attached and was thermally damaged. The exhaust port was undamaged. The aluminum intake attachment was fractured. The valves and valve seats exhibited normal appearance. The cylinder walls were not damaged. The piston top appeared wet with carbon build up. The piston skirt was smooth. The rings were intact. The piston retention pin and the rod end were smooth. The rod to crank shaft bearing was smooth.

The number 3-cylinder head revealed a wet valve assembly interior, and the top of the head was fractured with a section absent. The intake valve push rod and push rod tube were absent. The

intake attachment was fractured. The exhaust push rod and push rod tube remained attached and was thermally damaged. Several aluminum cooling fins were fractured and several steel cooling fins from the cylinder were dented and pushed inwards. The valves had a normal appearance and were displaced in the open position exposing the valve seats. The cylinder walls appeared smooth. The piston top appeared wet with carbon build up. The piston skirt was smooth. The rings were intact. The piston retention pin and the rod end were smooth. The rod to crank shaft bearing was smooth. The cylinder assembly appeared to have rotated about 5°.

Figure 18. Right-side view from underneath, showing cylinders 1, and 3.
