## **NATIONAL TRANSPORTATION SAFETY BOARD**

# **AIRFRAME AND ENGINE EXAMINATION**

**WPR21FA298**

Location: Banning, California  
Date: July 30, 2021  
Aircraft: Cessna 150  
NTSB IIC: Fabian Salazar

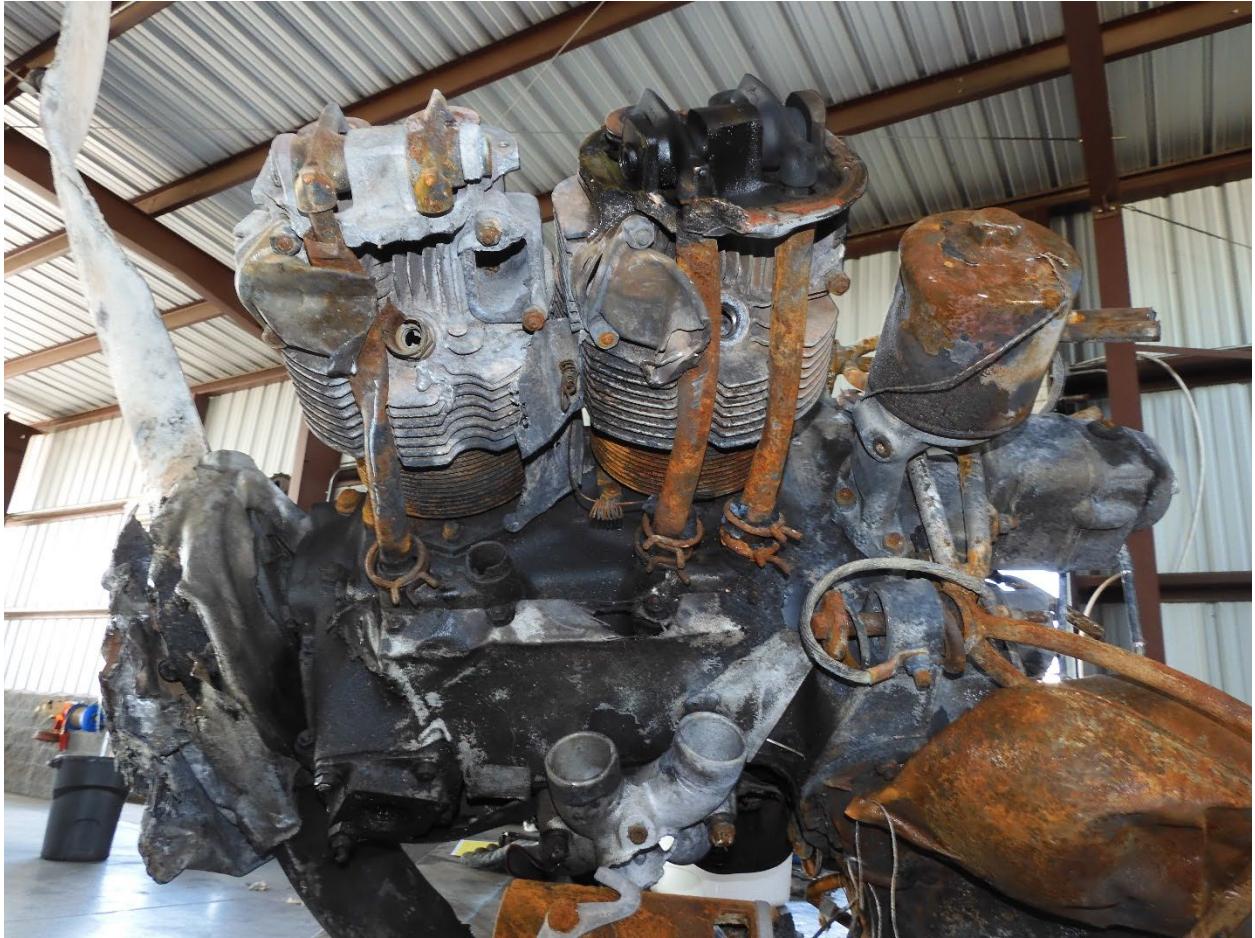
The number 2-cylinder head appeared wet with the top of the head fractured and a section absent. The exhaust attachment was not damaged but the exhaust pipe was crushed into the exhaust port. The aluminum intake attachment was fractured. Both the intake and the exhaust push rods, and push rod tubes remained attached and exhibited denting and displacement. The valves and valve seats appeared normal. The cylinder walls appeared smooth but with rust and corrosion exhibited. The piston top appeared dry with carbon buildup. The piston skirt was smooth. The rings were intact. The piston retention pin and the rod end were smooth. The rod to crank shaft bearing was smooth.

The number 4-cylinder head was dry and fractured with sections absent, and some thermal damage revealed melted aluminum from the head. Most of the mating surface for the valve cover was absent, exposing the inside of the valve assembly. Rust and corrosion covered the valve springs and rocker arms. The intake push rod and push rod tube were absent. The exhaust push rod and push rod tube remained attached and revealed heavy denting and displacement. The intake port attachment was damaged. The valves appeared normal but dry. The smaller valve appeared displaced from the valve seat. The cylinder walls appeared dry but smooth. The piston top appeared dry with carbon build up. The piston skirt was smooth. The rings were intact. The piston retention pin would not move from the piston, consistent with thermal damage. The cylinder assembly appeared to have rotated about 5°.

Figure 19. Left-side view from underneath, showing cylinders 2, and 4.

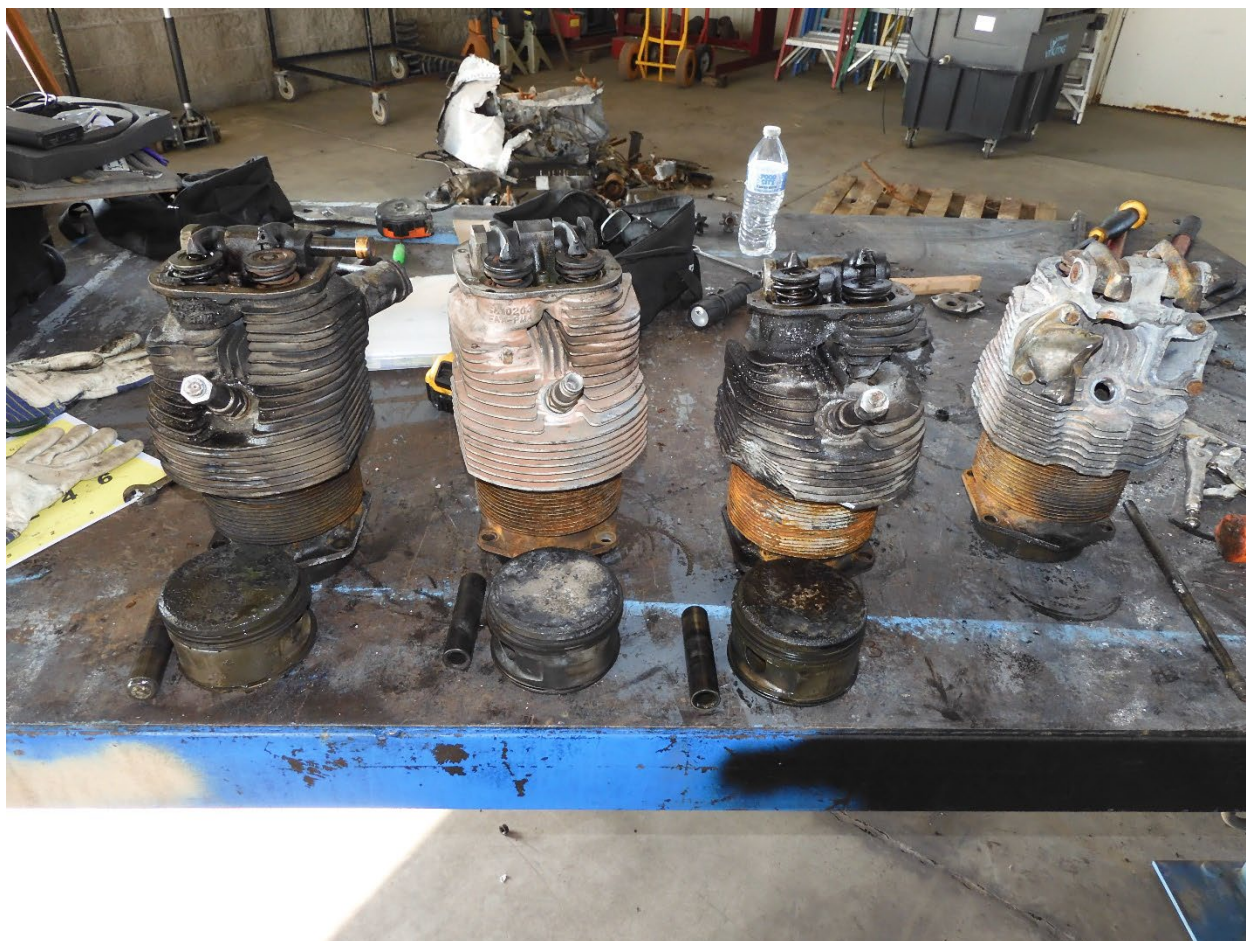
Figure 20. Cylinders 1 through 4 from left to right.
