## **NATIONAL TRANSPORTATION SAFETY BOARD**

# **AIRFRAME AND ENGINE EXAMINATION**

**WPR21FA321**

Location: Bountiful, UT  
Date: September 15, 2021.  
Aircraft: Cessna 182H, N8477S  
NTSB IIC: Elliott Simpson

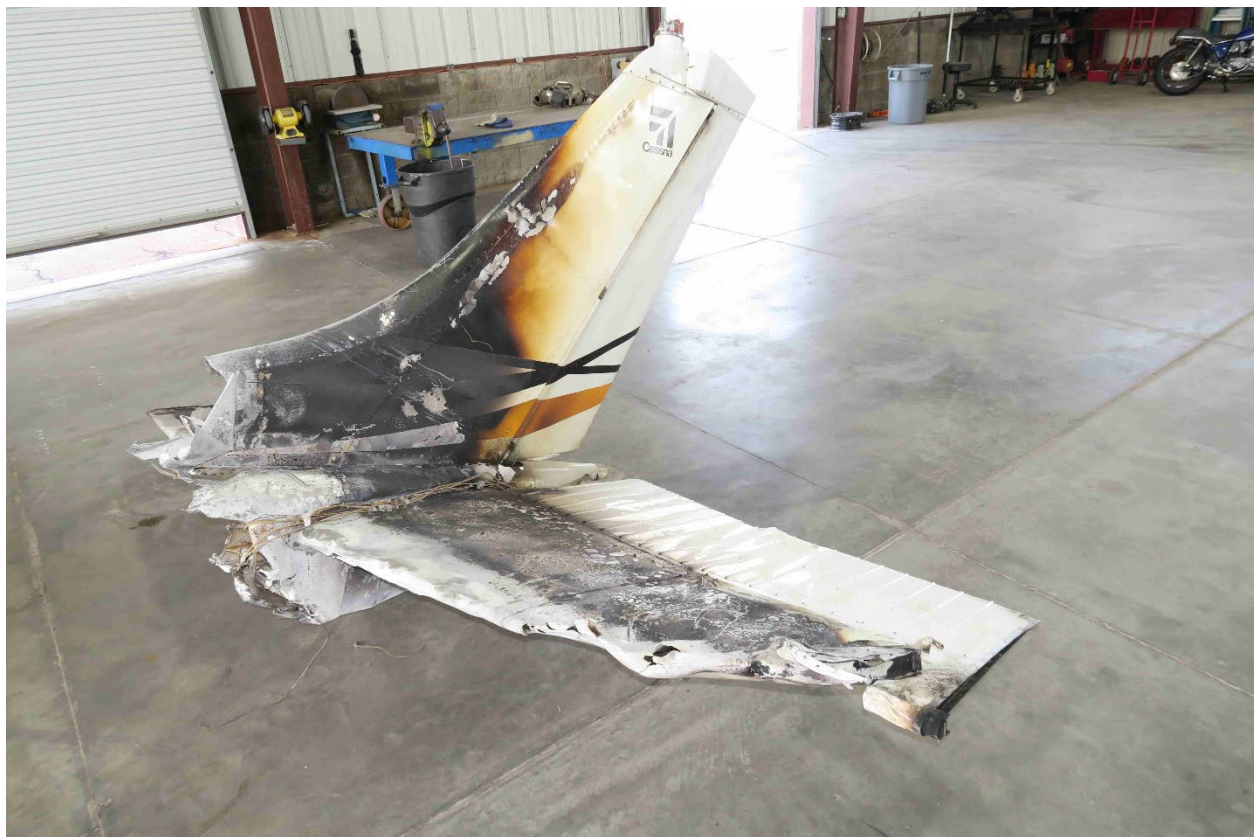
The entire fuselage forward of the vertical stabilizer through to the firewall was consumed by fire. The empennage was intact, and both the rudder and elevator remained attached to the vertical and horizontal stabilizers respectively (figure 1).

Figure 1 – Empennage

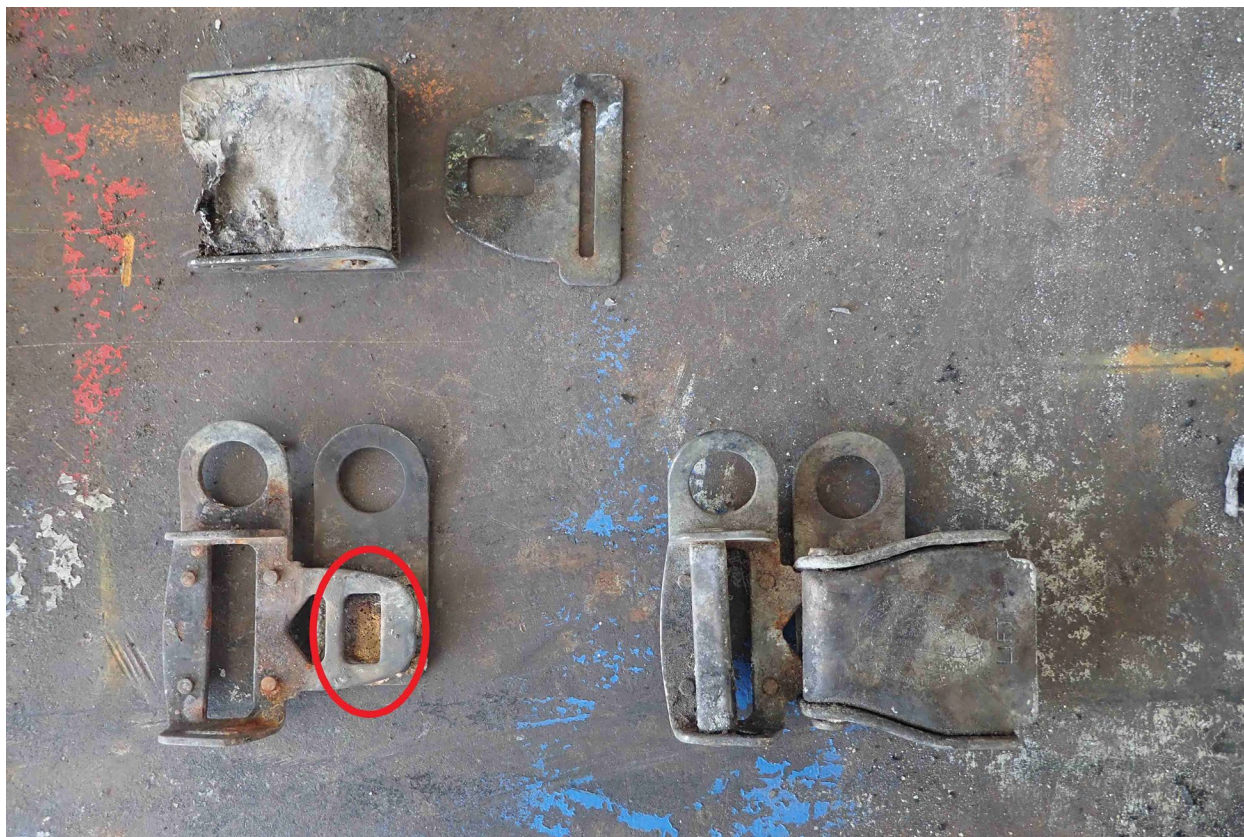
No seat remnants beyond padding springs were located and presumed to have been consumed by fire. The airplane was equipped with four seat buckles; all of the belt webbing had burnt away, and only three of the buckle assemblies were located. One rear buckle was found unlatched, and the second rear buckle was not located. A forward buckle was found latched, and the second forward buckle handle had melted away from its steel assembly, but its tongue was shiny and unburnt in the area of the melted buckle, consistent with it being latched at impact (figure 2).

Figure 2 – Seat belt buckles, circle indicates shiny unburnt surface of tongue

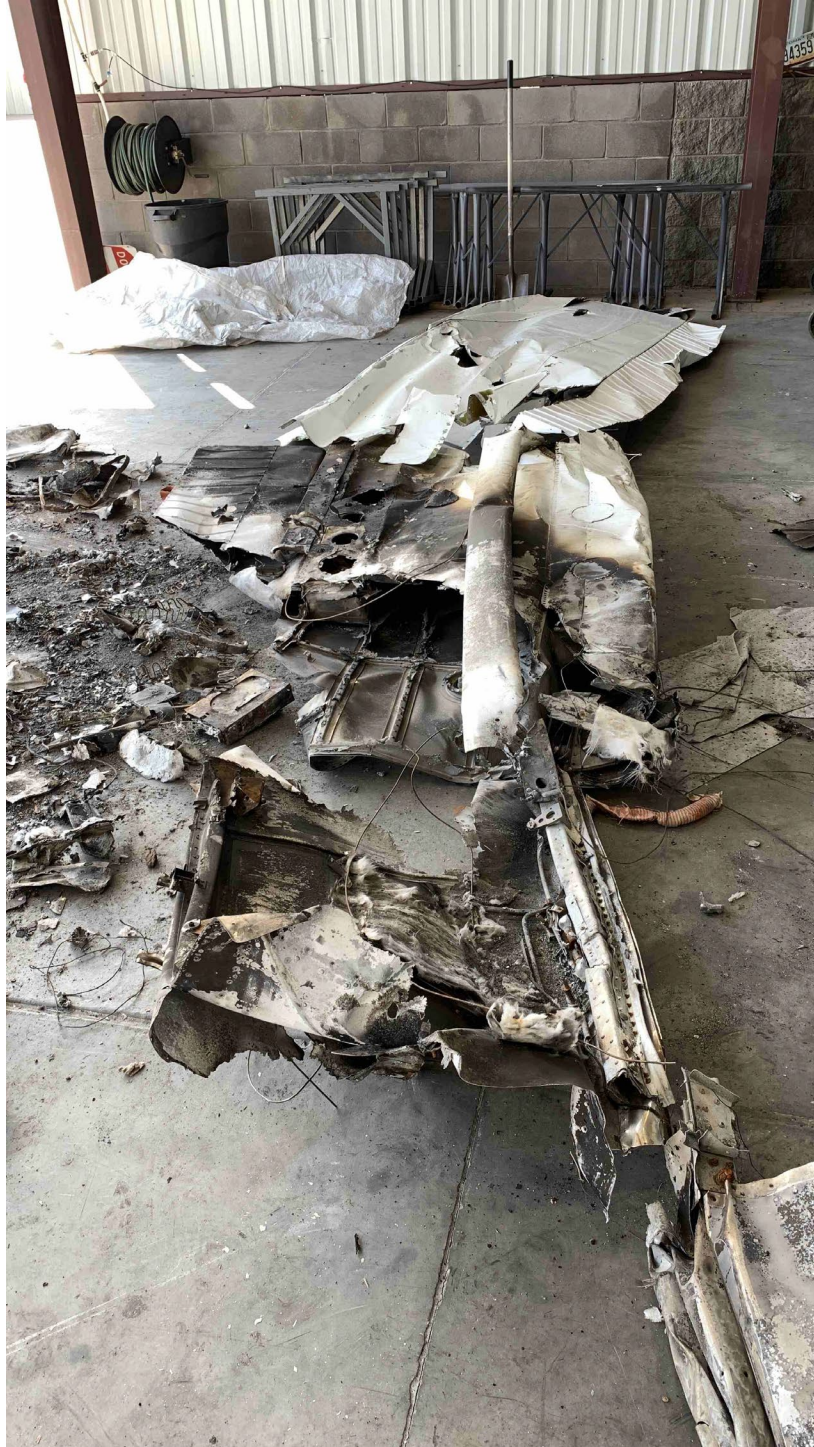
Almost the entire left wing, and the inboard section of the right wing were consumed by fire (figure 3, 4).

Figure 3 – Center cabin roof and right wing

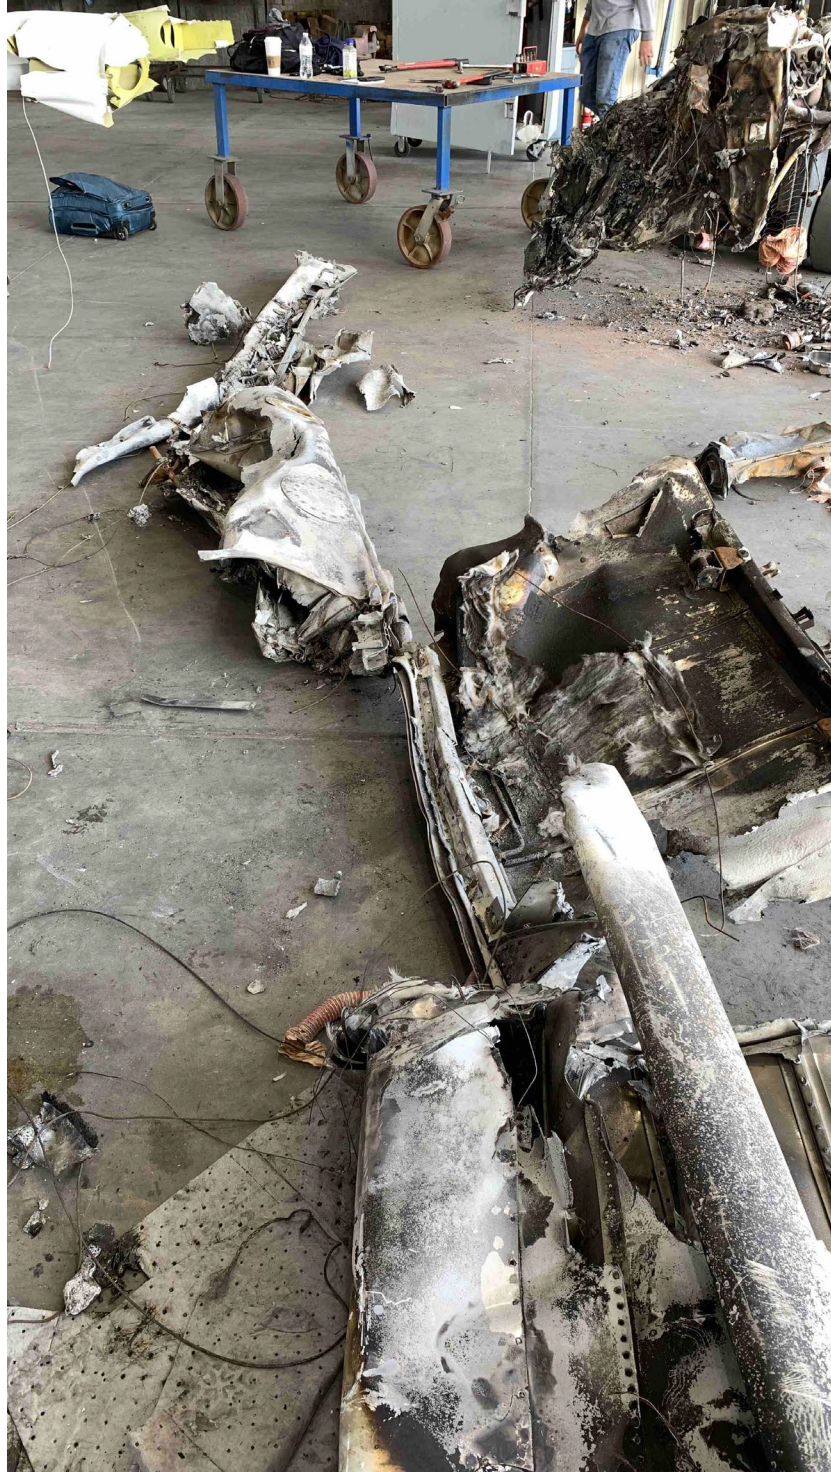
Figure 4 - Center cabin roof and left wing remnants

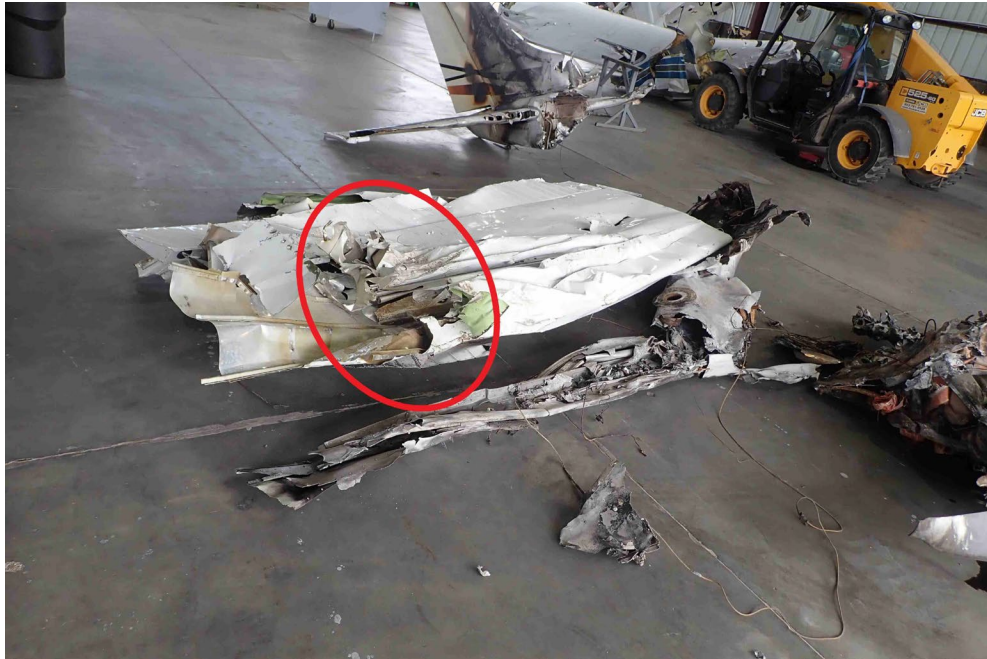
The outboard right wing had separated at the wing strut and was located at the base of the impact tree at the accident site. It had sustained a semicircular indentation to the leading edge and underside at the separation point (figure 5), which contained fragments of tree bark, wood fragments, and leaf needles.

Figure 5 – Tree damage to right wing leading edge and underside

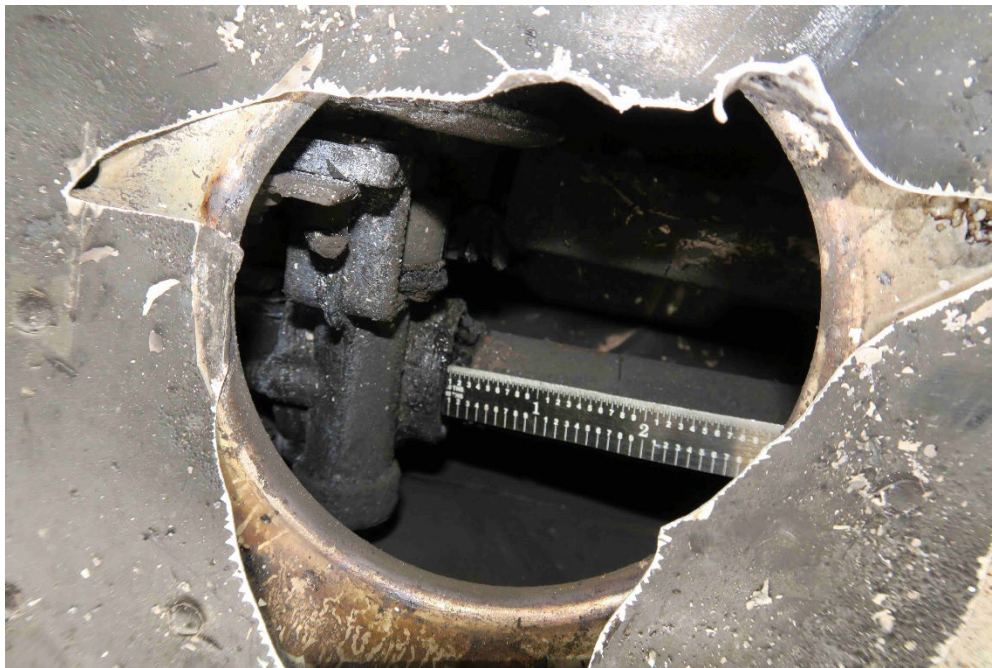
The remnants of the right flap remained connected to the wings aft spar and were flush with the wing surface. Burnt remnants of left flap skin were located within the debris. The flap drive actuator was in the fully retracted position, which corresponded to the flaps being fully retracted (figure 6).

Figure 6 – Flap actuator

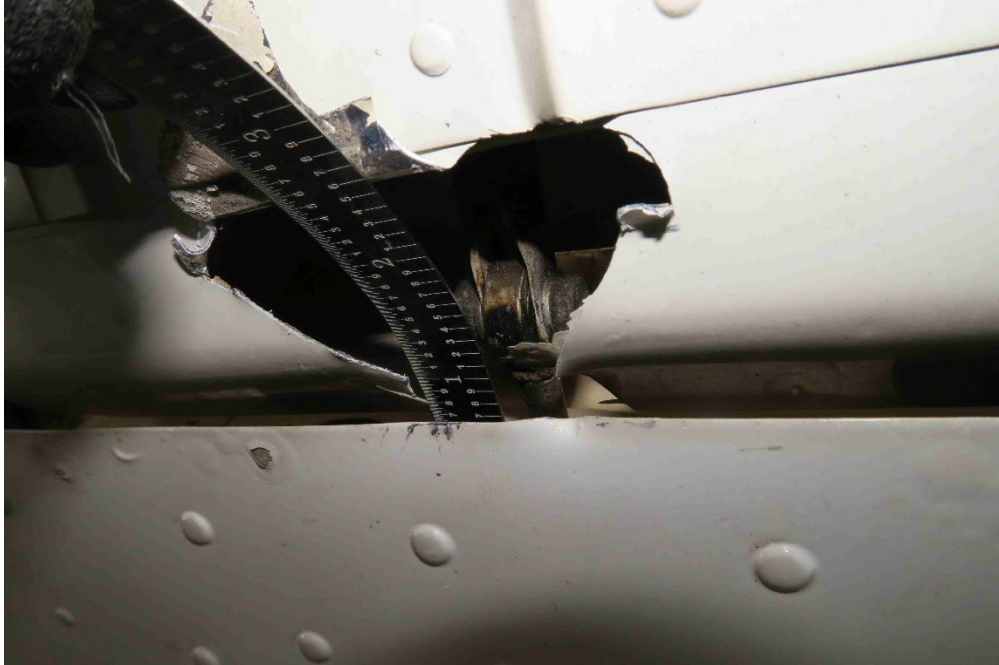
The elevator pitch trim servo exhibited 1.3 inches of extension, which when compared to Textron documentation, correspond to neutral trim. The trim surface was also flush with the elevator (figure 7, 8).

Figure 7 – Elevator trim actuator

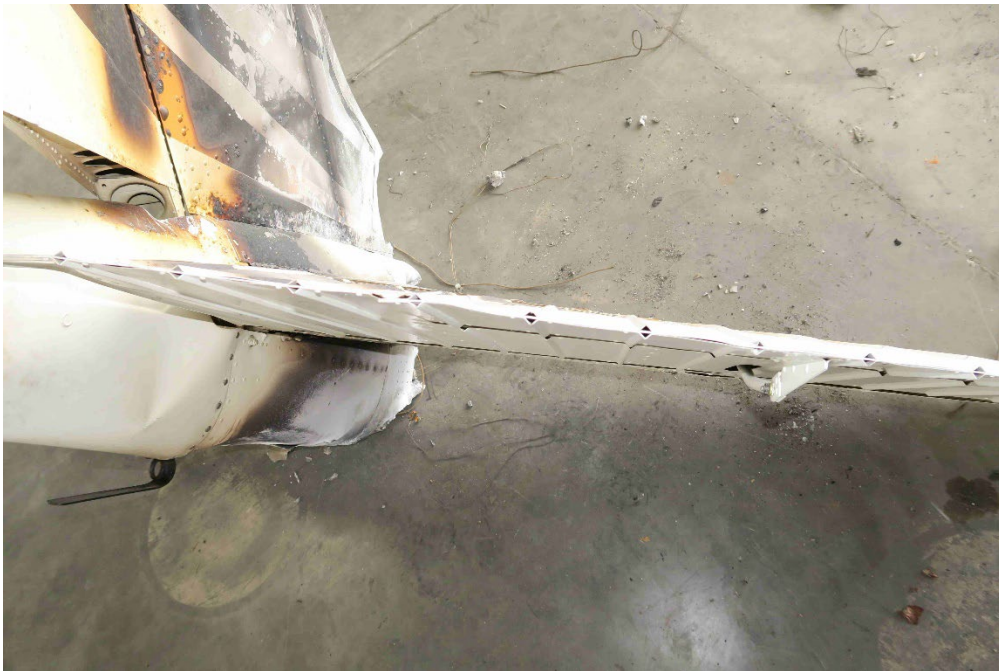
Figure 8 – Elevator trim tab

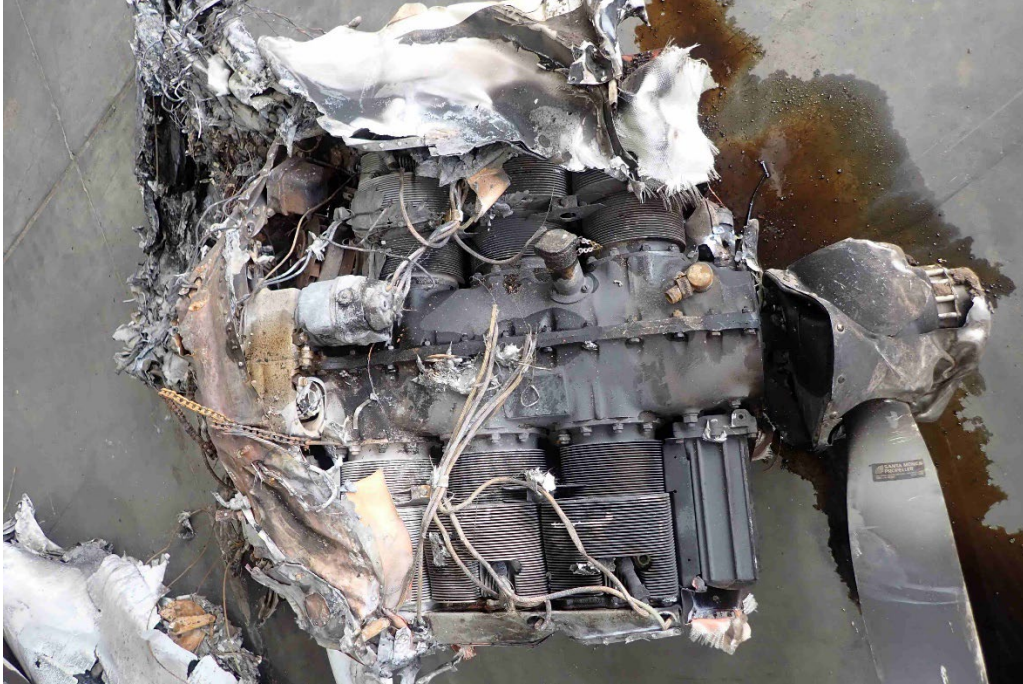
The engine remained attached to the firewall by its aft mounts. The firewall sustained extensive crush damage and had formed around the rear of the engine. The entire engine sustained thermal damage and was coated in a layer of black and grey soot (figure 9). The alternator had broken away from its mounting bracket, all other accessories remained attached to their respective pads at the aft of the engine. The exhaust manifolds remained attached and were crushed against the cylinder heads. The left and right intake manifolds were cracked and partially melted.

Figure 9 – Engine

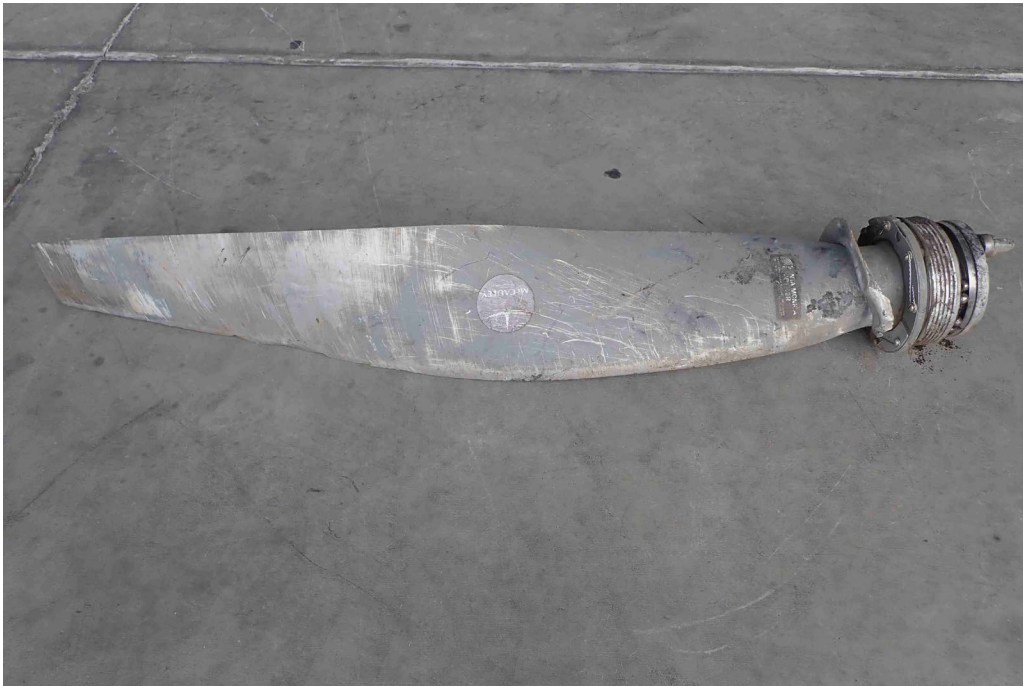
The propeller hub remained attached to the crankshaft. One blade had been liberated from the hub and was found adjacent in the wreckage. Both blades exhibited similar leading-edge gouges, chordwise scratch marks and blade twist. The spinner remained attached to, and had formed around, the hub, and exhibited radial score marks (figure 10, 11, 12).

Figure 10 – Propeller blade 1

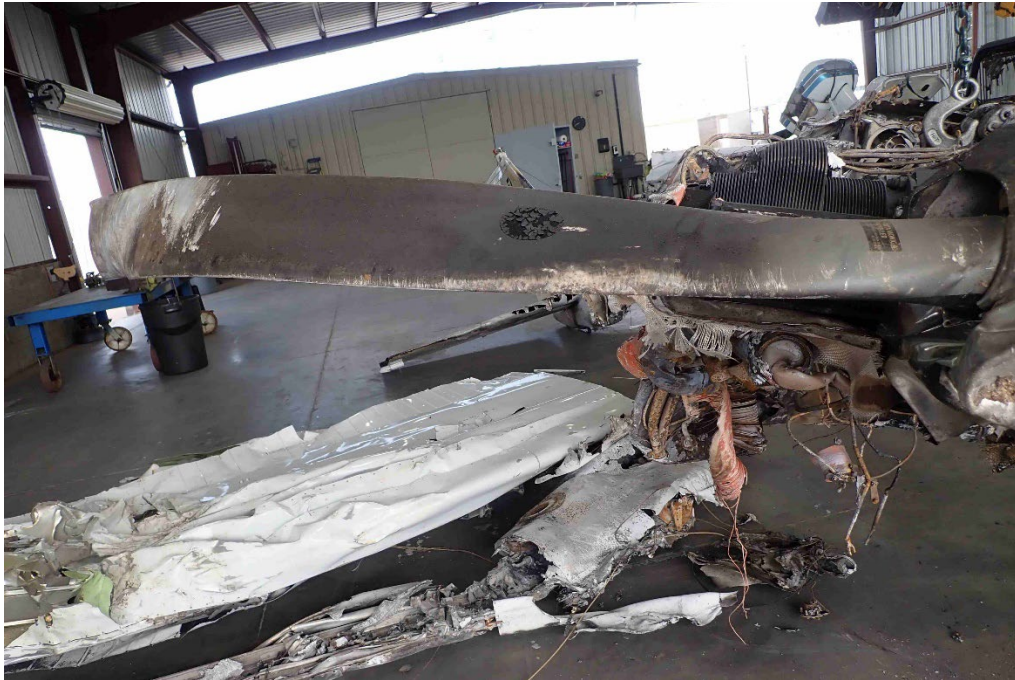
Figure 11 – Propeller blade 2

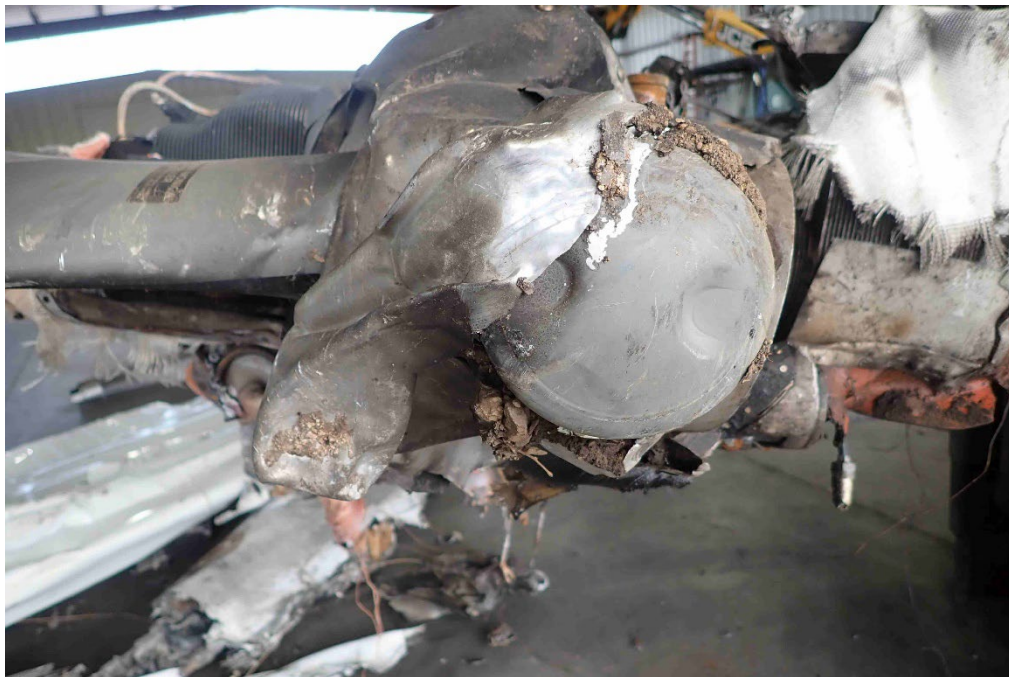
Figure 12 - Spinner

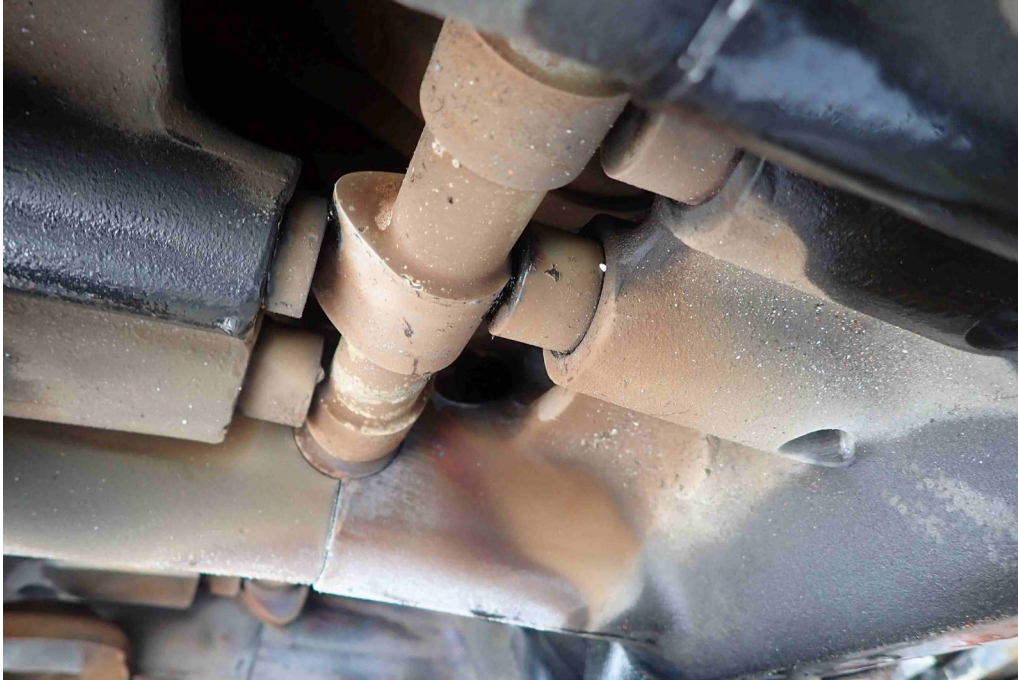
The aft end of the engine sump had melted away, exposing the accessory gear train and rear of the camshaft. The rest of the sump was crushed and impinged against the camshaft. Removal of the sump revealed the camshaft to be intact, with no indications of damage to any of the cam lobes or followers (figure 13). The oil pickup screen was clear of debris. The forward lower end of the crankcase had buckled aft and become impinged against the governor crown gear on the front end of the camshaft and the forward section of the crankshaft, preventing engine rotation (figure 14).

Figure 13 – Camshaft

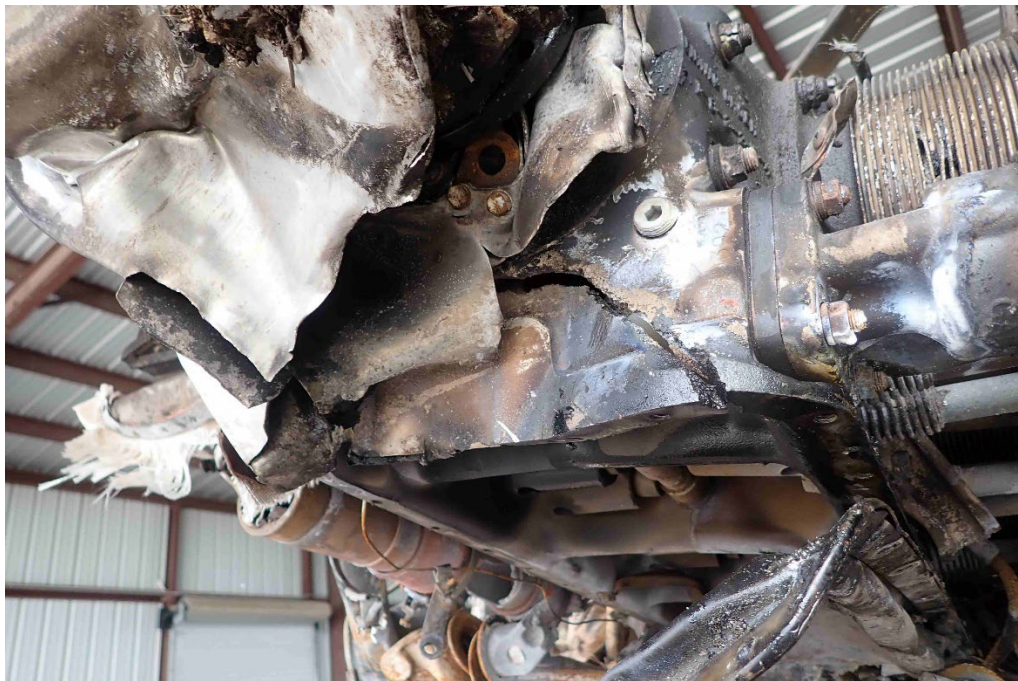
Figure 14 – Forward area of crankcase

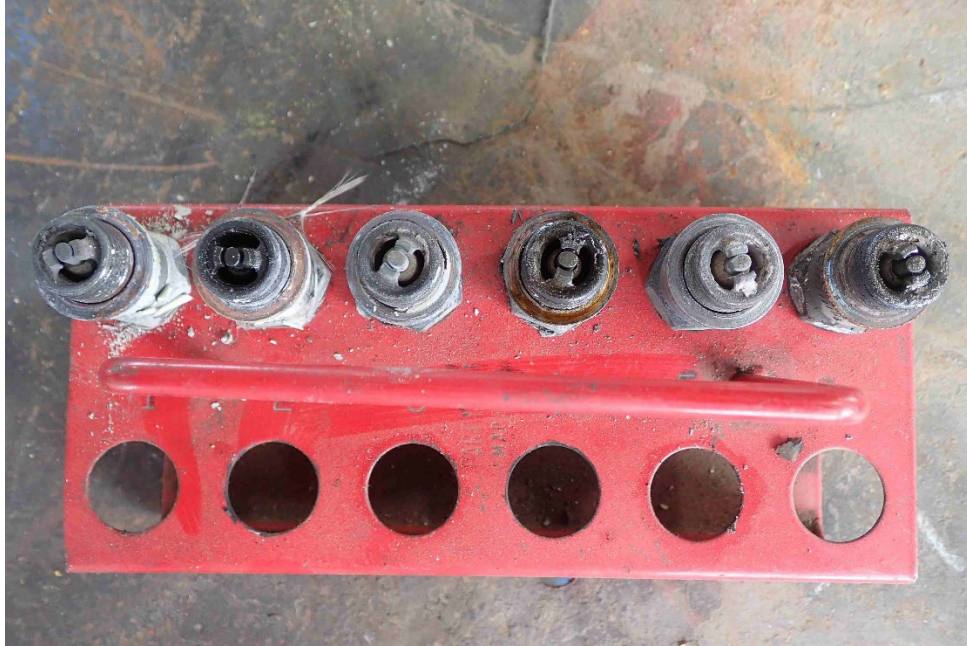
The top spark plugs exhibited dark grey deposits and normal to worn-out normal wear signatures. Plugs 2, 4, 6 were coated in oil. The plugs did not exhibit any evidence of catastrophic internal cylinder head failure (figure 15).

Figure 15 – Spark plugs
