**NATIONAL TRANSPORTATION SAFETY BOARD**  
Office of Aviation Safety

**Wreckage Examination Group Field Notes**

**A. ACCIDENT      WPR22FA330**

Location:      Bernard, Idaho  
Date:      August 28, 2021  
Time:      1318 MDT  
Operator:      Private  
Aircraft:      Cessna TU206F  
Registration:      N922MA

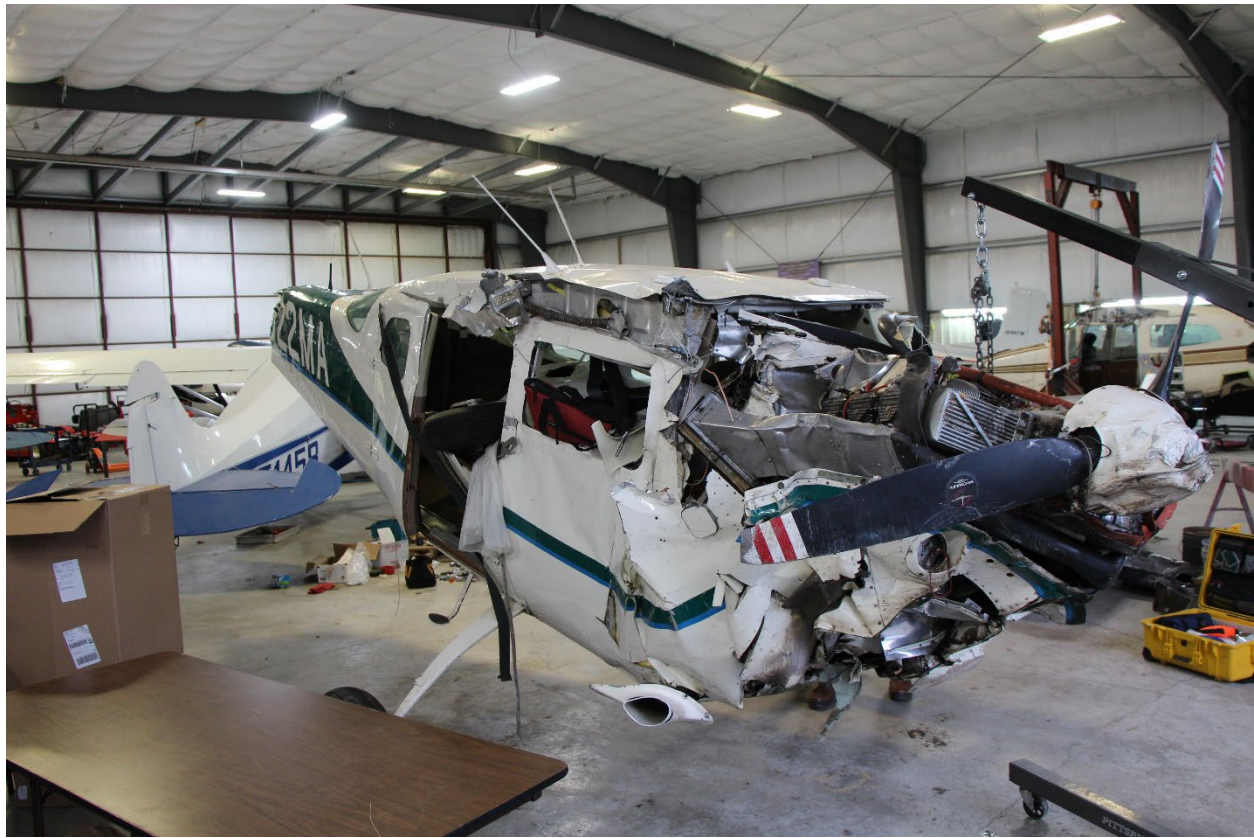
*Photograph 1: Accident airplane prior to examination*

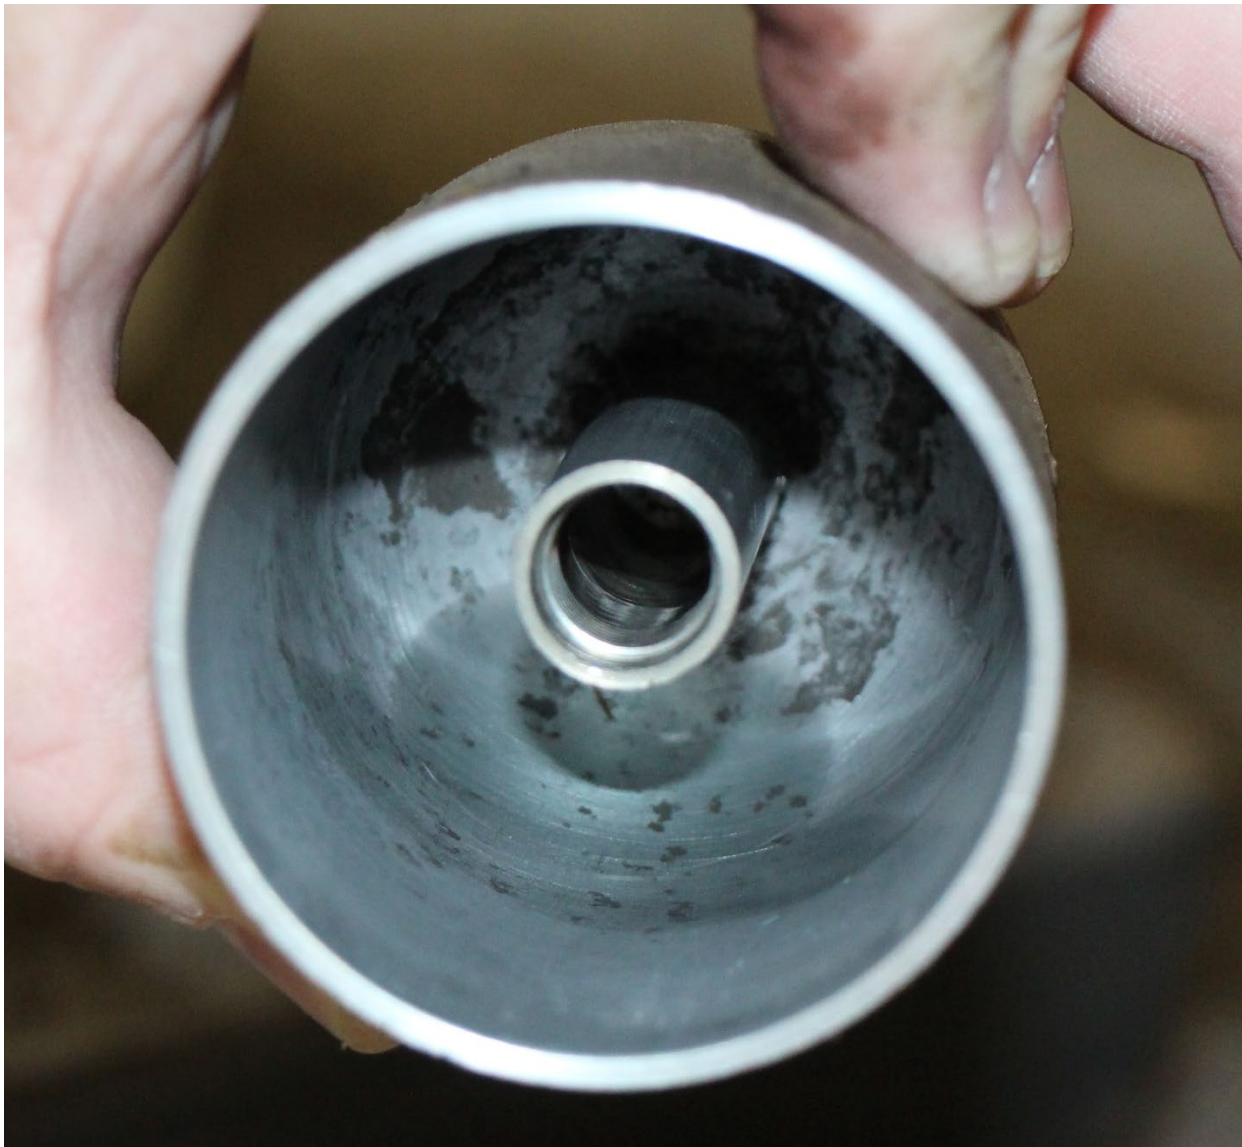
The fuel selector valve and handle were in the left tank position and was partially seized. The gascolator bowl displayed a trace amount of fuel that contained an odor consistent with 100 low lead aviation grade gasoline. The gascolator screen was free of debris.

*Photograph 2: Gascolator bowl*

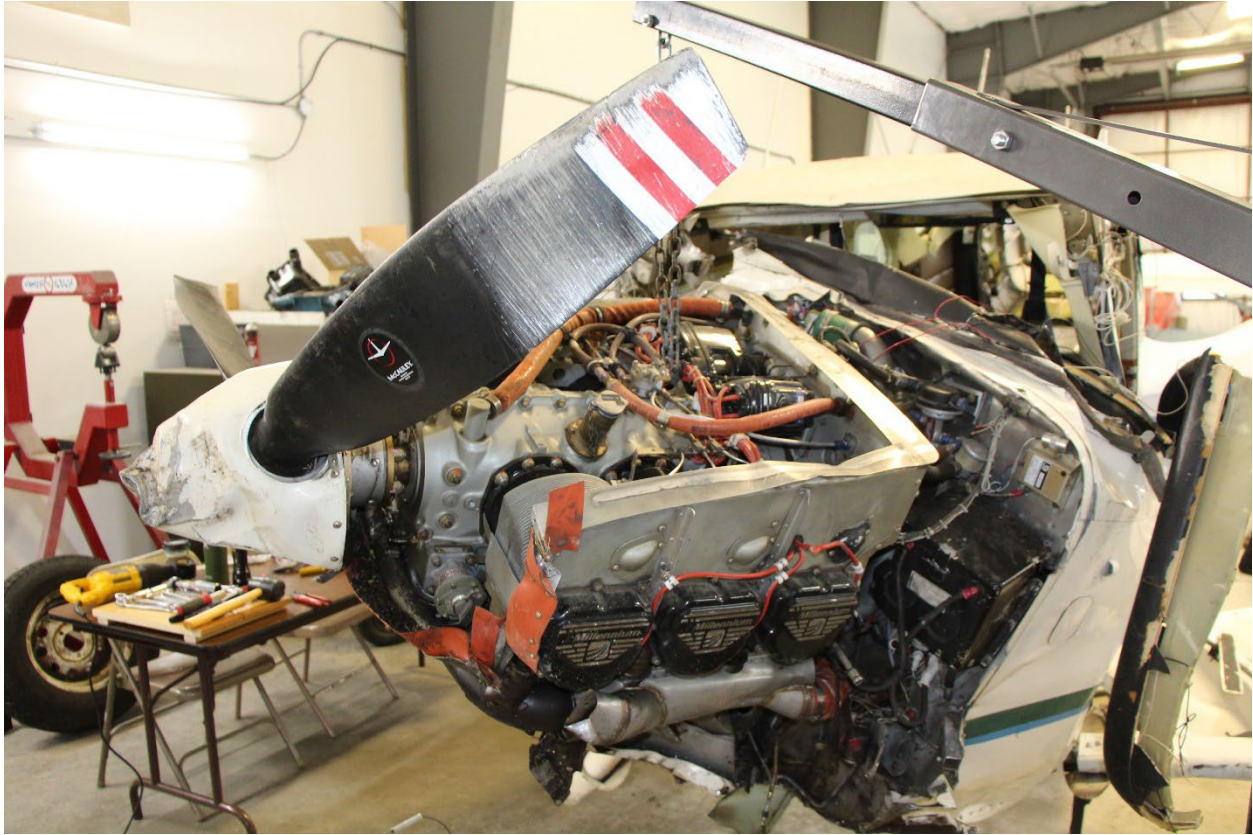
The engine was a Continental Motors IO-520-CCM, s/n 601419, an air-cooled, 285 hp reciprocating engine. The engine baffling was damaged, the induction tubes were crushed as were the exhaust tubes. The accessory case was intact, with exception of the alternator accessory

case pulley, which had been partially damaged. The pulley was also in contact with the throttle body, which inhibited movement of the propeller.

*Photograph 3: Engine prior to examination*

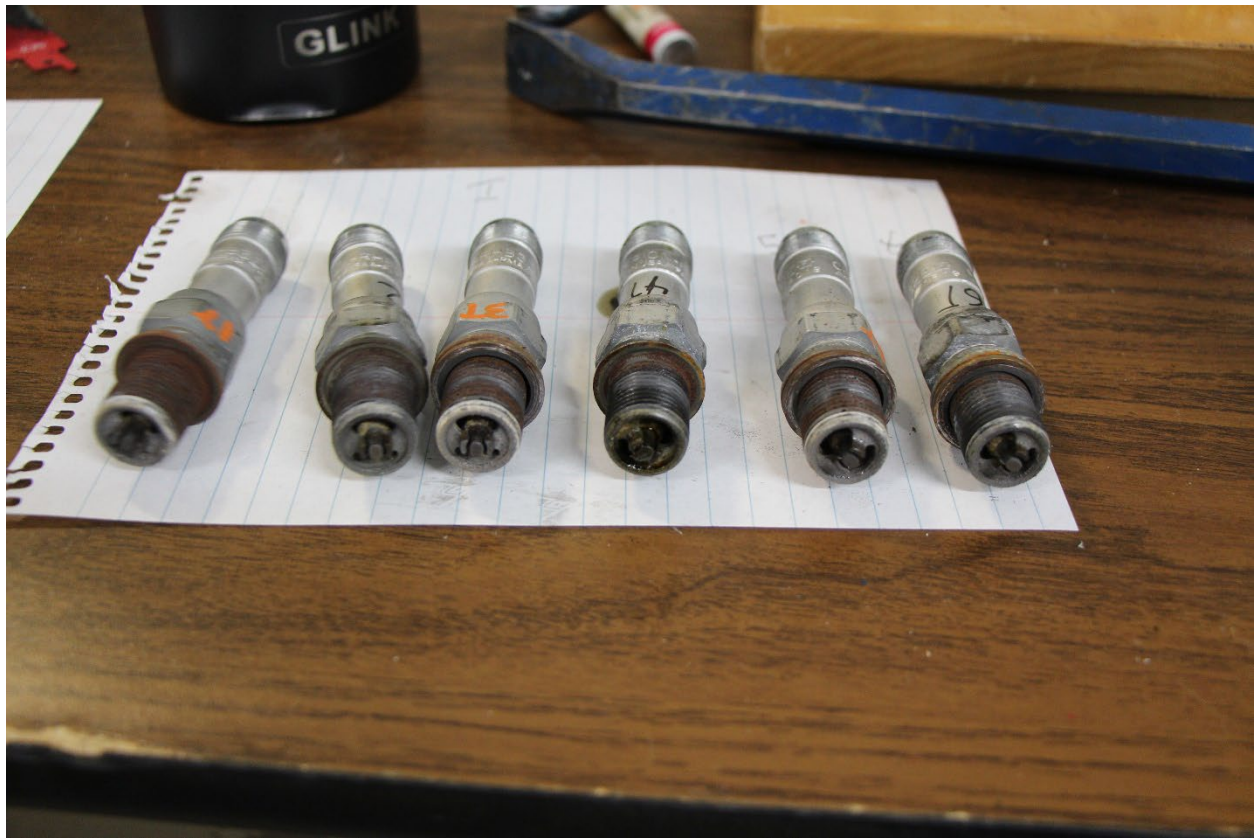
*Photograph 4: Top spark plugs*

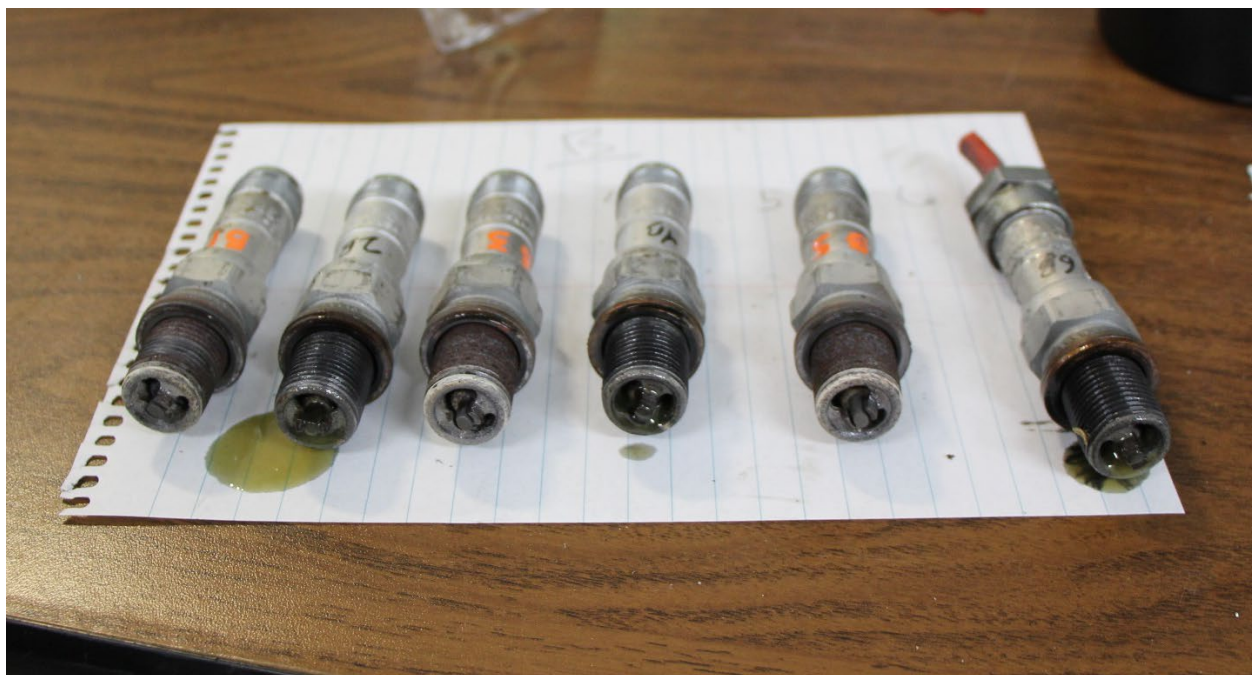
The magnetos were intact, but had moved slightly from their original position as indicated by slightly displaced torque stripe. The left magneto was a Continental Motors, Inc. SGRN-1225, s/n F17EA150R. The right magneto was a Continental Motors, Inc. SGRN-1225, s/n F16KA253R. Most of the ignition harness coils were secured tightly to their respective spark plugs. The top 5 ignition harness coil was loose. The bottom 2 and bottom 6 ignition harness leads were cut due to impact damage. Spark was observed at the bottom 1, 3, and 5 coils, and the top 2, 4, and 6 coils and the left magneto impulse coupling was heard as the propeller was rotated by hand. Both magnetos were subsequently removed and spark was observed on all 6 ignition harness leads while the magnetos were rotated using a drill. The top and bottom spark plugs were manufactured by Champion RHB 32E massive electrode plugs. All six of the top spark plugs were gray in appearance, consistent with normal wear. The bottom 6 spark plugs were grey in appearance with some carbon deposits.

*Photograph 5: Bottom spark plugs*
