# National Transportation Safety Board

WPR21FA340

## **MATERIALS LABORATORY**

Factual Report 23-004

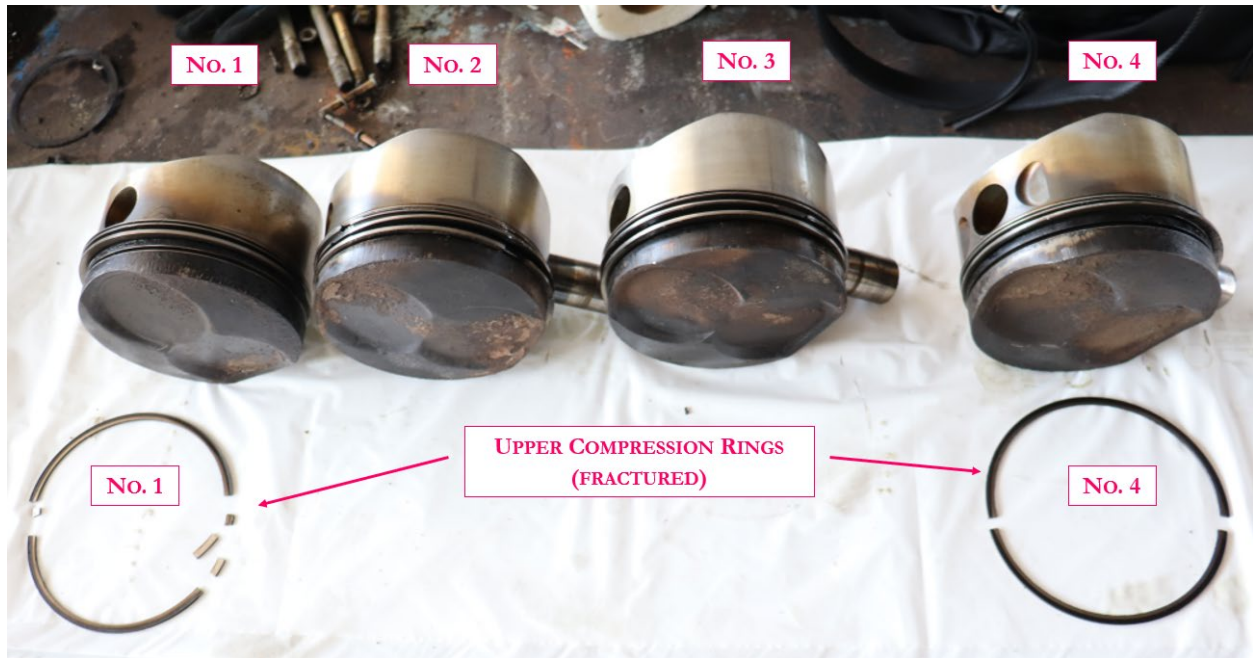
As part of the post-accident examination, the remainder of the Lycoming IO-360-A1B6 engine was completely disassembled.<sup>1</sup> According to the engine teardown report, the #1 and #4 top compression piston rings were fragmented (see Figure 1). The report stated evidence of corrosion and wear on all the piston skirts, with light scuffs and grooves from the base to the crowns oriented in the direction of actuation. There was additional evidence of blow-by with heat signatures on the piston skirts on all cylinders. Separation of the crankcase halves revealed severe spalling on the faces of all the intake lifters and the #3 exhaust lifter with evidence of galling. The camshaft showed excessive wear on the cam lobes, including rounding of the lobes, pitting, and material deformation.

and respective piston rings, photographed on-scene at the engine teardown before receipt of the parts. The figure illustrates the fractured upper compression rings from the #1 and #4 pistons, positioned near their respective piston assemblies.

**Figure 1.** Images of the pistons and fracture rings from the engine teardown.

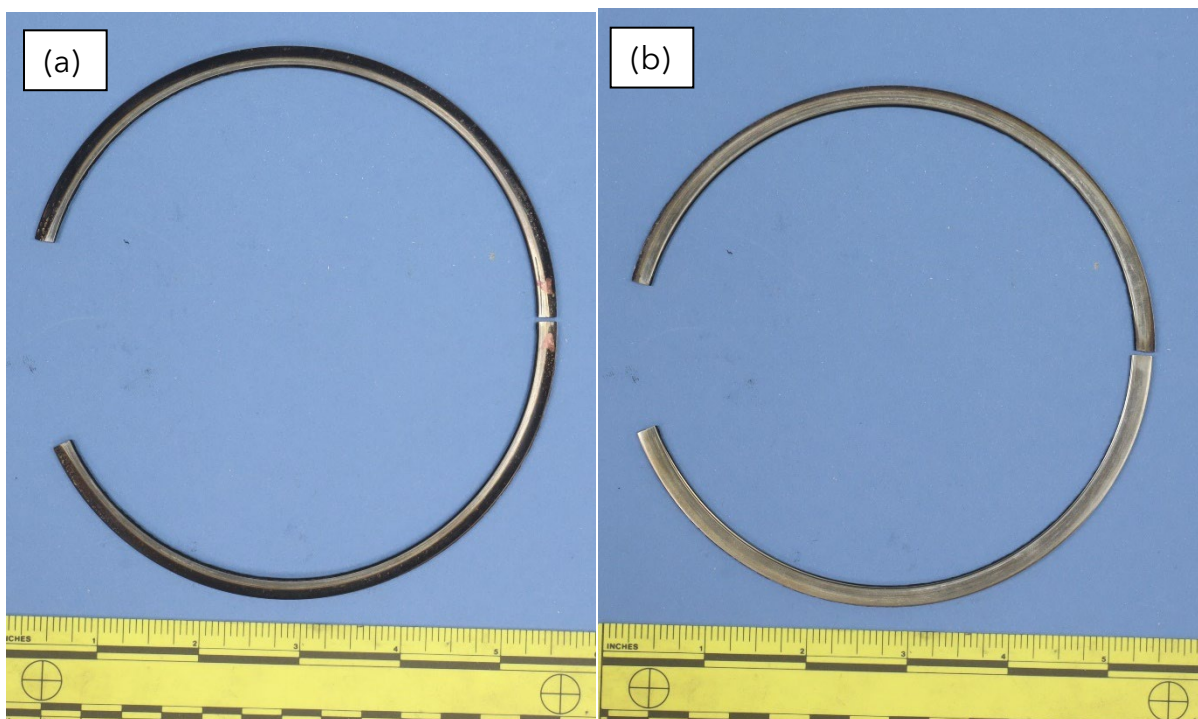
Figure 2 shows the opposite faces of the larger piston ring fragments from the #1 piston. The pieces exhibited a rounded, smooth face on the side in Figure 2a and a dull luster and rougher surface on the opposite (Figure 2b). The four small fragments from the #1 position are depicted from both faces in Figure 3. These fragments were labeled 1 through 4 for this report, from longest to shortest length.

**Figure 2.** The ring remnants from the #1 piston assembly, viewed from opposite sides..

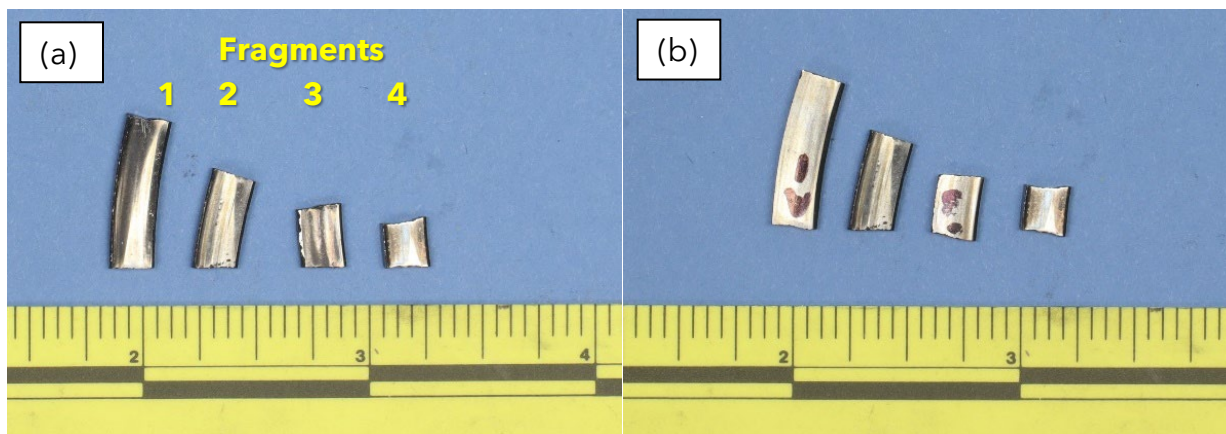
**Figure 3.** Smaller fragments of the ring retrieved from the #1 piston assembly.

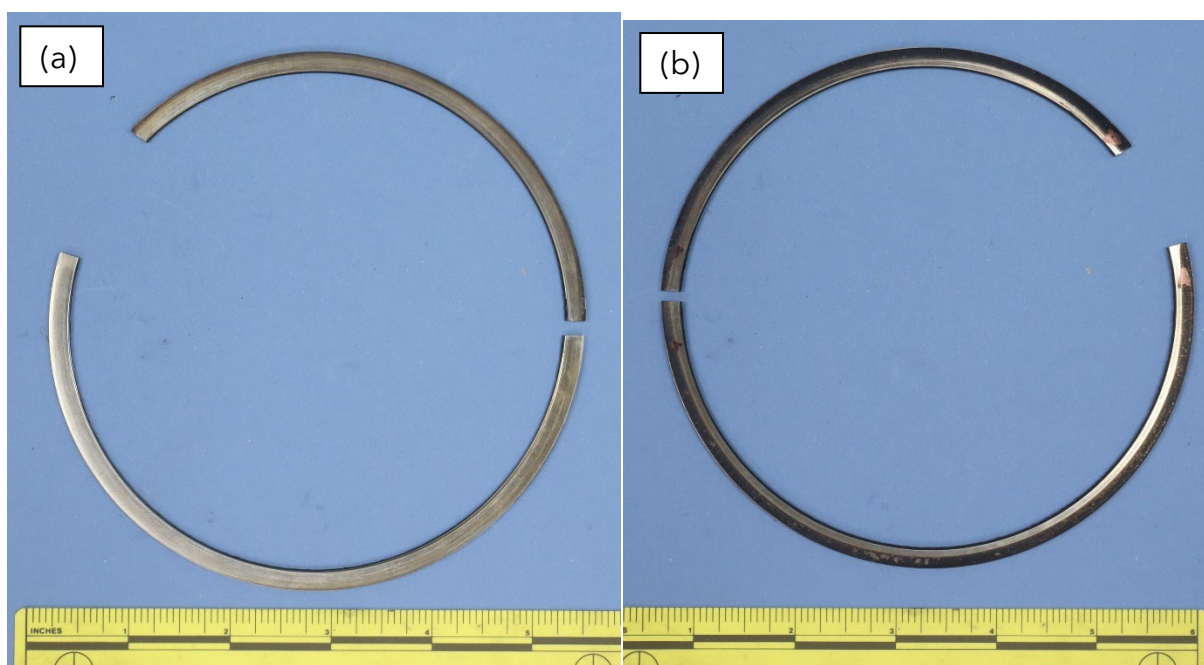
The upper compression rings from the #4 piston are shown in Figure 4. Similar to the larger ring pieces from the #1 piston, these also exhibited one face with a smoother, more reflective surface (Figure 4b) than that on the opposite face.

**Figure 4.** The ring remnants from the #4 piston assembly.

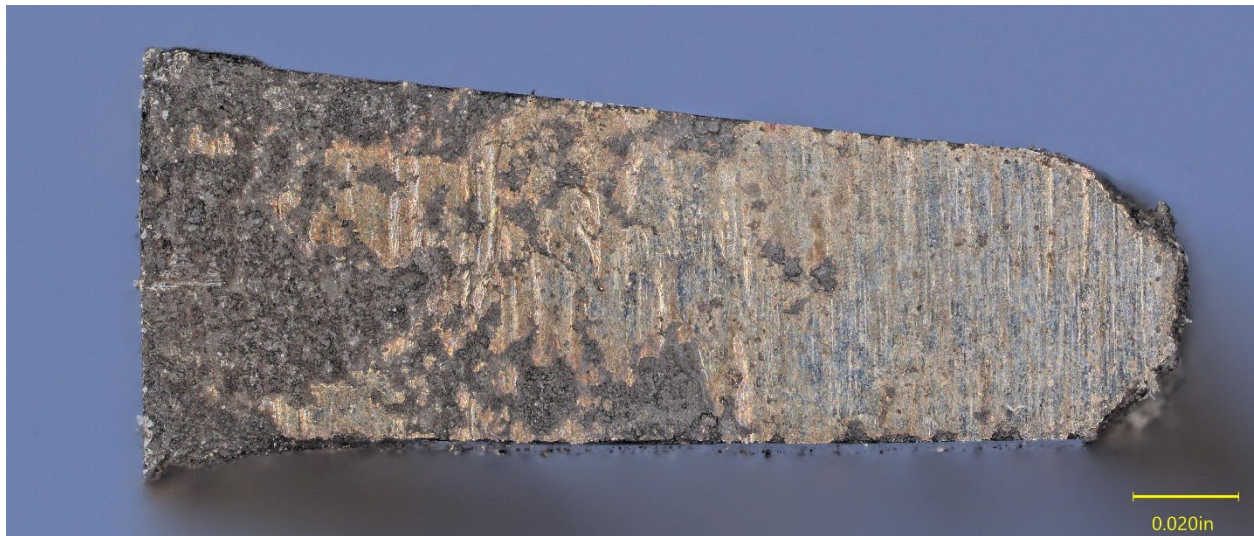
Figures 5 through 9 show the ends of the ring remnants from the #1 piston position. These were described by the larger and shorter remnant circumferential length, as depicted in Figure 2. These surfaces exhibited a combination of vertically-oriented streaks and dark, flaky divots. Figure 6 shows a closer view of one of the surfaces, highlighting the pock-marked dark depressions on the surface. The area surrounding the dark depression was reflective, exhibiting linear features that were not parallel. There were also indications of gouge marks on the surface. These reflective features were consistent with wear marks on the surface. The vertical direction (transverse to the ring cross sections) was consistent with the vertical movement of the piston during engine operation.

**Figure 5.** Surface 'A' from the larger #1 ring remnant.

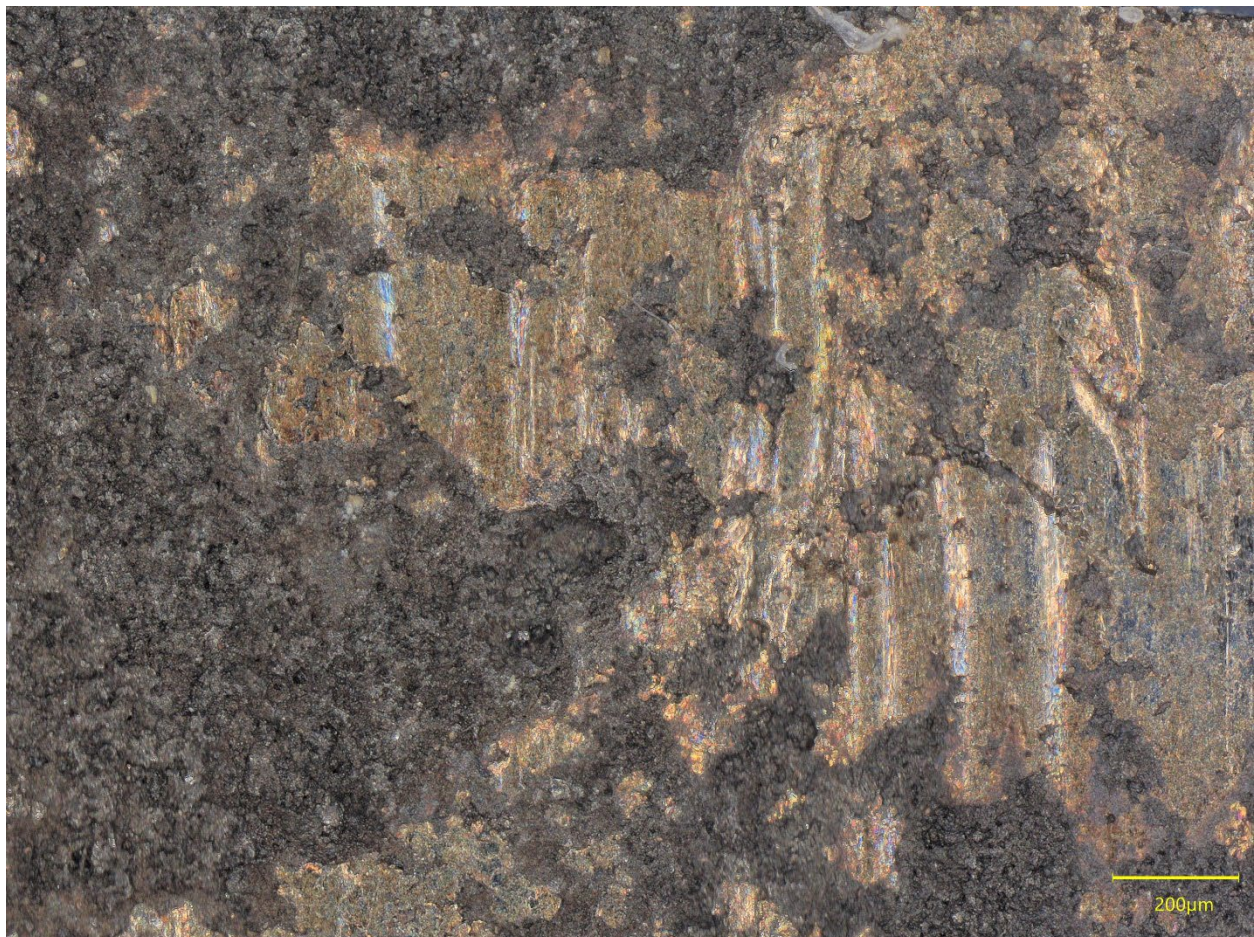
**Figure 6.** Closer view of depressions, foreign material, and vertically-oriented wear marks on the surface in **Figure 5**.

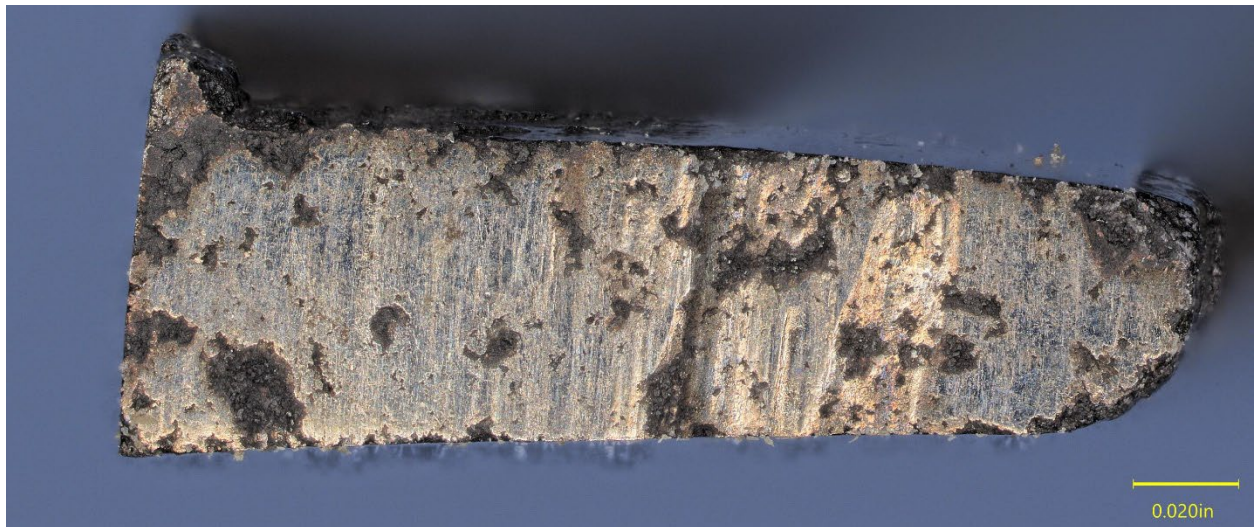
**Figure 7.** Surface 'B' from the larger #1 ring remnant.

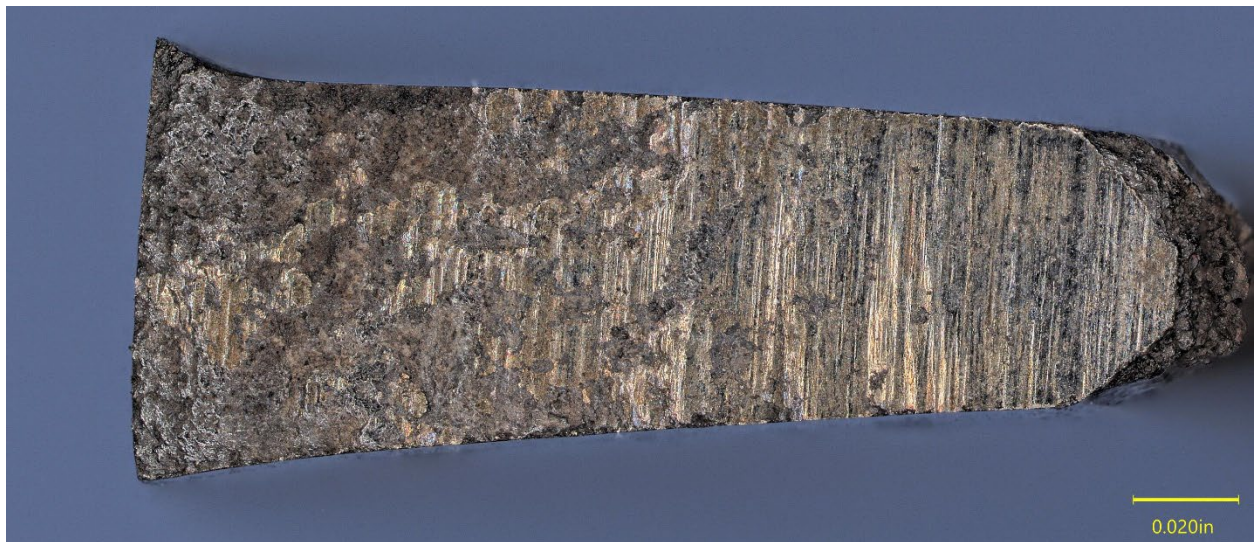
The lower edge of this #1 ring remnant surface was also examined, showing a wider area of depressed features and absent material (Figure 27). As illustrated in Figure 8, this region exhibited characteristics consistent with the other rough depressions, showing intergranular interstices, rounded facets, and dissimilar nonconductive material. These areas were examined using energy dispersive x-ray spectroscopy (EDS). The composition was consistent with iron oxide and high amounts of carbon, lead, bromine, and phosphorus. These later elements were consistent with combustion products from tetraethyl lead additives in avgas. This chemistry was consistent in all rough areas containing dissimilar, non-conductive material.

**Figure 8.** Surface 'A' from the shorter #1 ring remnant.

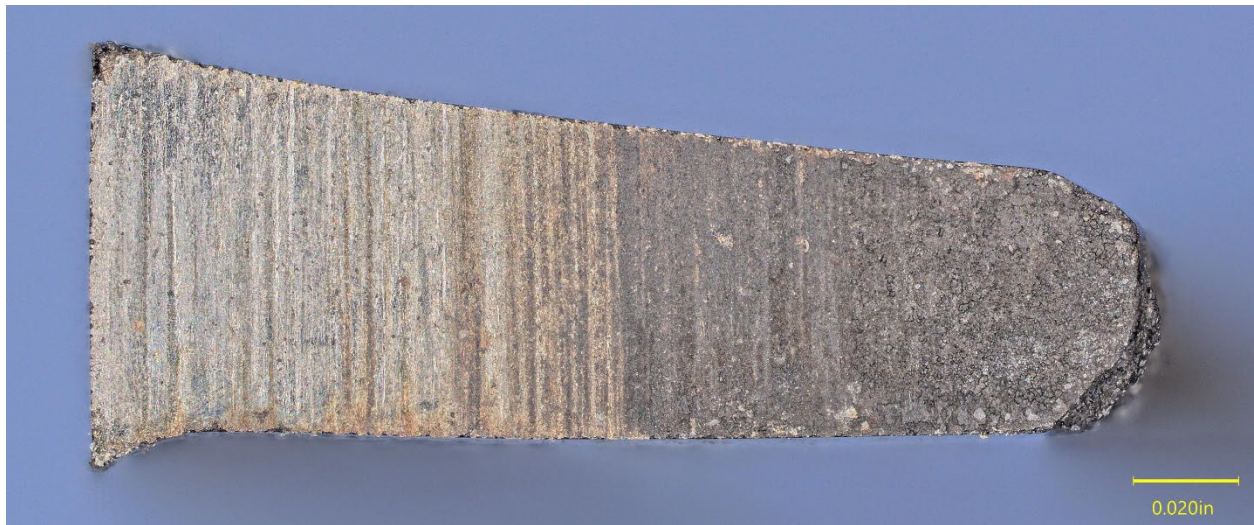
**Figure 9.** Surface 'B' from the shorter #1 ring remnant.

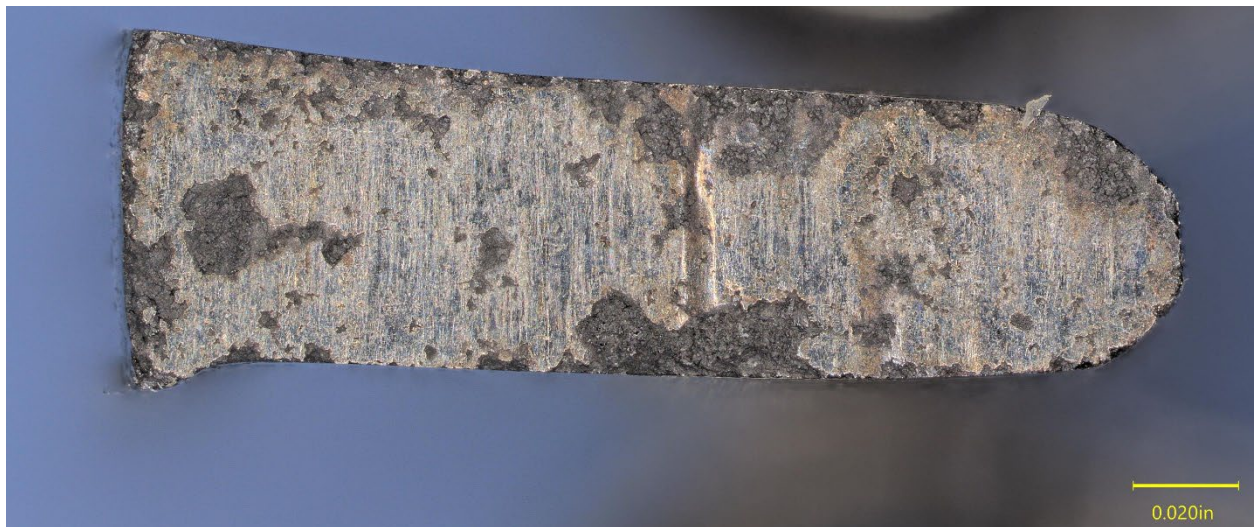
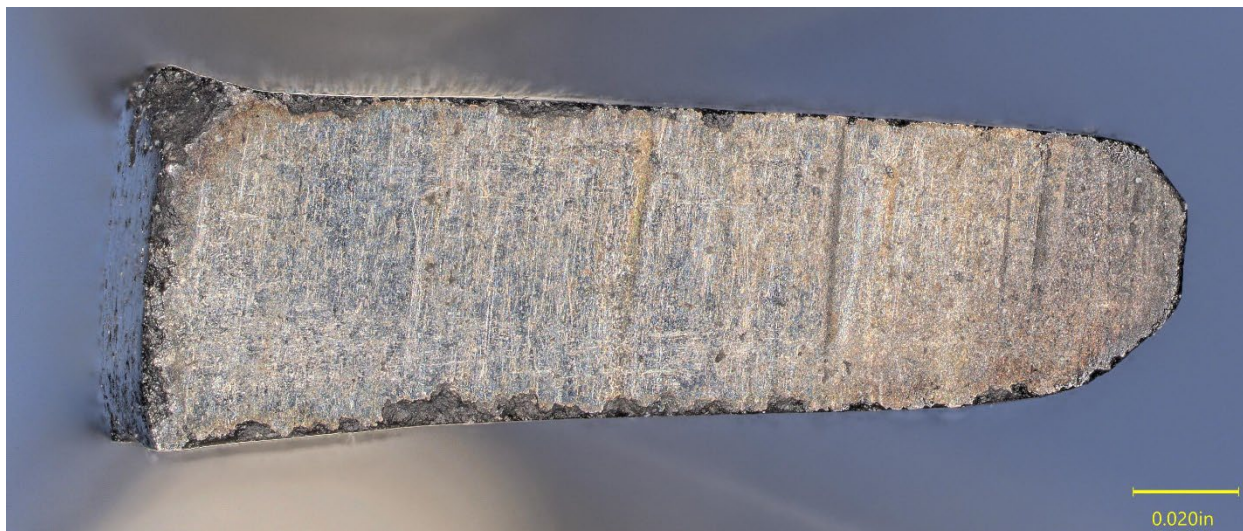
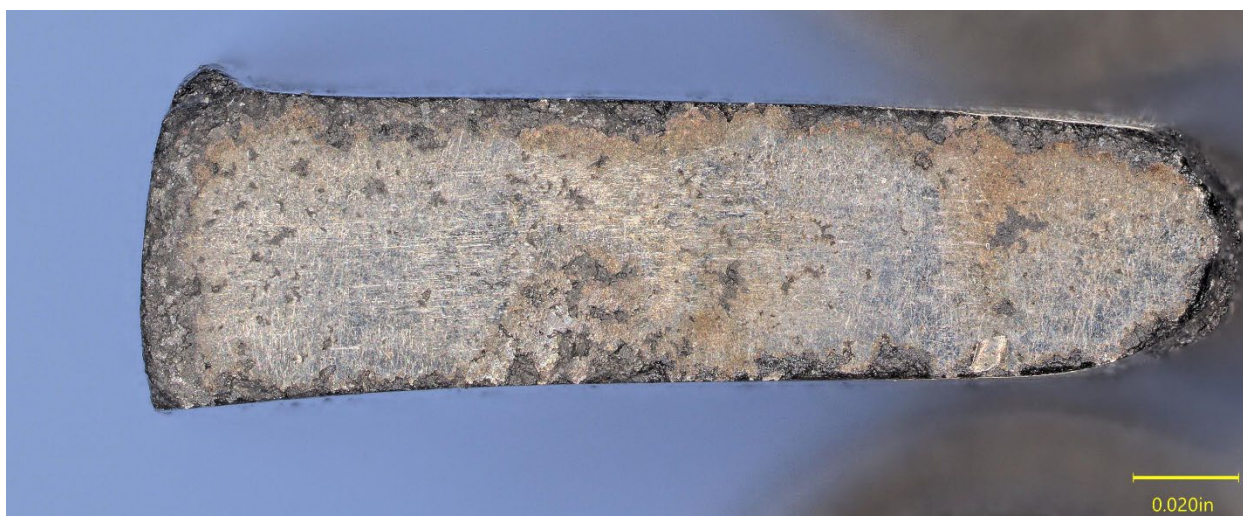
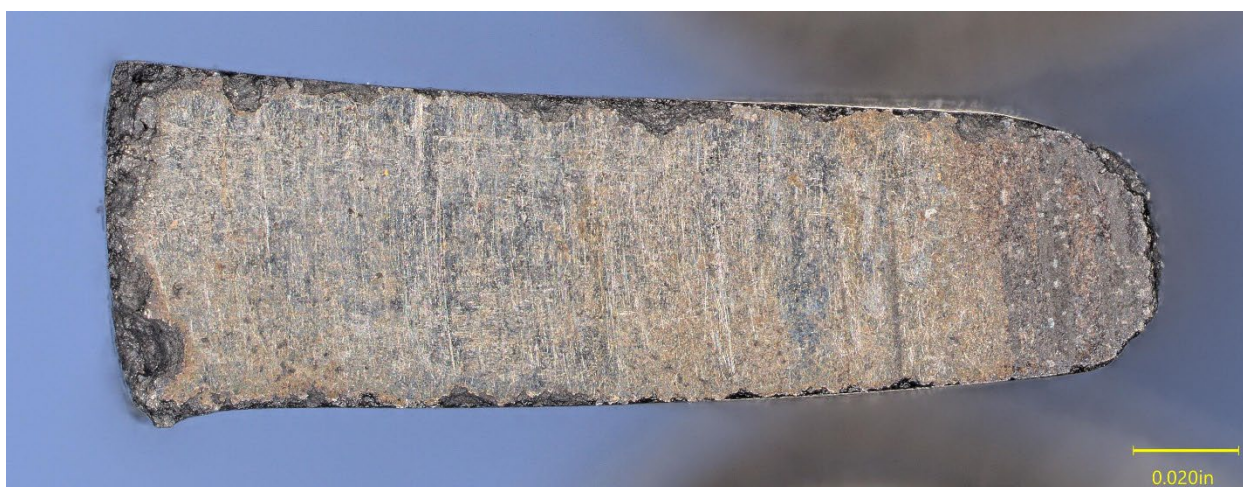
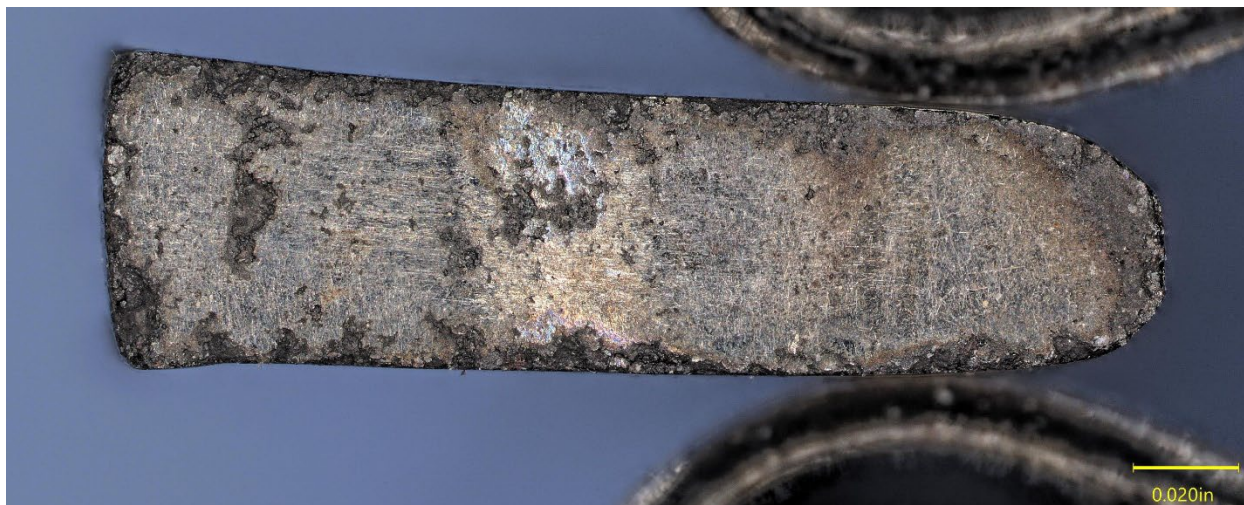
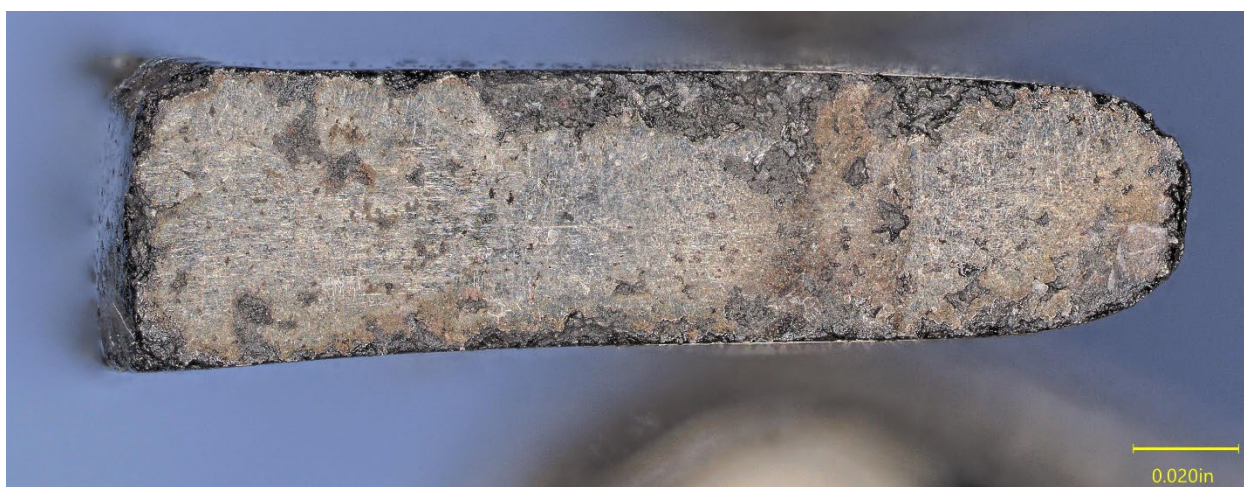
Figures 10 through 18 show the cross-sectional surface of the four fractured ring fragments. As documented in Table I, these fragments exhibited a smaller thickness and widths than the larger ring remnants. Most of the fragment cross sections showed rounded protrusions facing outward, located on the left side of the figures for these parts. As with the #1 ring remnant ends, these fragments exhibited vertical streaks, wear marks, and darker mottled depressions. The smallest piece, illustrated

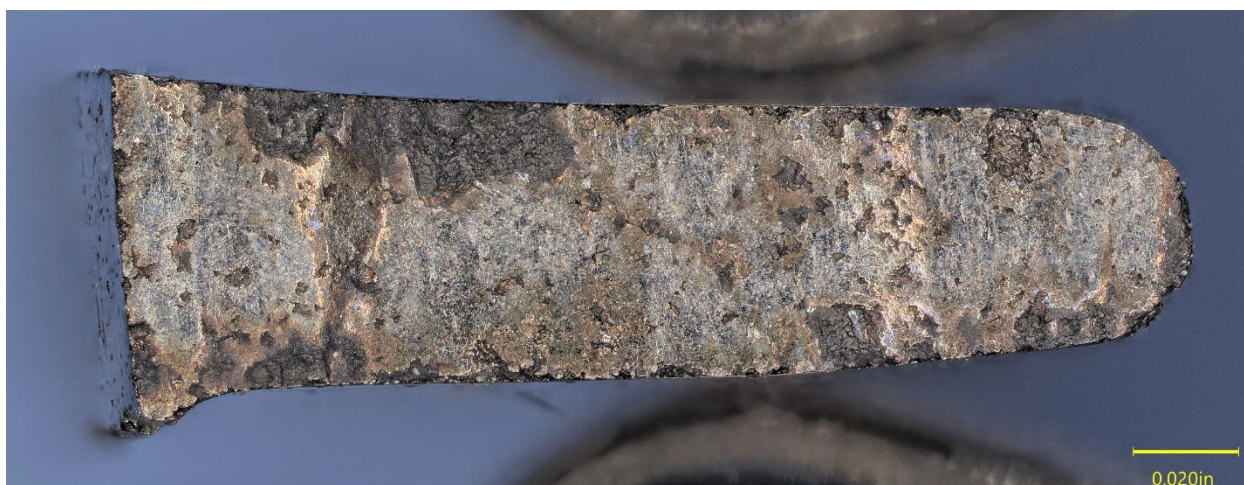
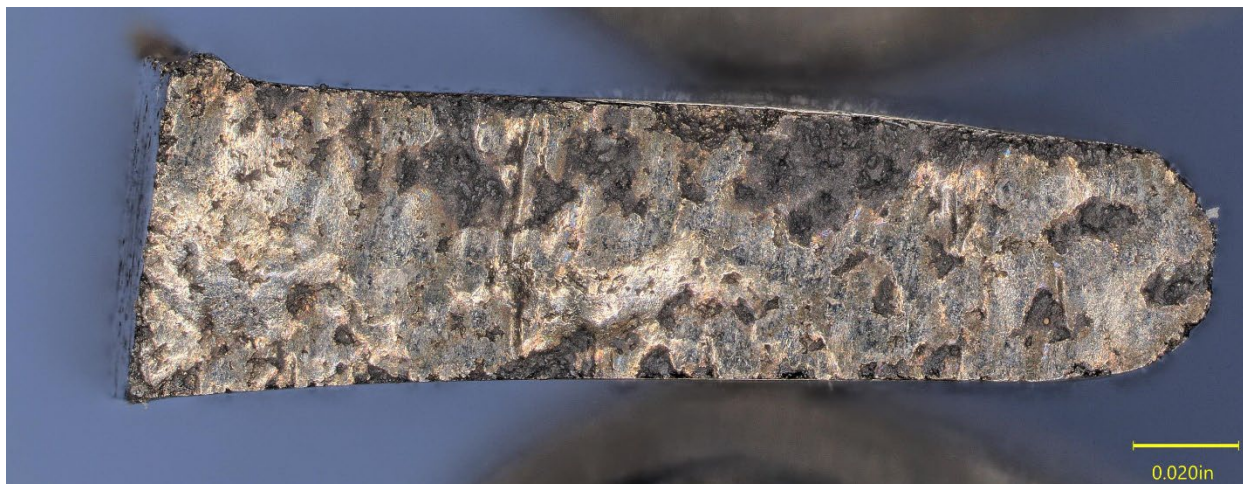
in Figures 16 and 17, revealed the most severe surface damage, with most surface areas reflecting light consistent with smoothing from wear.

**Figure 16.** Surface 'A' from the ring fragment #4.

**Figure 17.** Surface 'B' from the ring fragment #4.

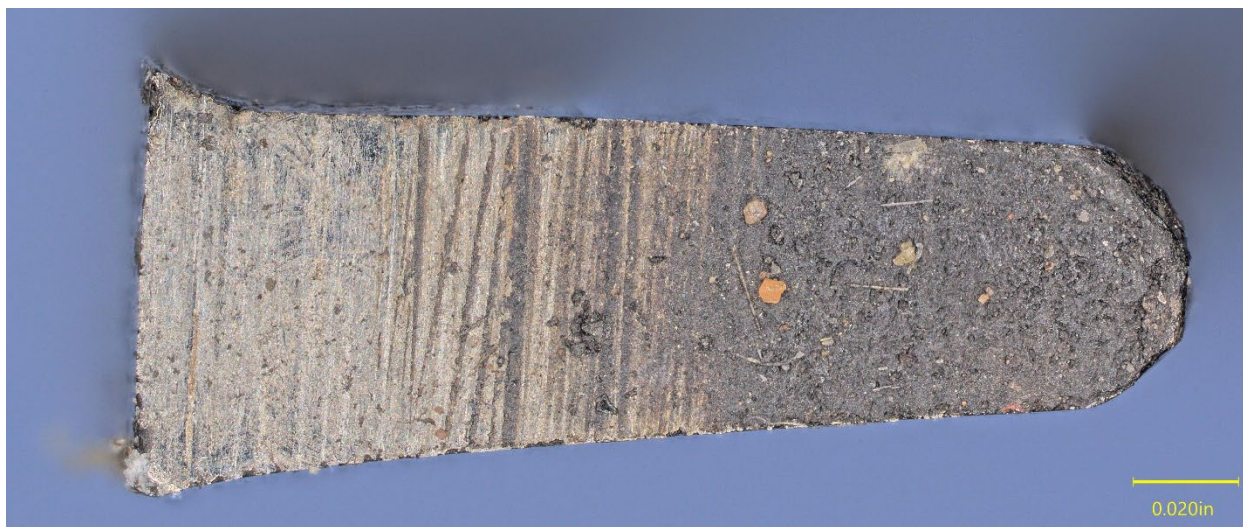
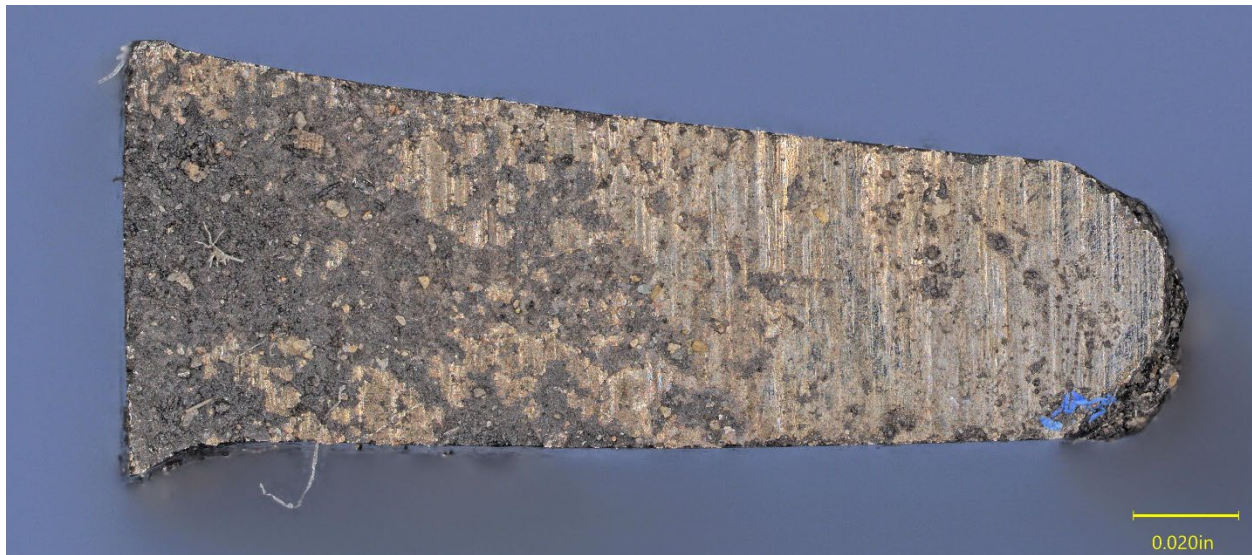
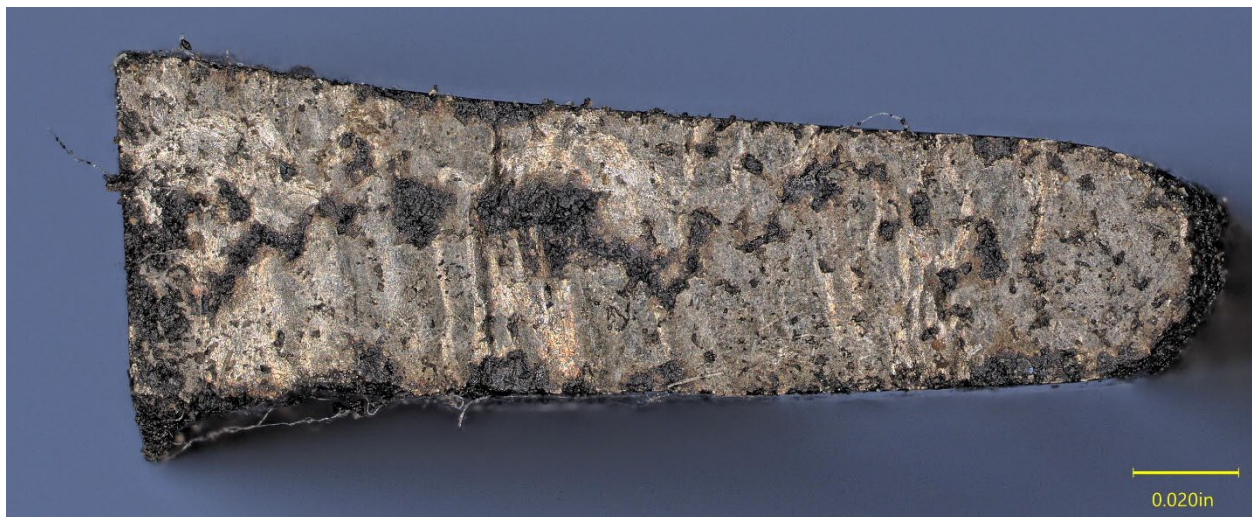
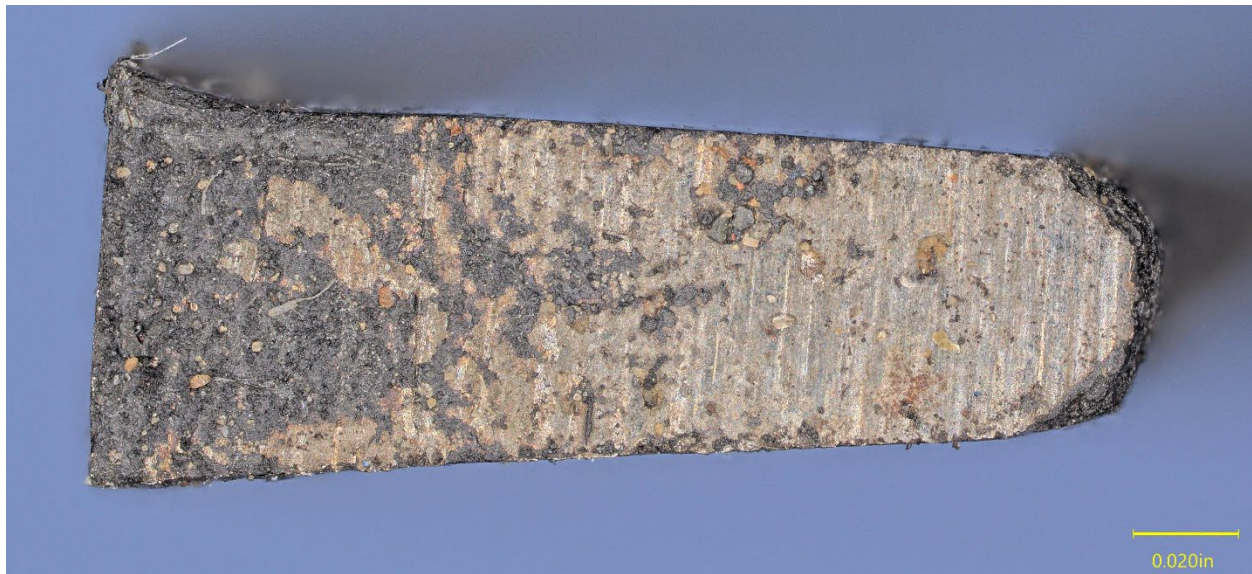
Figures 18 through 21 show the ends of the ring remnants from the #4 piston position. Like the ends of the #1 rings and the smaller fragments, the #4 ring remnants displayed a combination of vertically-oriented streaks and dark, depressed areas.

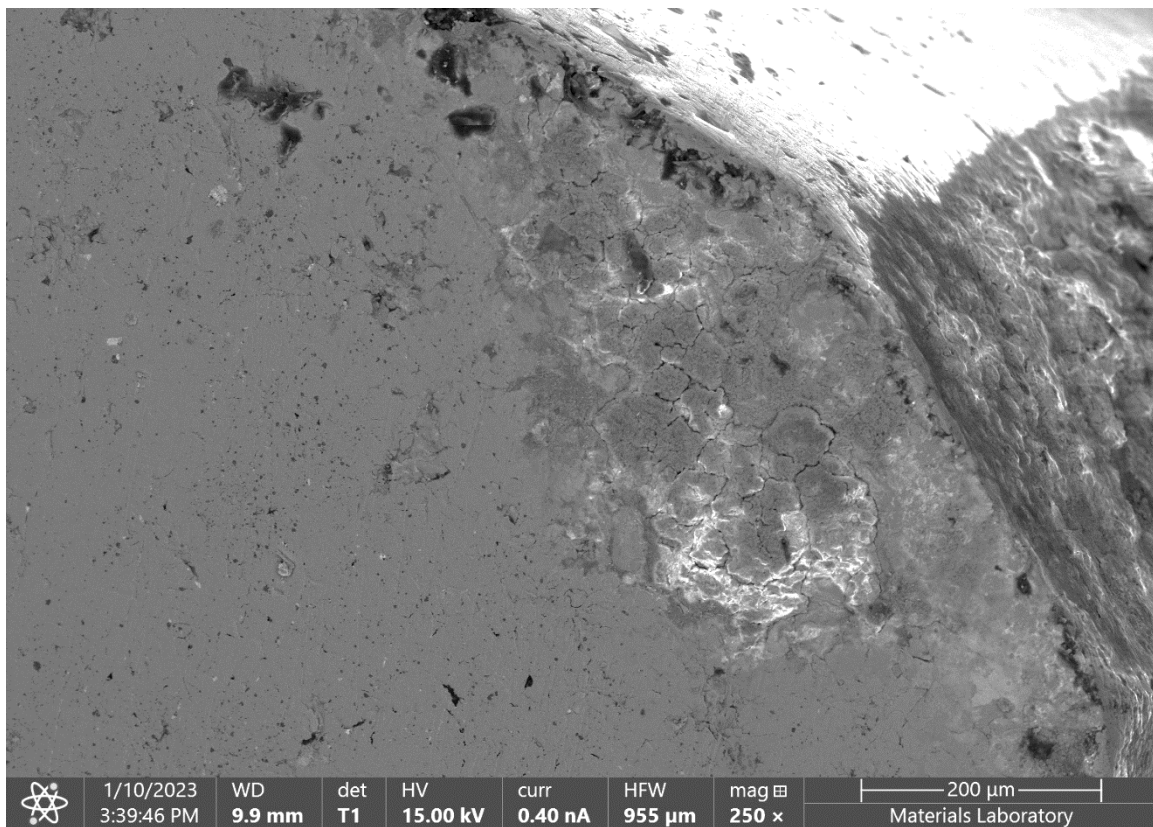
Several fragments and the shorter #1 ring remnant were examined using a field emission scanning electron microscope (SEM). Figure 22 shows a typical area along the inner edge of the #1 ring, side 'A,' shown visually in Figure 8. The rough and darker area contrasted with the surrounding smoother regions of the surface (toward the left and bottom in Figure 22).<sup>2</sup> The pock-marked area exhibited peripheral areas of light contrast. Closer views in Figure 23 showed these regions displayed electrical noise, consistent with the charging effects of nonconductive materials in an electron microscope. This region also exhibited a rounded intergranular appearance, with secondary cracks present normal to the surface.

**Figure 22.** Backscattered electron (BE) micrograph of the inside corner of the shorter #1 ring surface A.

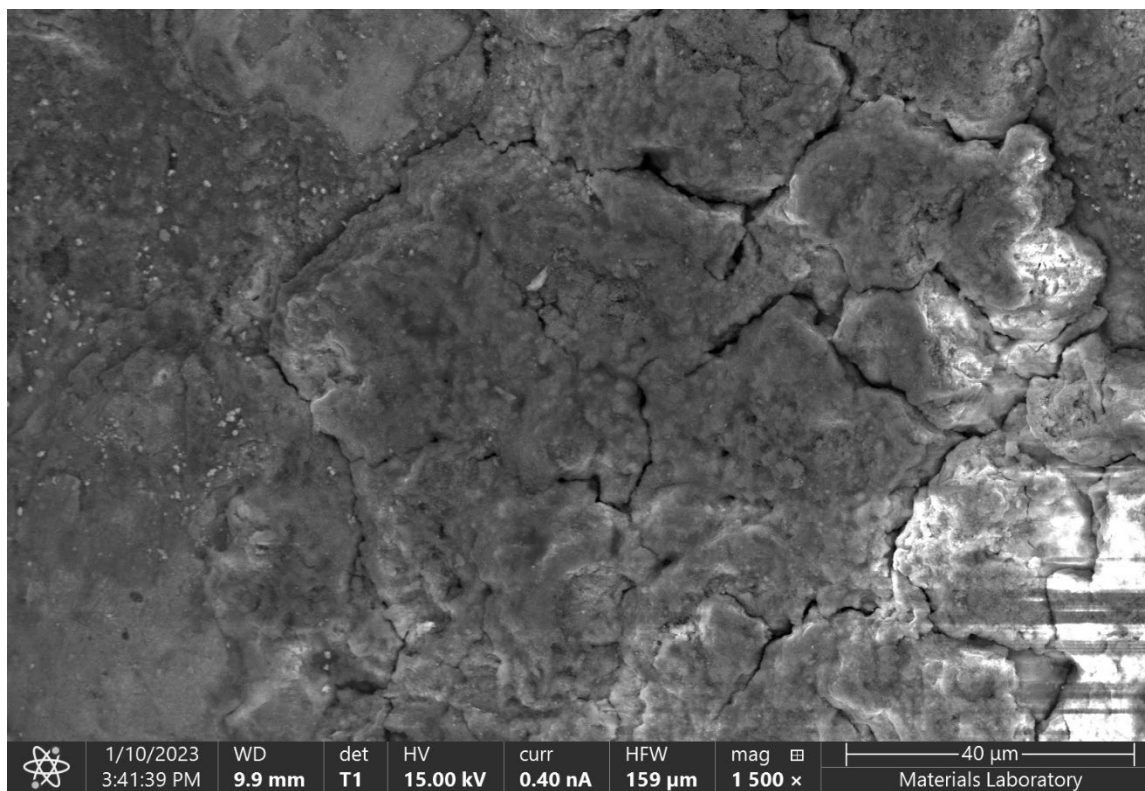
**Figure 23.** BE micrograph of the rumpled area in the upper right of **Figure 22**.

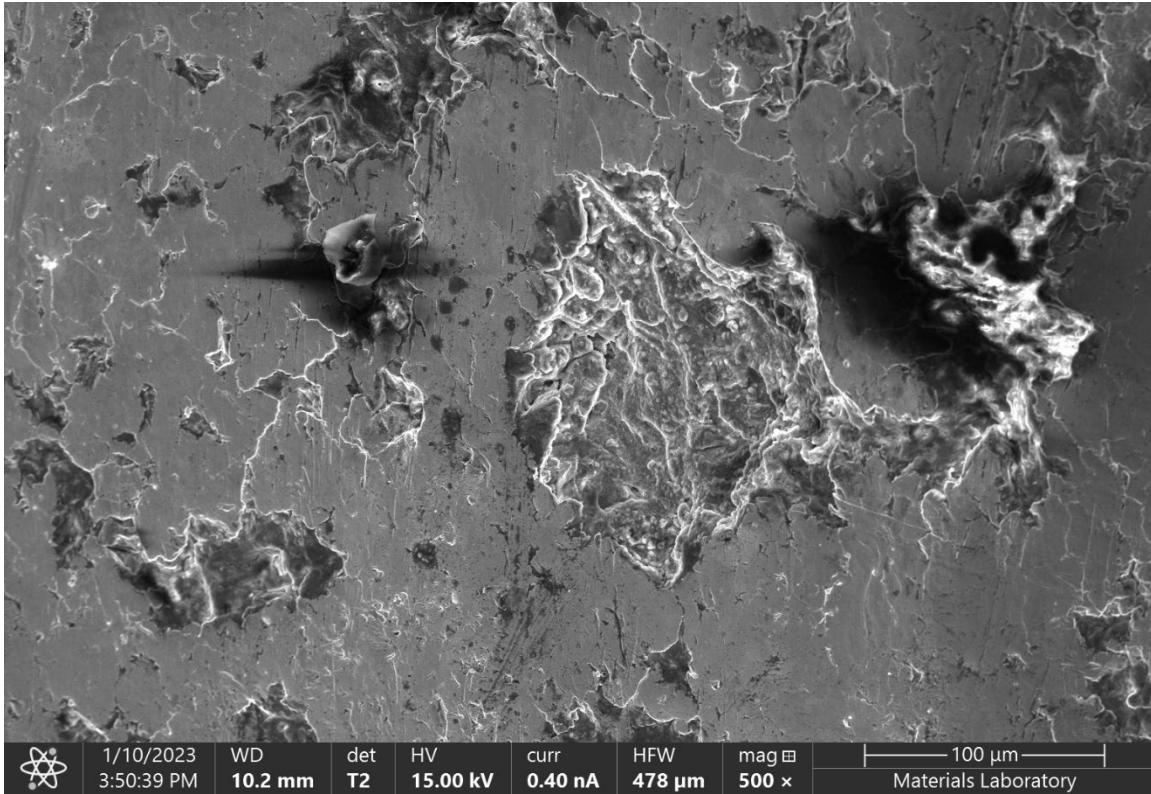
A smoother area of the #1 ring surface 'A' was also examined, showing more minor depressions along the surface (see Figure 24). The smoother regions exhibited a layered appearance, consistent with deformation and exuding of the ring material over gaps and valleys. As shown in the backscattered micrograph in Figure 25, the surface depressions exhibited some contrast, consistent with dissimilar material present. Figure 26 shows a closer view of the central depression in Figure 24. The feature exhibited a rounded intergranular appearance, with smaller protrusions on the surface indicative of oxidation or corrosion deposits.

**Figure 24.** Secondary electron (SE) micrograph of a depression on the worn area of #1 ring surface A.

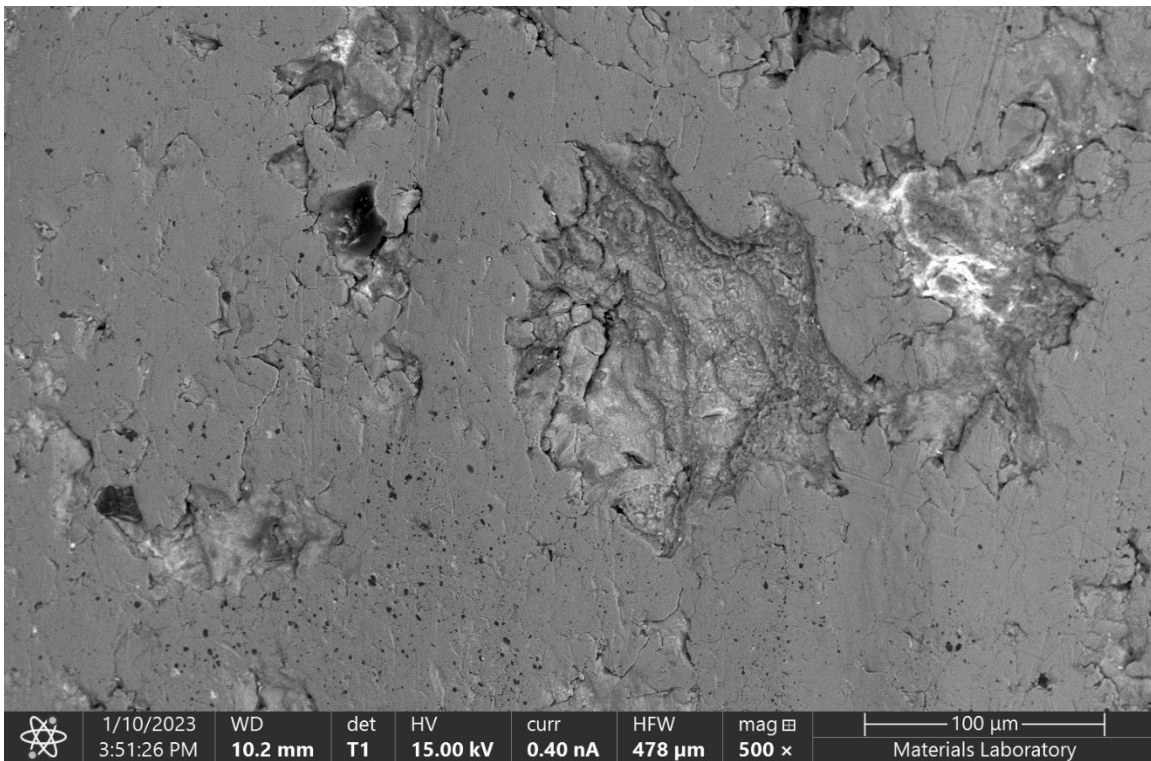
**Figure 25.** BE micrograph of the area in **Figure 24**.

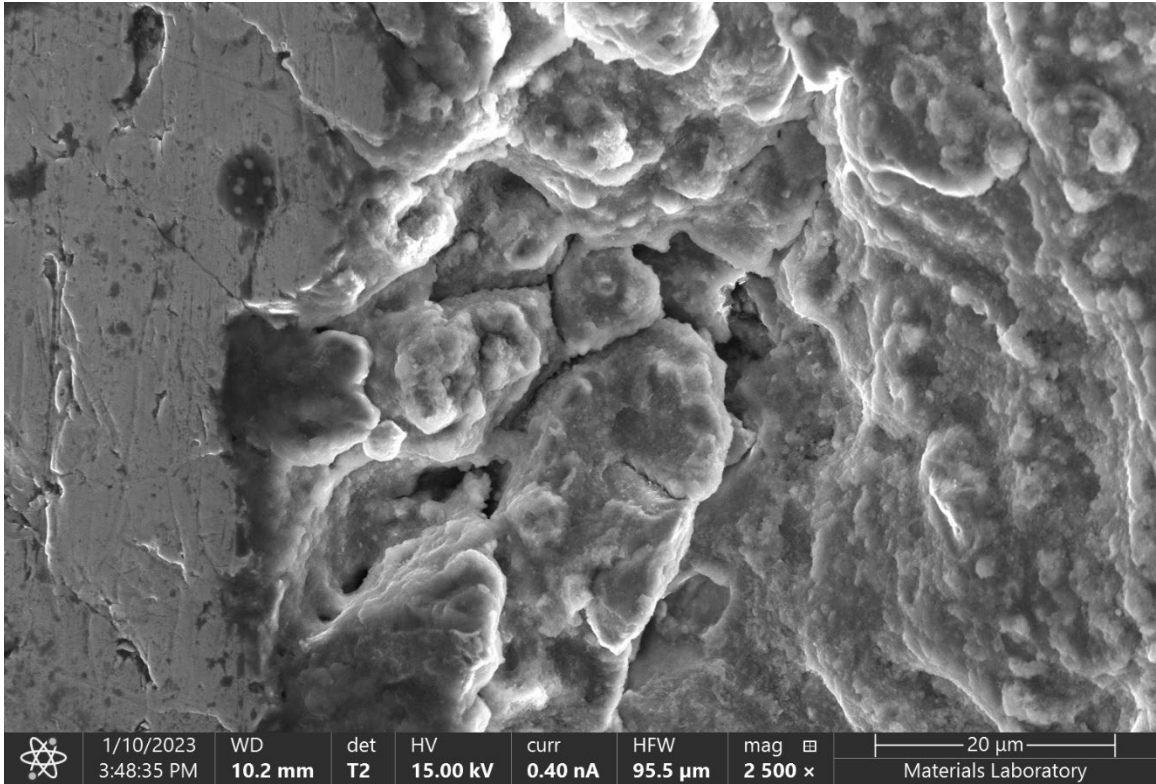
**Figure 26.** SE micrograph of a closer view of a corner of the depression in **Figure 24**.

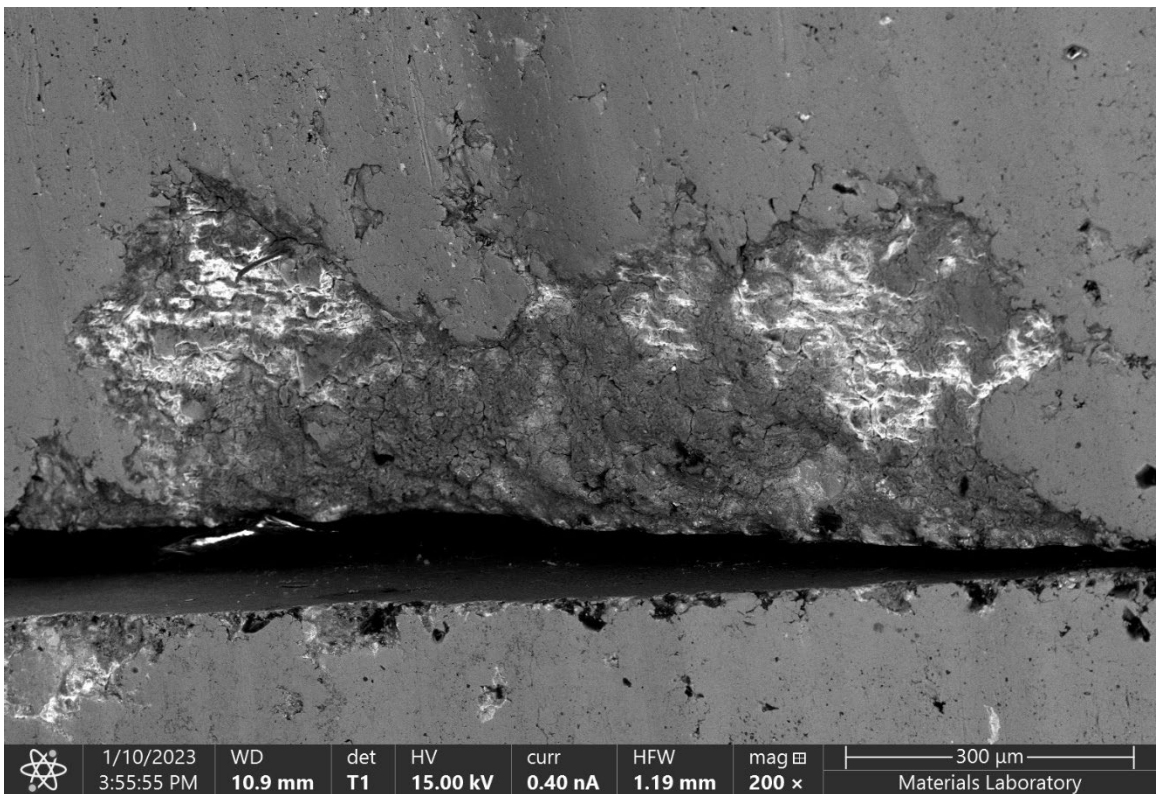
**Figure 27.** BE micrograph of wear and corrosion on the middle of the lower edge of the shorter #1 ring.

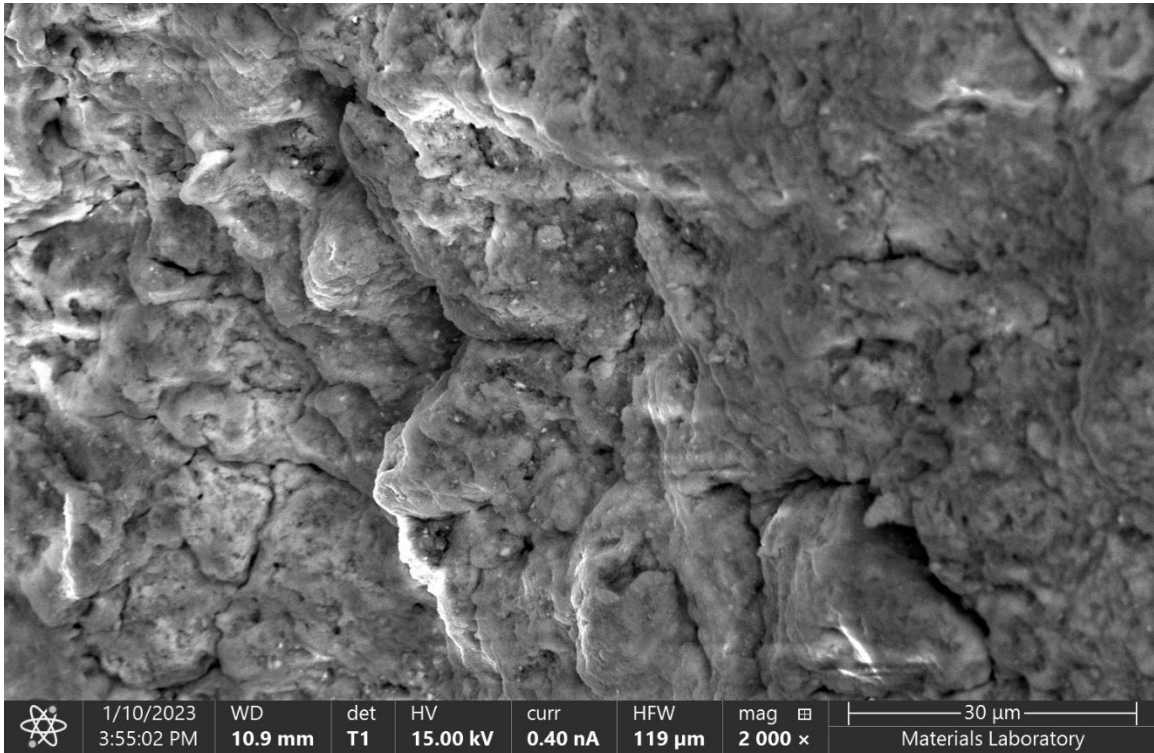
**Figure 28.** BE micrograph showing a closer view of the corroded, intergranular portion of the fracture (lower middle of **Figure 27**).
