# National Transportation Safety Board

WPR21FA340

## **MATERIALS LABORATORY**

Factual Report 23-004

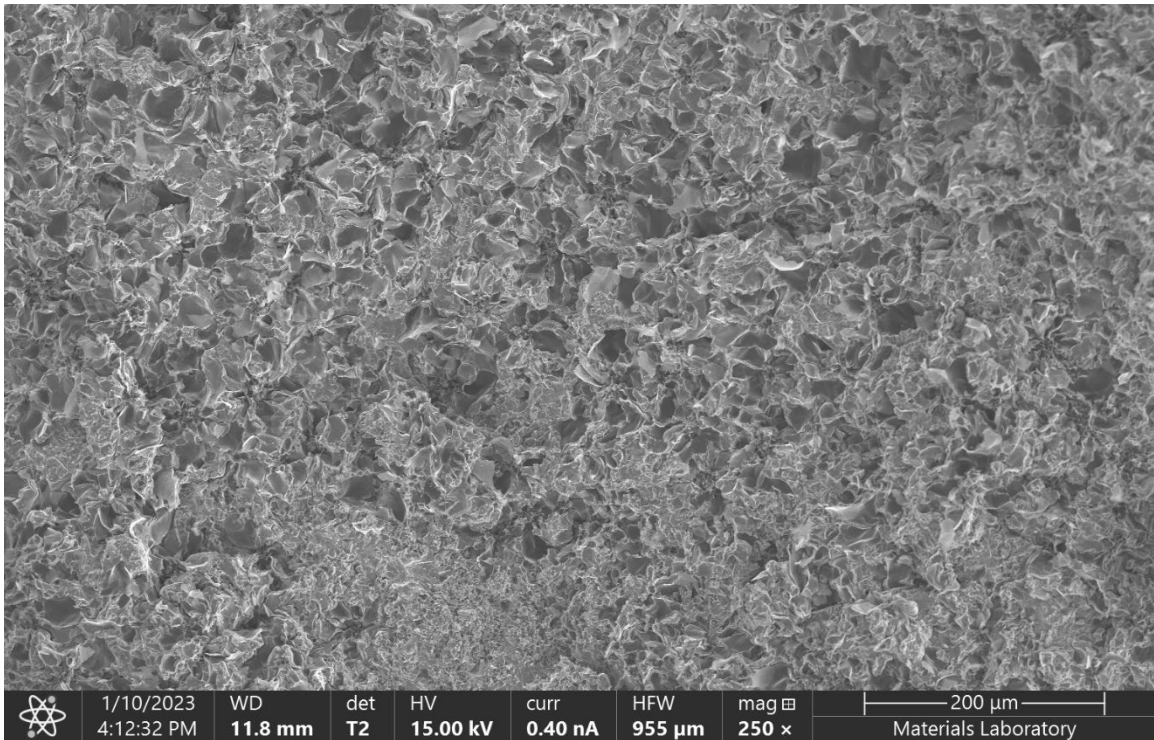
One of the ring remnants from the #1 piston was intentionally fractured in bending overstress to examine how such a fracture surface would appear. Figure 29 shows a typical area of the intentionally overstressed fracture surface. The surface exhibited a

blocky, faceted appearance. Imaging with backscattered mode revealed randomly alternating areas of light gray and dark features, consistent with dissimilar constituents on the fracture.

**Figure 29.** SE micrograph of the laboratory opened fracture surface of the #1 shorter ring, showing an intergranular morphology.

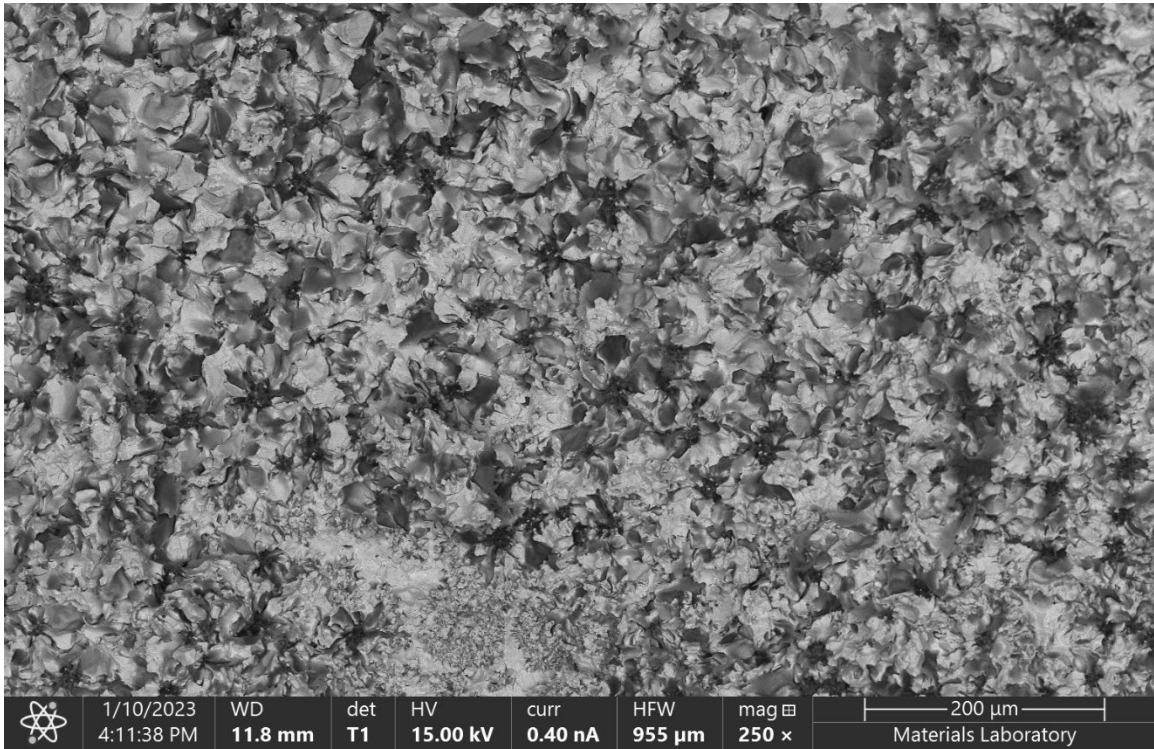
**Figure 30.** BE micrograph of the laboratory opened fracture surface of the #1 ring.

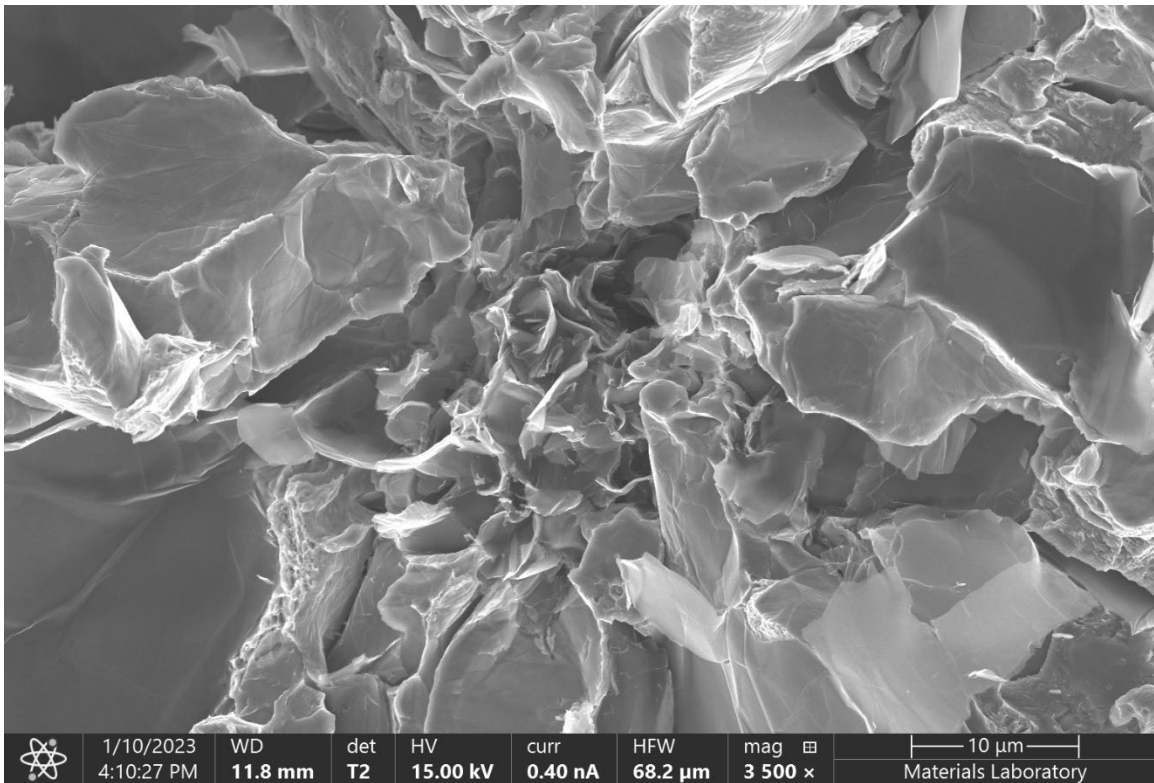
Figure 31 shows a closer view of one of the faceted features on the fracture surface. This feature exhibited a 'rosette' of faceted river patterns emanating from a central acicular feature. When imaged in backscattered mode, this constituent displayed darker contrast (lower atomic number), found to be consistent with nearly all carbon when examined by EDS (Figure 32). The surrounding iron-rich material exhibited cleavage facets and some areas of fine-dimpled rupture (as exemplified in Figure 33).

**Figure 31.** SE micrograph of the 'rosette' shaped features on the laboratory opened fracture surface.

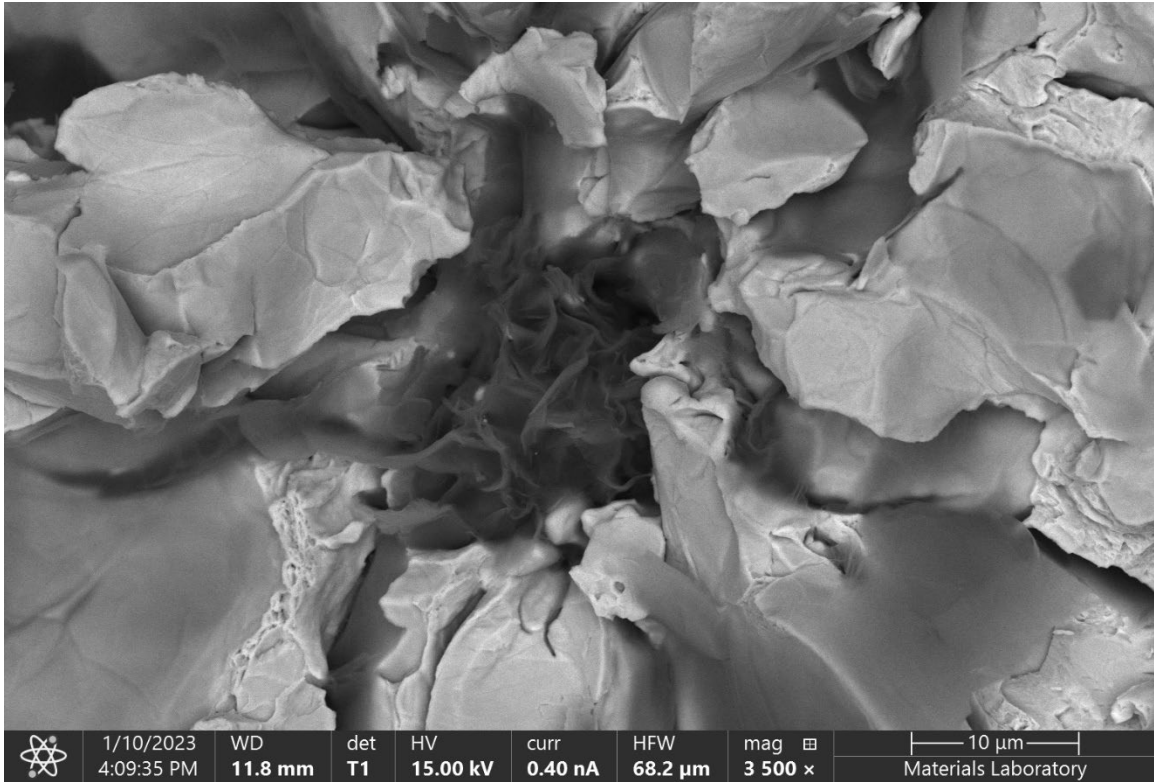
This laboratory fractured surface was examined by EDS. The composition, along with the morphology of the fractured carbon-rich phases on the surface, were consistent with malleable iron.

**Figure 32.** BE micrograph of **Figure 30**, showing a central C-rich area.

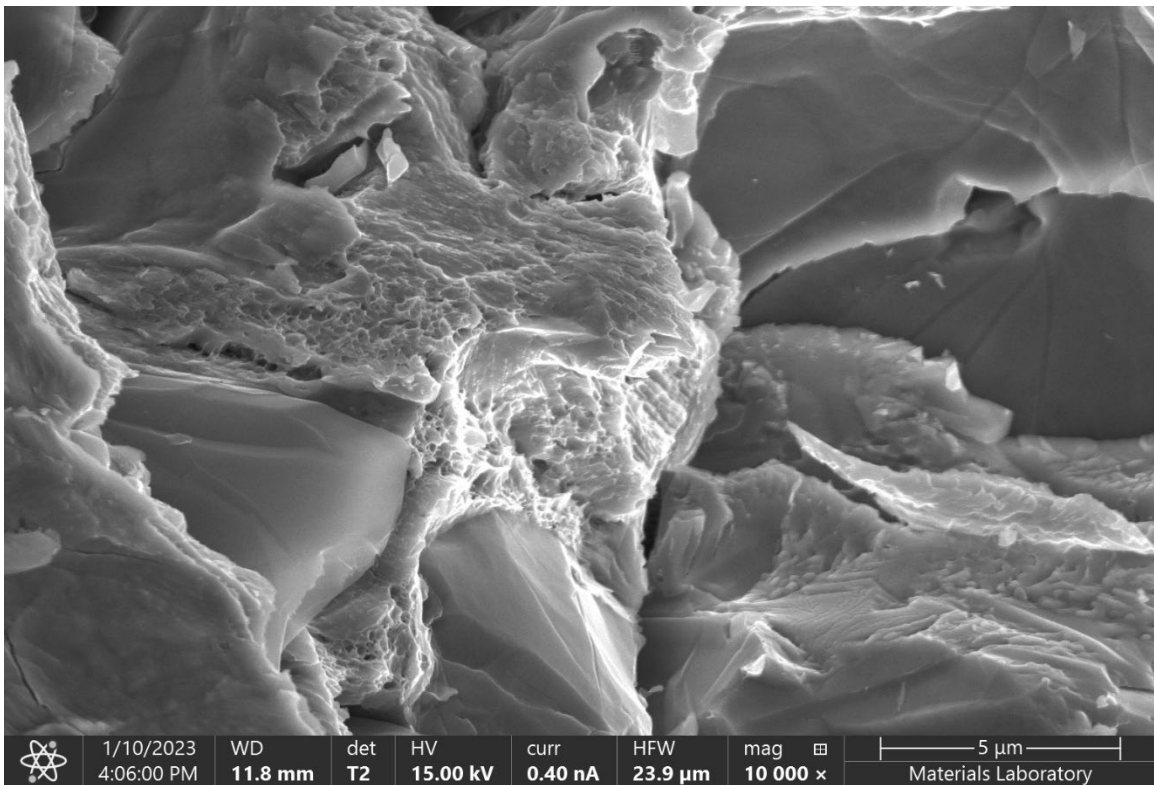
**Figure 33.** SE micrograph of fine dimpled rupture on facets in the laboratory opened fracture surface.
