## INVESTIGATION SUPPLEMENTAL MATERIAL

On September 12, 2021, about 1609 mountain standard time, a Cessna 177RG, N2085Q, was substantially damaged when it was involved in an accident near Lake Havasu Airport, Lake Havasu, Arizona. The pilot was fatally injured. The airplane was operated as a Title 14 *Code of Federal Regulations* (CFR) Part 91 personal flight.

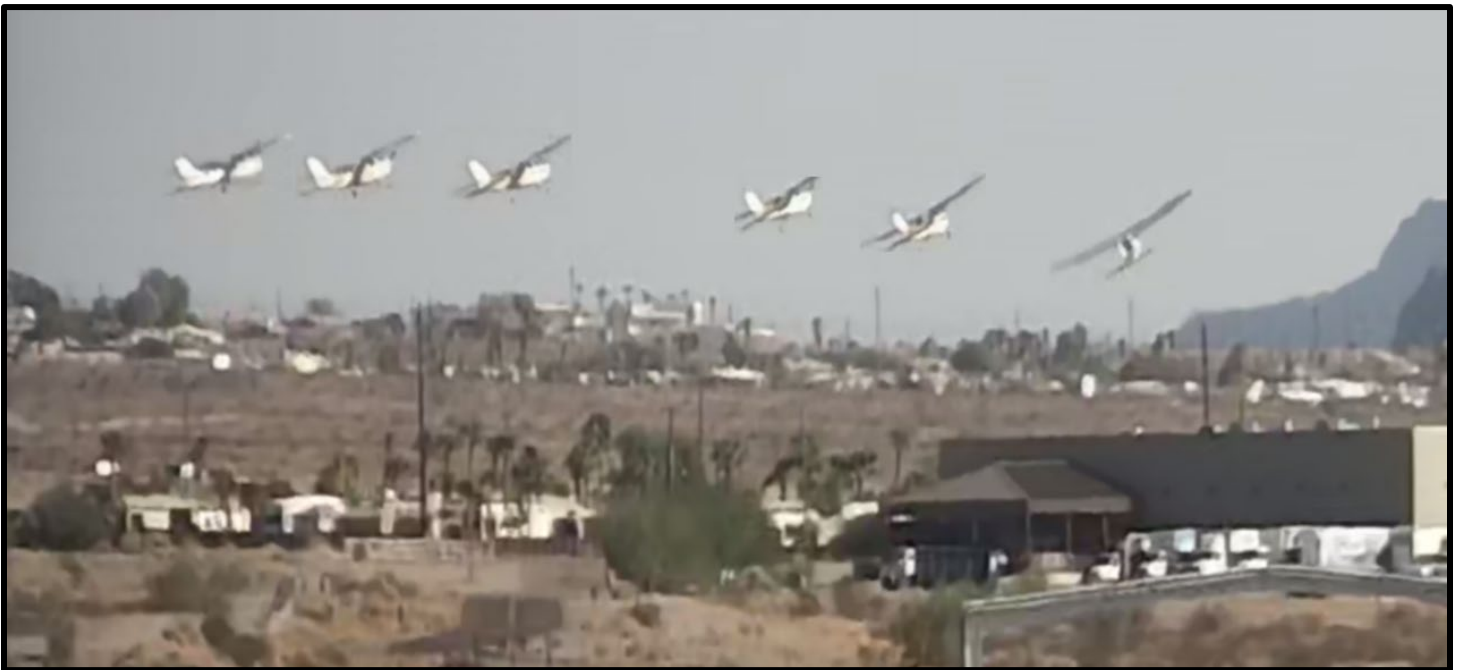
Figure 1: Security Camera Footage Showing Initial Right Turn

Investigators reviewed video recordings, audio recordings, and flight track data covering the area of the accident during the time surrounding the accident using Federal Aviation Administration (FAA) provided Automatic Dependent Surveillance-Broadcast (ADS-B) data.<sup>1</sup> The airplane taxied to runway 14 and after performing a run-up, departed about 1608. Witnesses report that they observed the airplane takeoff down the runway at a slow groundspeed and noted that the engine sounded rough as though it was making partial power. The airplane did not ascend as expected and veered to the right of the centerline reaching 100-150 feet agl (see Figure 1 below). The ADB data shows the airplane accelerating down the runway up to a derived airspeed of 65 kts.

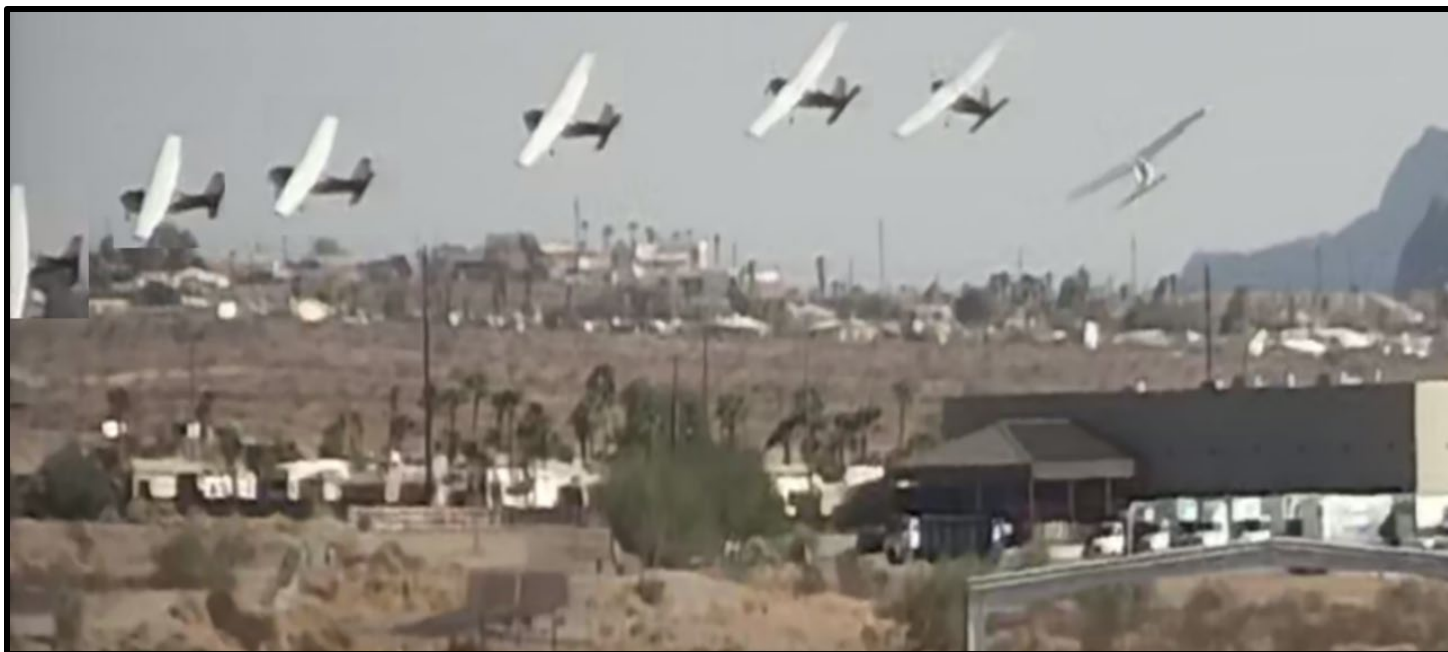
Figure 2: Security Camera Footage of Bank to the Left

The airplane then pitched up to a nose-high attitude and made an aggressive left bank consistent with pilot attempting to make 180-degree turn back to the runway (see Figure 2 below). Witnesses observed the airplane's wingspan turn nearly perpendicular to the horizon and then stall with the left wing dropping toward terrain.

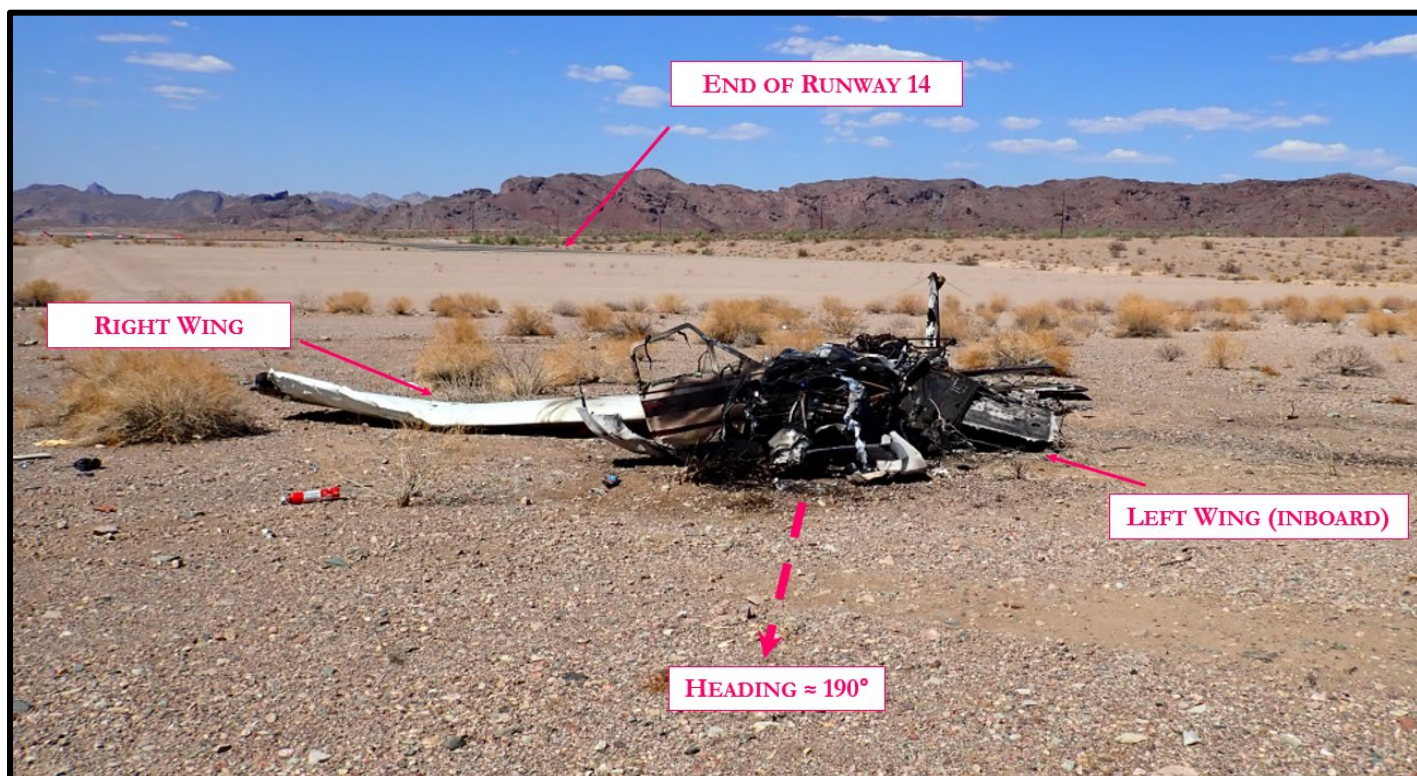
Figure 3: Main Wreckage at the Accident Site

The accident site was located in the desert terrain about 830 ft from the end of runway 14 at an elevation of 790 feet msl. In character, the terrain was composed of dry, soft dirt with sparse brush. The wreckage was found distributed over a 200 ft distance on a median magnetic bearing of about 60°.

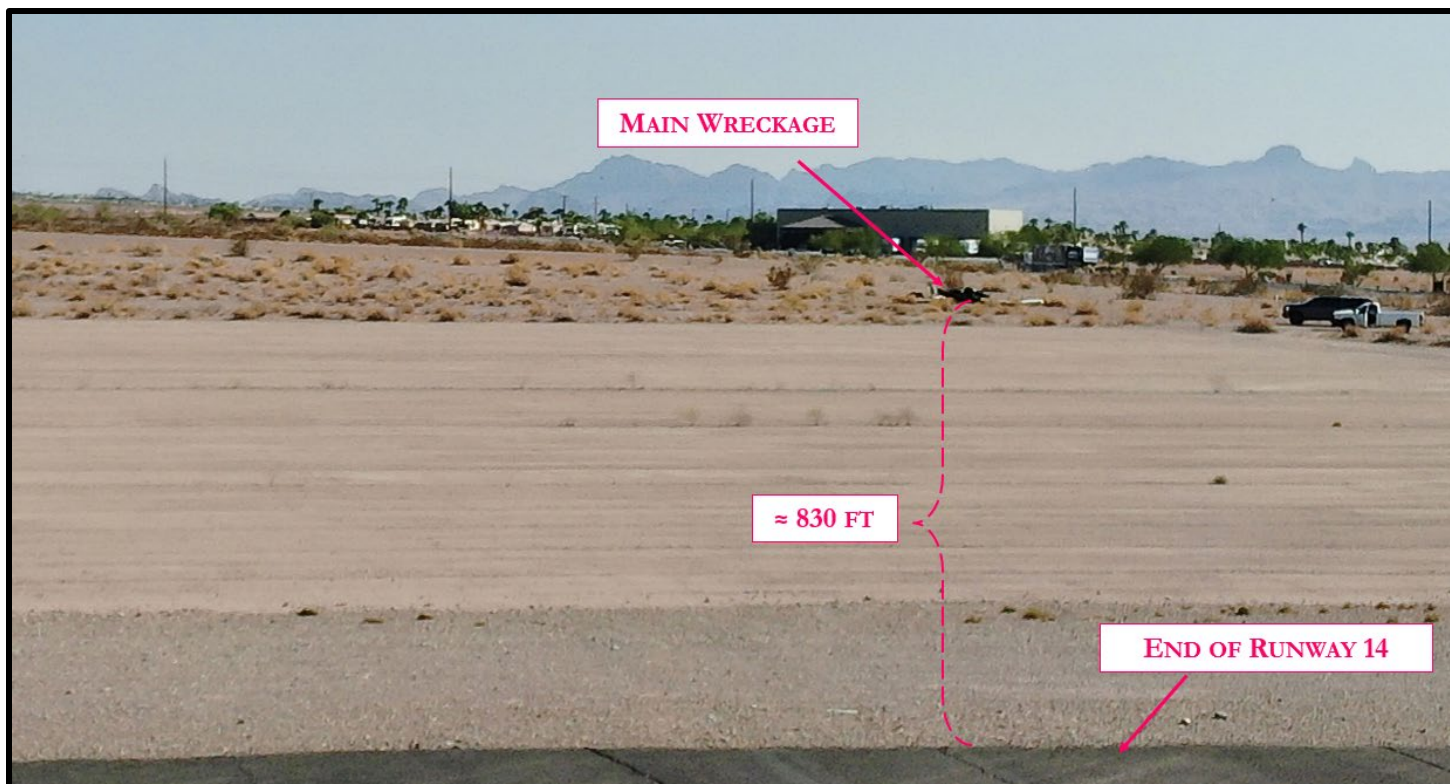
Figure 4: Main Wreckage in Reference to the Runway

The main wreckage consisted of a majority of the airframe and engine, which had been consumed by fire with the exception of the right wing. The main wreckage came to rest on a heading of about 190°. The remaining wreckage was found in the debris field and adjacent to the main wreckage and principally consisted of the wing tip fragments, Plexiglas, and items loosely in the cockpit. The only item identified that could not be found at the accident site was an approximate 2-inch outboard portion of one of the propeller blades.

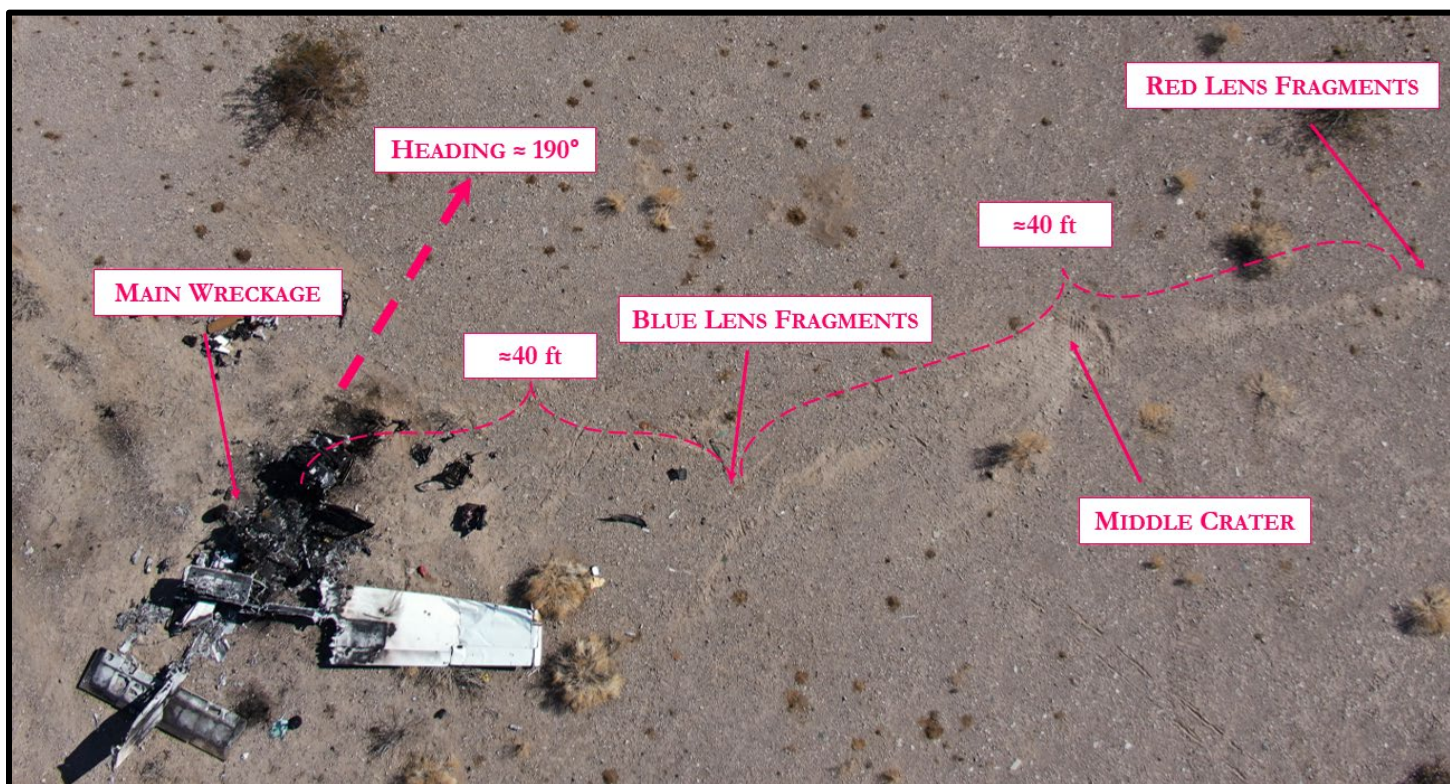
Figure 5: Main Wreckage in Reference to First Identified Point of Impact

The first identified points of contact consisted of disrupted dirt on the flat desert terrain making up the far east-southeast end of the debris field. The markings started as an indentation dirt with shards of red lens fragments imbedded within consistent with the left-wing tip impacting first. The crater was continuous for about 40 ft in the debris path and continued northeast toward the main wreckage with the end of the crater having blue/green lens fragments imbedded. A larger center indentation was found in between the ends of the crater with the red and green/blue lens fragments and had a large arc-shaped disruption of dirt consistent with a rotating propeller blade. The craters were consistent in size and orientation to that of the wings. The main wreckage was located about 40 ft from the blue/green lens fragments consistent with the airplane impacting in a nose low attitude and rotating about itself coming to rest on a heading of 190°.

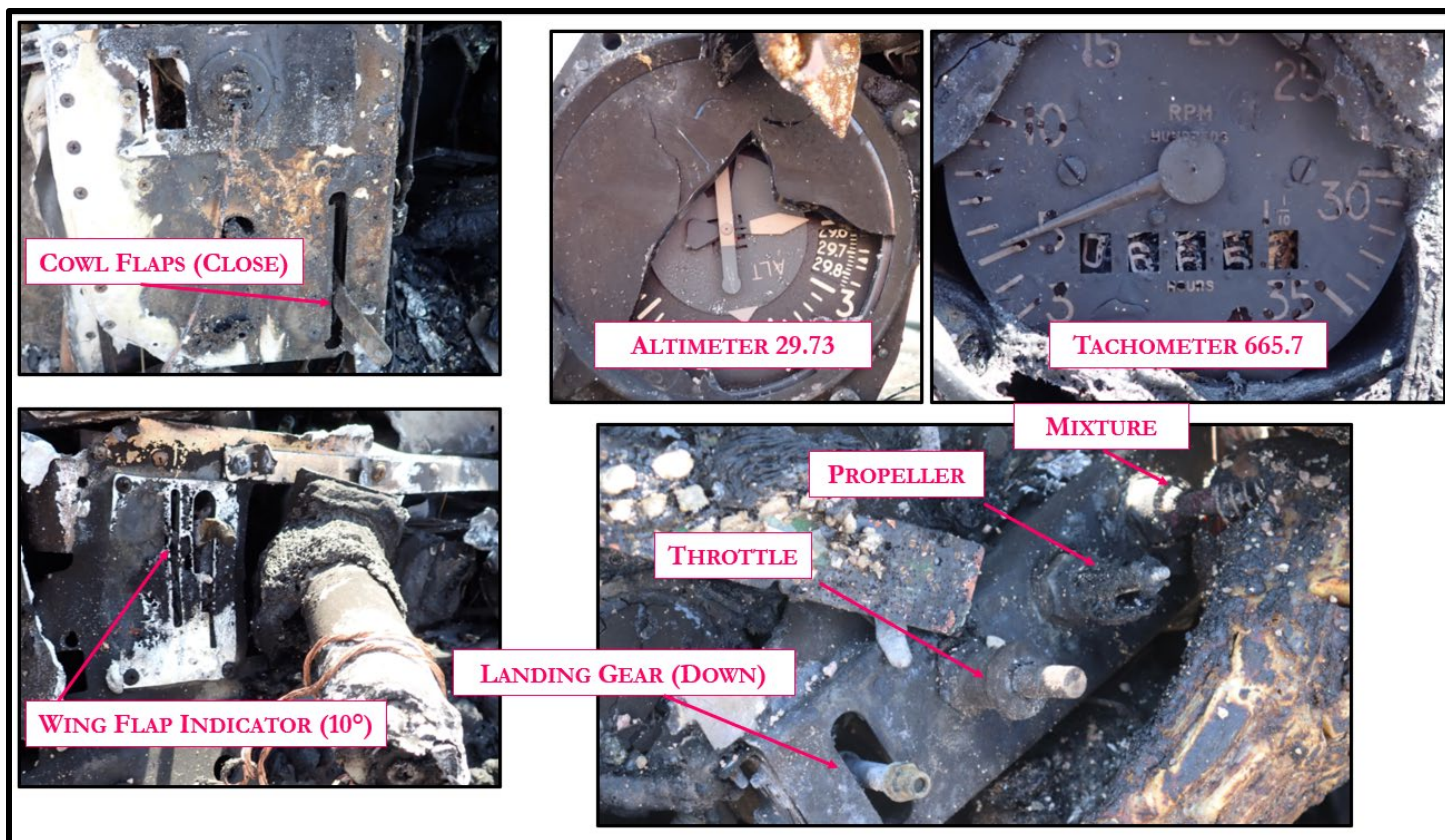
Figure 8: Cockpit Gauges

The cockpit sustained thermal damage prohibiting investigators from obtaining any meaningful information from a majority of the gauges. The following information was garnered: The cowl flap handle was in the closed position; The Kollsman window for the altimeter was set for 29.73; The tachometer read 0665.7; the wing flap indicator was in the 10° position; the landing gear handle was in the down position; the throttle, propeller and mixture knobs were full forward. The key appeared engaged but the position could not be determined because of thermal damage. The auxiliary fuel pump switch was consumed by fire.

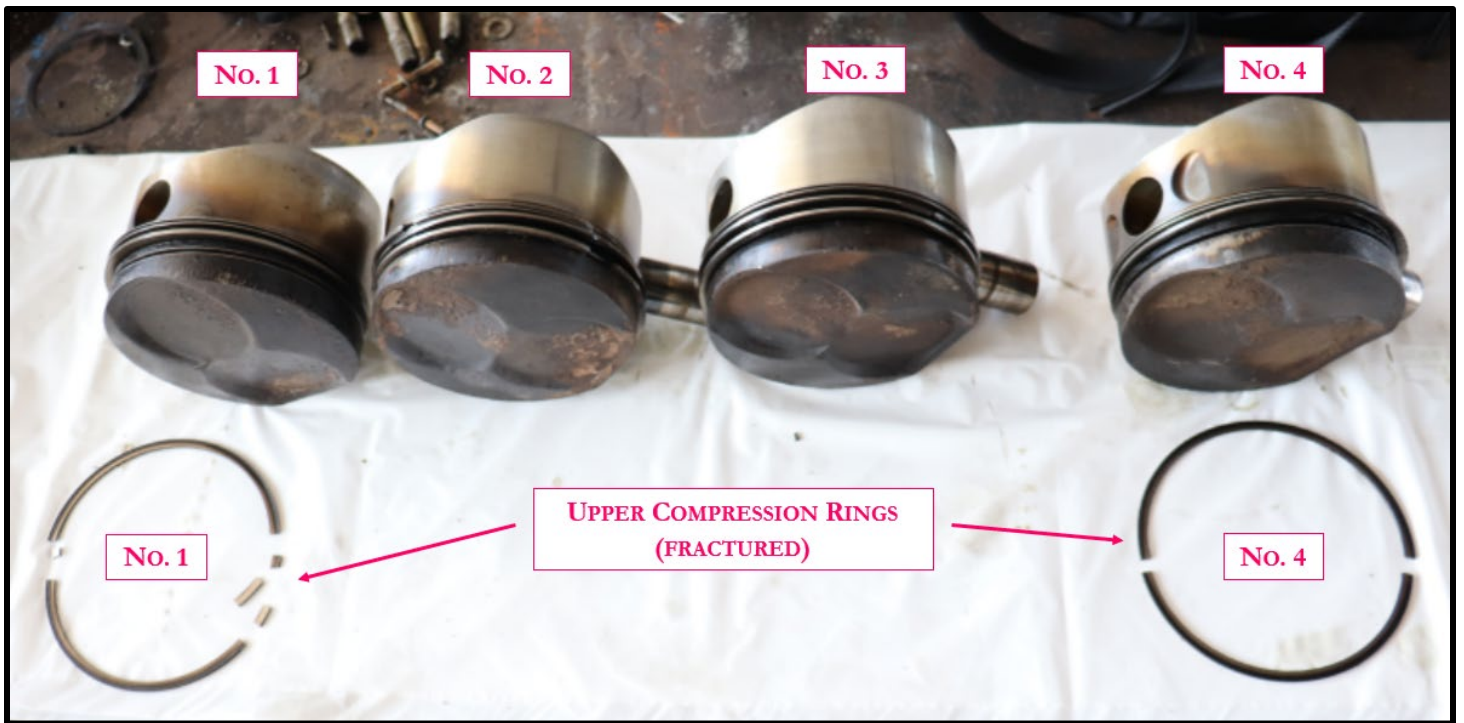
Figure 9: All Pistons (Showing Fractured Rings)

A majority of the engine and its respective components were completely disassembled. The cylinders' combustion chambers and barrels showed light scratches, but there was no evidence of foreign object ingestion or detonation. The valves were intact and undamaged. There was no evidence of valve to piston face contact observed. The pistons were intact. The top compression rings (p/n 74241) on the Nos. 1 and 4 cylinders were fractured. There was evidence of deposits and coking in a majority of the ring lands. The piston skirts showed evidence of carbon build-up and wear with light scuffs/grooves oriented from the base to the crowns. There was evidence of blow-by with combustion signatures on the piston skirts on all cylinders, but the least damage was on the No. 3 cylinder. There was significant combustion deposits on the exhaust ports on the Nos. 1 and 4 cylinders and the piston face on the No. 2 cylinder. The No. 4 cylinder was different in appearance to the other cylinders with wrist pin boss having chamfered grooves surrounding it.

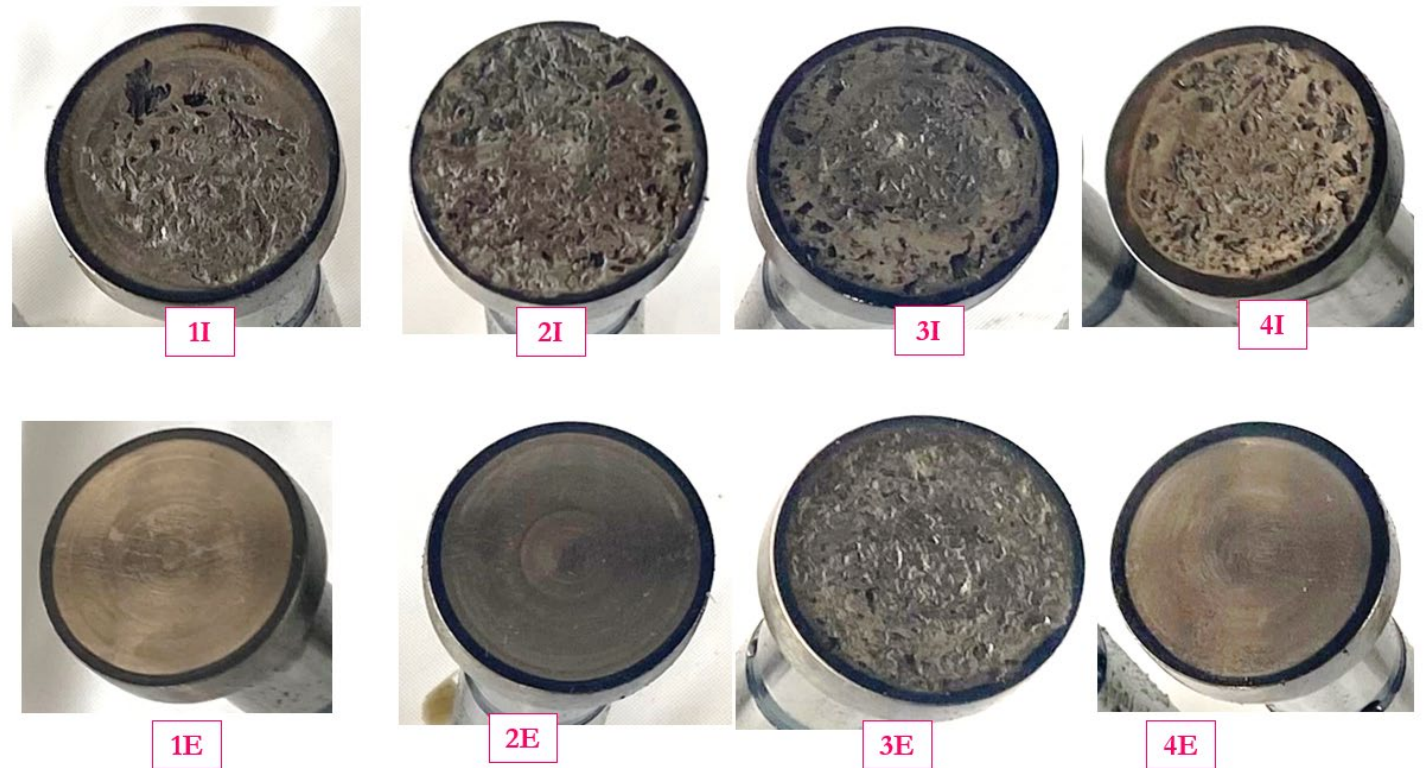
Figure 14: Lifter Faces (Showing Intakes on the top and Exhausts on the bottom)

Removal of the pistons revealed that the cam lobes and lifter<sup>2</sup> faces showed evidence of wear, necessitating complete disassembly. After separating the of the crankcase halves, investigators removed the lifters. There was severe spalling on the faces of all the intake lifters and the No. 3 exhaust lifter; there was also evidence of galling noted. On the remaining lifters there was evidence of wear with circular patterns and pitting.

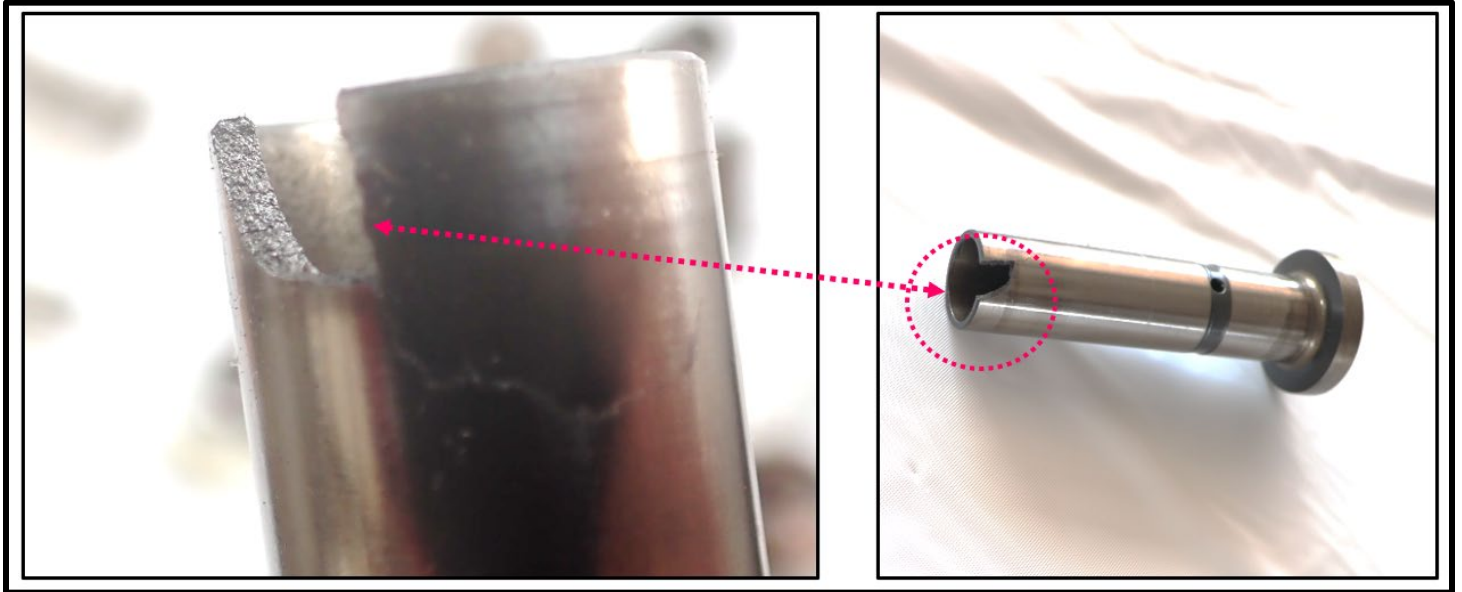
Figure 15: Lifter Body

The lifter on the No. 4 exhaust valve had a tear in the base of the body. This is consistent with the valve failing to close or too much wear on the cam lobe that the push rod becomes loose and the hydraulic socket is allowed to come out of the lifter body. If the socket cocks at an angle when the lobe returns back around, the socket would be able to get pressed against the body of the lifter and break it.

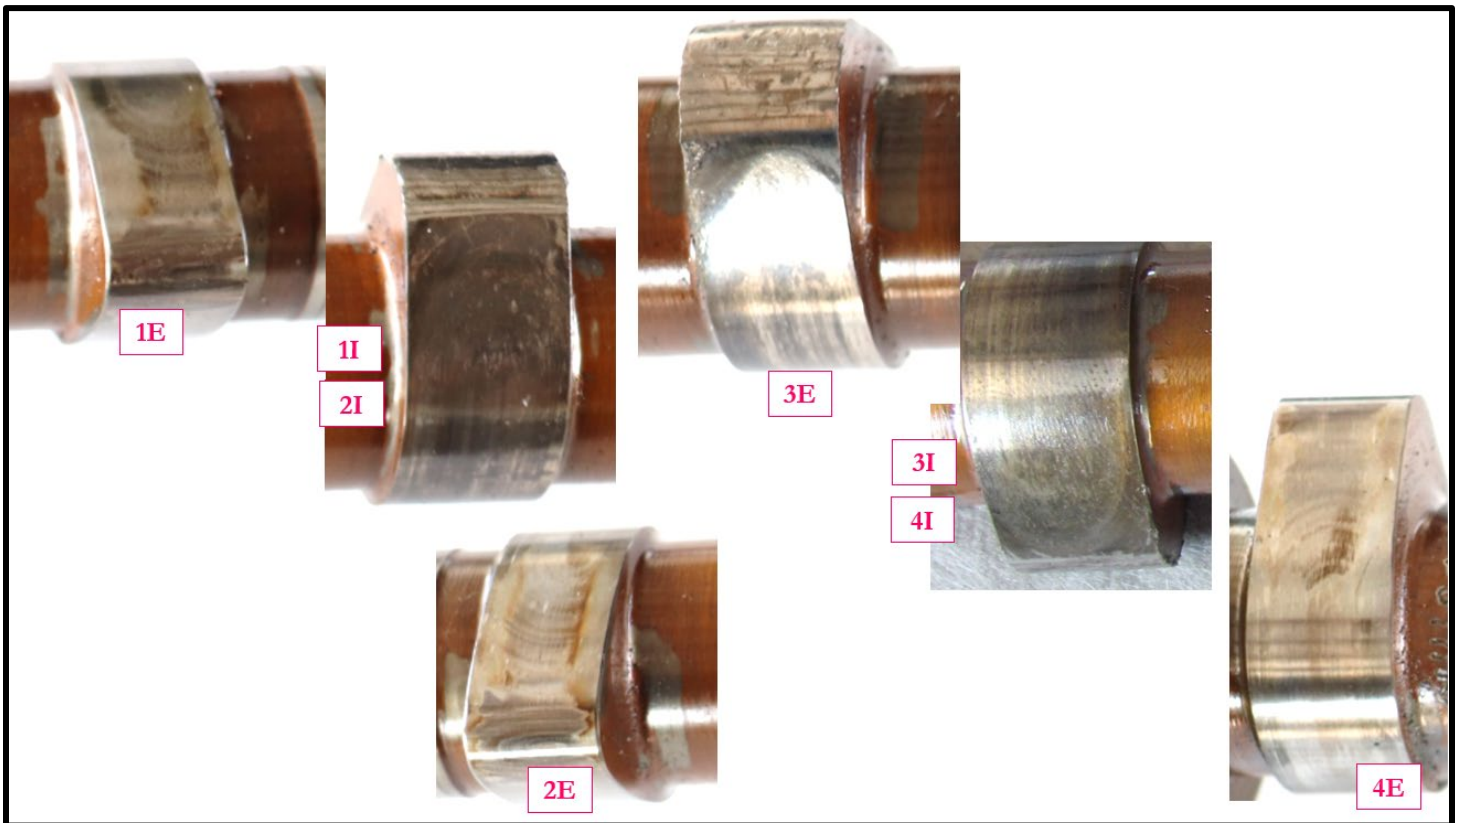
Figure 16: Camshaft Lobes

The camshaft revealed signatures of excessive wear on the cam lobes including, rounding of the lobes, pitting and material deformation observed on the lobes.

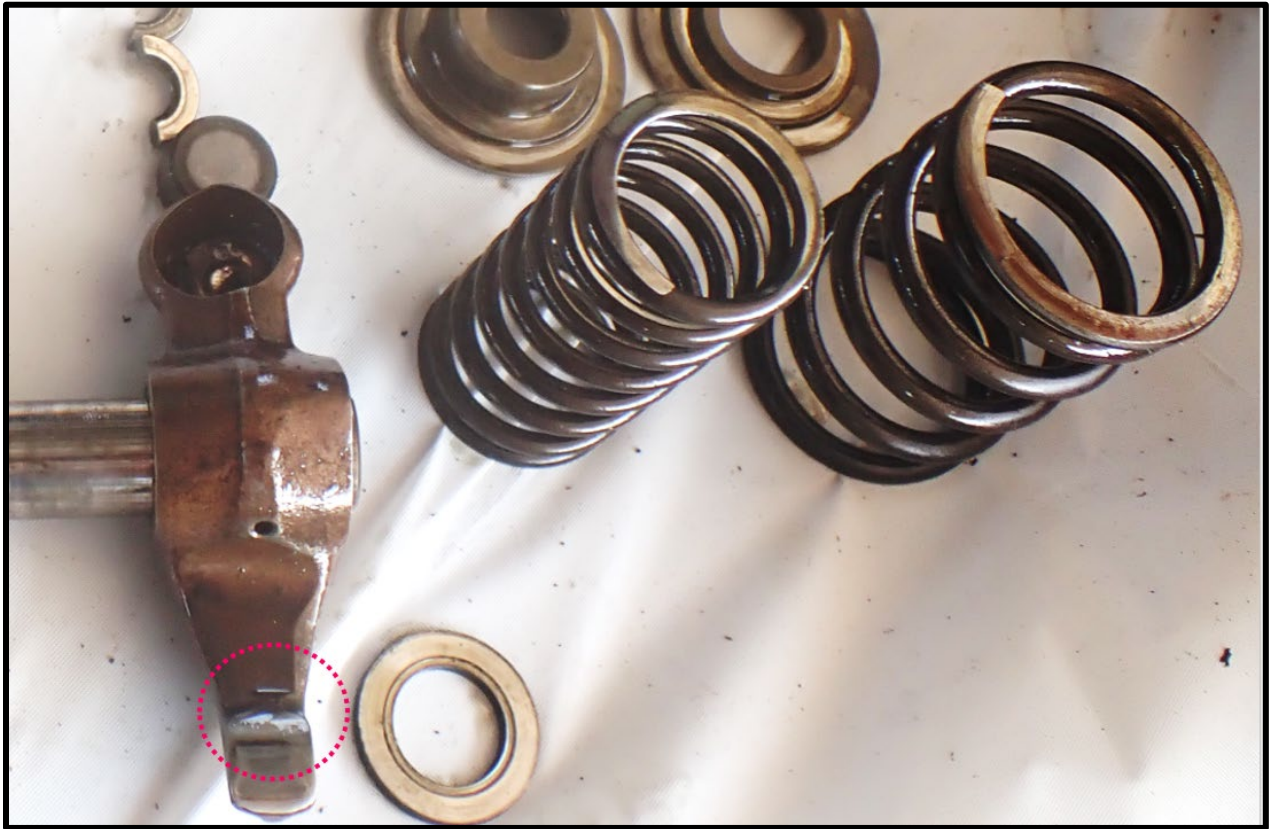
*Figure 17: No. 4 Intake Rocker Arm and Valve Springs*

The valve springs showed on the No. 4 cylinder showed wear as did the lower seat. The rocker arm had a horizontal mark above the toe, consistent with it making contact with the upper valve seat. The No. 1 cylinder valve springs additionally showed wear.

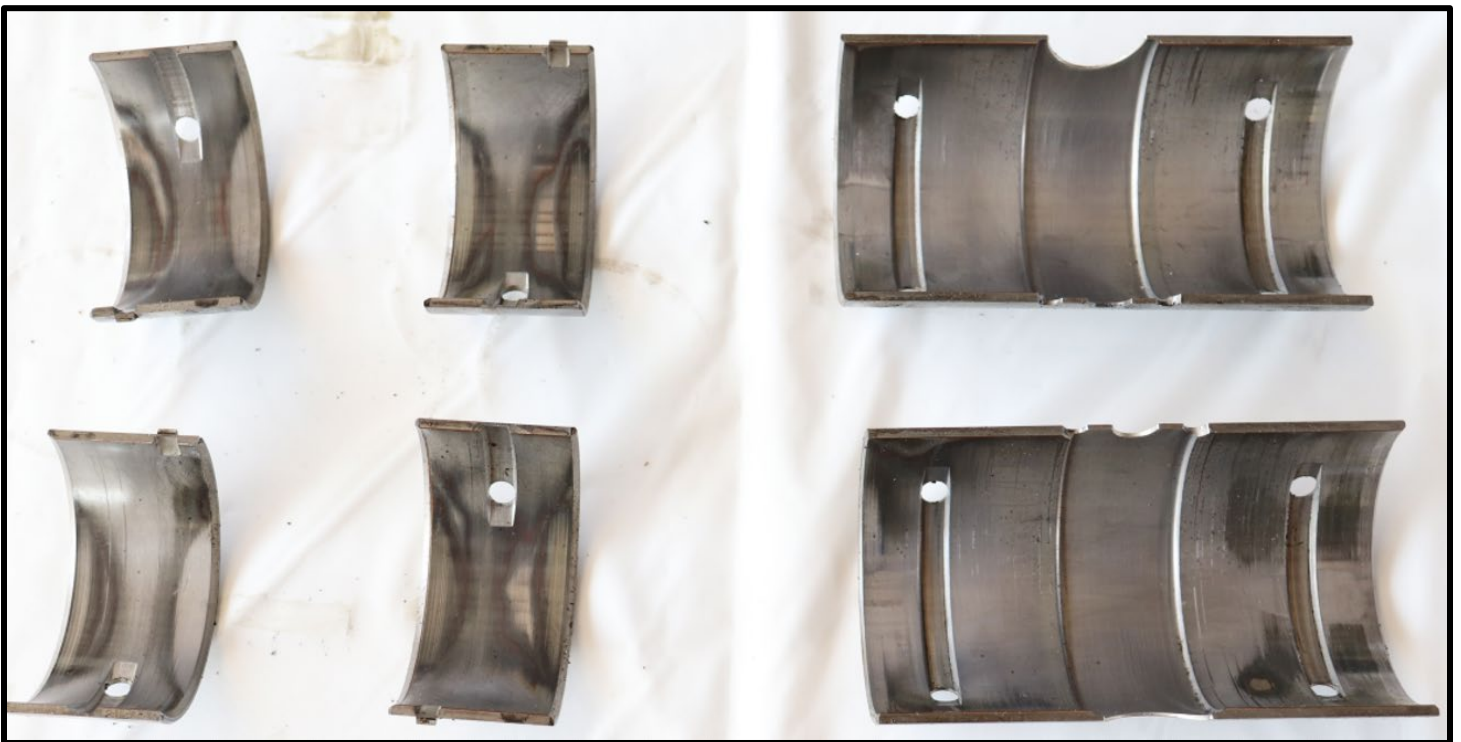
*Figure 18: Main Bearings*

The main bearings showed evidence of wear and several areas of wiping. There semi-circular wear patterns on the mating internal bearings. The crankshaft had light circumferal scoring.

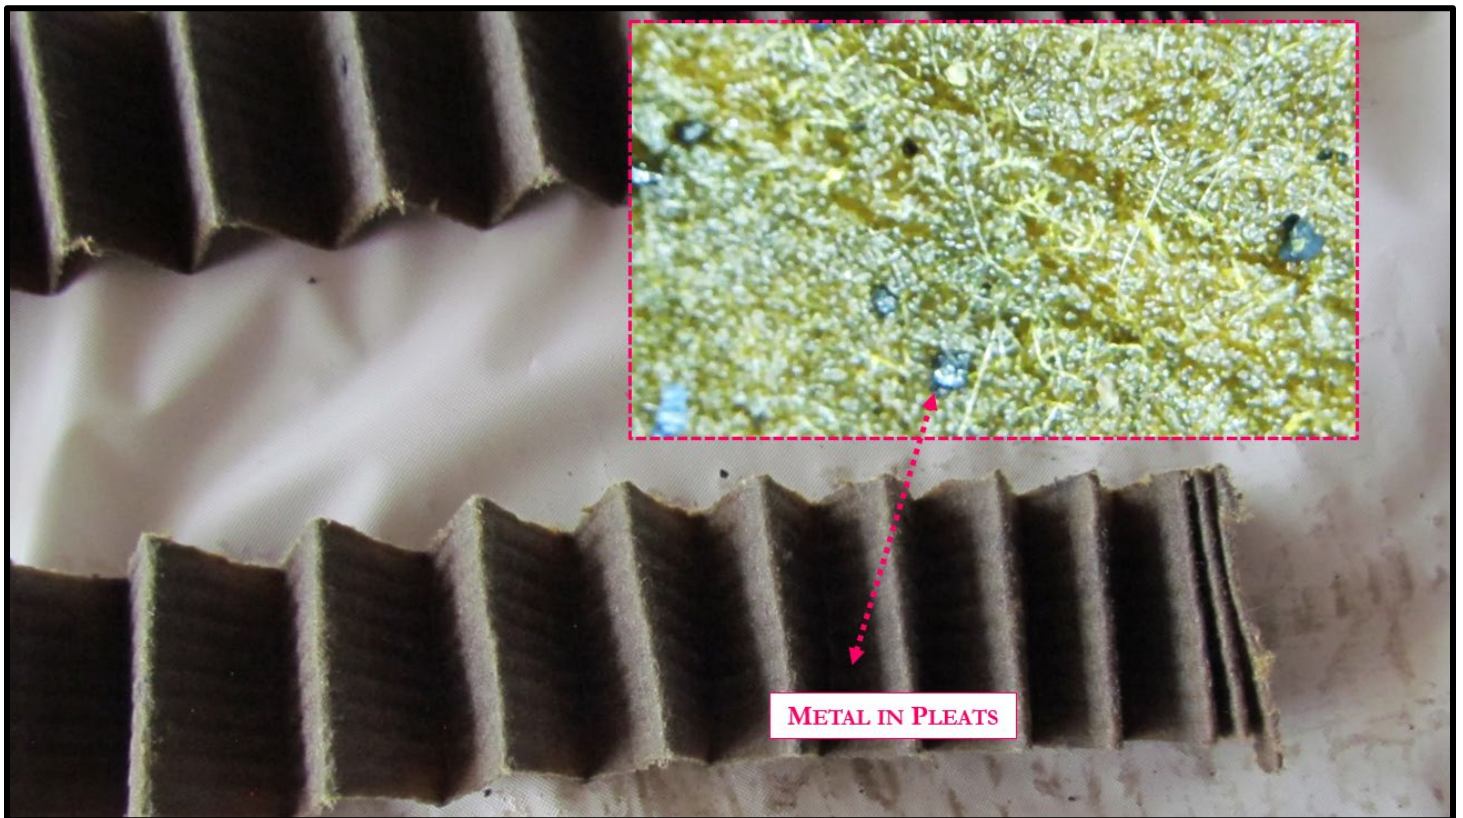
*Figure 19: Microscopic Metal Particles Found in the Pleats of Oil Filter*

The oil filter and suction screen were secure at their respective mountings. The oil filter and suction screen were removed and examined. The oil filter was cut open to expose the filter media. Visually there was no evidence of pre-mishap metal contamination observed in the filter pleats, but a microscopic inspection revealed small metal particles. There were several small pieces of metal in the suction screen.

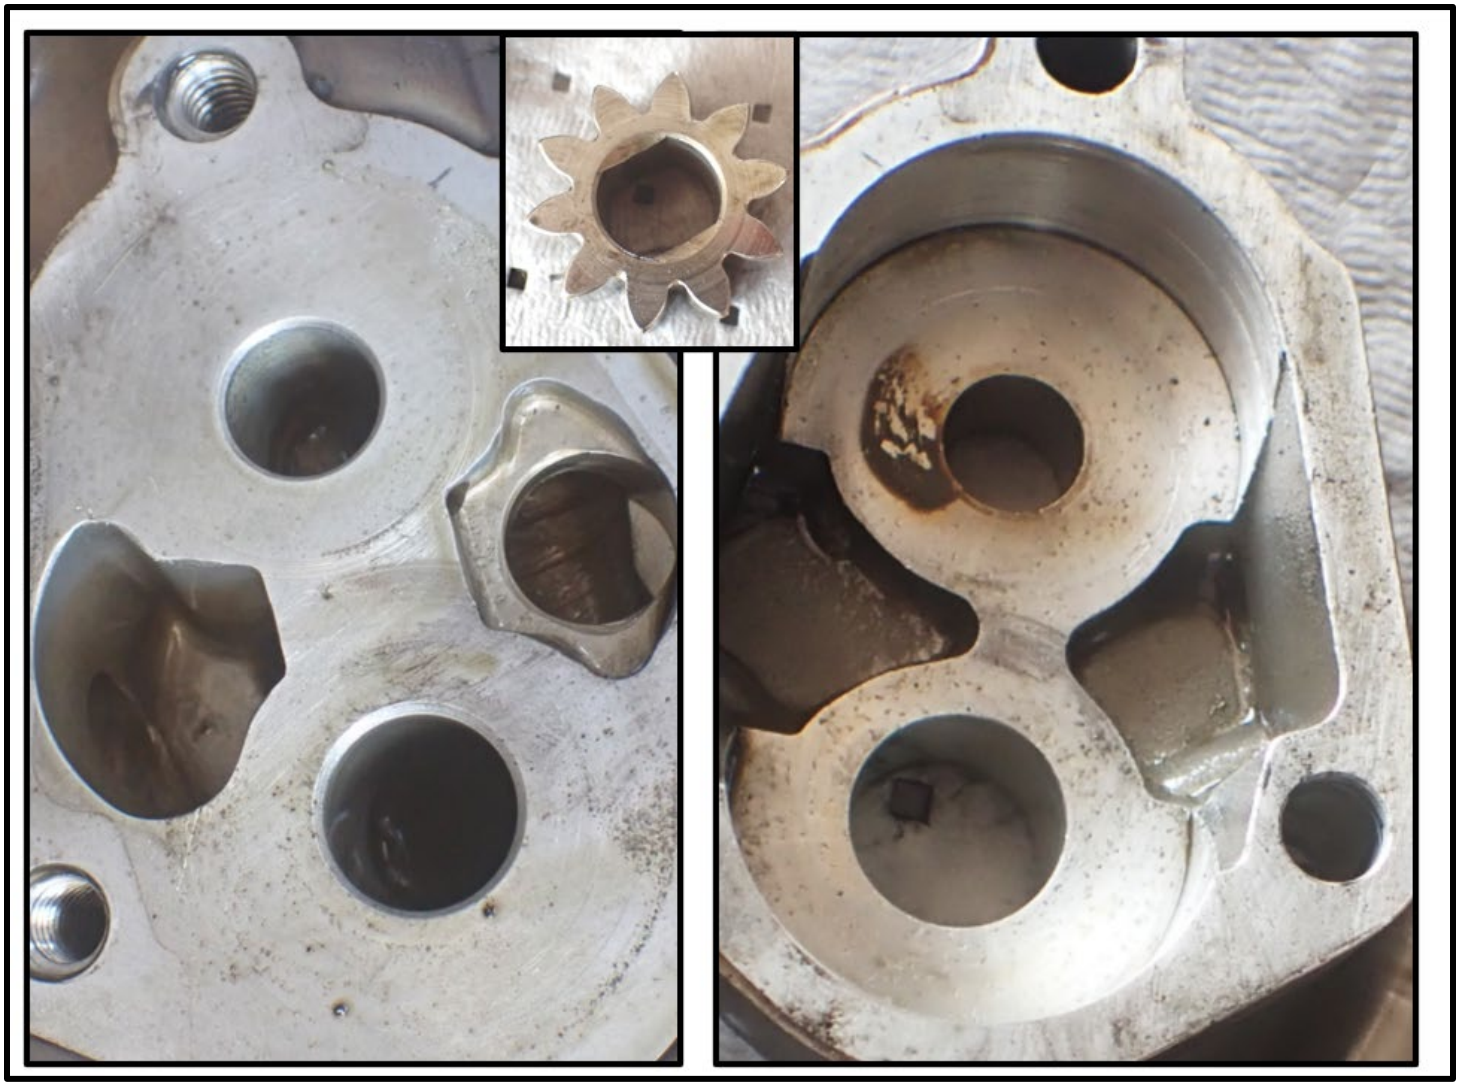
*Figure 20 Oil Pump*

The oil pump was removed and light scoring was found in the housing and on the gerotor gears.

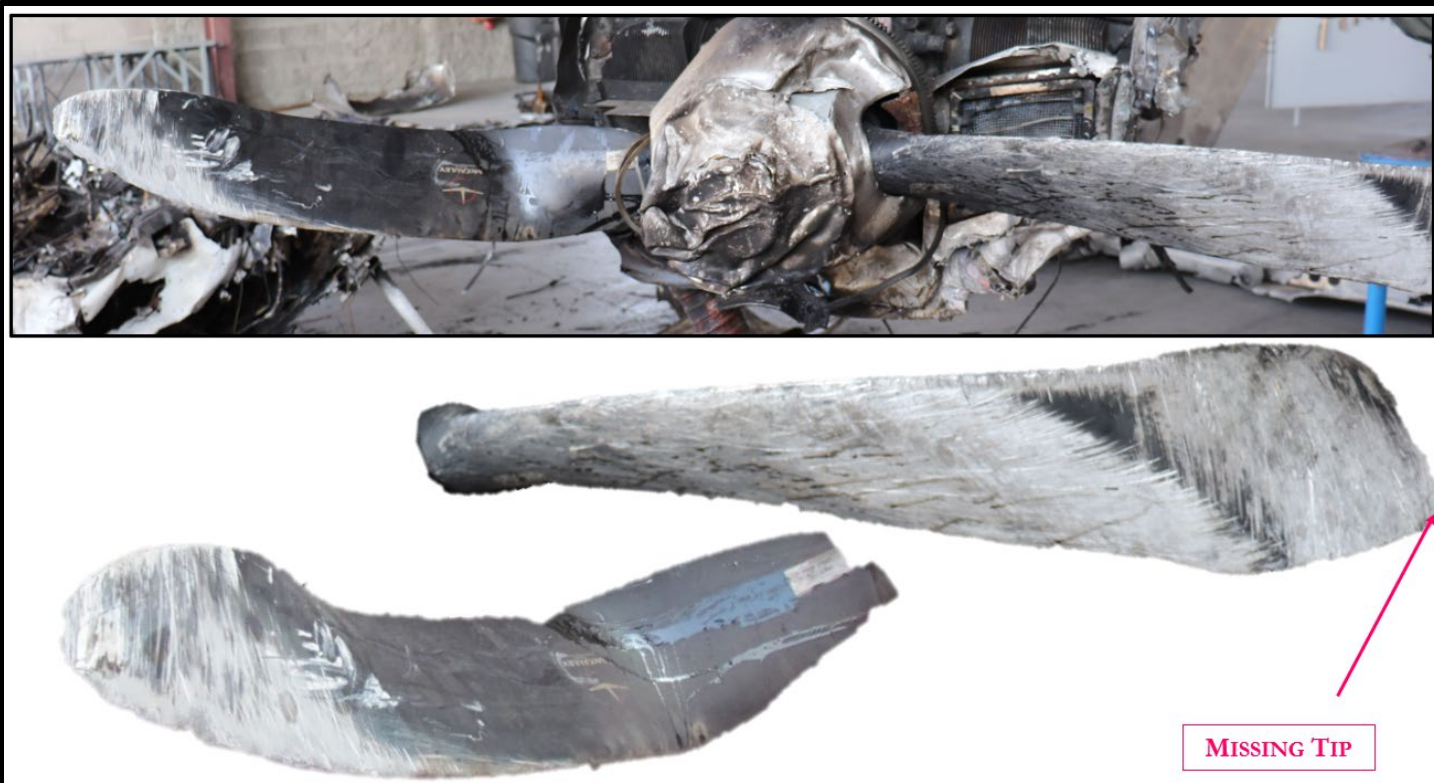
Figure 21: Propeller Blades

The propeller, a McCauley B2D34C207, was overhauled in September 2020. The blades remained attached to the hub. The blades had sustained impact damage, exhibiting chordwise scratches and leading-edge gouging.

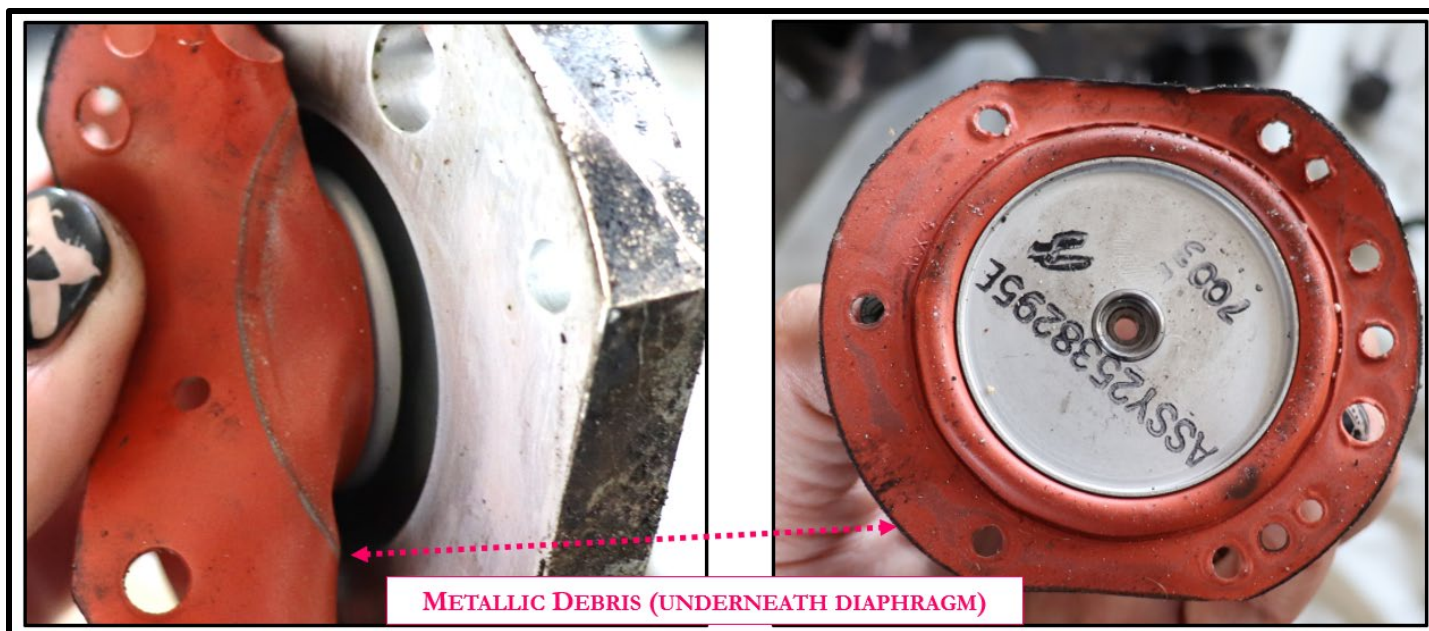
Figure 22: Fuel Servo Regulator Diaphragm

The mechanical fuel pump remained attached to the engine at the mounting pad; it was free of internal mechanical malfunction and could be operated by hand. The diaphragm was burned. Investigators disassembled the fuel servo; the plastic area underneath the ball of the regulator stem was melted. There was a light dusting of metallic material on the diaphragm.
