## NATIONAL TRANSPORTATION SAFETY BOARD

### Wreckage Examination Report

#### **A. ACCIDENT**      **WPR21FA352**

Location:      Page, Arizona  
Date:          September 22, 2021  
Time:          1624 MST  
Operator:      Private  
Aircraft:      Piper PA-28R-200  
Registration:   N3906X

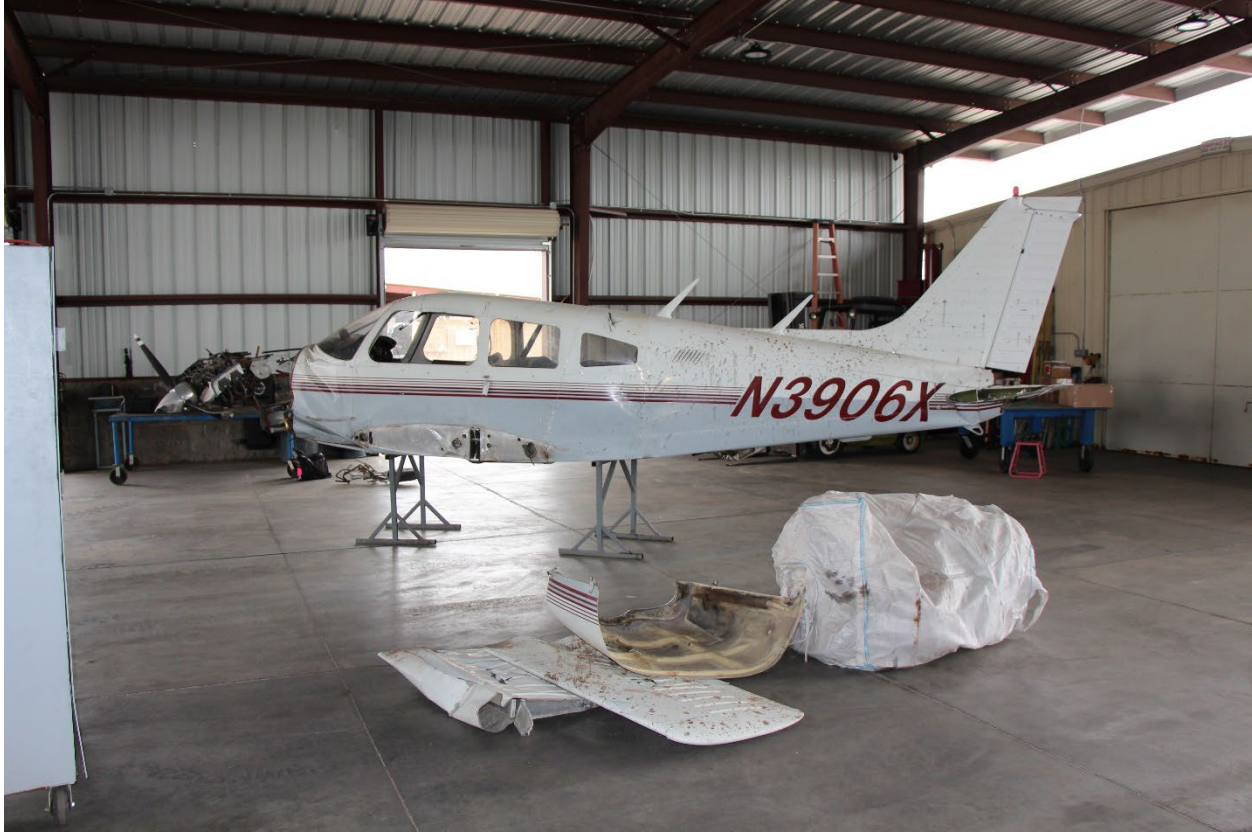
*Photograph 1: Accident airplane and engine prior to examination*

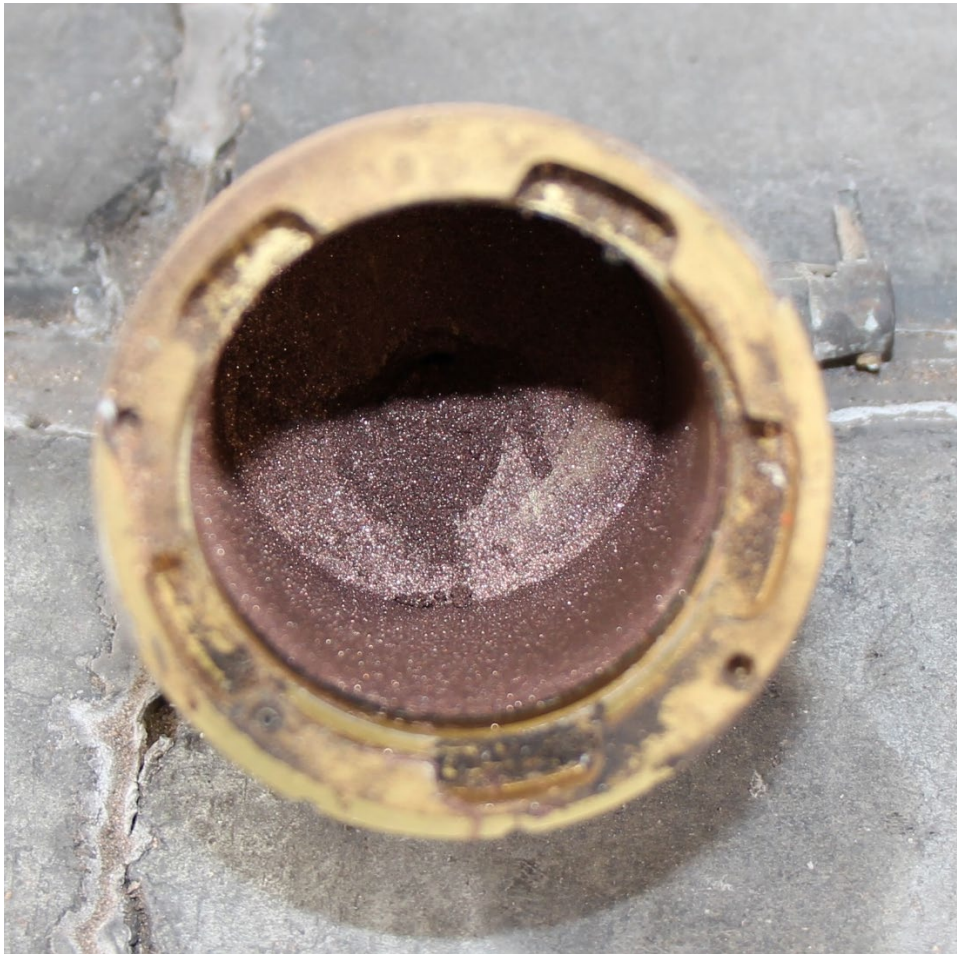
The gascolator bowl did not contain any liquid, but the bowl was lined with a brown/silver film. The fuel screen was unremarkable.

*Photograph 2: Gascolator bowl*

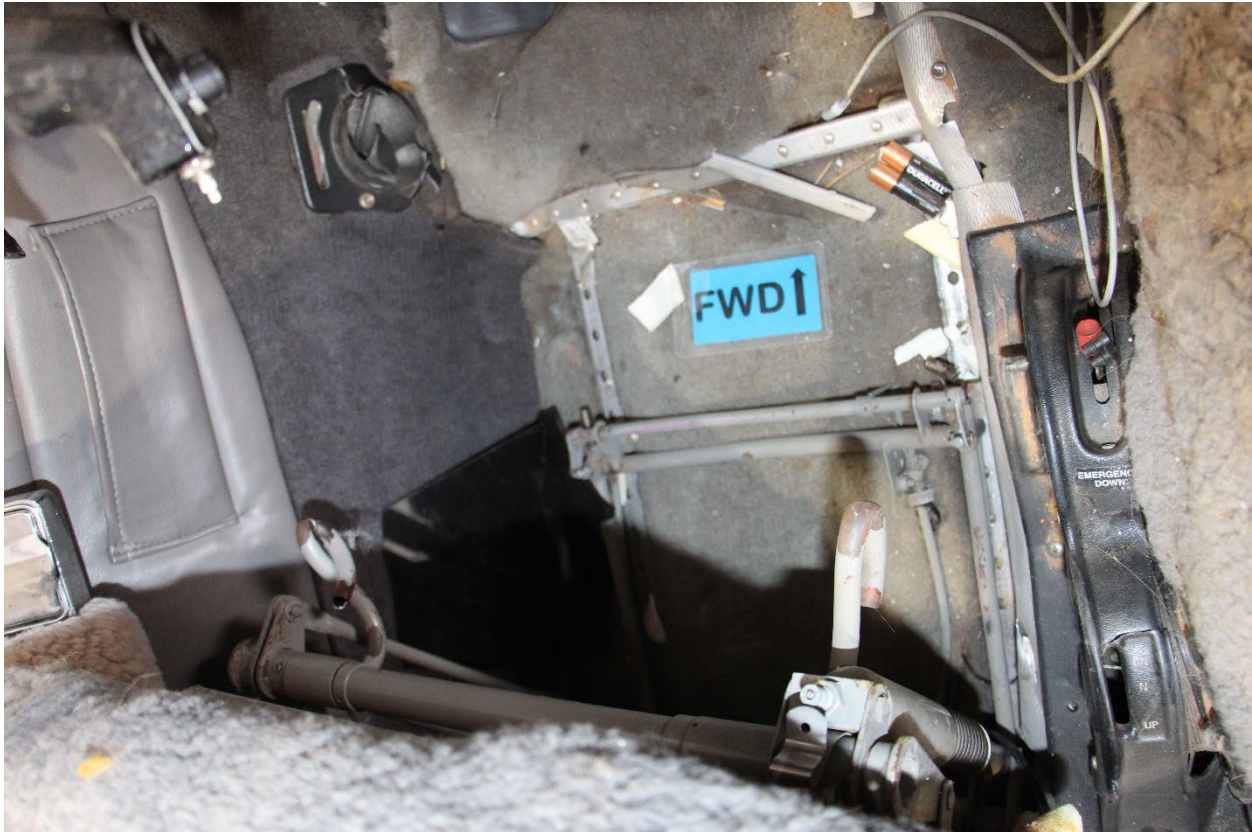
The forward frame tubes were folded and displaced downward. The left aft frame tube was folded as was the right, which subsequently fractured when little force was applied upward to the seat. The rest of the seat structural hardware was otherwise secure and unremarkable. The seat tracks remained attached to the floor and the roller was attached to the tracks.

*Photograph 3: Seat no. 1 forward tubes and seat tracks*

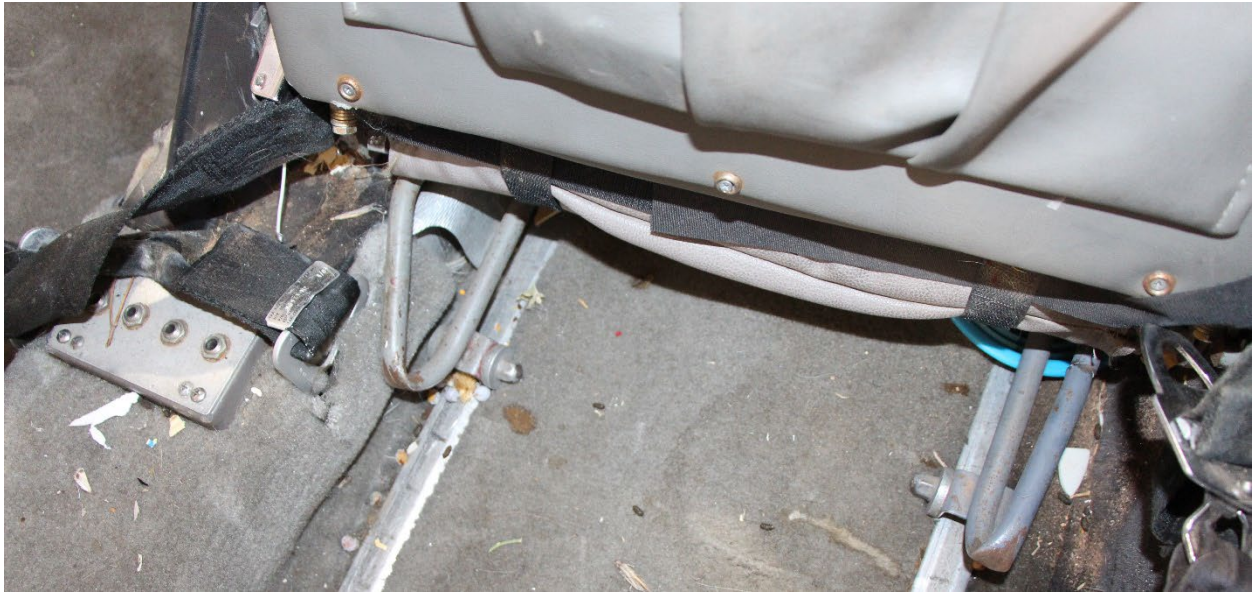
The forward frame tubes were partially collapsed. The left aft frame tube was partially folded and the right tube was crushed. Similar to seat no. 1, the seat track was attached to the floor and the roller remained attached to the seat track.

Photograph 4: Seat no. 2 aft frame tubes and seat tracks

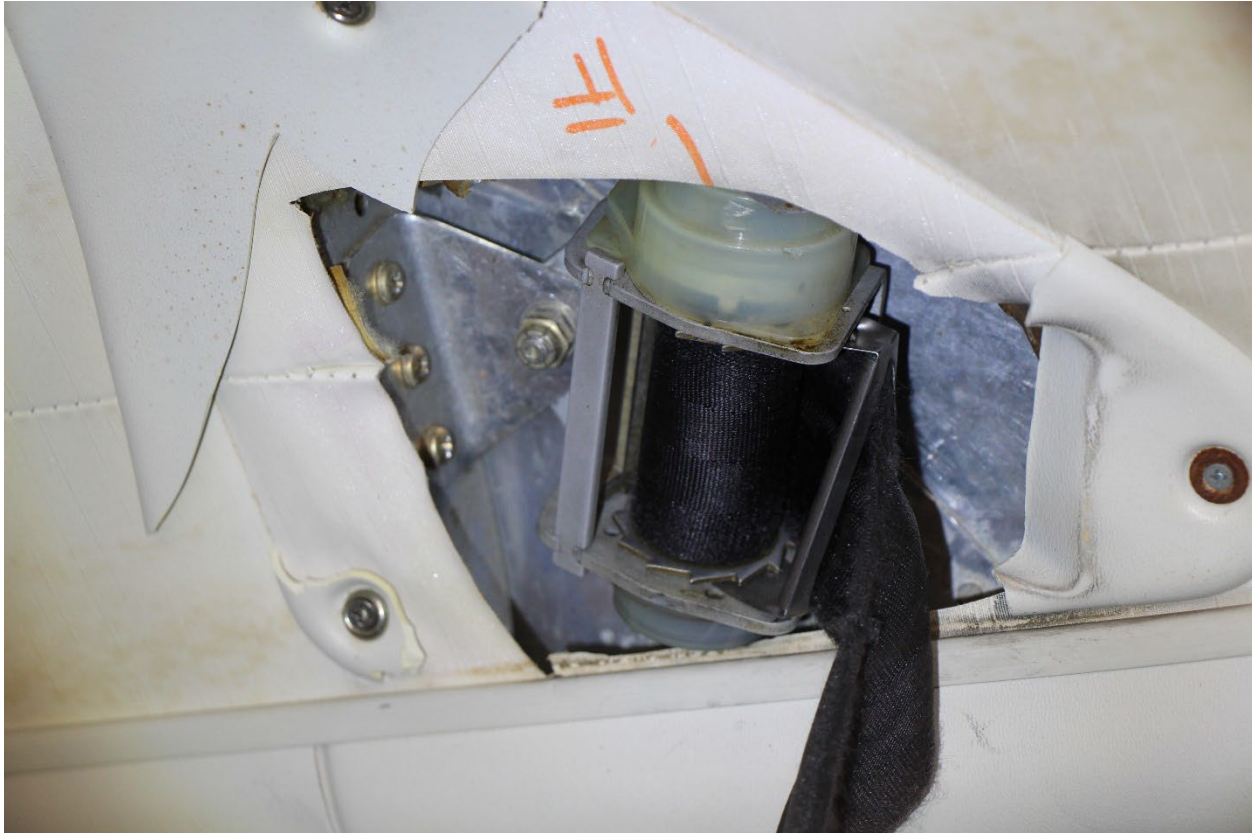
The floor mounted seat attachment points were undamaged. Both ceiling mounted inertial reels were jammed in place. The rollers and were intact and part of the rolled shoulder belts remained at their rollers. The left seat shoulder harness was cut by recovery personnel.

*Photograph 6: Seat no. 1 inertial reel*

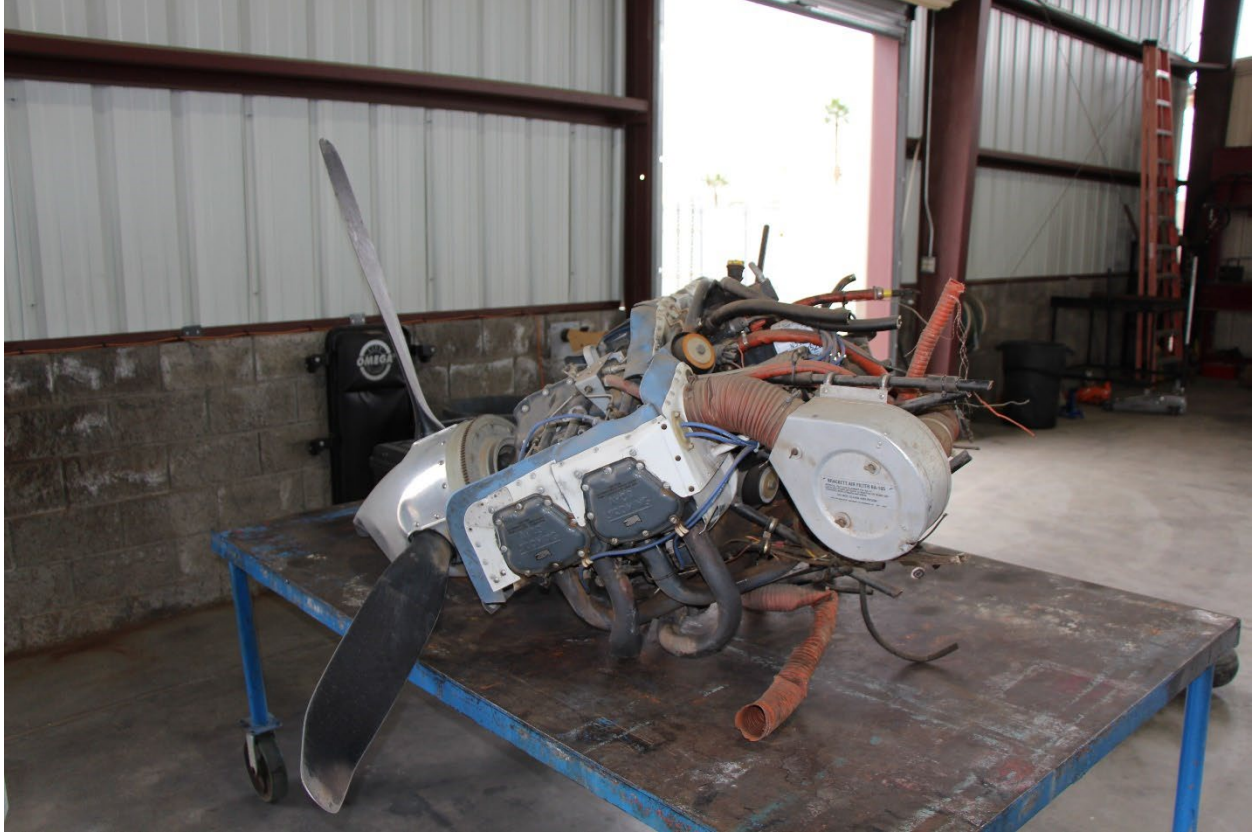
The engine was a Lycoming Engines IO-360-C1C, s/n L-14426-51A, an air-cooled, 200 hp reciprocating engine. The engine baffling was damaged and the no. 1 exhaust tube was partially bent. Additionally, an engine mount tube had collapsed onto the no. 4 induction pipe and the O ring was partially extruded at the collar. The engine was otherwise unremarkable. The accessories remained attached to the engine case and the induction and exhaust tubes were intact and undamaged.

*Photograph 7: Engine prior to examination*

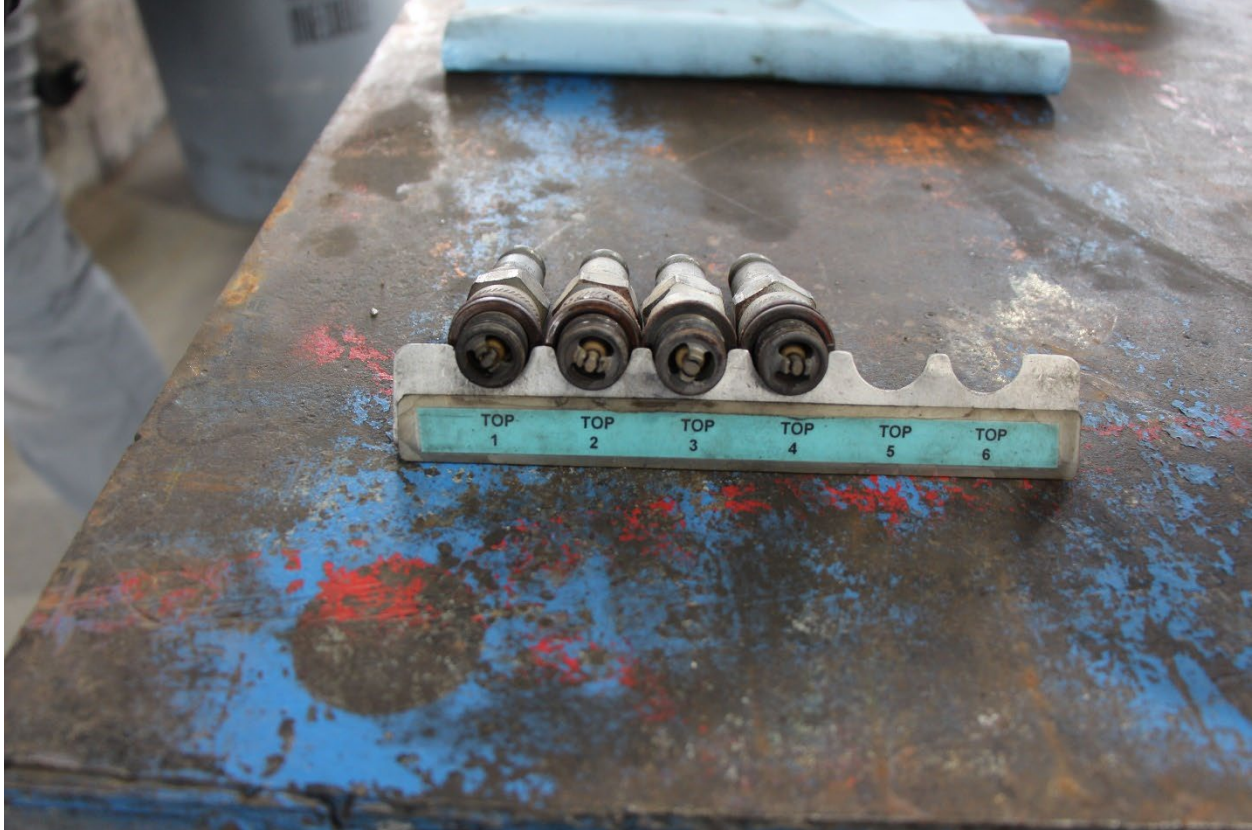
The left magneto was a Teledyne Continental Motors model no. S4LN-1227. The right magneto was a Teledyne Continental Motors model no. S4LN-1209, s/n F16KA253R. The magneto to engine timing was 20° BTDC. Each of the ignition harness coils were secured tightly to their respective spark plugs. The left magneto impulse coupling was heard as the propeller was rotated by hand. Both magnetos were subsequently removed and the ignition leads were cut; spark was observed at the cut ends of all 8 ignition harness leads as each magneto was rotated by hand. The top and bottom spark plugs were manufactured by Champion, model REM 38E massive electrode plugs. Each of the 8 spark plugs were gray in appearance, consistent with normal wear.

*Photograph 8: Top spark plugs*
