# National Transportation Safety Board

WPR21FA353

## **ACCIDENT SITE, AIRFRAME, AND ENGINE EXAMINATION**

Location: Billings, Montana  
Date: September 26, 2021  
Time: 1922 mountain daylight time  
Airplane: N354M, Beech S35

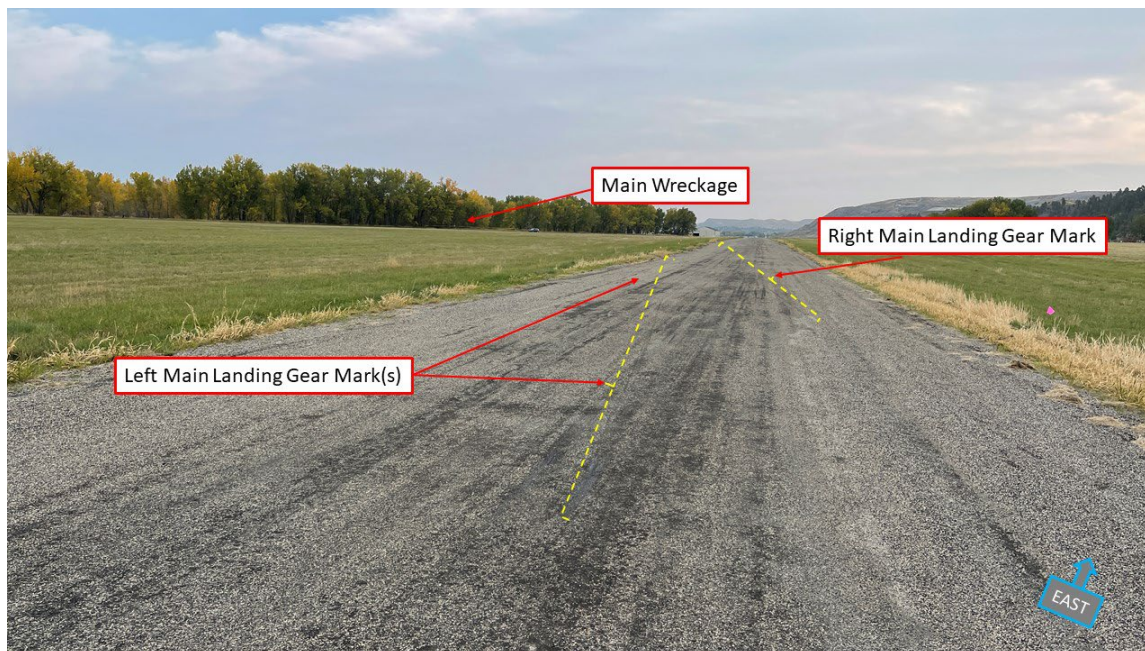
Examination of the runway revealed that the first identified point of contact was a tire mark, consistent with the left main landing gear, about 882 ft from the approach end of the runway. An additional mark, consistent with the right main landing gear was observed about 924 ft from the approach end of the runway. A solid black track, consistent with main tire material transfer, originated from both marks and progressed toward the left side of the runway. The tracks exited the runway surface about 1,078 ft from the approach end of the runway.

**Figure 1: Runway marks with annotations.**

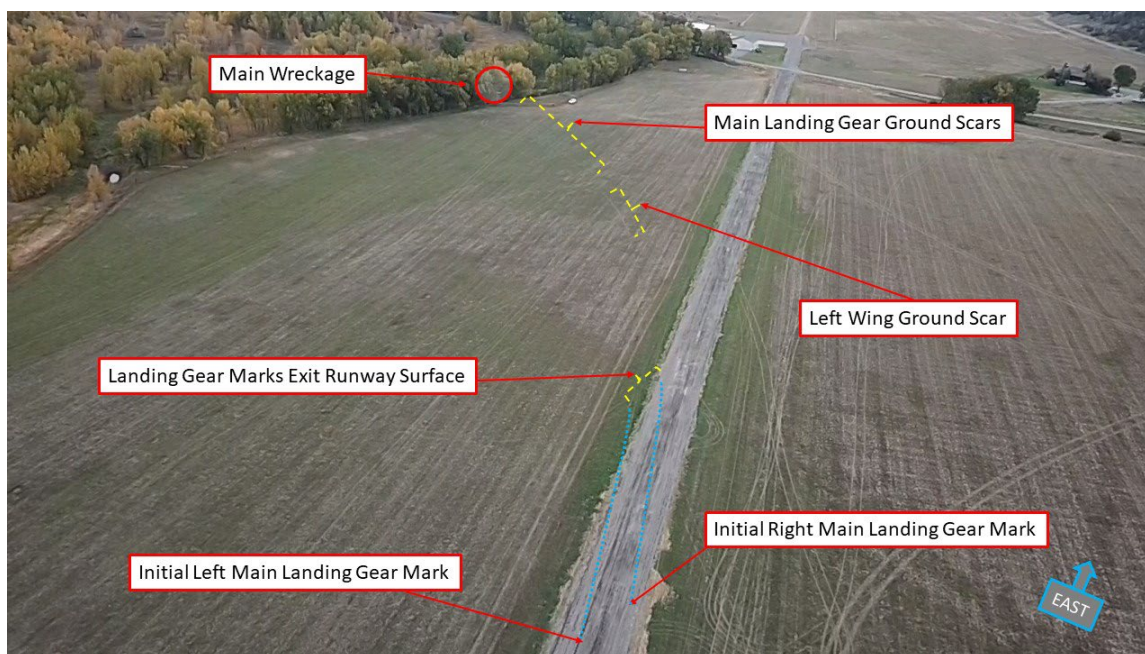
A ground scar consistent with a left wing impact was about 60 ft in length was located about 1,500 ft from the approach end of the runway, and 91 ft left of the runway edge. Additional ground scars, consistent with the main landing gear, was observed about 68 ft beyond the end of the left wing ground scar and arced toward the north and main wreckage.

**Figure 2: Accident site diagram with annotations. Photo courtesy of a witness.**

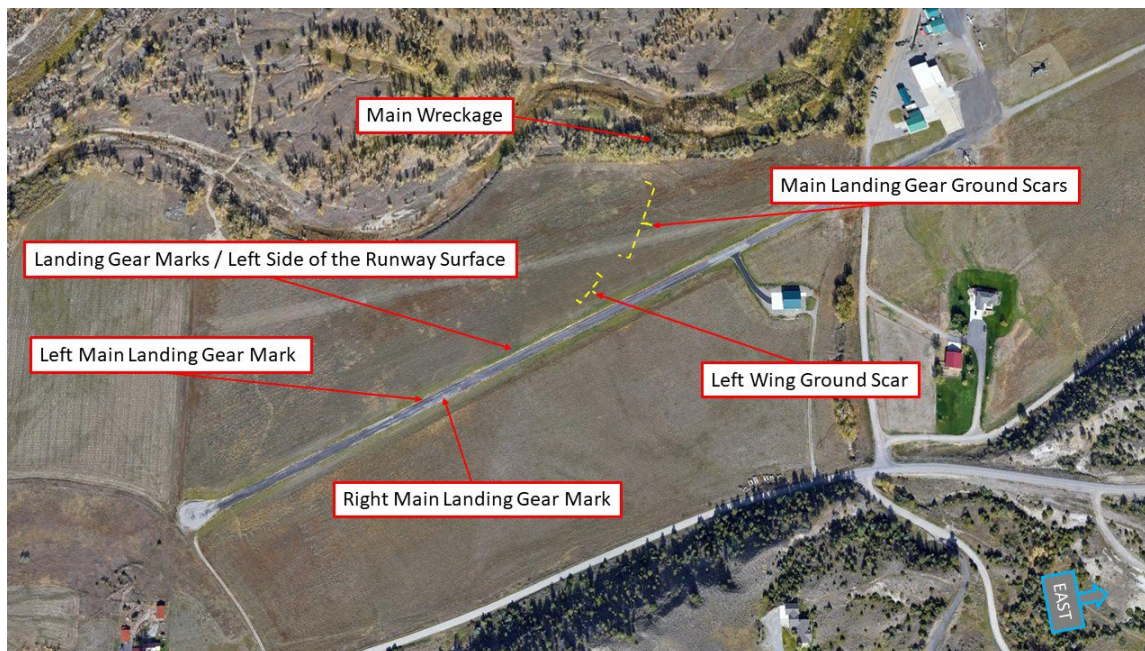
Examination of the accident site revealed the airplane came to rest within a tree line about 450 ft north of the runway, and about 1,938 ft northeast of the approach end the runway. All major structural components of the airplane were located within about 40 ft of the main wreckage.

**Figure 3: Accident site diagram.**

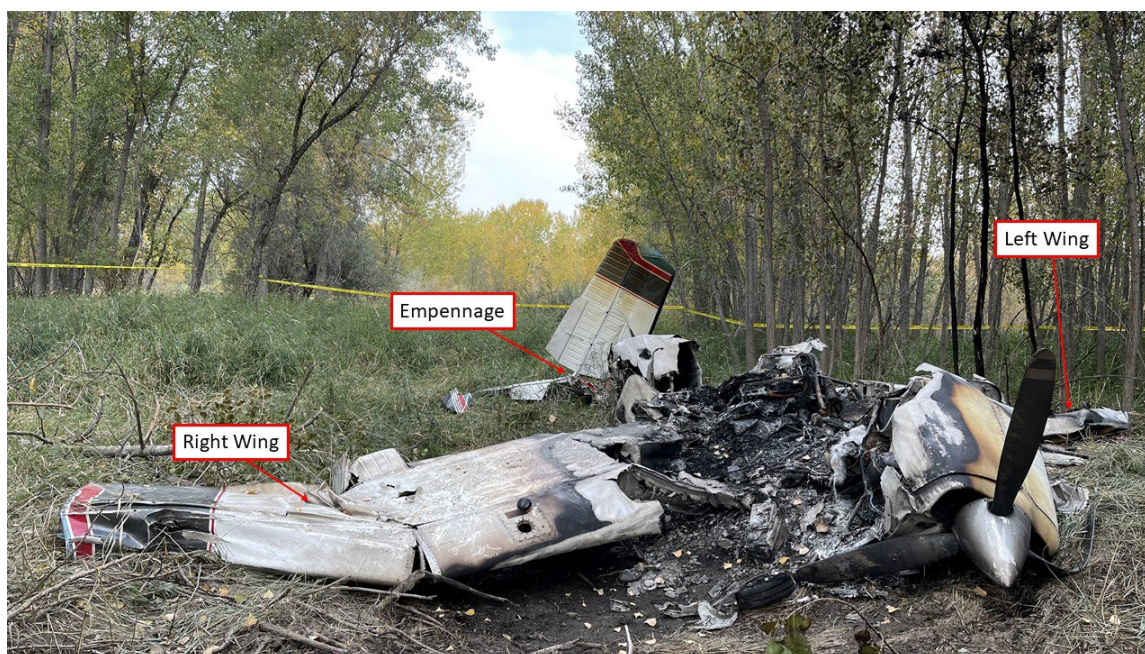
Examination of the accident site revealed the airplane impacted trees about 450 ft north of runway 6, about 1938 ft east of the runway, and came to rest on a heading of about 108°.

**Figure 4: Accident site diagram.**
