## Air Safety Investigations Aircraft Incident/Accident Technical Report

| Aircraft Incident/<br>Accident Information | Year: 1964 | Make: Beechcraft | Model: S35 |
| | Serial number: D-7516 | | Registration: N354M |
| Air Safety Investigator Jennifer D. Barclay | | Report #: ASI-21-CR-T | Report date: 02-16-22 |

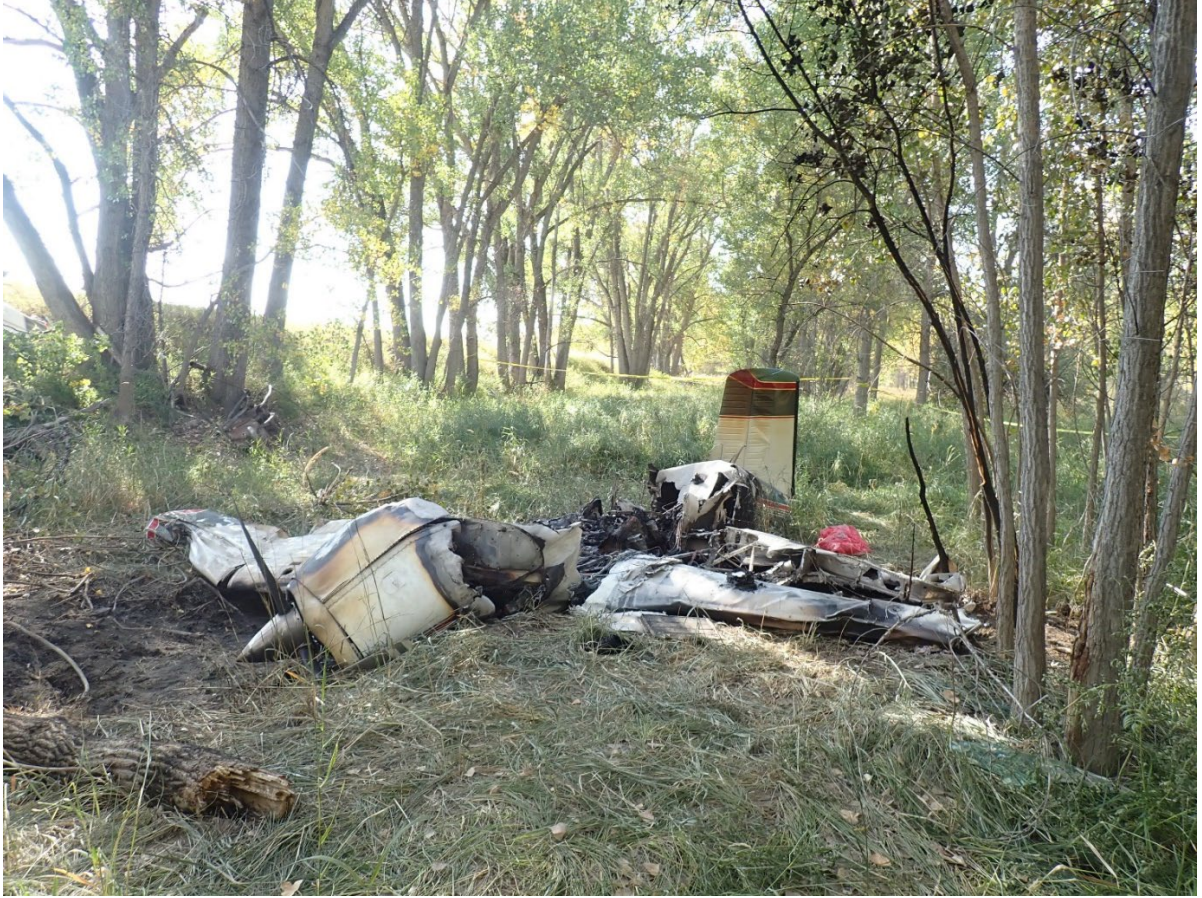
Following an attempted landing, the aircraft departed the runway to the left approximately 1,078' from the approach end of Runway 08 and briefly became airborne before contacting terrain with the left wing while crossing an open field. Ground scars indicated all three landing gear then contacted terrain before the aircraft became airborne again. Then a tail strike was visible before the aircraft impacted trees in a wings-level, nose-high flight attitude. The left wing separated at the aileron-flap junction. The aircraft came to rest upright on a heading of 108°. A post-impact fire consumed the inboard left wing between the forward and aft spar, a portion of the inboard right wing from the landing gear wheel well to the root, and most of the fuselage.

Both wings sustained tree impact damage to the leading edges. The left horizontal stabilizer exhibited tree impact damage to the outboard leading edge.

Site overview, ASI-21-CR-004

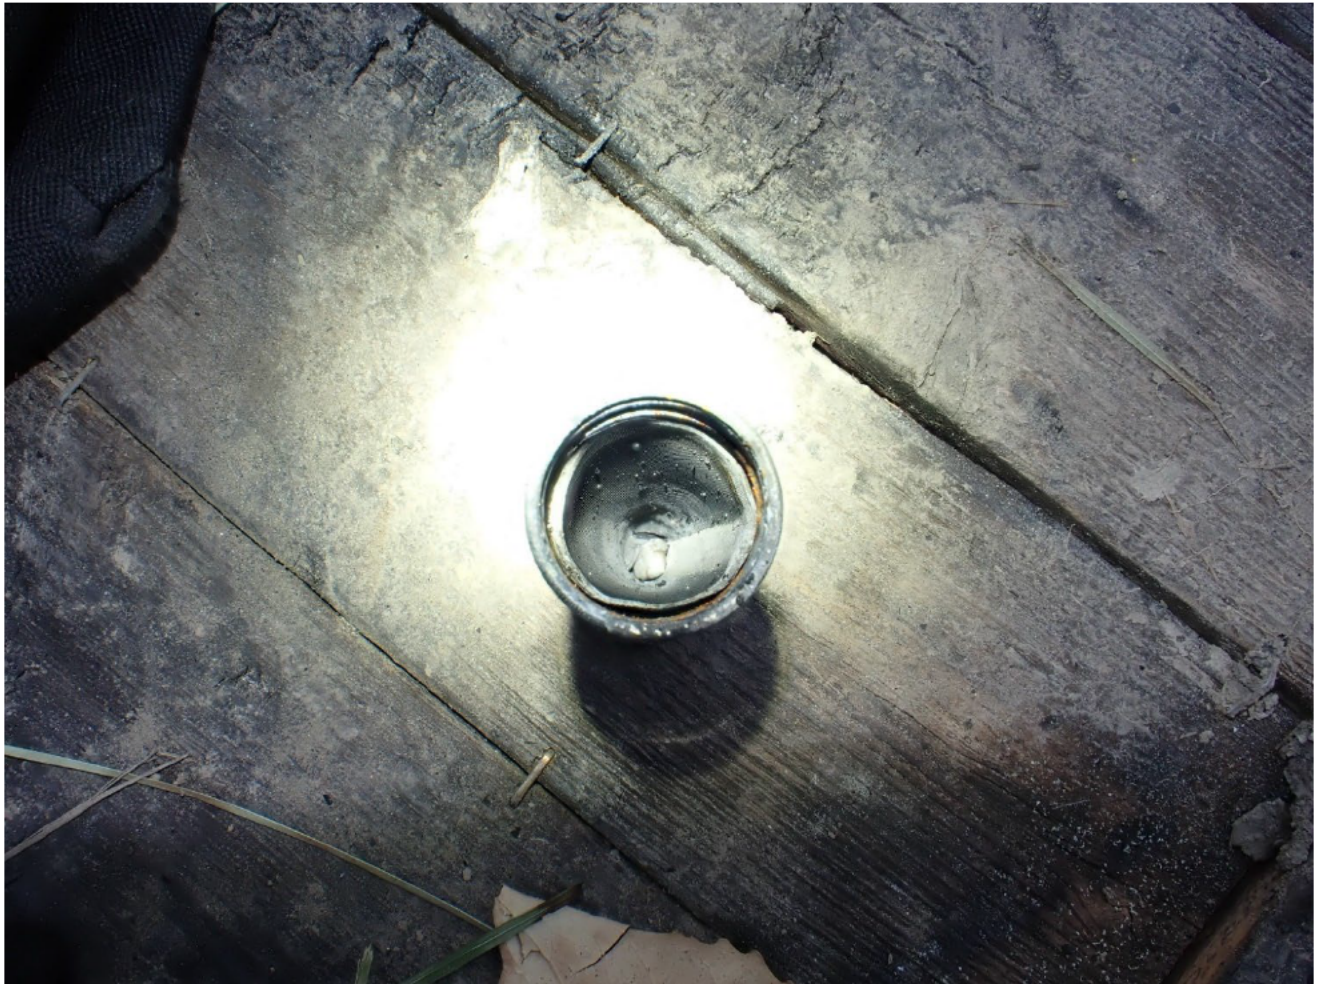
The fuel strainer screen and bowl contained light soot deposits.

Fuel strainer screen, ASI-21-CR-065

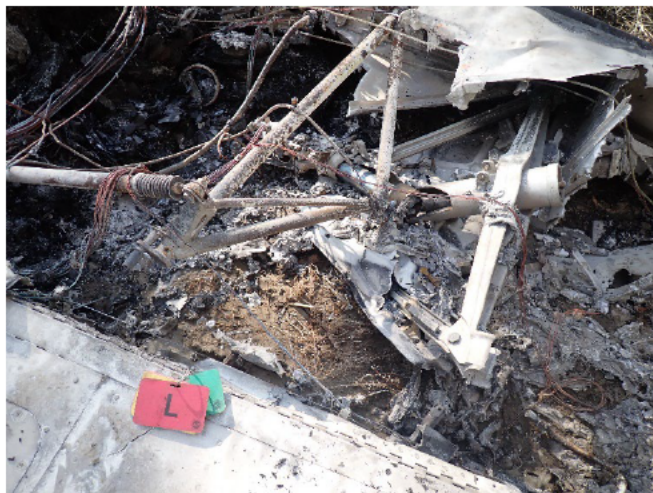
The left main landing gear truss was separated from the forward spar. The oleo strut assembly was fractured at the upper barrel portion. The landing gear gearbox was damaged in the post-impact fire. The aircraft was not equipped with the optional dual brake system.

Left main landing gear, ASI-21-CR-027

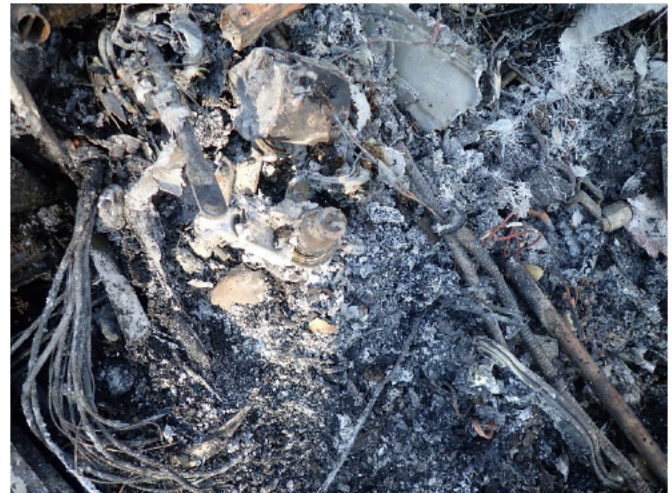
Landing gear gearbox, ASI-21-CR-054

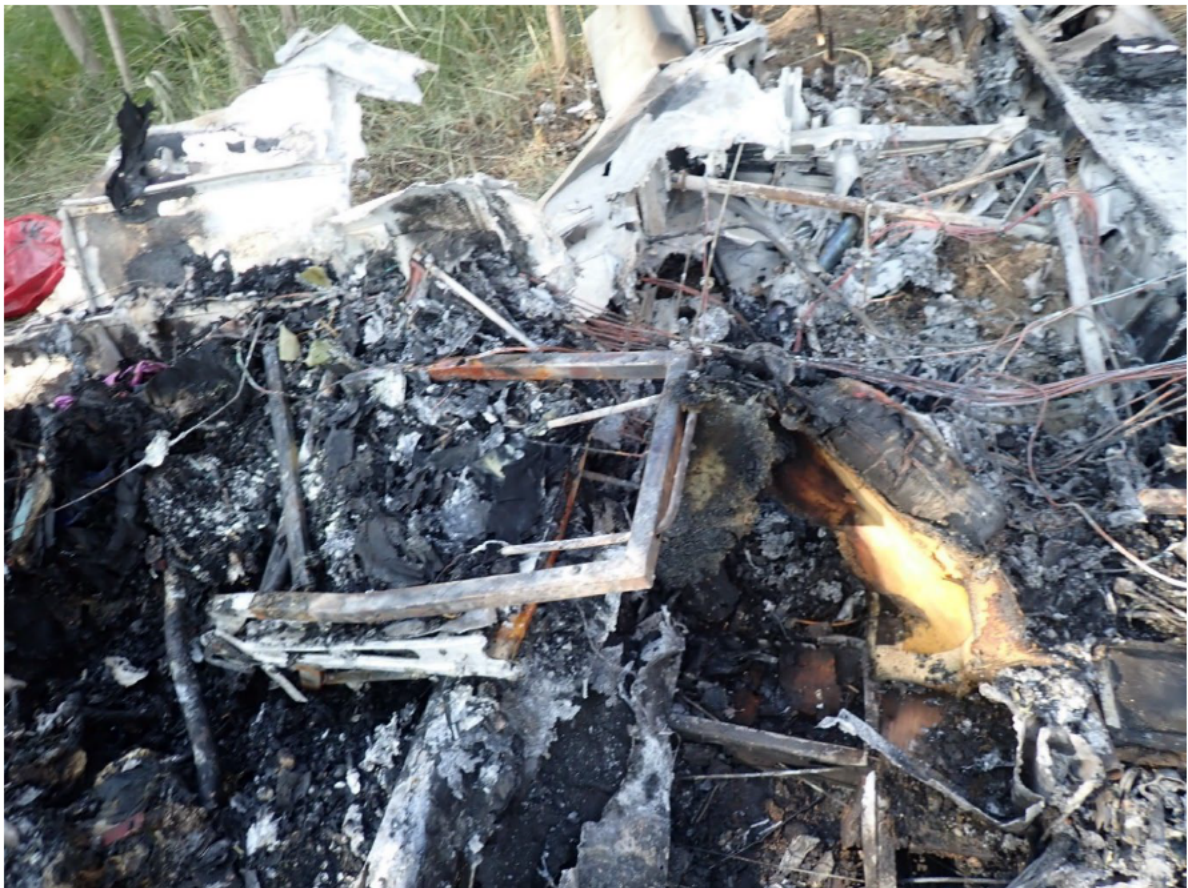
Based on the condition of seat 3, it appears the rear seat passenger was in seat 4. A dog was located in the area of seat 3.

Seat 3, ASI-21-CR-057
