# N601SA

Aircraft inspection performed on October 23, 2020

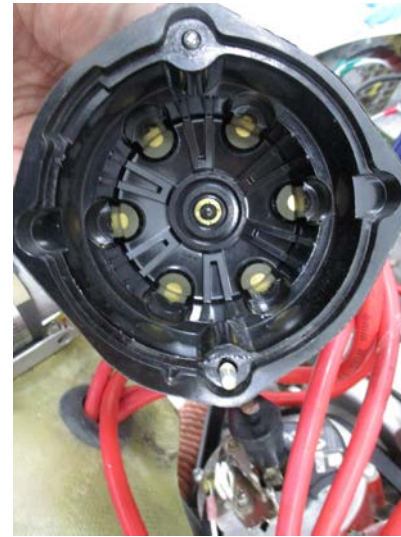
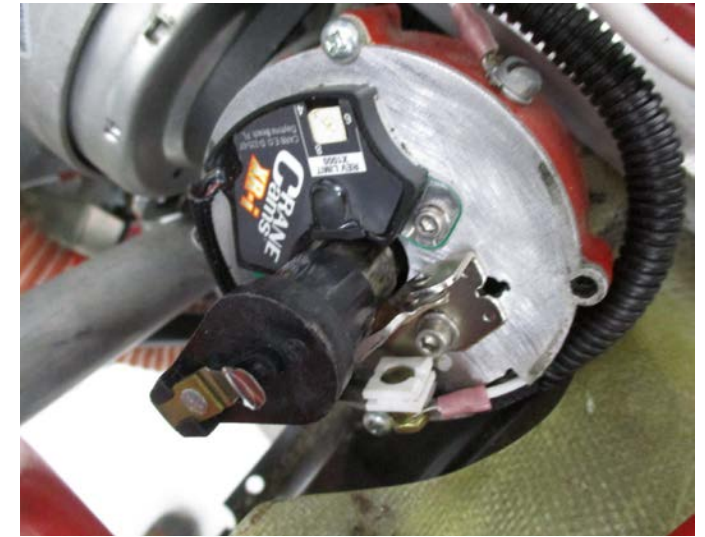
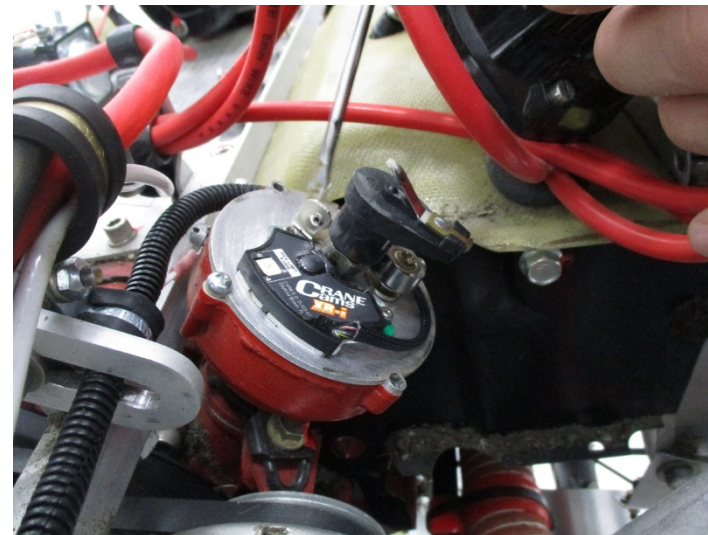
# Inspection of rotor, cap and points

- No issues noted

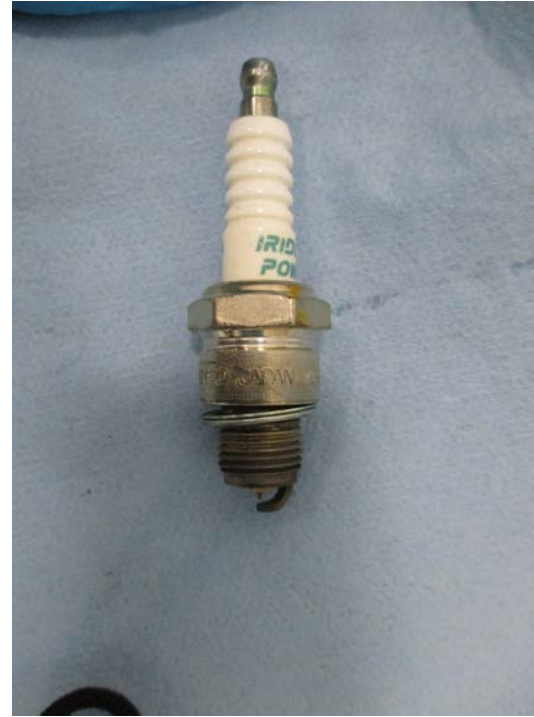
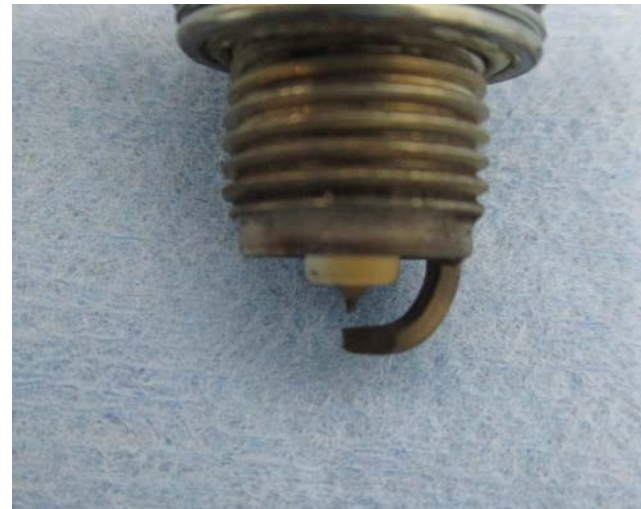
# Inspected spark plugs on cylinders 1,2,3,4,5 and 6

- No issues noted

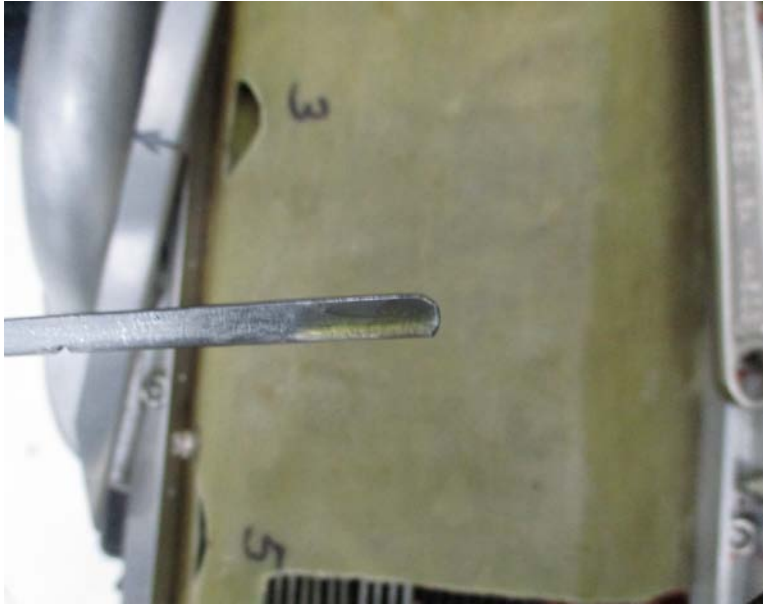
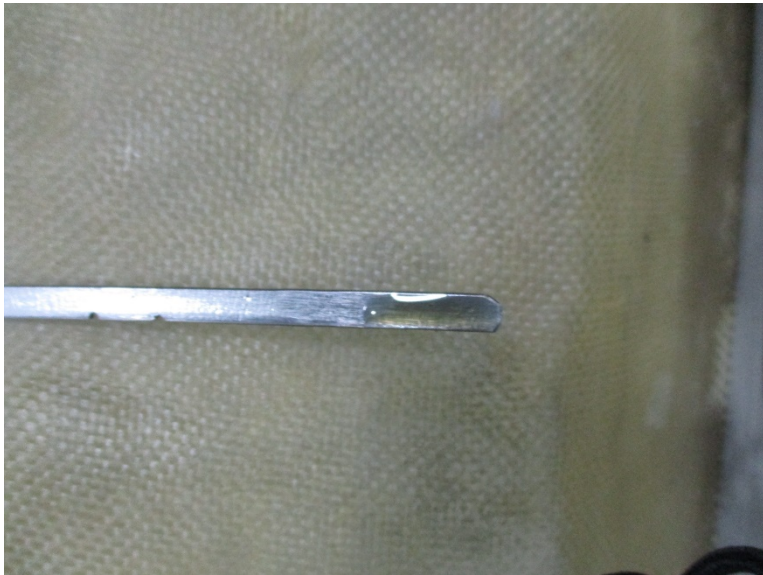
# Checked engine oil level

- No issues noted

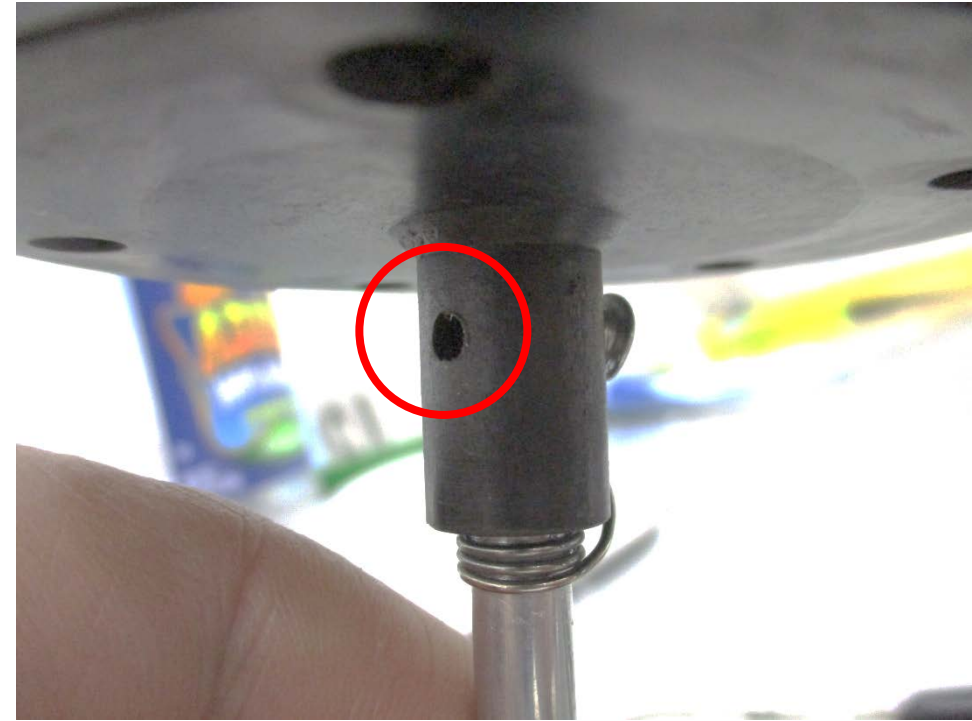
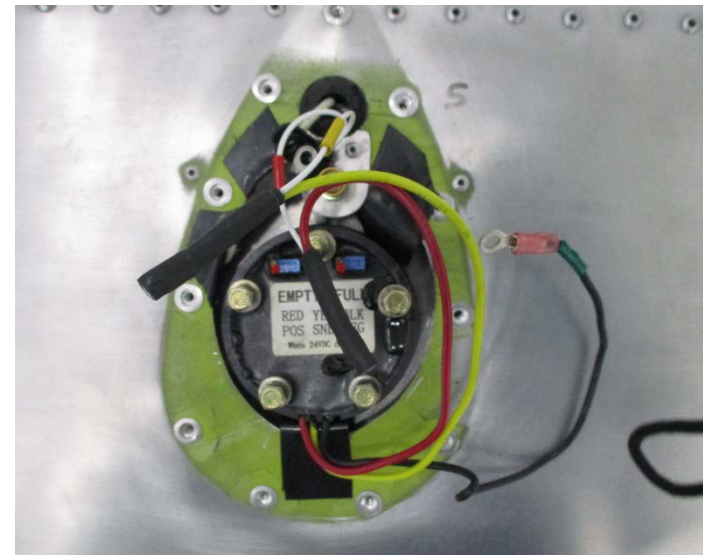
## Right wing fuel probe

- Fuel quantity readings indicated  $\frac{1}{2}$  tank in the right fuel tank prior to draining. After draining 5.5 gallons of fuel from the right wing tank, fuel quantity indicator indicated empty (E). Fuel drained consistent with 100LL
- Retaining/alignment rivet was broken prior to the removal of the right probe, allowing the probe to freely swivel from the head unit
- Note: Inspected left wing fuel probe for connections and condition but did not remove. No issues noted. Left tank reading  $\frac{1}{4}$  tank prior to draining and empty (E) after draining. Drained 2 gallons from the left tank. Fuel drained consistent with 100LL

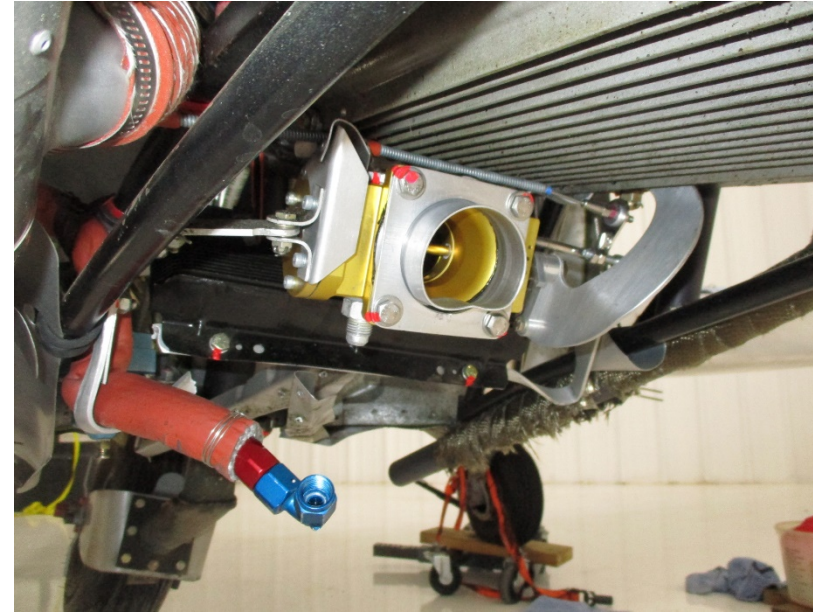
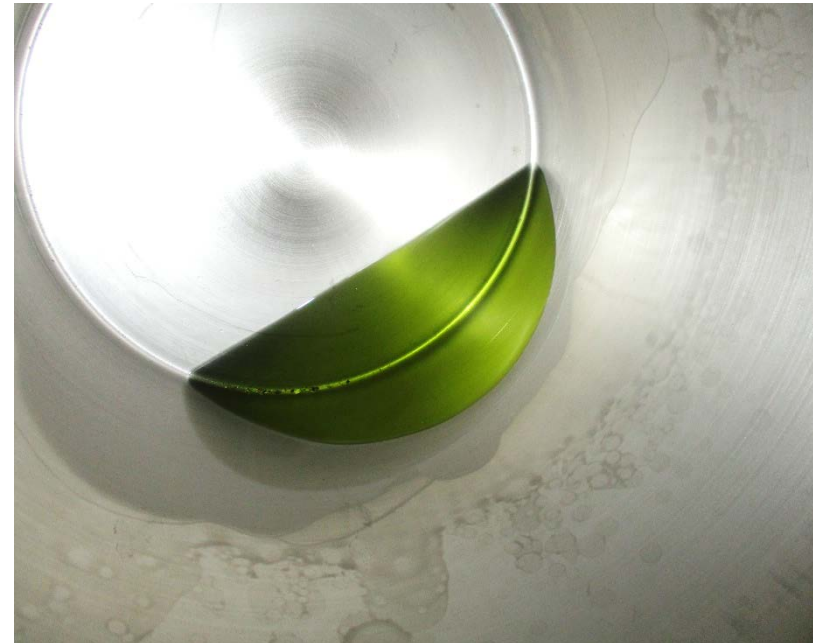
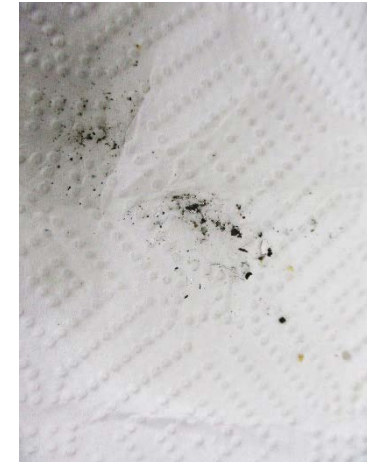
# Fuel purge

- With both L & R tanks drained and empty
  - Disconnected fuel feed line to the carburetor.
  - Turned Master switch on
  - Fuel selector valve to “Right”
  - Turned main and right aux fuel pumps on
    - No fuel captured from the carburetor fuel line
  - Turned main and left aux fuel pumps on
  - Fuel selector valve to “Left”
    - Approximately 1 pint of greenish liquid captured from the carburetor fuel line
    - Fuel sample also contained unidentified debris
  - Filled the left fuel tank with previously drained fuel.
  - Turned main and left aux fuel pumps on
  - Fuel selector valve to “Left”
    - Fuel captured from the carburetor fuel line was consistent with 100LL

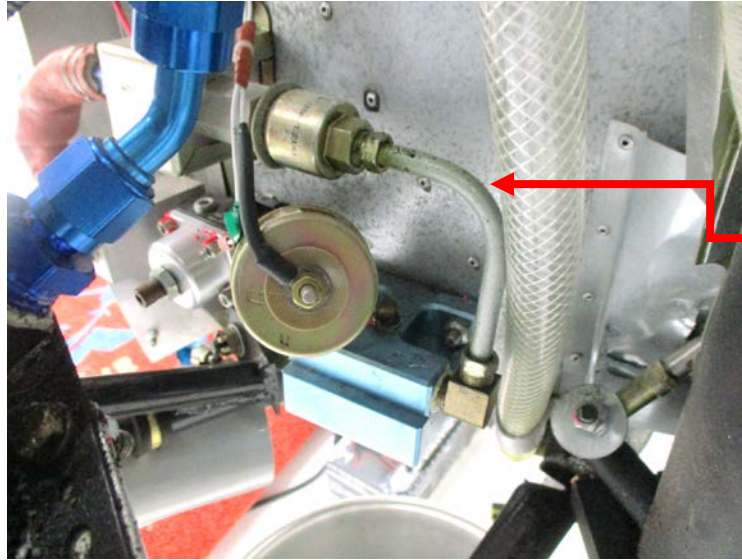
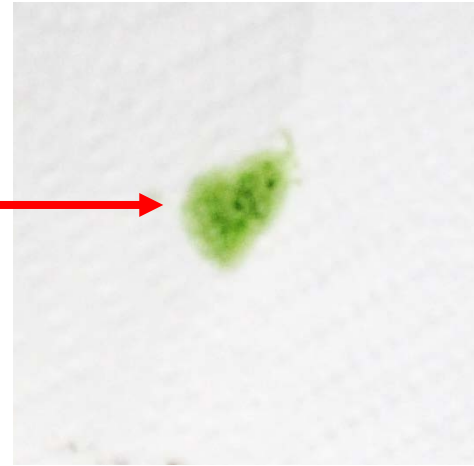
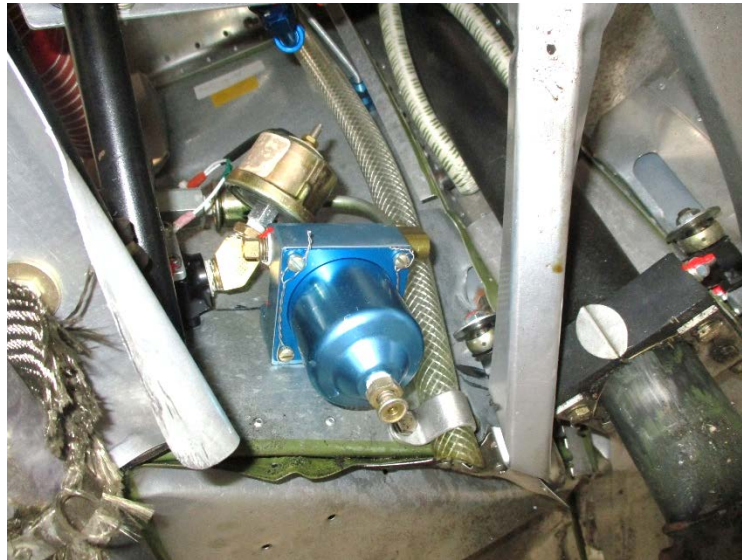
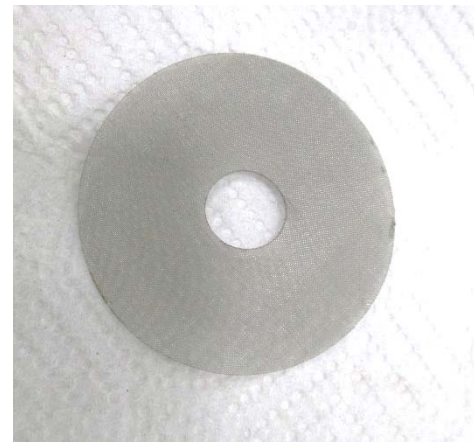
# Gascolator

- Conditions and connections
  - No issues noted
- Internal filter screen
  - Clean and void of debris
- Fuel line exterior
  - Greenish film/liquid covering the exterior of the fuel line from the gascolator to the main fuel pump

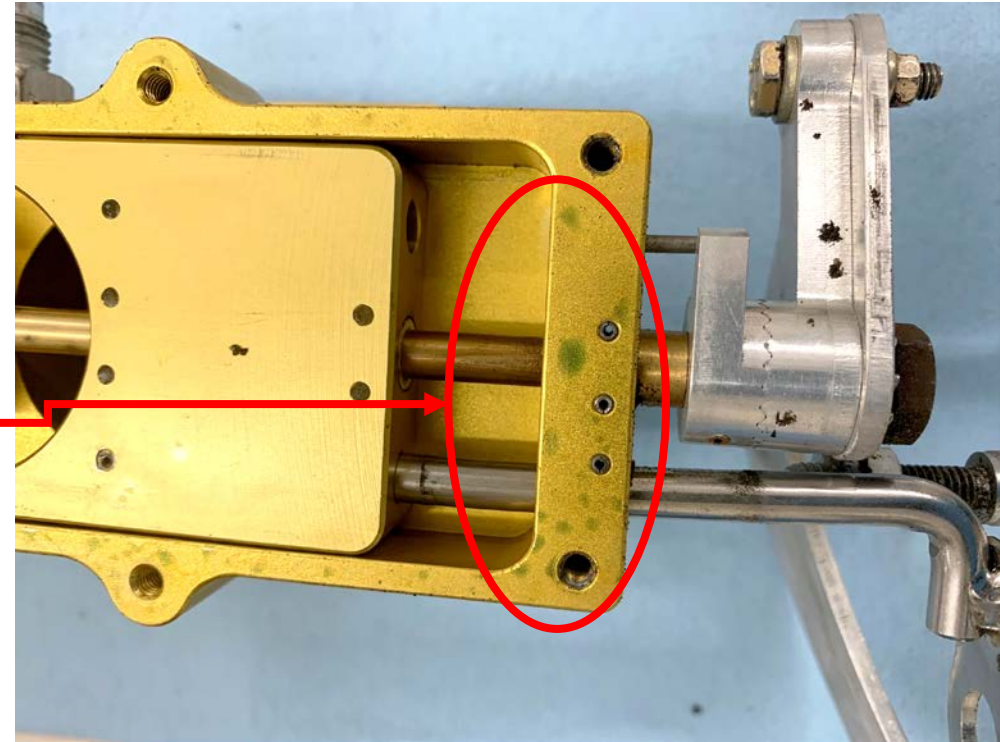
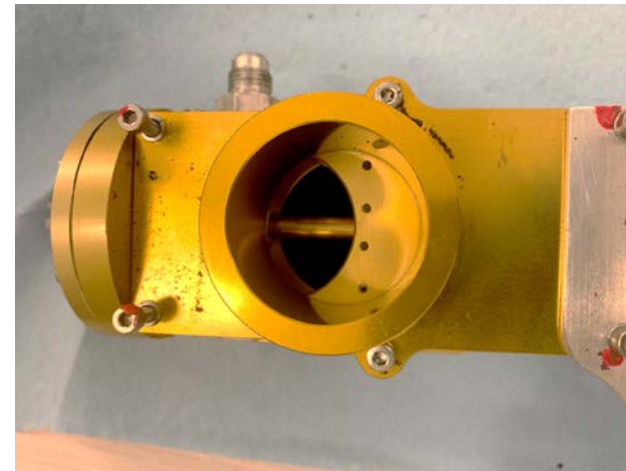
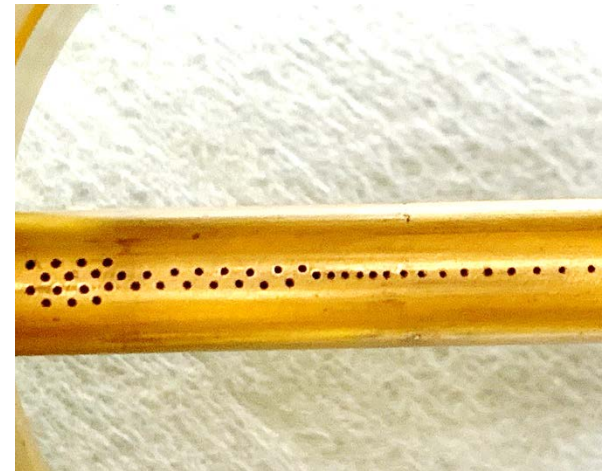
# Throttle body

- Disassembled
  - Greenish liquid consistent with that found previously in and around the aircraft fuel system noted in the throttle body
  - Micro orifices were not clogged and clear. Checked with light source illuminated internally
  - Mixture control arm/bracket was bent preventing the throttle from advancing more than  $\frac{1}{2}$  full open
