## **NATIONAL TRANSPORTATION SAFETY BOARD**

# **AIRFRAME AND ENGINE EXAMINATION SUMMARY**

**WPR21LA003**

Location: Hawthorne, California  
Date: October 4, 2020  
Aircraft: N449WB; Evolution Revo

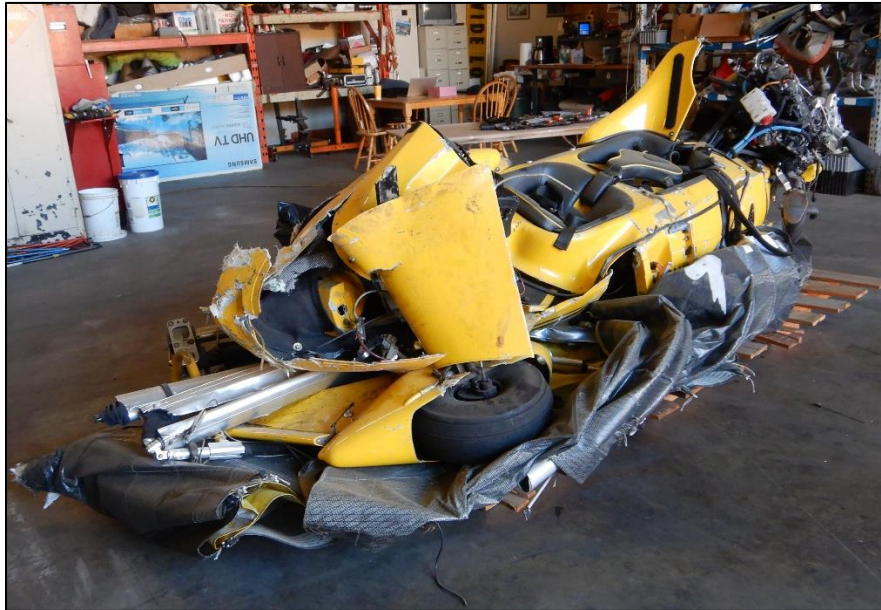
The tricycle fuselage was positioned on the damaged folded wing for purposes of the relocation of the wreckage from the accident site. The forward section of the fuselage had impact damage and was partially separated from main wreckage. The rear main wheel assemblies both separated from the fuselage. The parachute system was deactivated by cutting the T-handle pull cord by the recovery company.

Figure 1-Main wreckage, view of the forward left side.

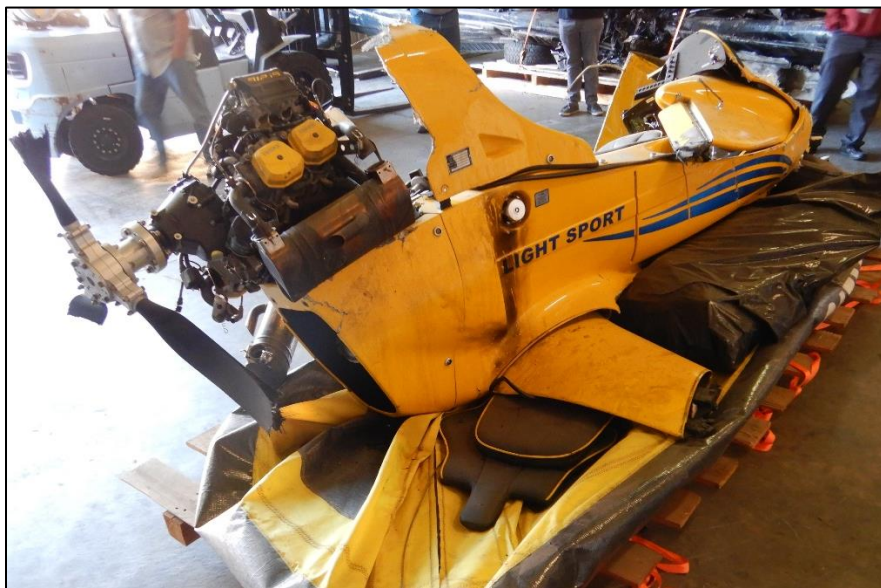
Thermal damage was noted near the fuel cap area and the left side of the engine. The wing mast separated from the fuselage.

Figure 2-Main wreckage, view of the aft right side.

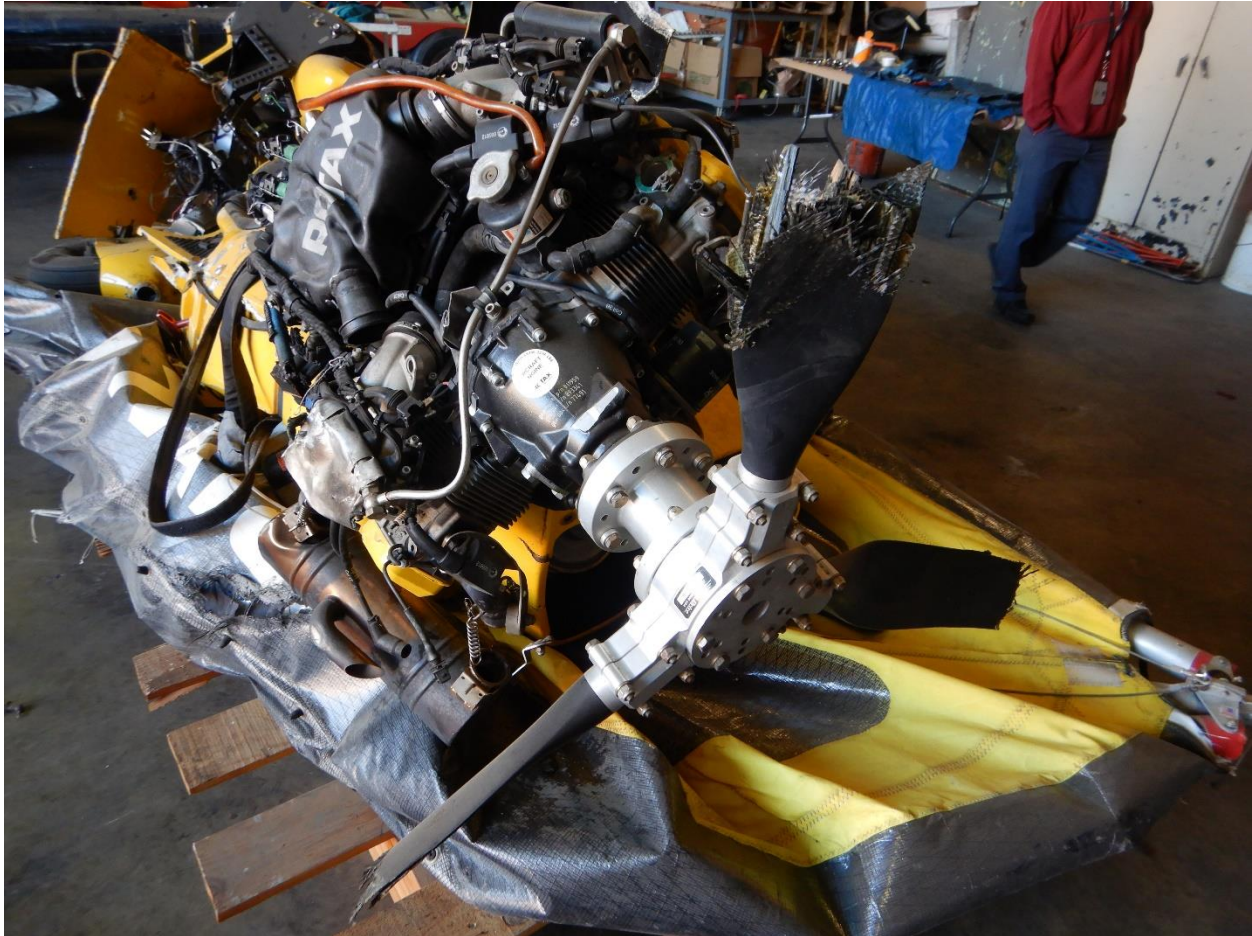
The engine remained attached to the fuselage and had impact and thermal damage. The propeller assembly remained attached to the engine and had impact damage to each of its blades. The blades had about half of their material missing. The left side of the engine had impact damage and thermal damage. The engine control unit was undamaged and removed from the fuselage. The engine control unit was successfully downloaded.

Figure 3-Engine and propeller assembly.

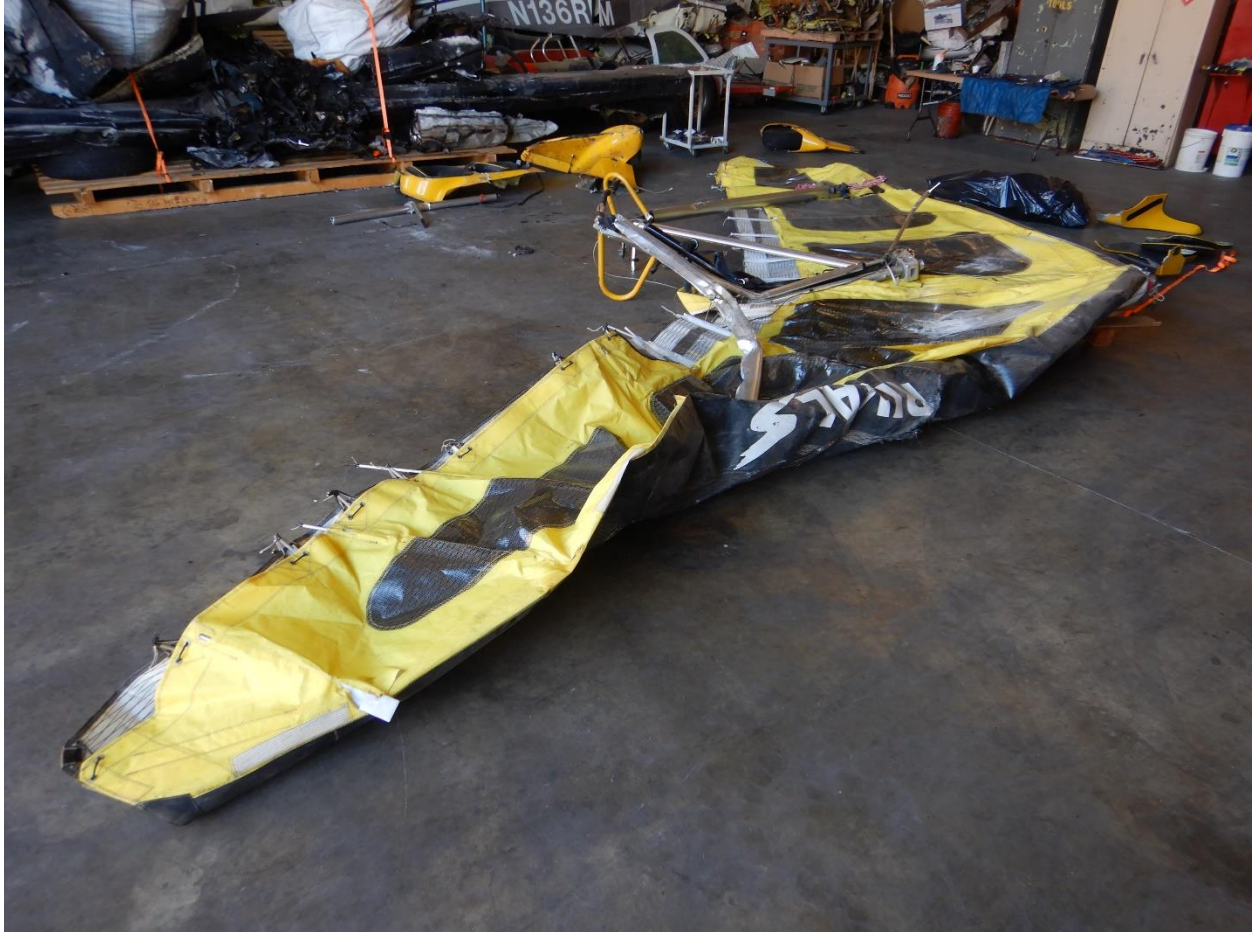
The wing was unfolded, and its internal structure had impact damage at numerous areas. The left side of the wing shows extensive damage at the leading edge. The wing support structure was positioned in its relative area and all structure was accounted for.

Figure 4-Wing, lower side.

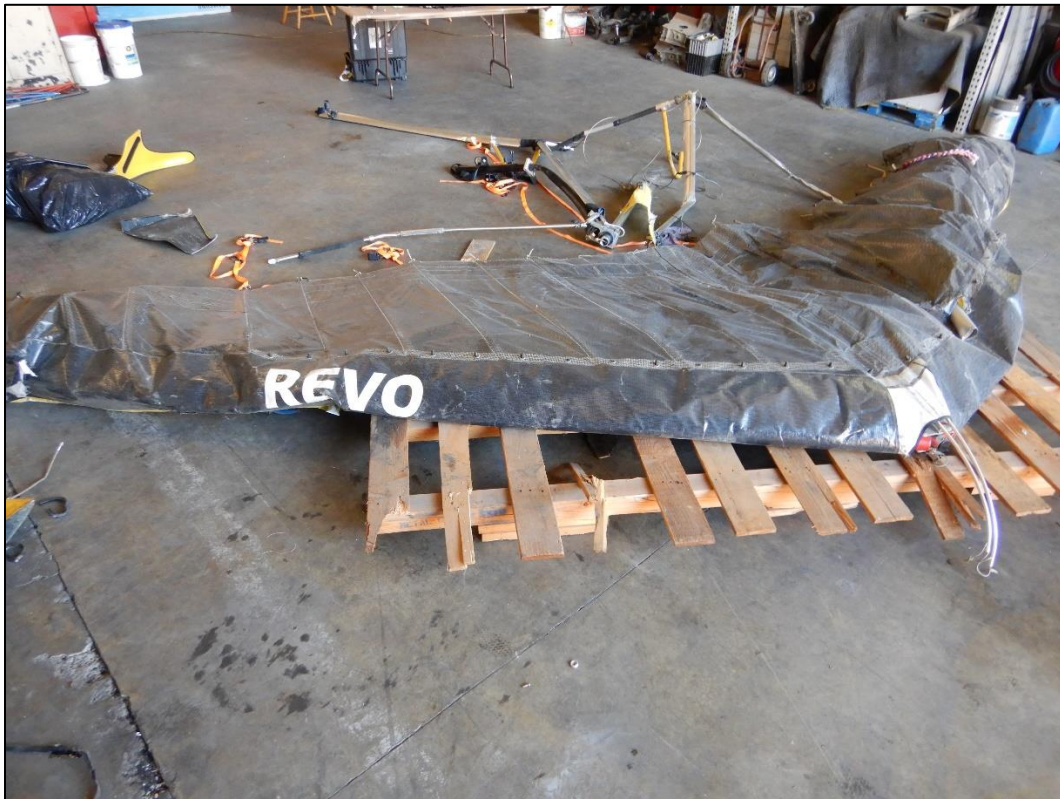
**Figure 5-Wing, upper side.**

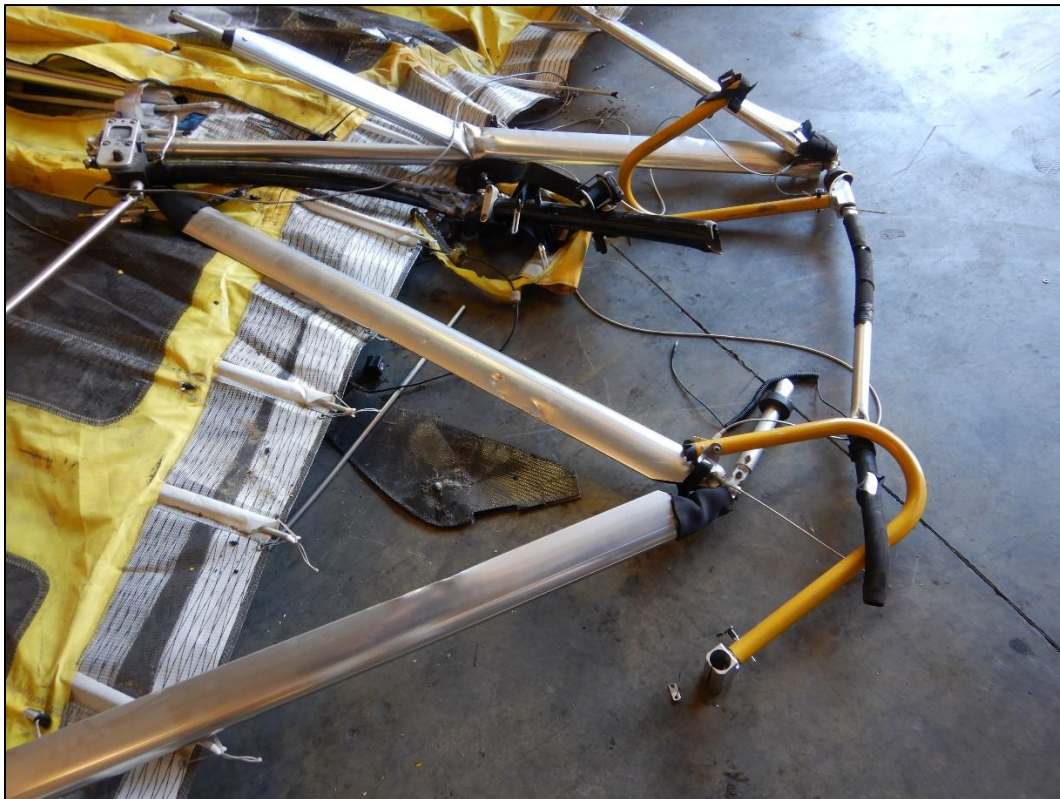
**Figure 6-Wing, control structure.**

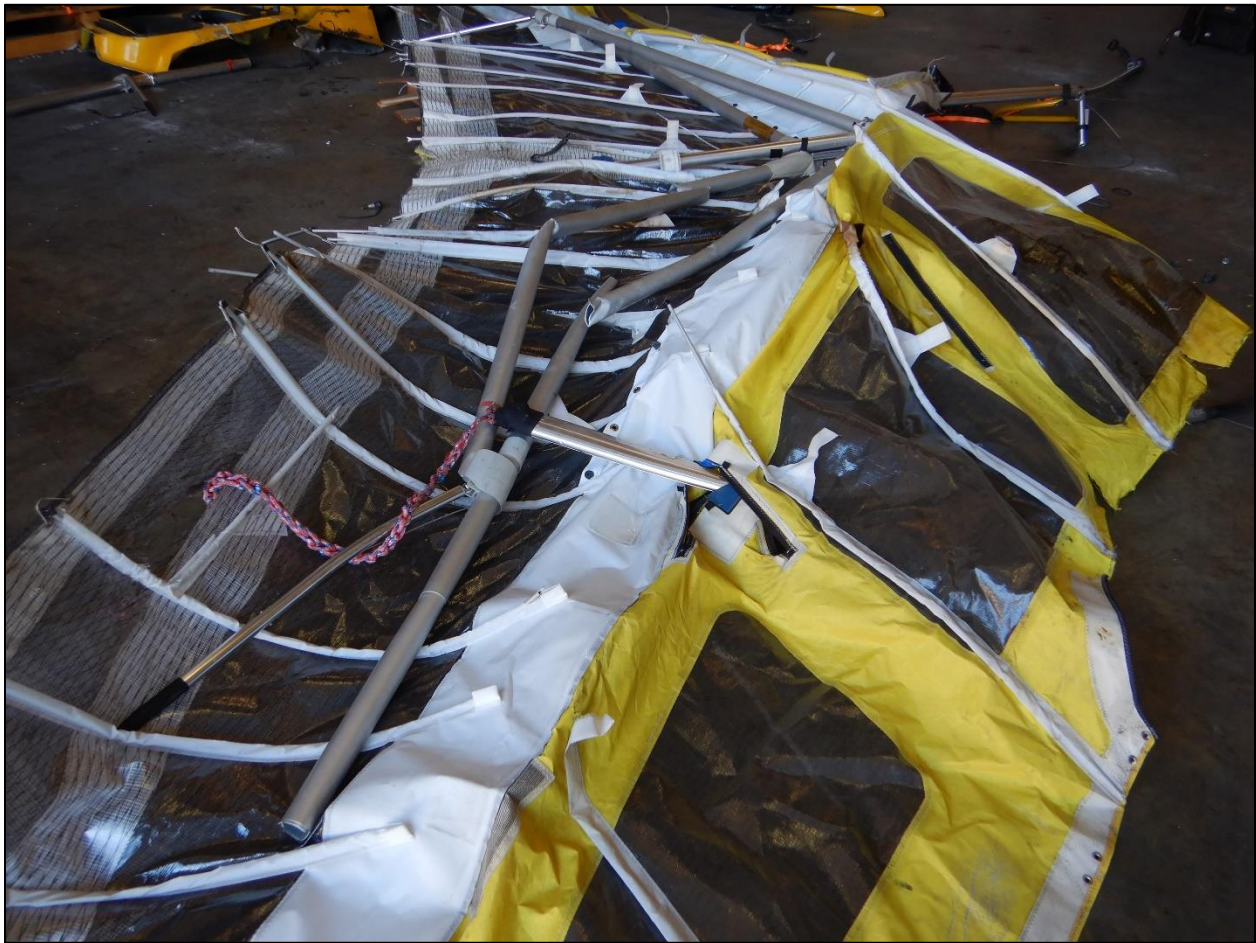
Figure 7-Wing, internal structure.
