## INVESTIGATIVE SUPPORT MATERIALS SUPPLEMENT

On October 06, 2020 at 1533 Pacific daylight time, a Rans S-7 Courier amphibian airplane, N55893, was substantially damaged when it was involved in an accident near Spirit Lake, Idaho. The pilot sustained fatal injuries and the passenger sustained minor injuries. The airplane was operated as a Title 14 Code of Federal Regulations Part 91 personal flight.

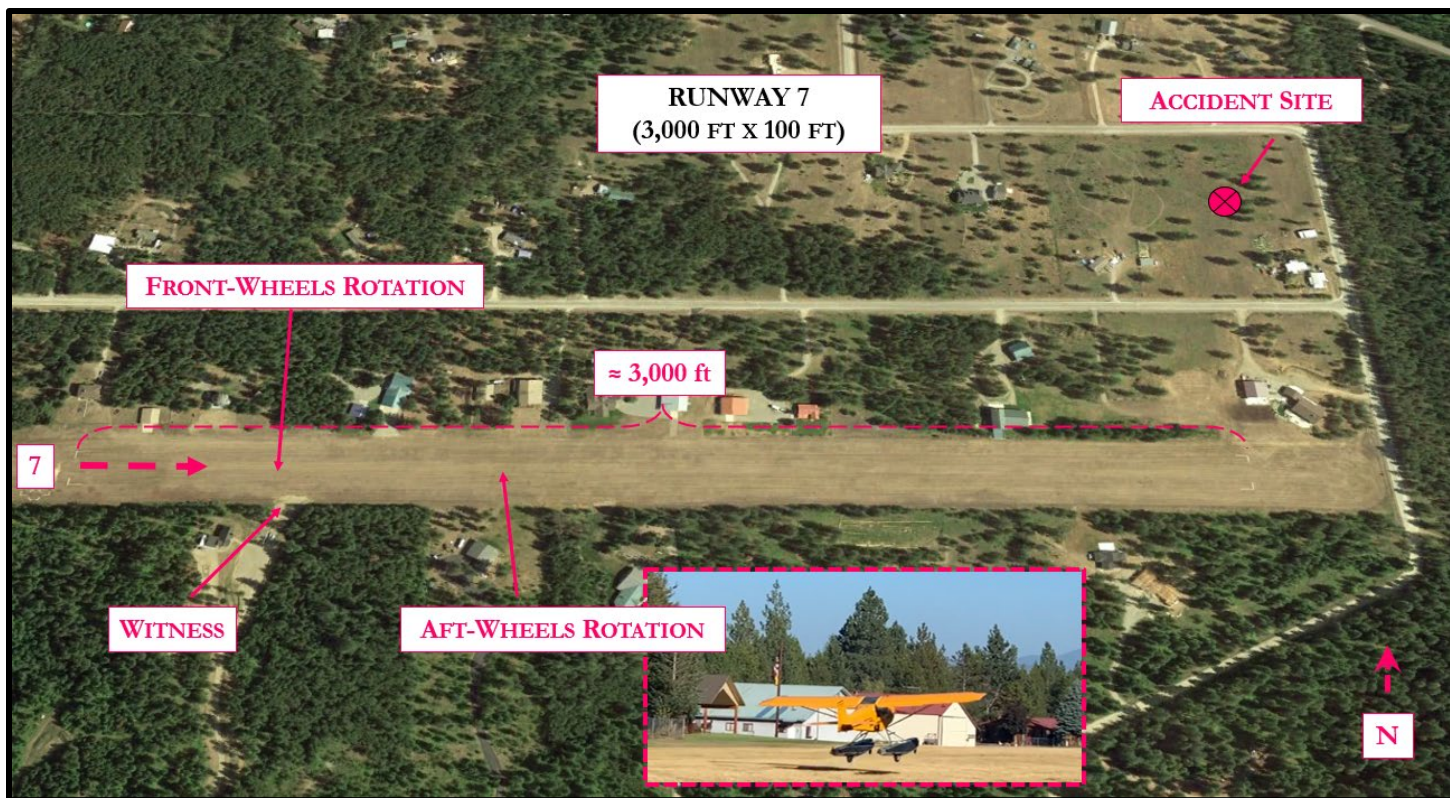
Figure 1: Runway Diagram

The acquaintance's son captured a video of the takeoff on his cell phone and witnessed the accident. A review of the video revealed that as the airplane departed runway 07 it became airborne about 1,100 ft down the grass runway (see Figure 1). As the departure continued, the wings rocked as it slowly ascended and then it temporarily climbed above the tree line (see Figure 2). The airplane turned left (to the north) and then descended below the tree line. The airplane came to rest about 900 ft north of the runway centerline (see Figure 3).

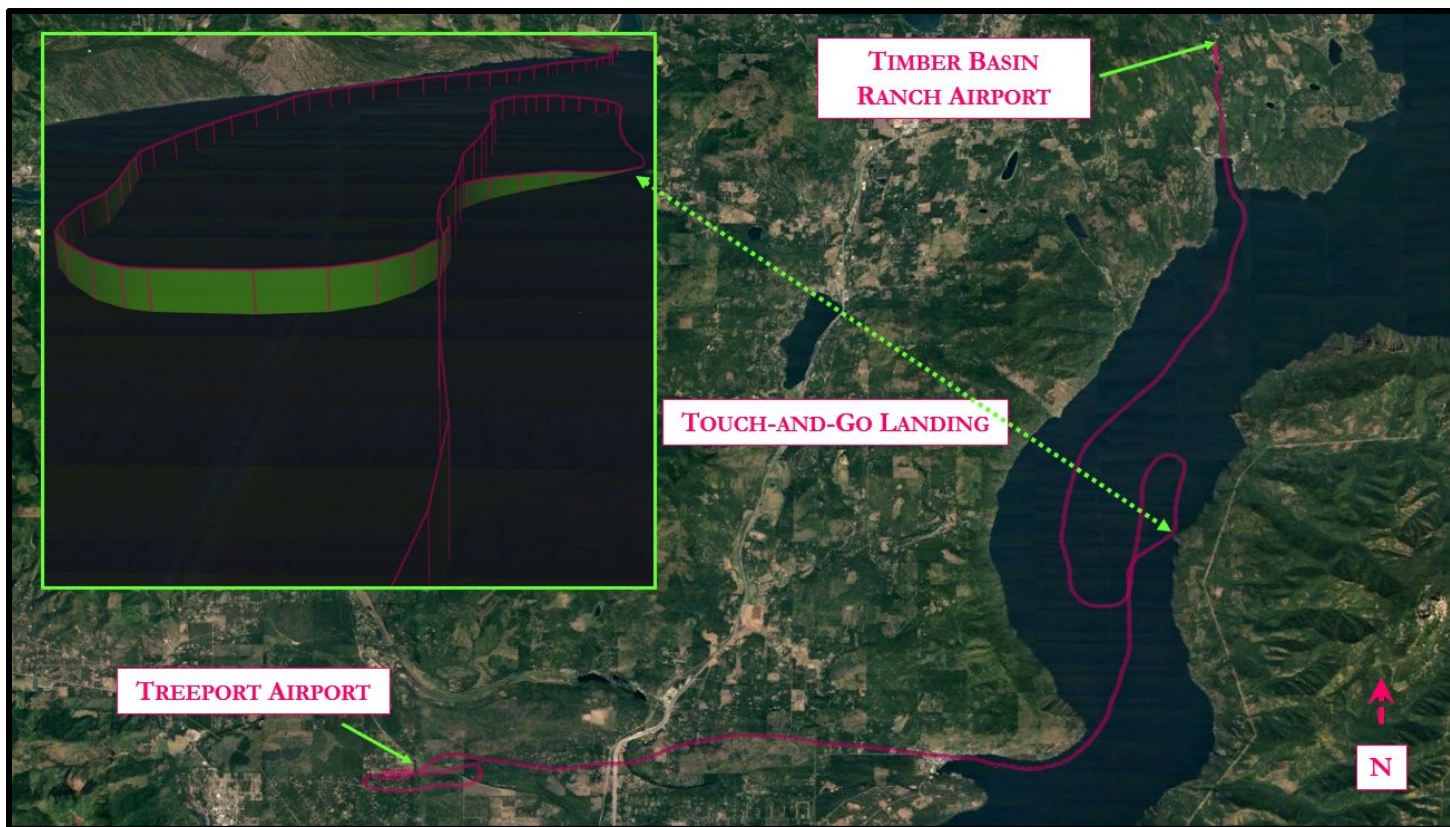
*Figure 4: Prior Flight*

In an effort to determine the estimated ground track, ground speed, altitude, orientation angles and engine speed of the airplane, the NTSB completed a performance study using the video recorded by a viewer on the ground. The airplane had a Garmin Aera 660, battery-powered multi-functional display (MFD) and GPS receiver. Recorded data plots were recovered for the flight prior to the accident and the accident flight. The data revealed that the airplane departed Timber Basin Ranch airport about 1325. The airplane flew south, made a maneuver over Lake Pend Oreille which appeared to be a touch-and-go landing. Thereafter, the airplane then continued to Treeport Airport, where it landed on runway 25 about 1410.

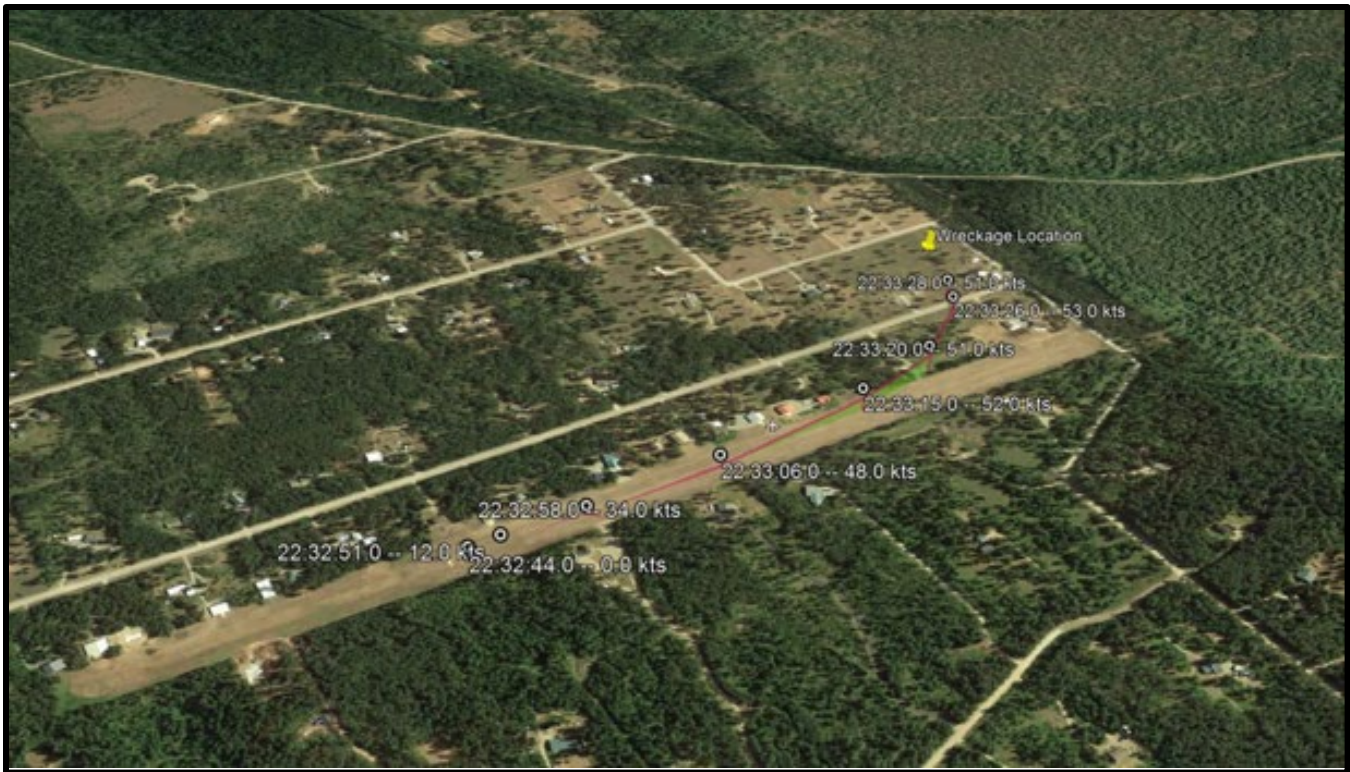
*Figure 5: Google Earth Overlay Showing the Accident Flight and Recorded Groundspeed.*

The track record indicated the airplane departed runway 07 at 1532:50 Pacific standard time. After becoming airborne, 7 hits were recorded, the last track at 1533:08 prior to impact (See figure 5). During that time the airplane's groundspeed increased from 41 to 52 knots, then 51 knots as the airplane climbed over the tree line.

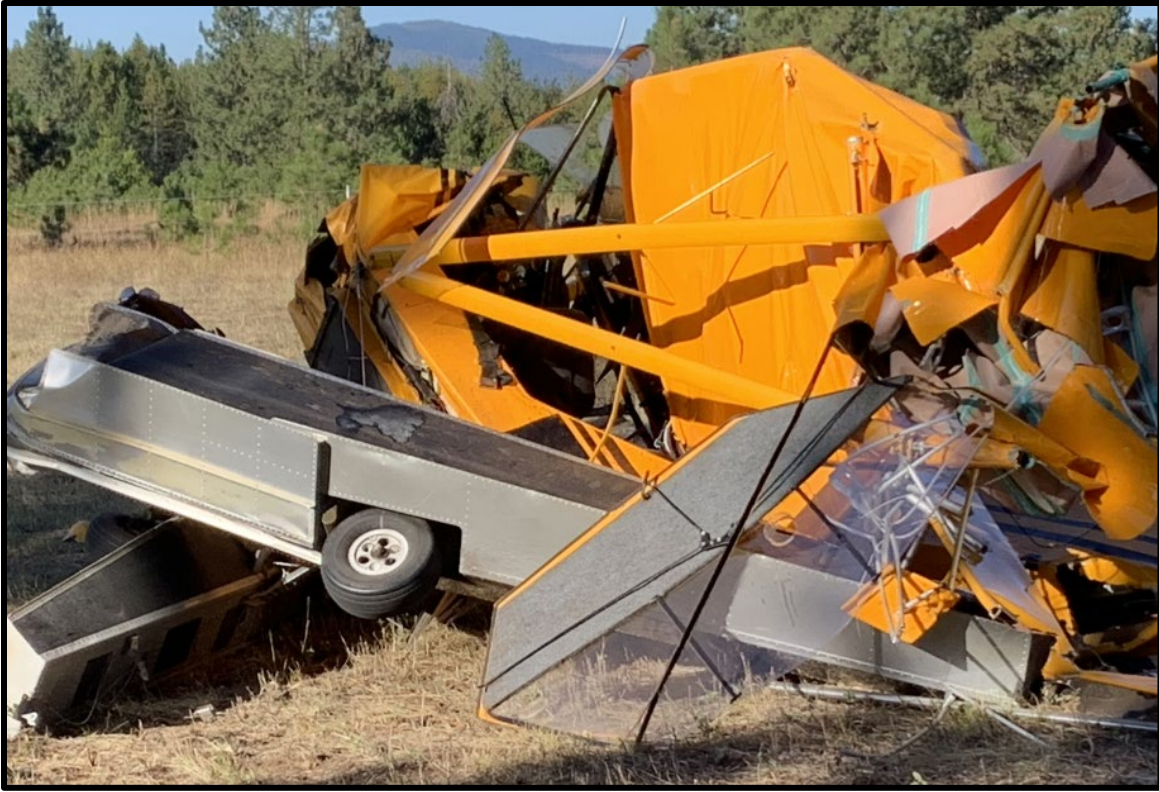
*Figure 6: Wreckage (provided by the FAA)*

Safety Board investigators were unable to go to the accident site due to the COVID pandemic. There was no evidence of water in the floats, but it could not definitely determined, because of the position the airplane came to rest after the impact.
