## **NATIONAL TRANSPORTATION SAFETY BOARD**

# **AIRFRAME AND ENGINE EXAMINATION**

**WPR21LA015**

Location: Puyallup, Washington  
Date: October 15, 2020  
Aircraft: Cessna 152, N6585L  
NTSB Investigator-in-Charge: Maja Smith

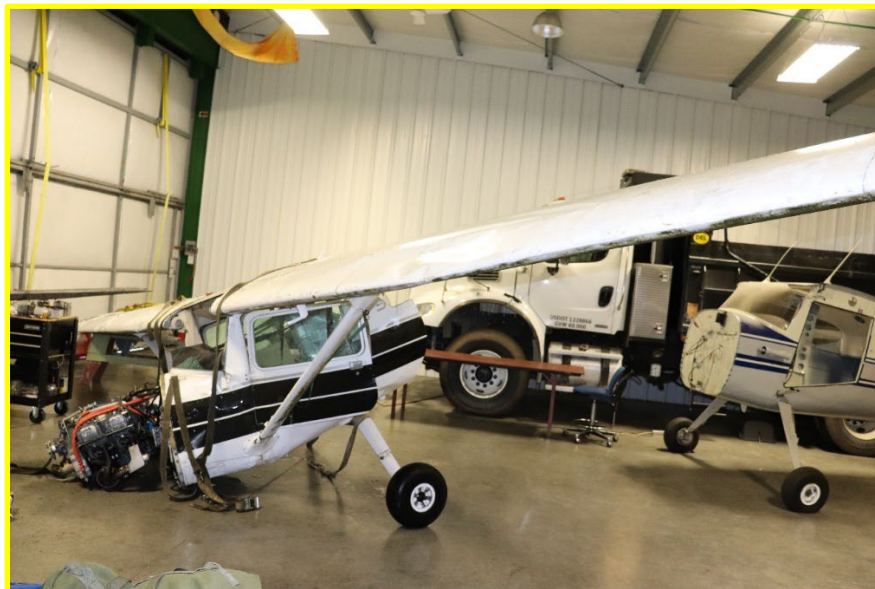
**Figure 1. View of airplane during examination**

The left and right wings remained attached to the airframe and exhibited buckling and dents throughout. The left and right fuel tank covers were in place and all of the screws appeared corroded. A heavy amount of moss was observed on the bottom side of both wings and fuselage. A visual inspection was conducted on both left and right fuel caps and tanks. Both fuel caps had rubber seals appeared worn, with rust like discoloration. Both fuel tanks had rust discoloration at the fuel filler neck.

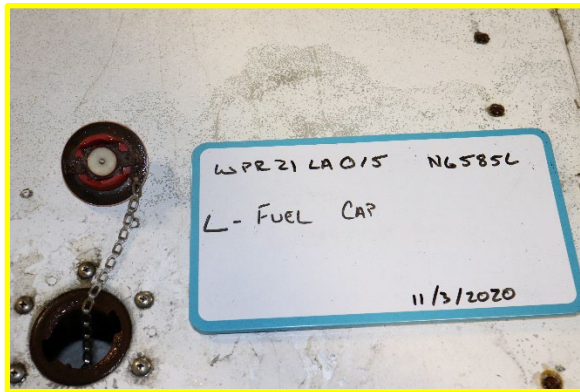
Figure 2. View of left fuel cap

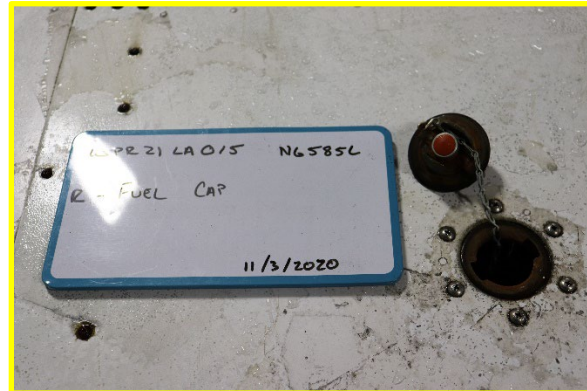
Figure 3. View of right fuel cap

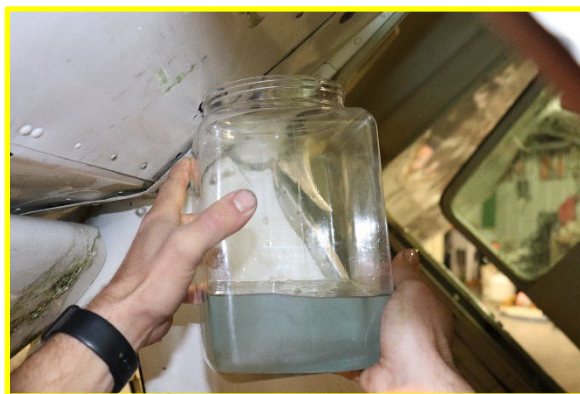
The right wing drain plug was removed, about 1.5 gal of liquid was recovered. The liquid resembled a blue color, similar to 100 low lead fuel, along with a clear, brownish color liquid, consistent with water. The liquid was tested for water using SAR-GEL water finding paste, with positive results. Visual inspection inside the right wing fuel tank revealed clear liquid droplets throughout the bottom of the fuel tank, which was consistent with water. Additionally, the bottom edges of the fuel tank exhibited rust discoloration.

Figure 4. A portion of liquid drained from right fuel tank

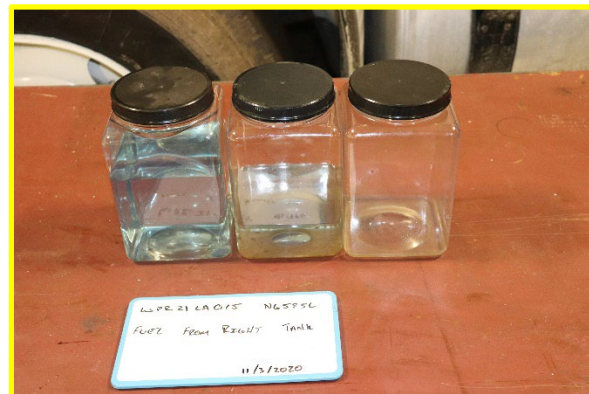
Figure 5. Total liquid drained from the right fuel tank

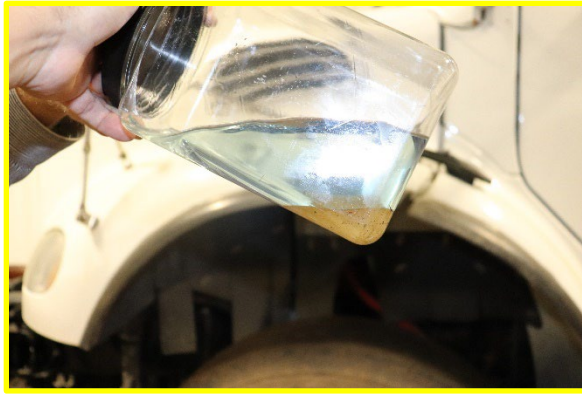
Figure 6. Water and fuel from right fuel tank.

The examination of the recovered airframe and engine revealed water in the right wing fuel tank. The number two cylinder bottom spark plug exhibited foreign debris within the electrode area. The remainder of the airframe and engine examination did not reveal any pre-impact anomalies.

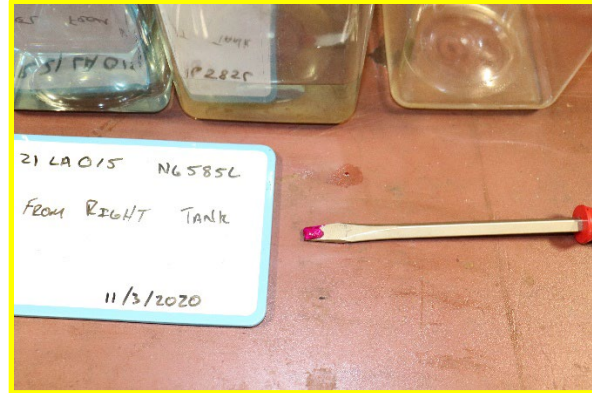
Figure 7. SAR-GEL test results (pink in color).

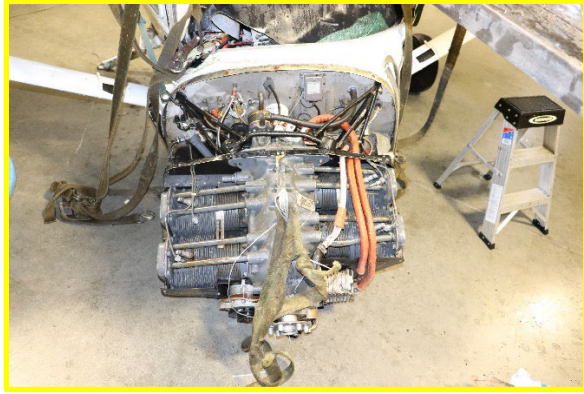
- The engine remained attached to the airframe through the top two engine mounts, however, the bottom two engine mounts were damaged due to impact.
- The crankcase remained intact.
- The cylinders remained attached to the crankcase.
- The upper portion of the carburetor was impact damaged, and a portion of it remained attached to its respective mount. The lower portion (carburetor float bowl) was separated and not present within the recovered debris. (see picture 5). The top spark plug leads were disconnected.
- The exhaust was intact, remained attached to all four cylinders, with no anomalies noted.
- The air filter and airbox were not located within the recovered wreckage.
- The induction system was intact with no anomalies noted.

Figure 8. Overview of engine

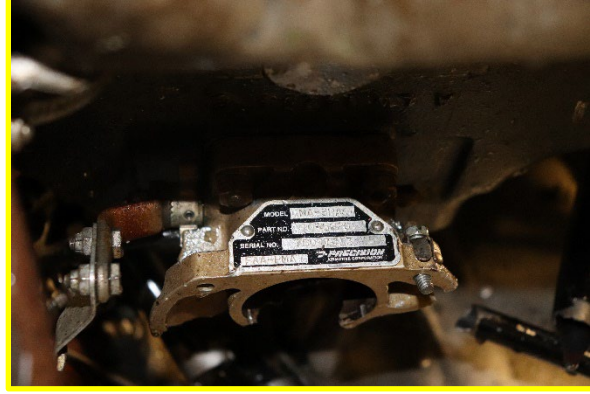
Figure 9. Carburetor impact separated at the mount

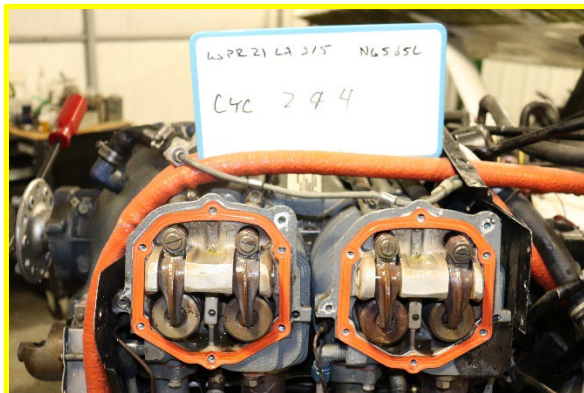
Figure 10. View of number 2 & 4 cylinders

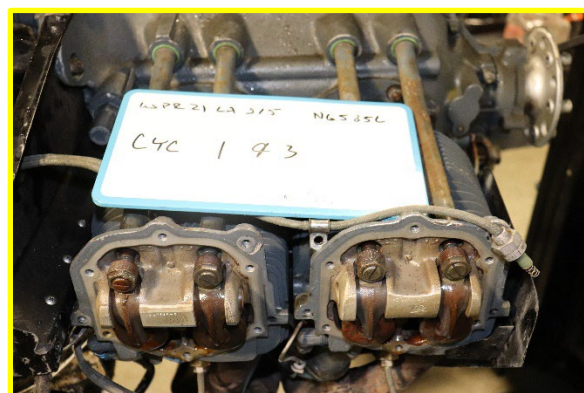
Figure 11. View of number 1 & 3 cylinders

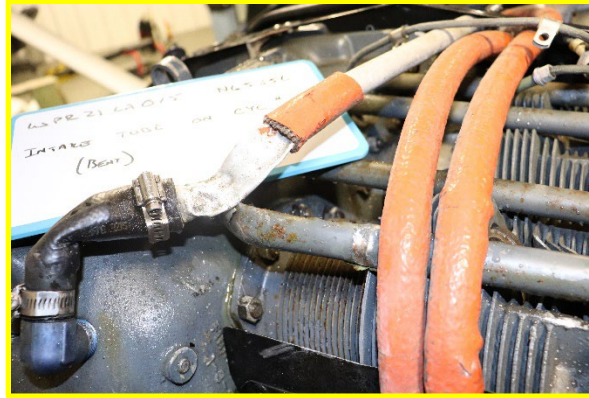
Cylinder 2 had impact damage to the intake pushrod tube and pushrod. However, movement could be seen when rotating the engine crankshaft.

Figure 12. Number 2 Cylinder intake push rod tube and push rod damage

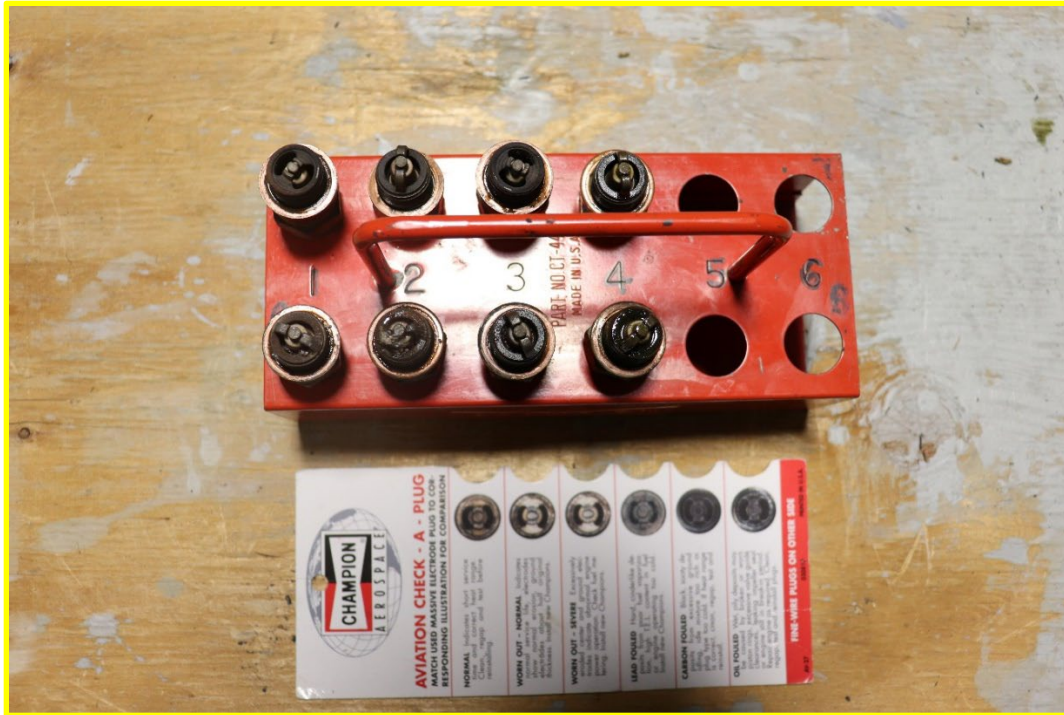
All spark plugs were removed from the engine and they were the massive electrode type. Cylinders 1 and 3 had REM40E style spark plugs on top. Cylinders 2 and 4 had REM37BY style spark plugs on top. Cylinder 1 top spark plug when compared to the Champion Check-A-Plug Chart exhibited "WORN OUT-SEVERE". All other top spark plugs were light grey in color and exhibited "WORN OUT-NORMAL" when compared to the Champion Check-A-Plug Chart.

All the bottom spark plugs were REM37BY, cylinder 1 bottom plug showed some lead deposits. Cylinder 2 bottom spark plug had foreign debris. Cylinder 3 bottom spark plug exhibited "WORN OUT-NORMAL" when compared to the Champion Check-A-Plug Chart. Cylinder 4 bottom spark plug was oil soaked.

Figure 53. Overview of spark plugs
