## RECORD OF EMAIL

**Samantha Link**  
**Aviation Accident Investigator**  
**Western Pacific Region**

**Date: October 26, 2020**  
**Person Contacted: Mr. Bill Shinn (Federal Aviation Administration)**  
**NTSB Accident Number: WPR21LA017**

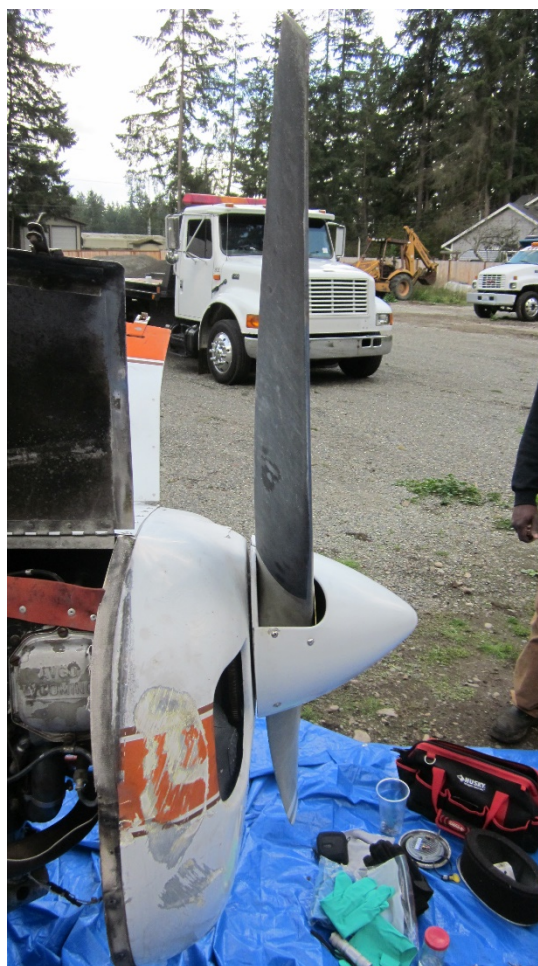
*Figure 2: Propeller*

- The propeller is in good shape.

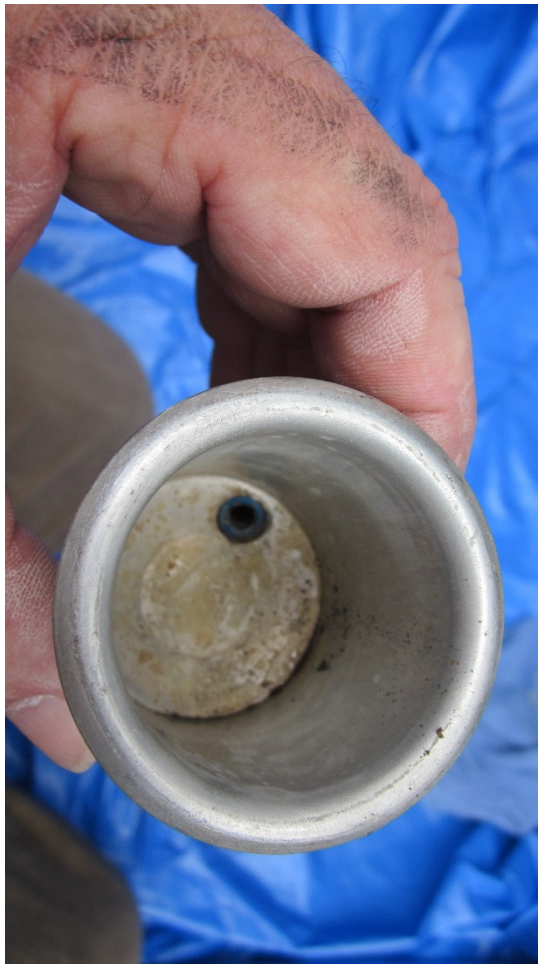
*Figure 5: Fuel Strainer Bowl*

- The gascolator was clean and the electric fuel pump functioned fine.
- I did not see any "smoking guns" so to speak with the exception of the ignition system.

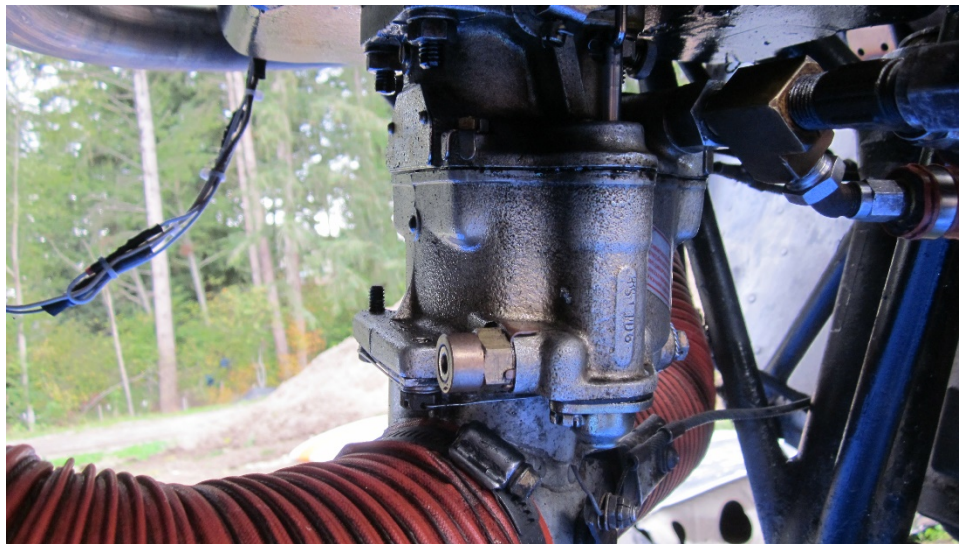
*Figure 6: Carburetor*

- Its intake was clear, and the filter looked great.
- There was full fuel in the carburetor bowl and the accelerator pump functioned fine. Carburetor appeared to be fairly new.
