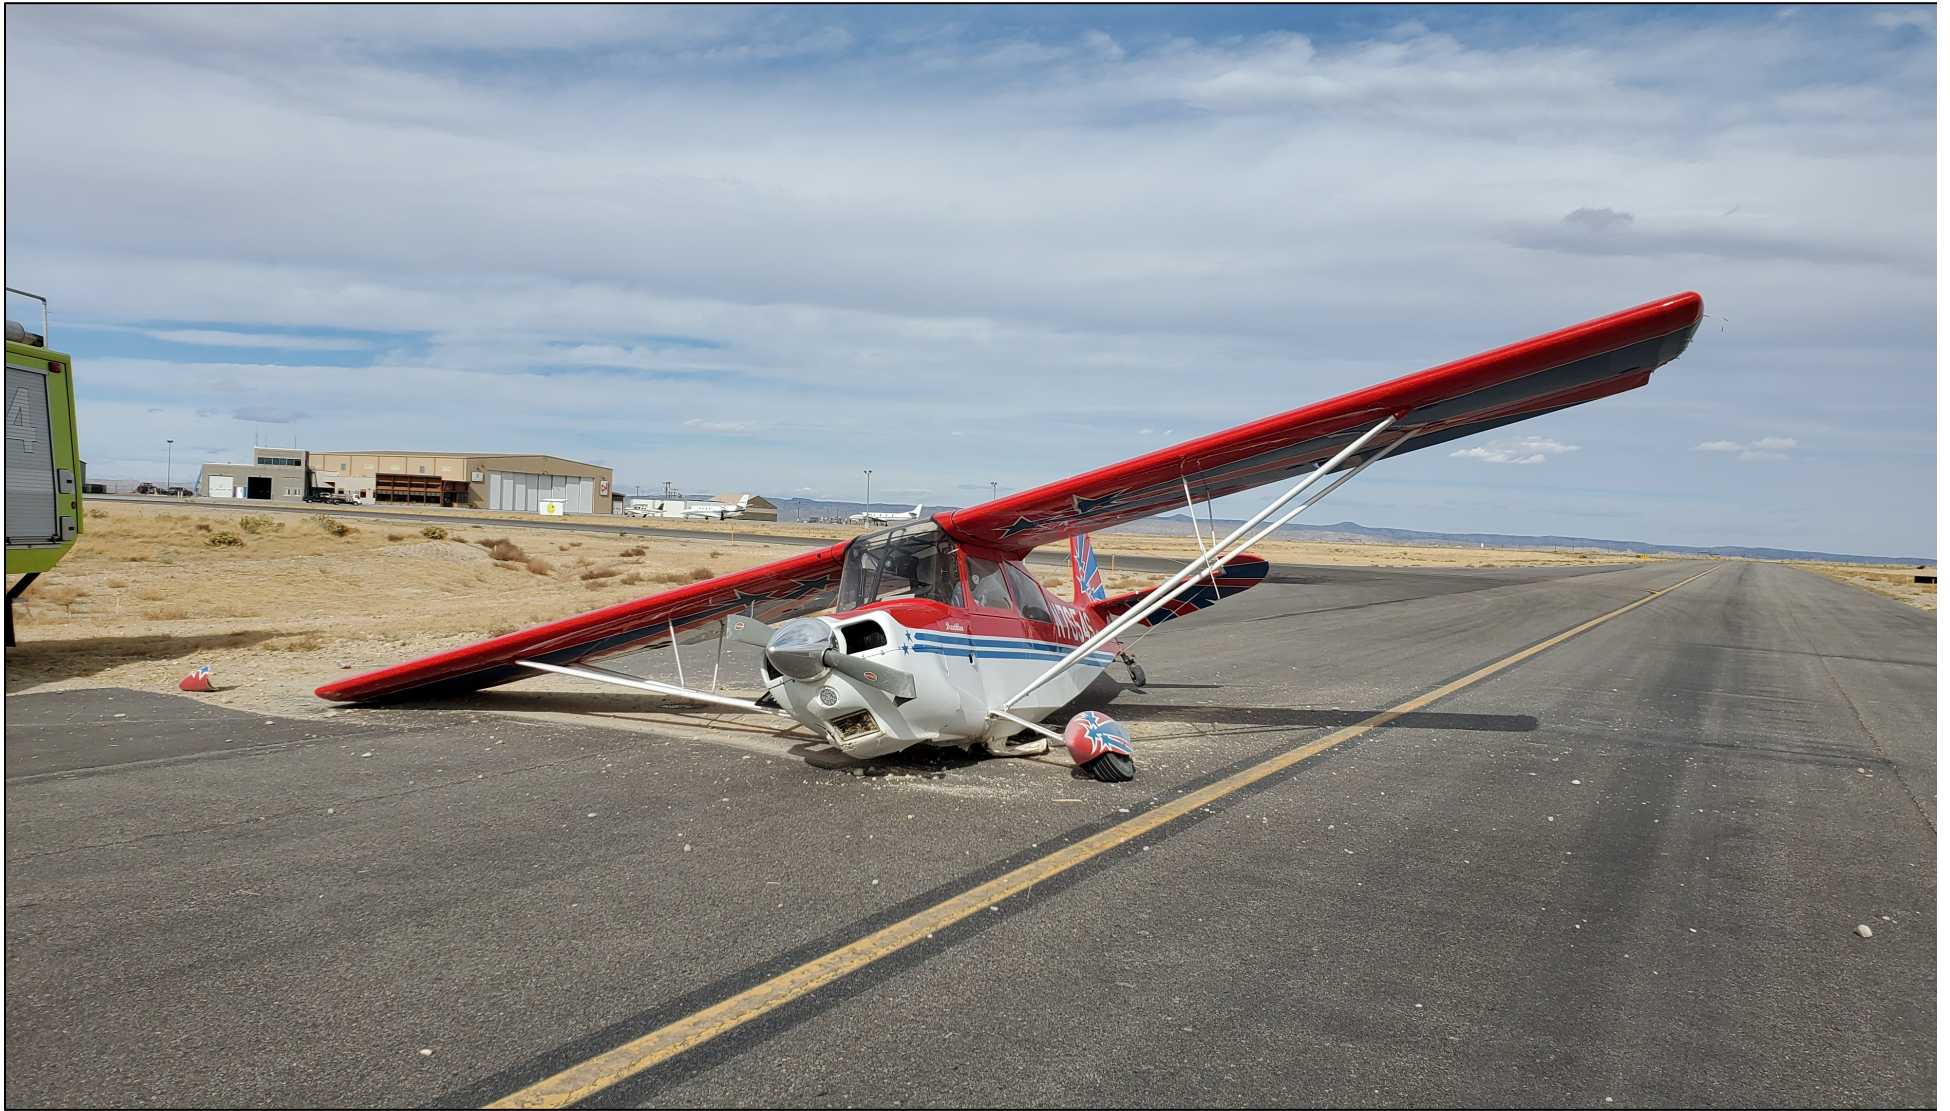
**Photo 1 – Accident site.**

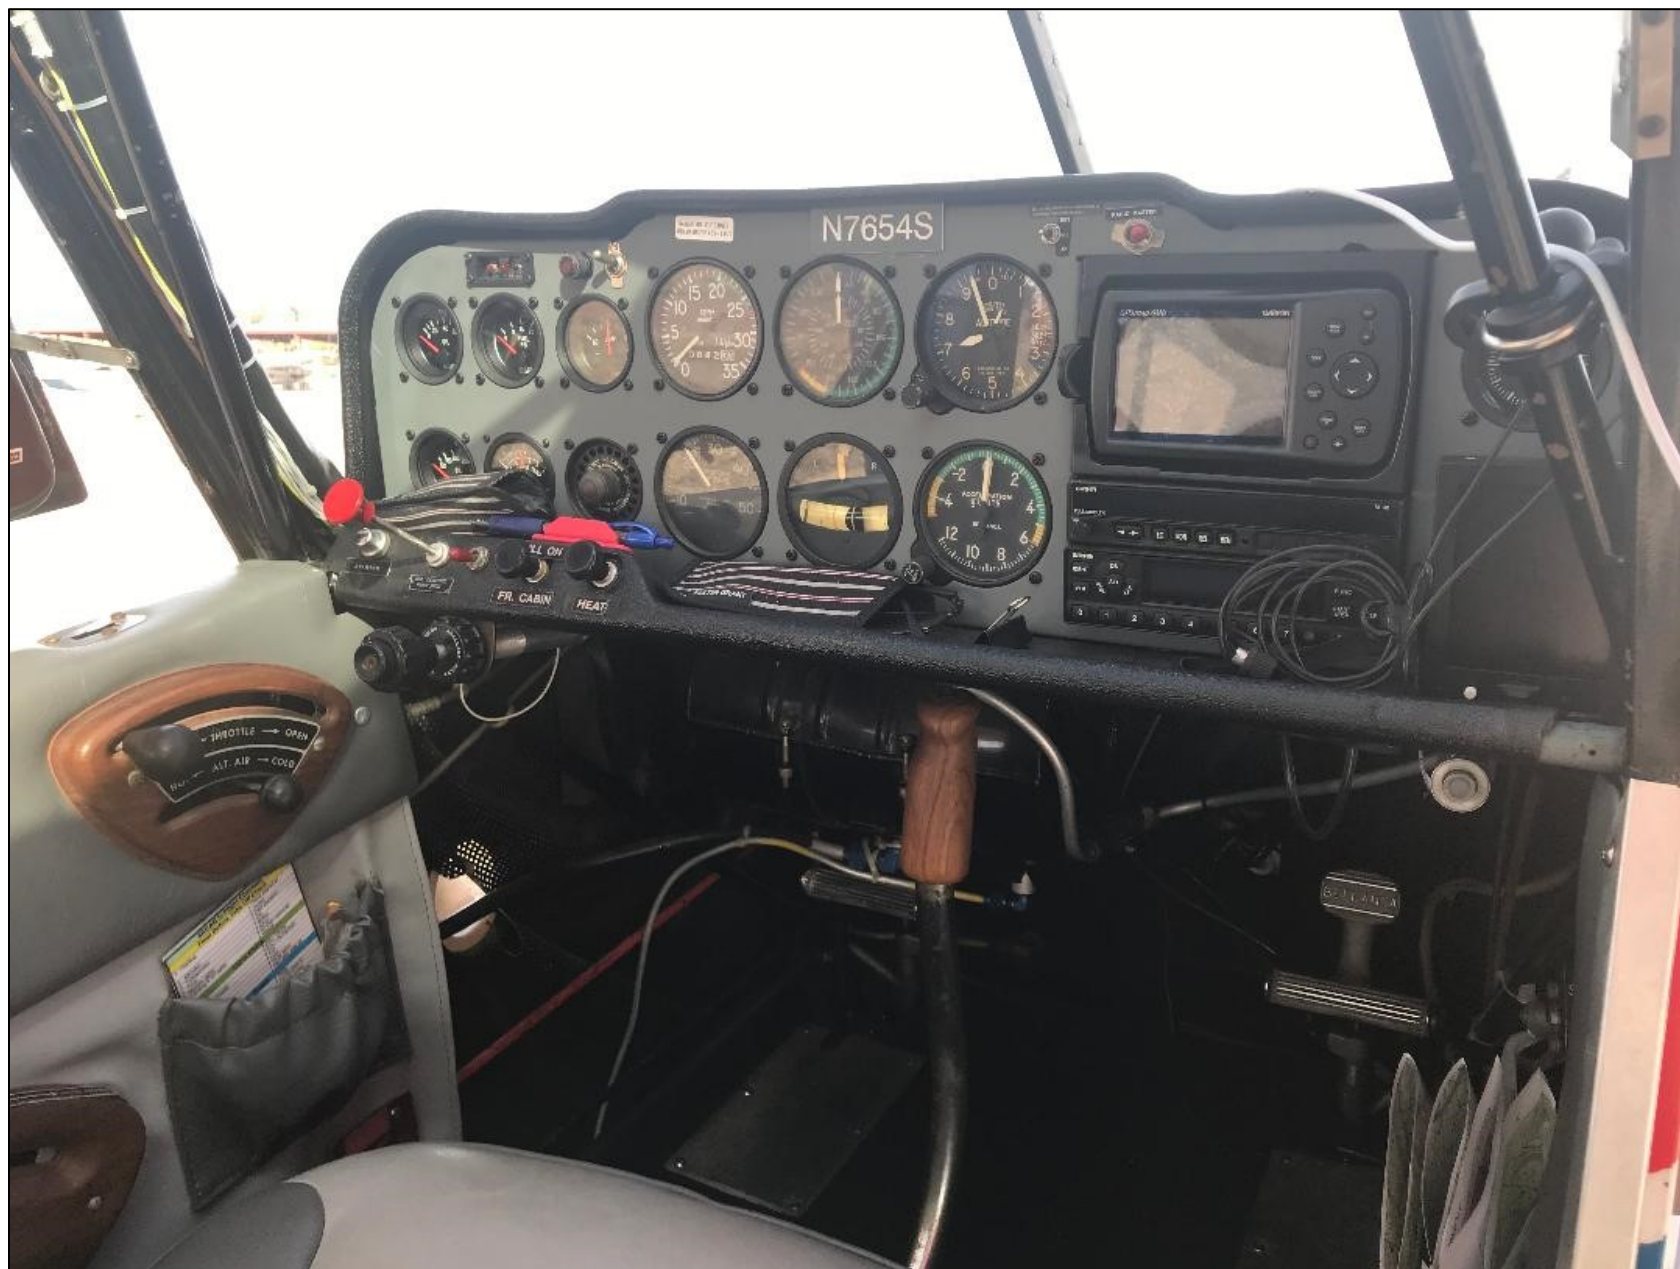
**Photo 2 - Cabin area, with wood grip installed on the control column.**

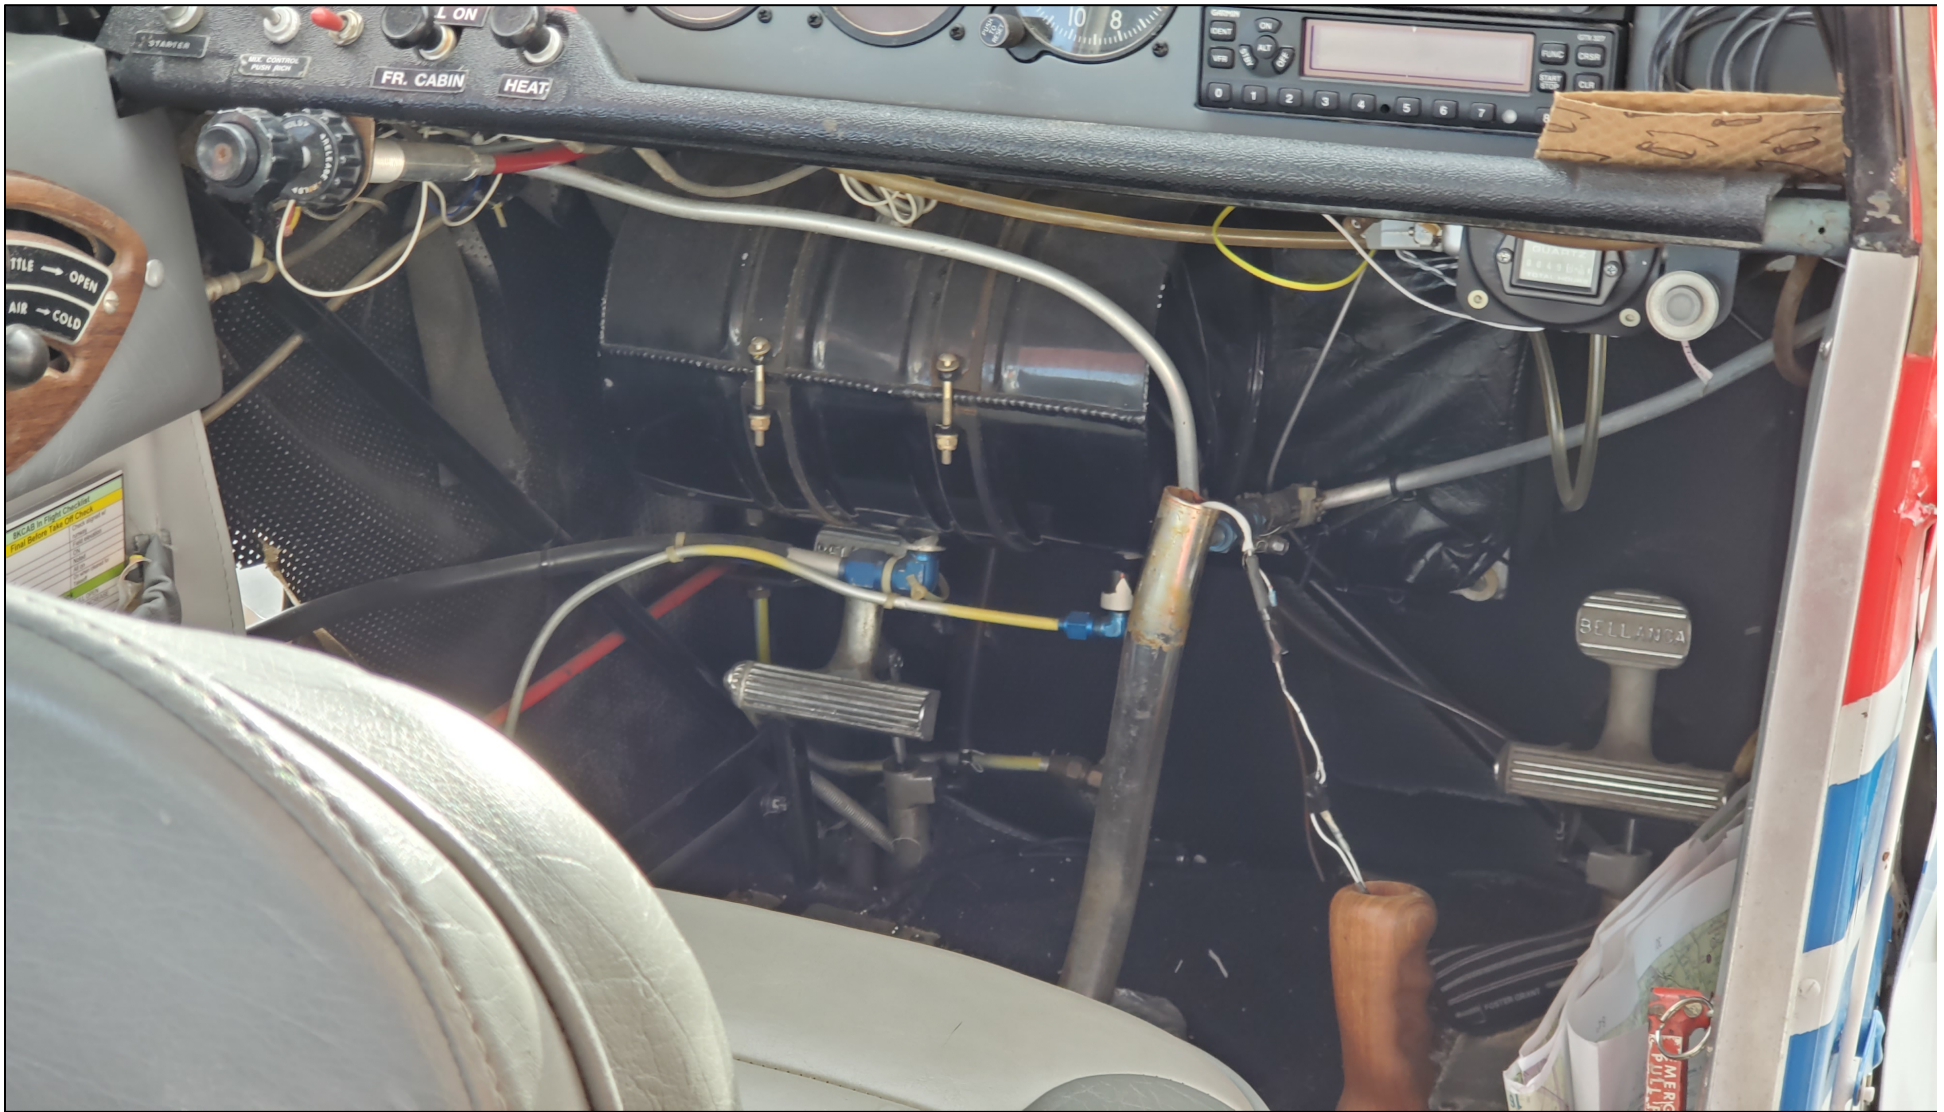
**Photo 3 – Cabin area, with wood grip separated from control column.**

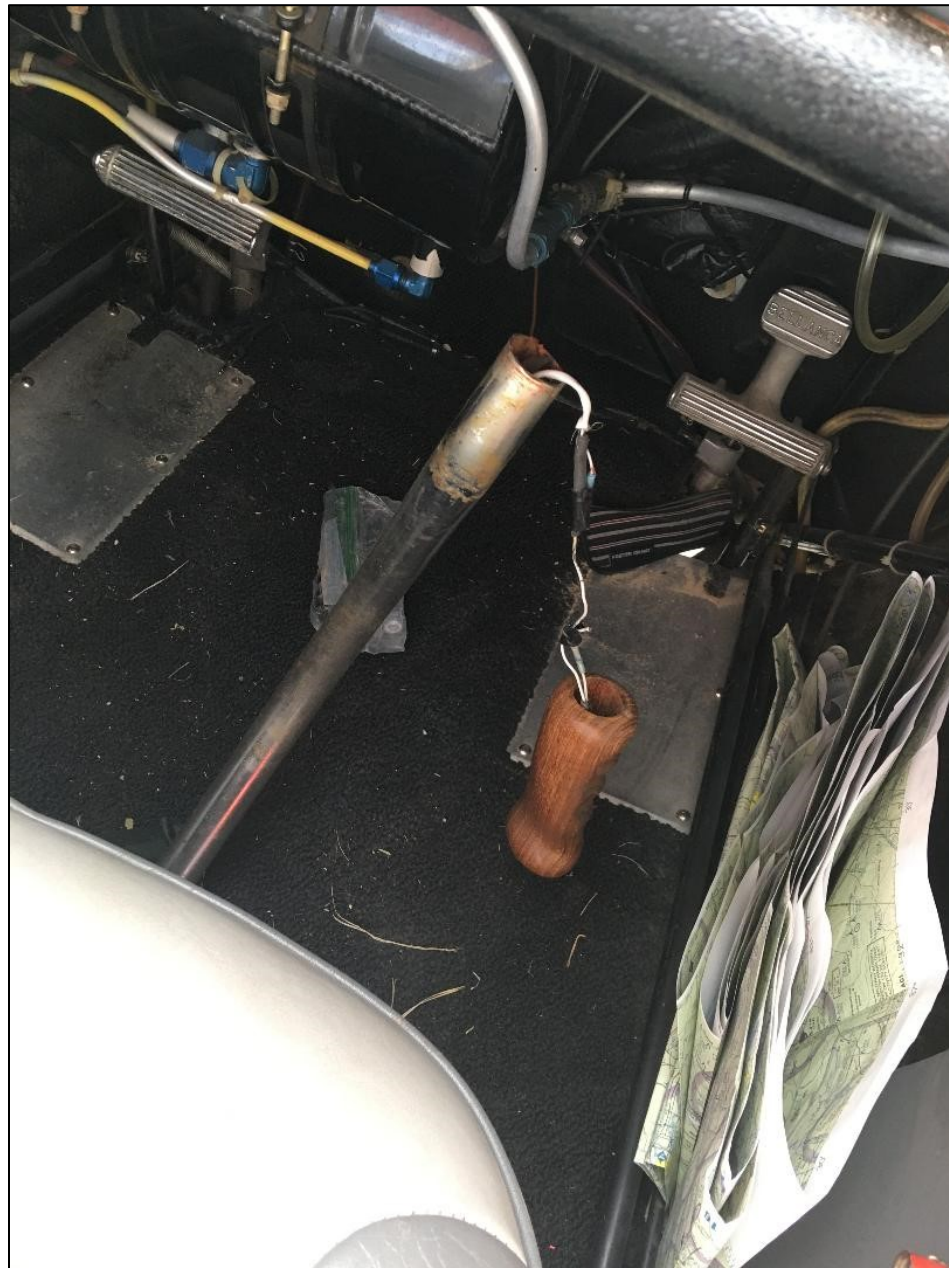
**Photo 4 - Cabin area, with wood grip separated from control column.**
