# NATIONAL TRANSPORTATION SAFETY BOARD

MATERIALS LABORATORY FACTUAL REPORT

Report No. 21-096

Place : Las Vegas, Nevada  
Date : October 29, 2020  
Vehicle : Cessna 310R, N101G  
NTSB No. : WPR21LA030  
Investigator : Maja Smith, ASI-WPR

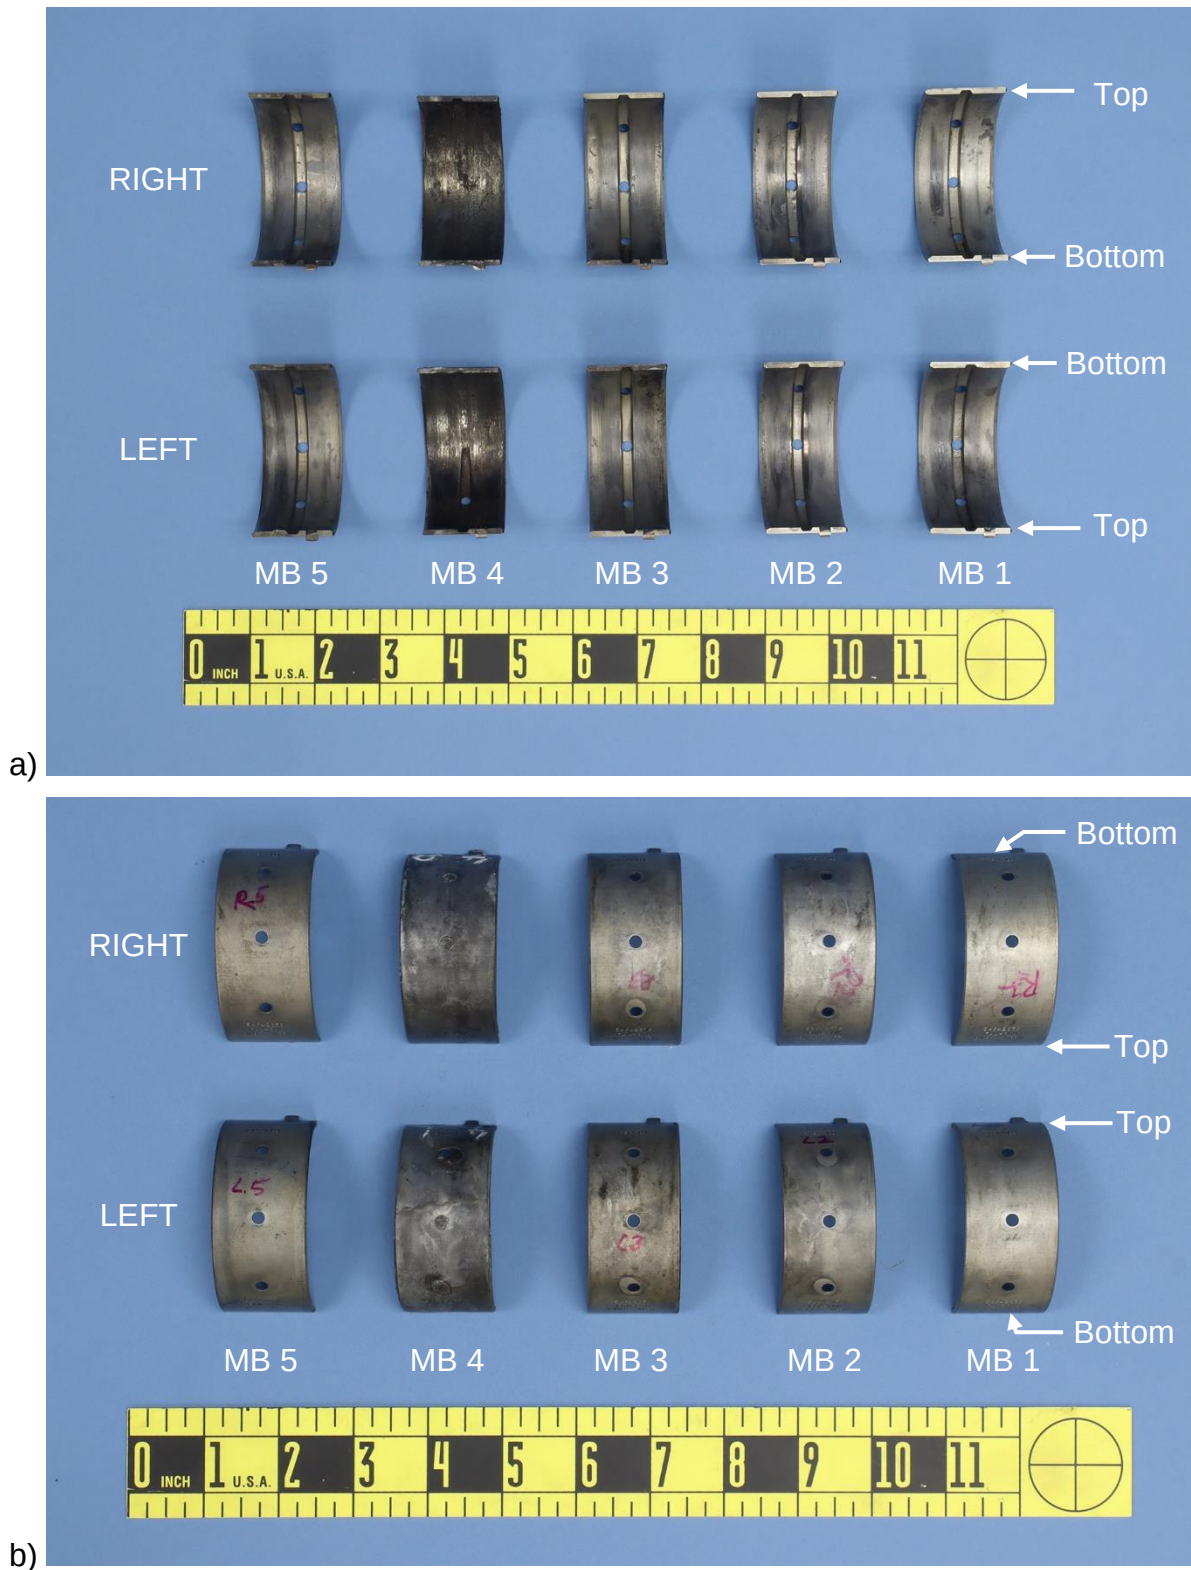
**Figure 1:** Main bearing inserts 1 through 5 – a) journal-bearing side and b) crankcase-facing backside.

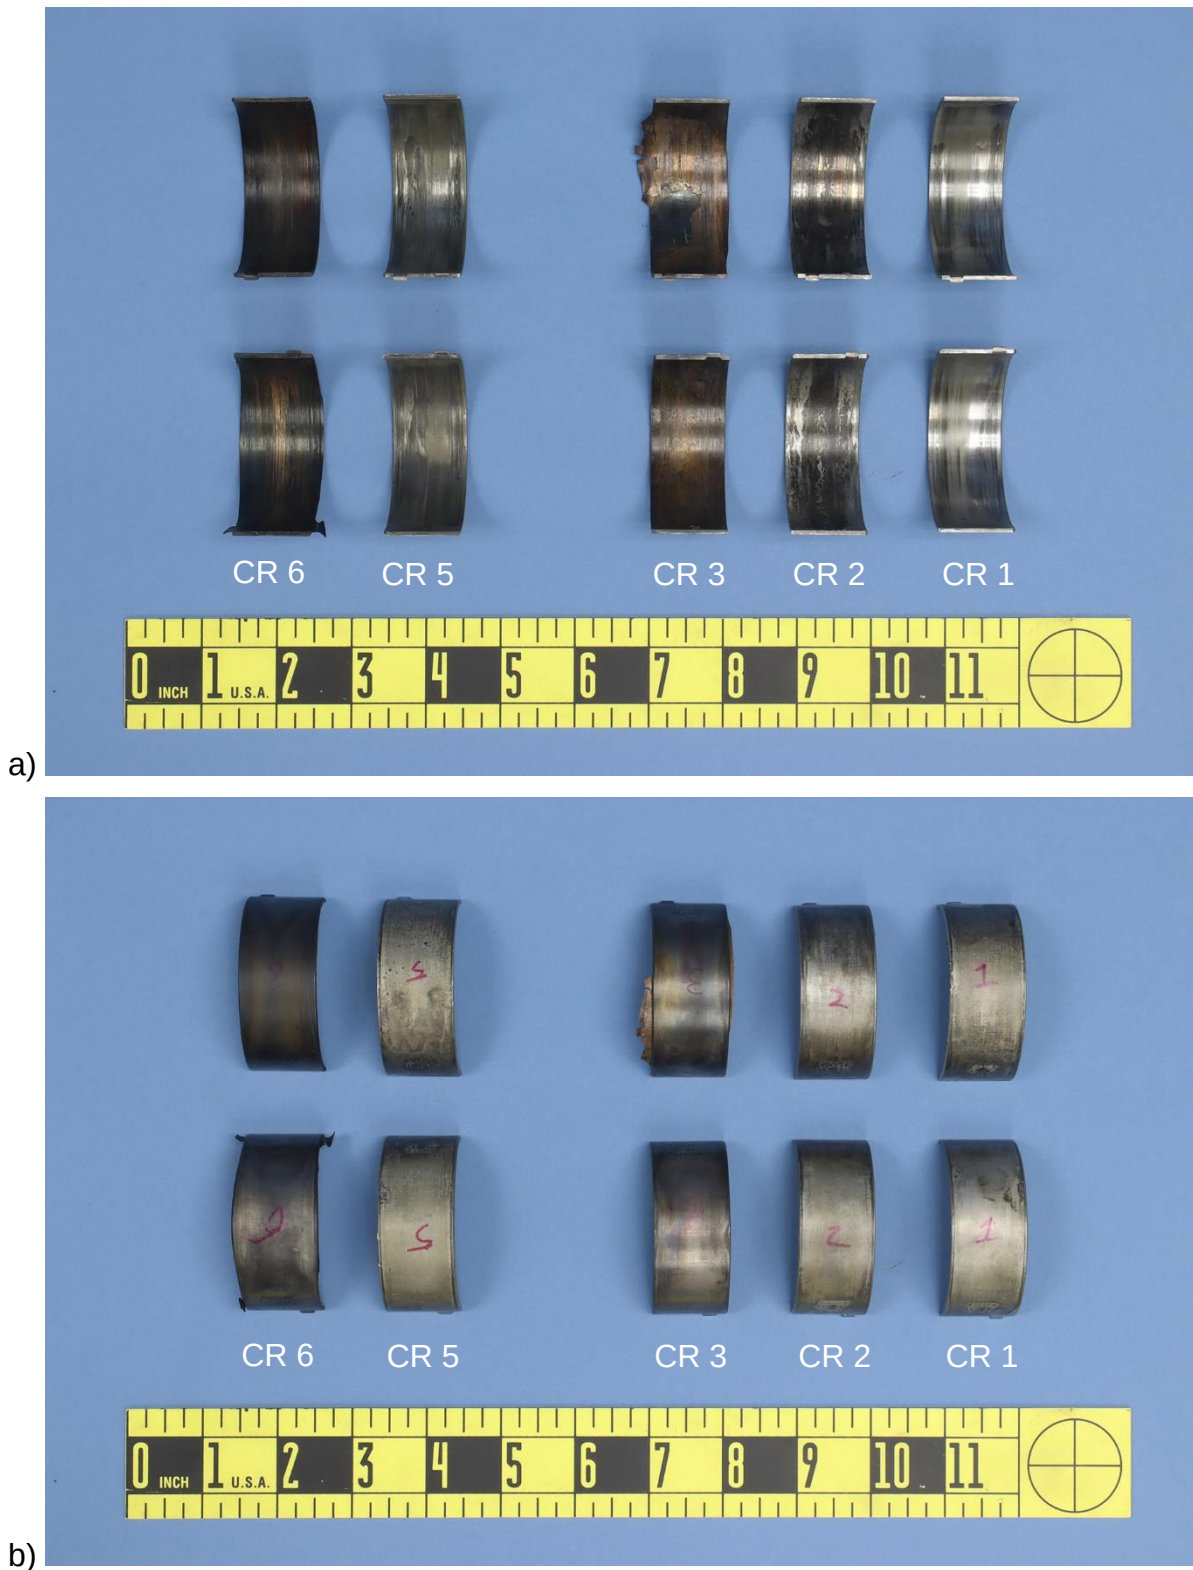
Figure 2: Connecting rod bearing inserts 1, 2, 3, 5, and 6 – a) journal-bearing side and b) backside.

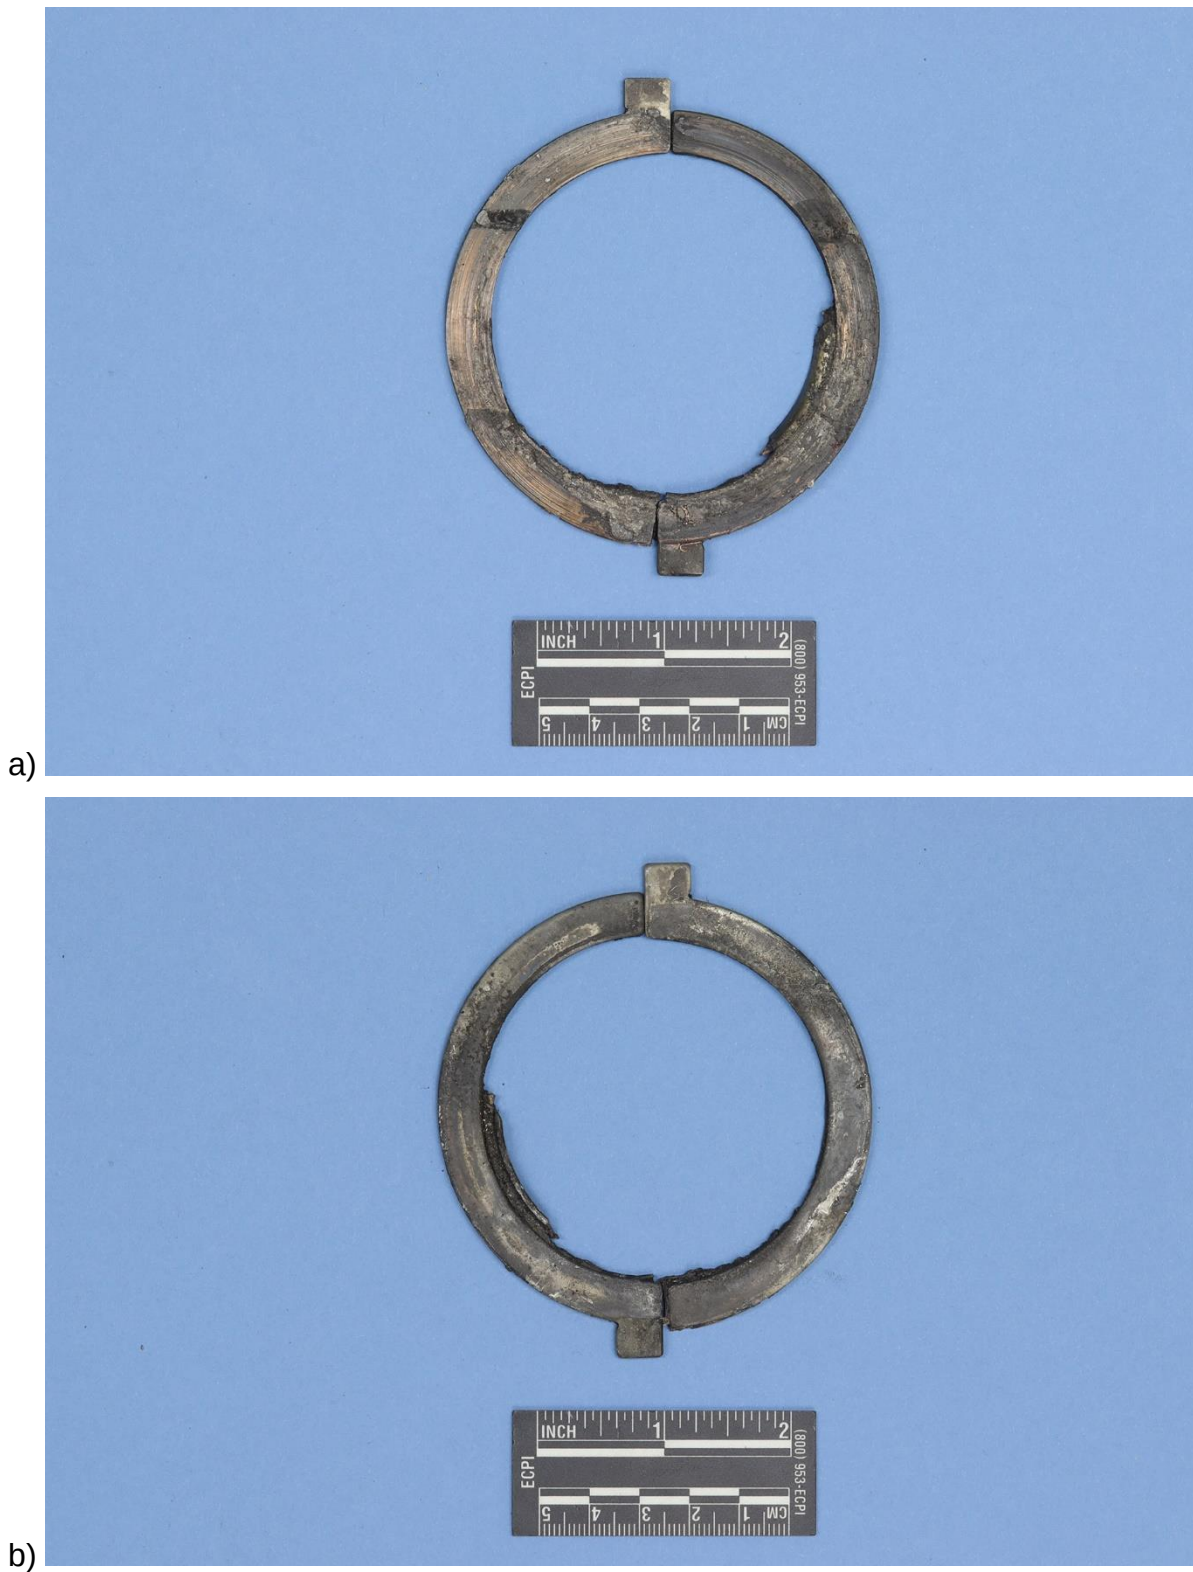
**Figure 3:** Thrust bearing aft of number 4 main bearing –a) Aft looking forward b) forward looking aft.

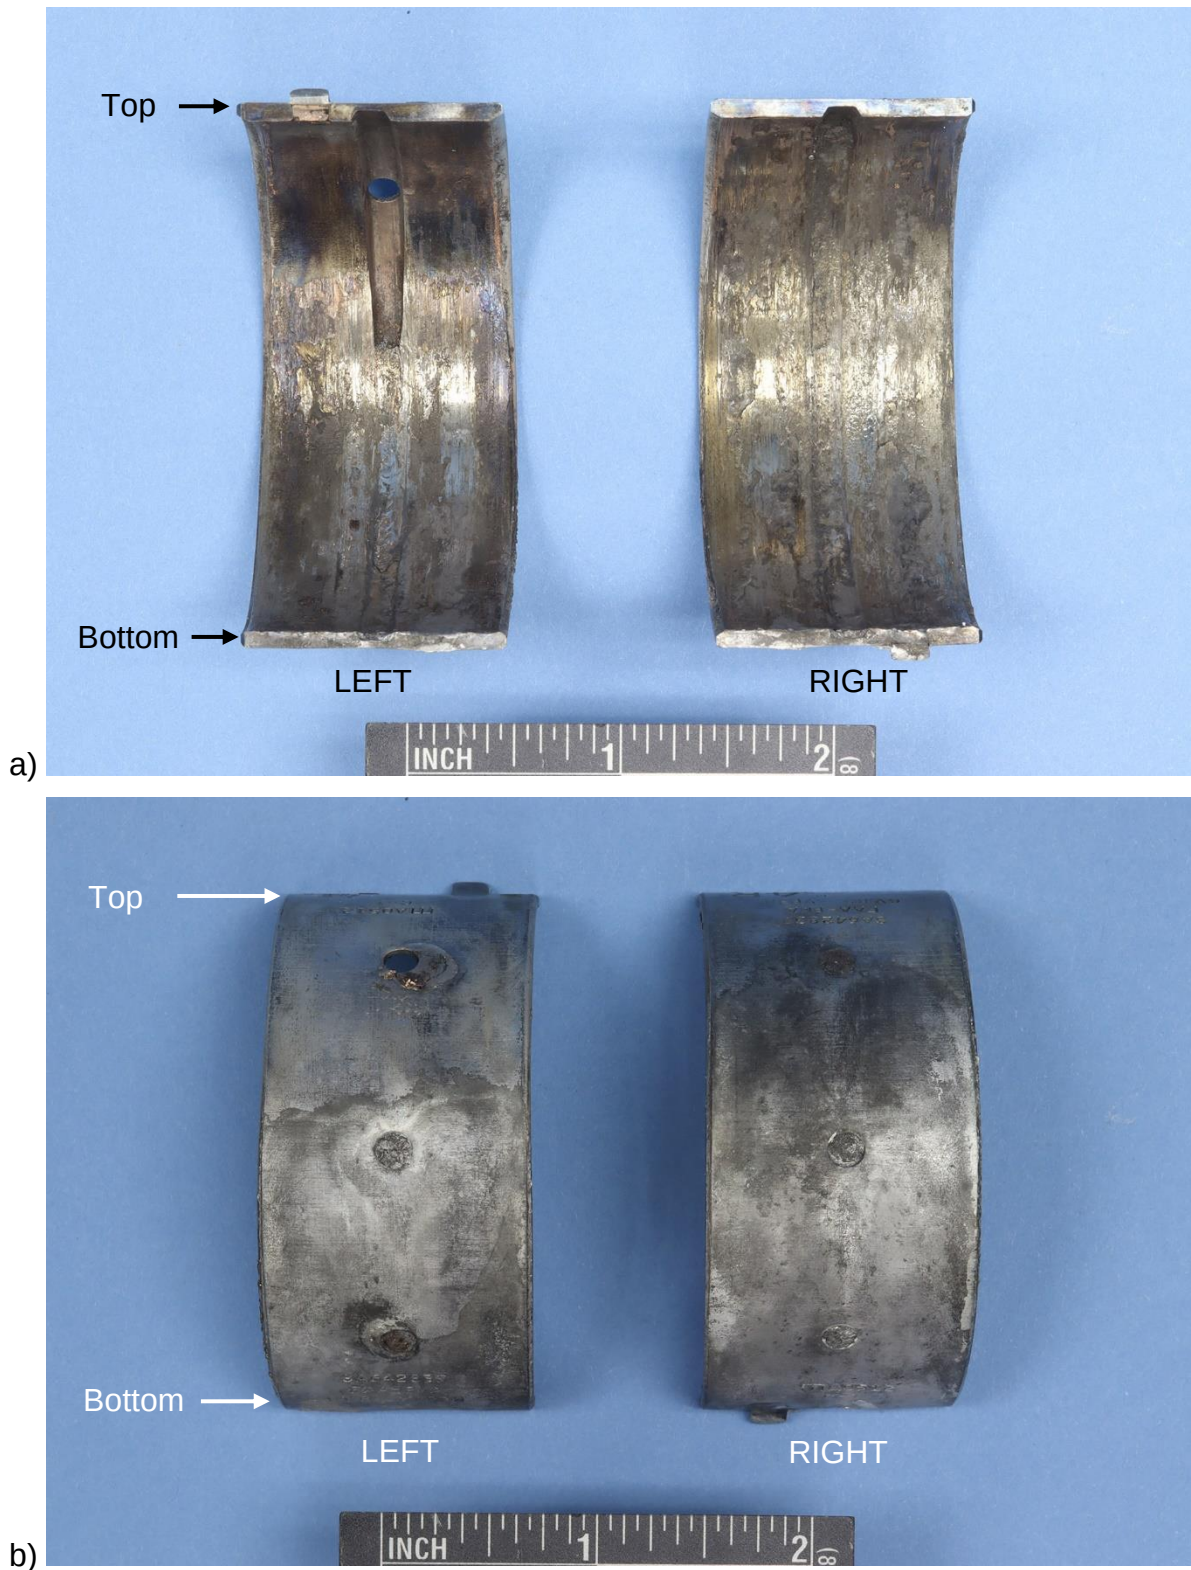
Several of the inserts exhibited features consistent with heat exposure. The number 4 main bearing inserts were comparatively dark as were the numbers 3 and 6 connecting rod bearing inserts. The number 4 main bearing inserts exhibited heavy rubbing damage and removal of the babbitt on the bearing face. Metal had filled in much of the bearing groove, as seen in figure 4, obstructing five of the six oil through-holes. One each of the numbers 3 and 6 connecting rod inserts exhibited plastic deformation, extruding in the forward and aft directions.

**Figure 4:** Number 4 main bearing inserts – a) journal-bearing sides and b) crankcase-facing backsides.

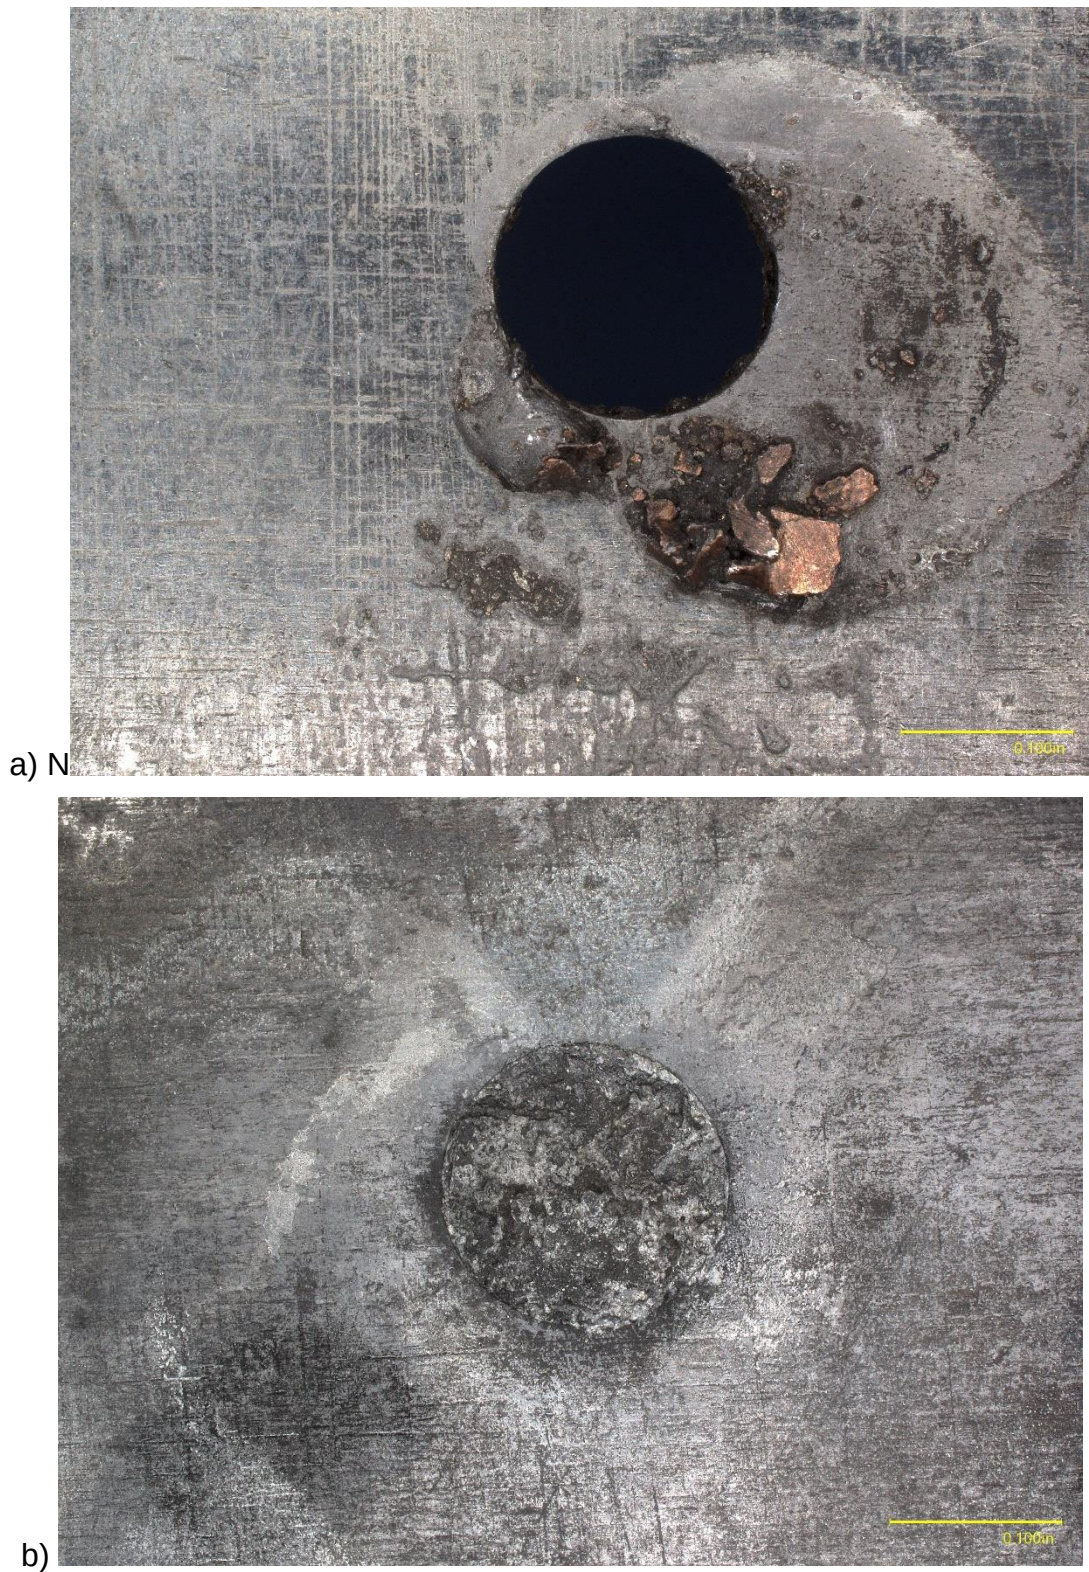
The material in and around the oil through-holes was examined in greater detail by optical microscopy and scanning electron microscopy (SEM). Higher magnification images of the through holes on the number 4 main bearing left insert are shown in figures 5a – c. The uppermost hole, shown in figure 5a, exhibited a piece of melted and resolidified metal and copper-colored metal flakes adjacent to the hole. The two features were examined by an SEM equipped with an energy-dispersive X-ray spectrometer (EDS) and were determined to contain primarily lead/tin and copper, respectively, consistent with babbitt metal and backing material, respectively (not shown). The middle hole was obstructed by a gray-colored material, as shown in figure 5b. The material was examined by SEM/EDS and was determined to be composed primarily of aluminum (Al) and silicon (Si) with additional contributions from iron (Fe), copper (Cu), chromium (Cr) and nickel (Ni), as shown in figure 6a. The lower hole was obstructed by a gray-colored material over approximately 1/3 of the hole and the remainder was obstructed by a bronze-colored material. The bronze-colored region was examined by EDS and exhibited primarily Fe and Cu, as shown in figure 6b. The gray-colored region exhibited an EDS spectrum similar to that shown in figure 6a.

**Figure 5:** Oil through-holes in the number 4 left main bearing insert – a) upper hole showing solidified metal and babbitt backing material; b) middle hole – blocked;

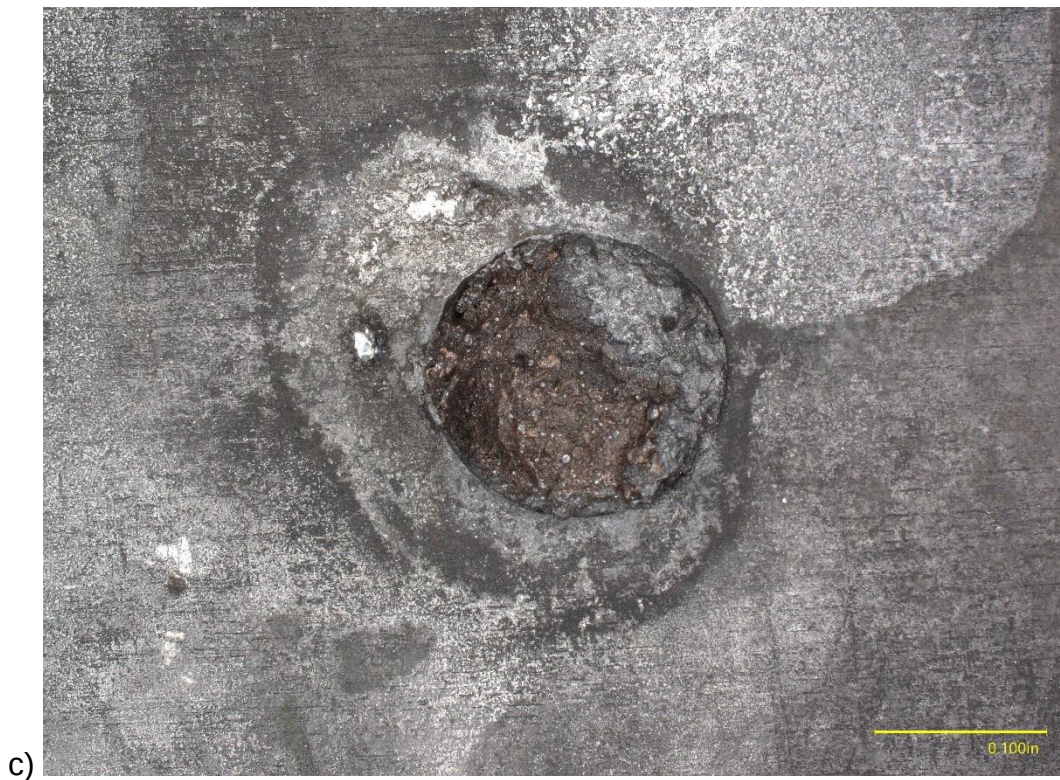
**Figure 5 (cont.):** c) lower hole – blocked.

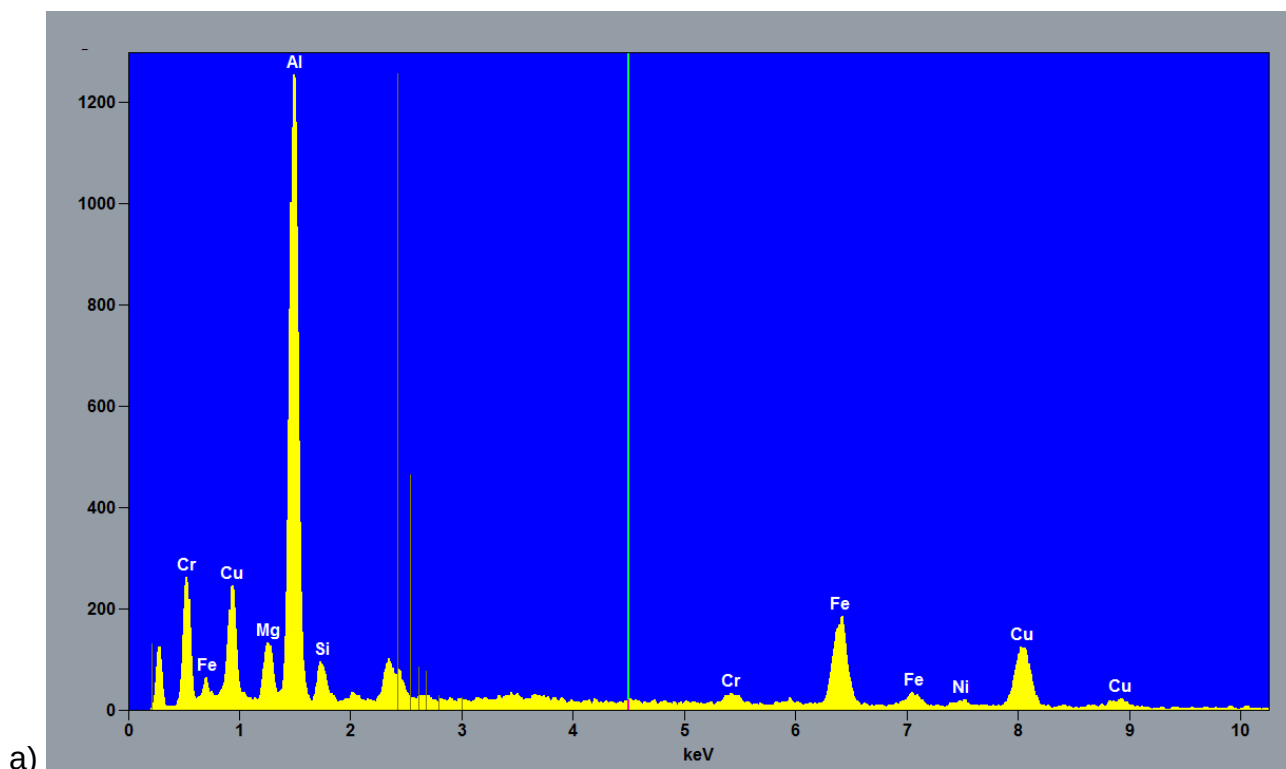
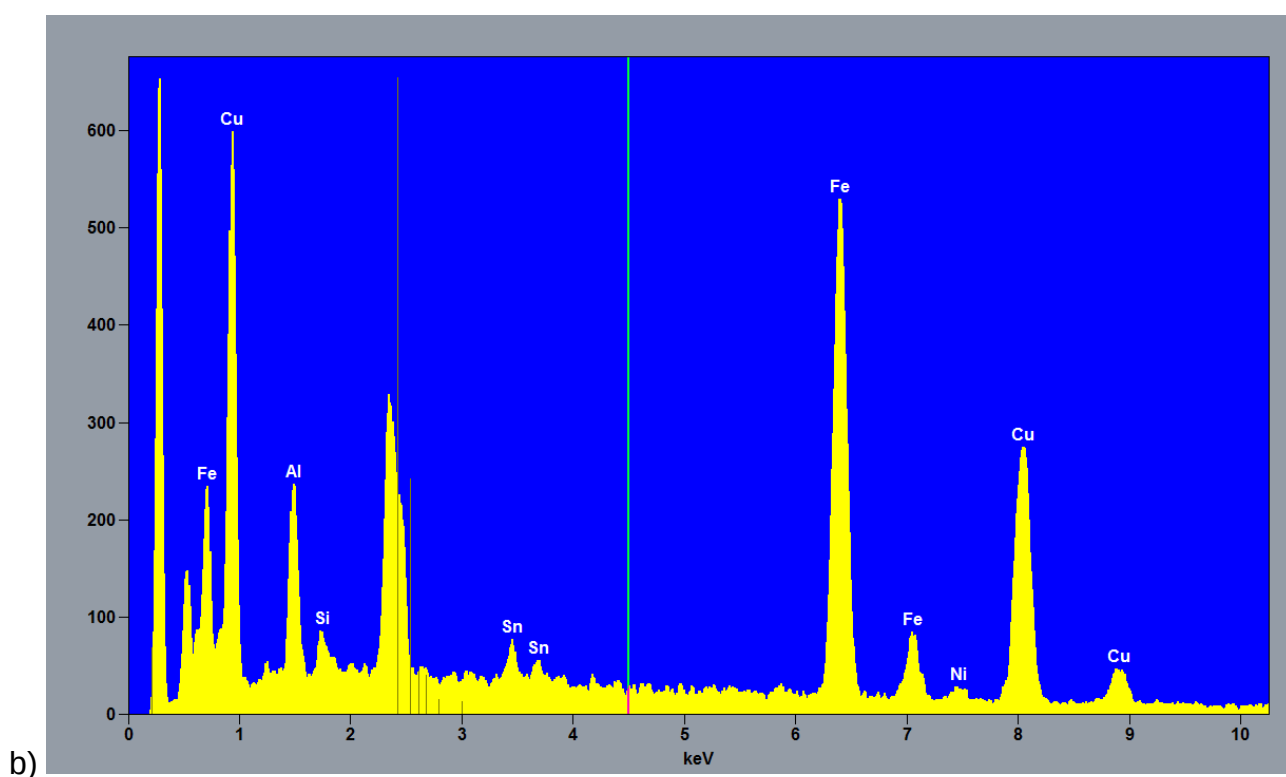
**Figure 6:** EDS spectra from the number 4 main bearing left insert – a) the blocked middle hole and b) the blocked lower hole.

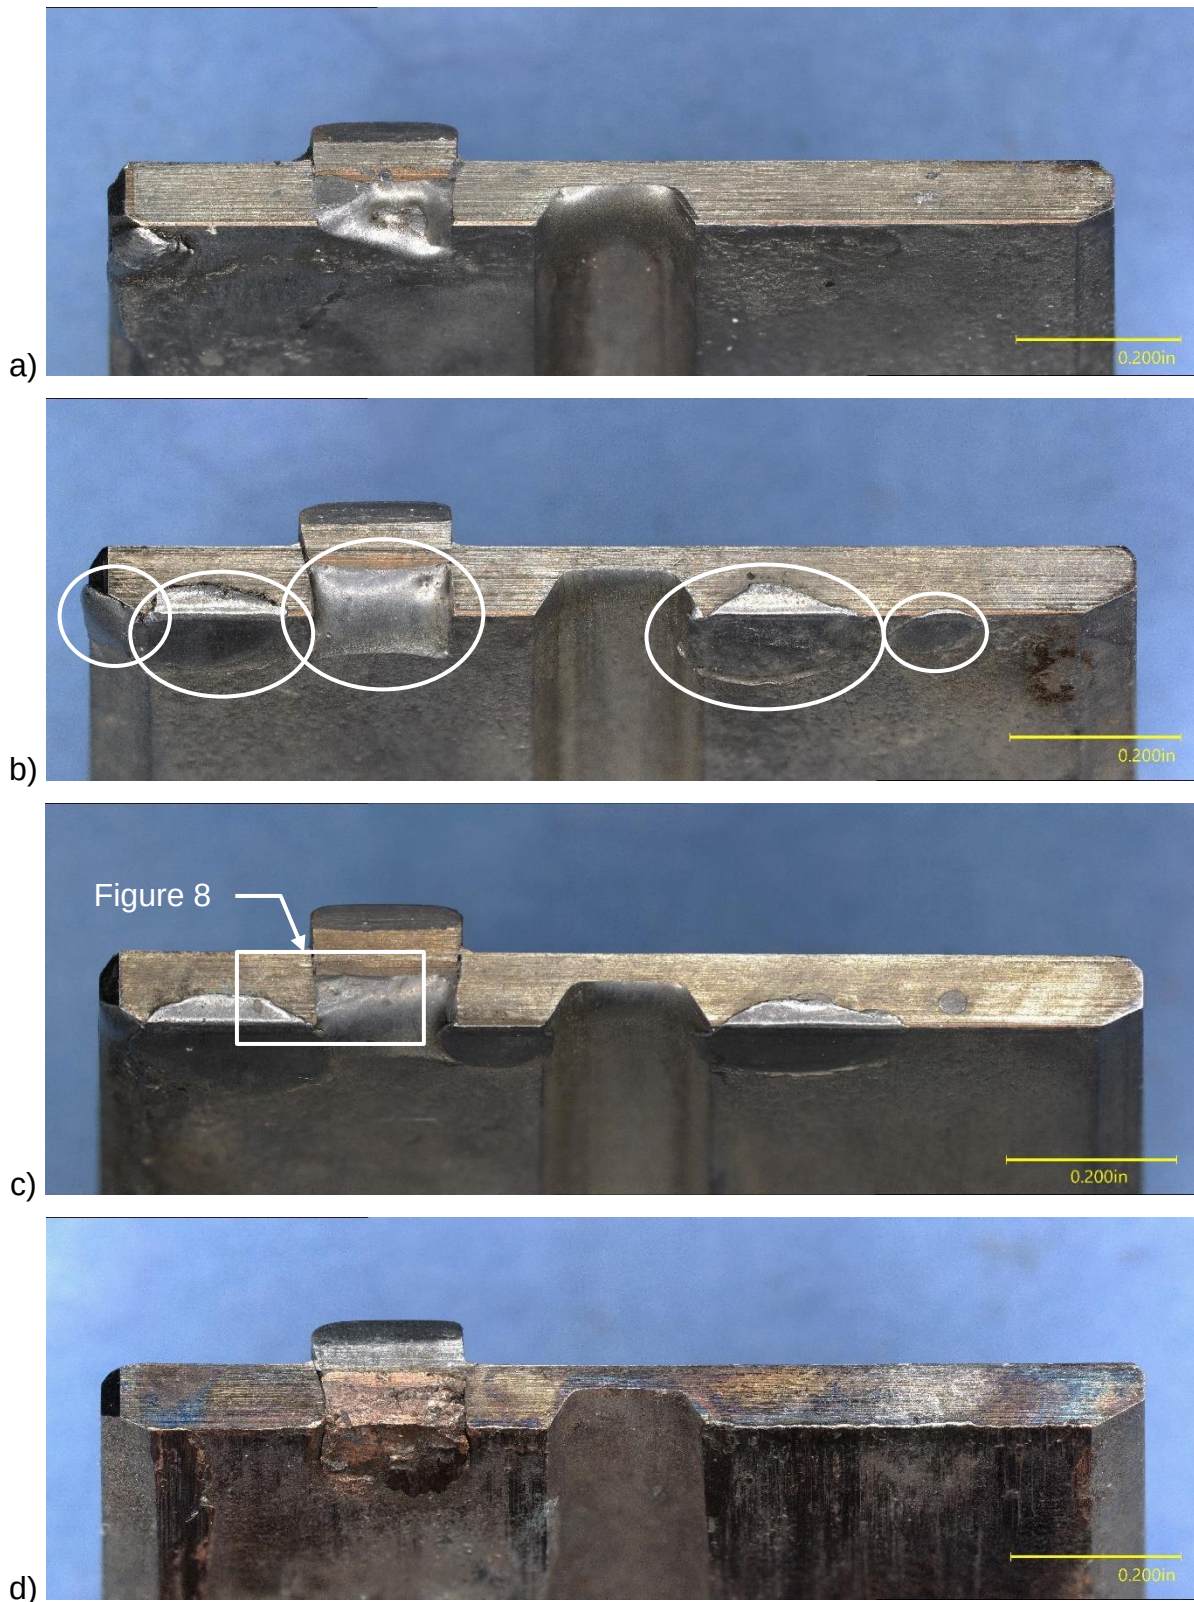
All of the main bearing left inserts exhibited features consistent with melted and resolidified metal near the insert end face, as shown in figures 7a – e for bearings 1 through 5, respectively. A silver-colored metal had pooled and solidified in the recess beneath the tang, in the groove, and on the bearing face, as indicated for insert number 2 in figure 7b. The composition of the metal was examined by EDS, as shown in figures 8a and b. The metal consisted primarily of lead (Pb) with additional amount of tin (Sn), and copper (Cu). A semi-quantitative method used to estimate the composition of the metal indicated that it was approximately 82% lead, 9% tin, and 9% copper. The results were most consistent with the material used for the babbitt layer.

**Figure 7:** Upper end of main bearing left inserts showing presence of melted and resolidified metal – a) number 1; b) number 2; c) number 3; d) number 4; and

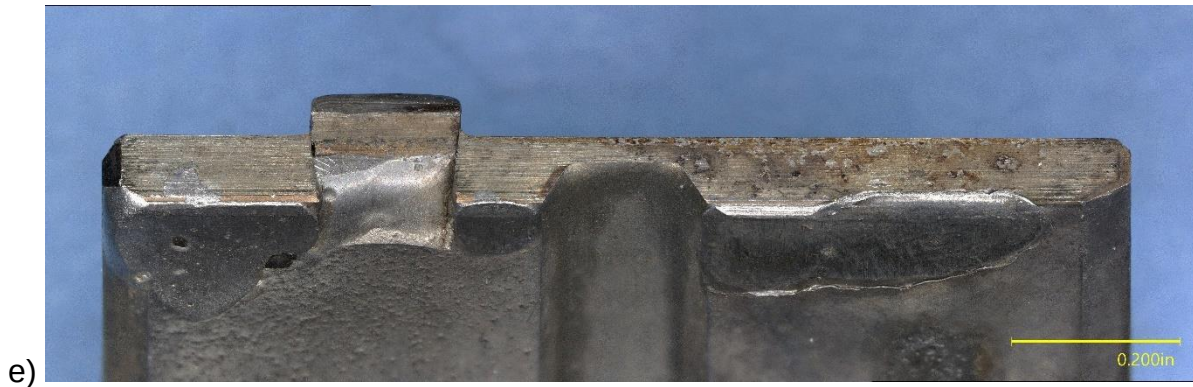
**Figure 7 (cont): e) number 5.**

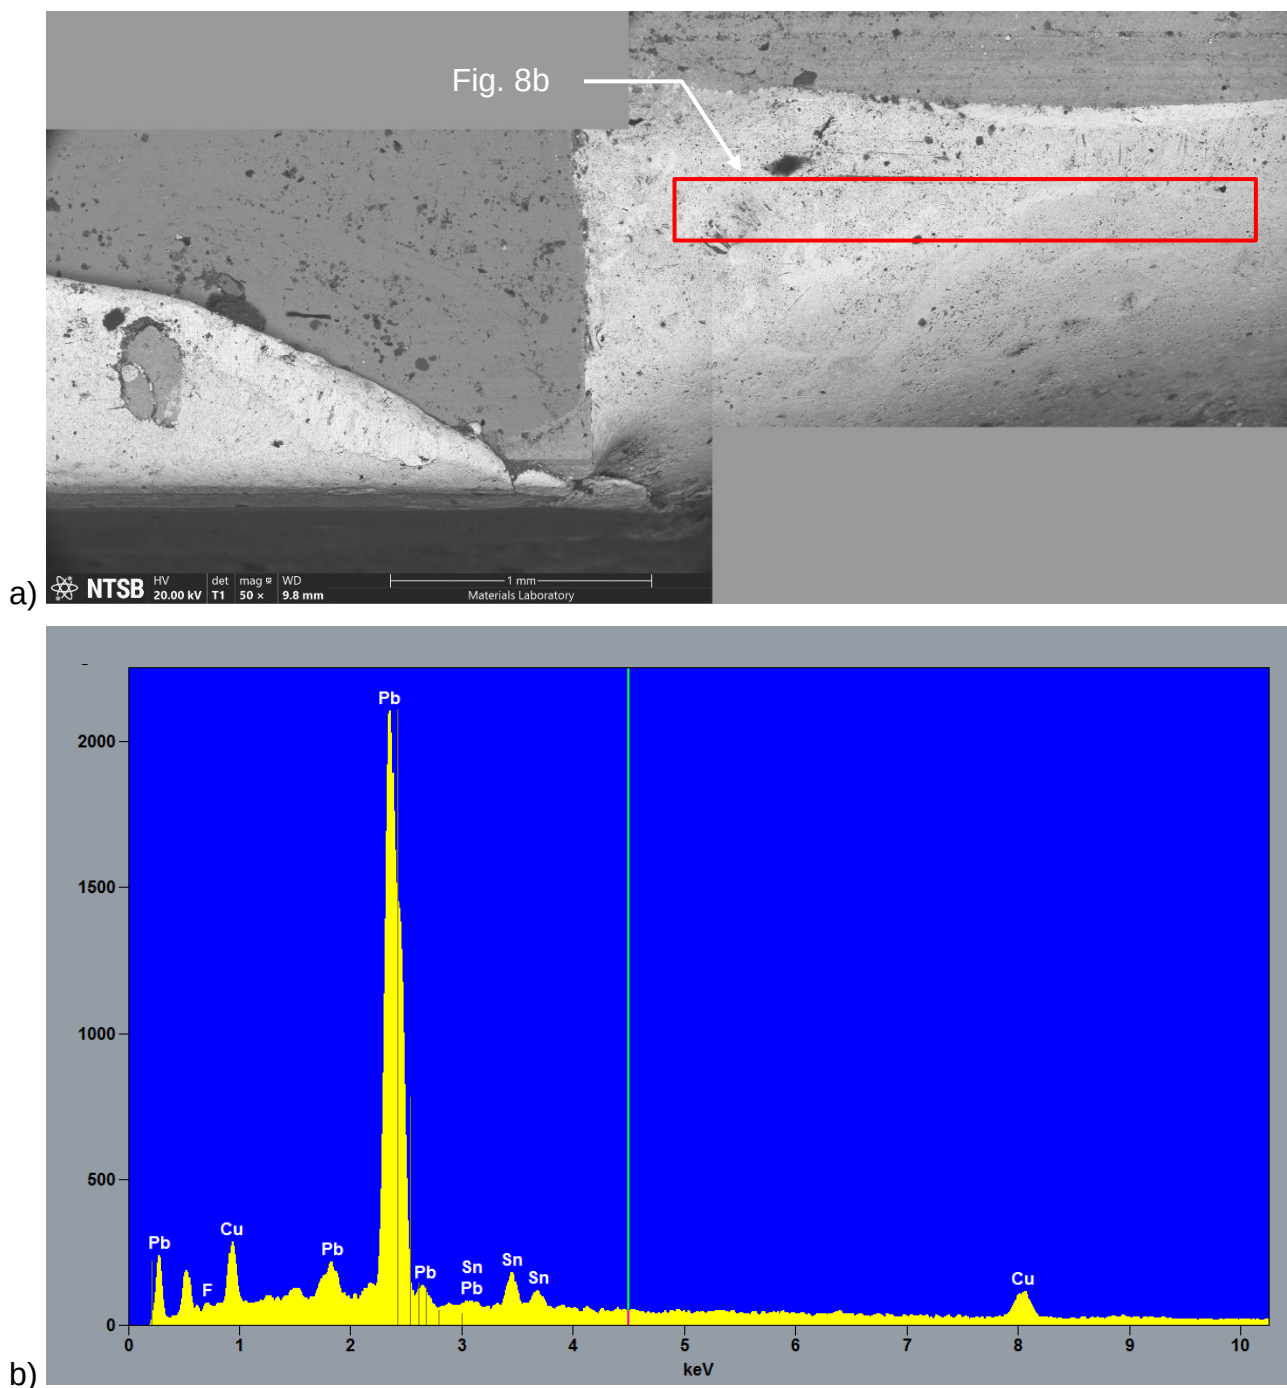
**Figure 8:** a) SEM image of the number 3 main bearing left insert near the tang where metal had resolidified and b) EDS spectrum of the resolidified metal showing lead (Pb), tin (Sn), and copper (Cu), consistent with the babbitt metal.
