**National Transportation Safety Board**  
Office of Research and Engineering  
Washington, D.C. 20594

## Airplane Performance Study

**Location:** Billings, Montana  
**Date:** October 30, 2020  
**Time:** 0105 GMT (1905 MDT)  
**Airplane:** Cessna 172M Skyhawk, N124TW  
**NTSB Number:** WPR21LA032

### **WPR21LA032, N124TW, Cessna 172M Skyhawk, October 30, 2020**

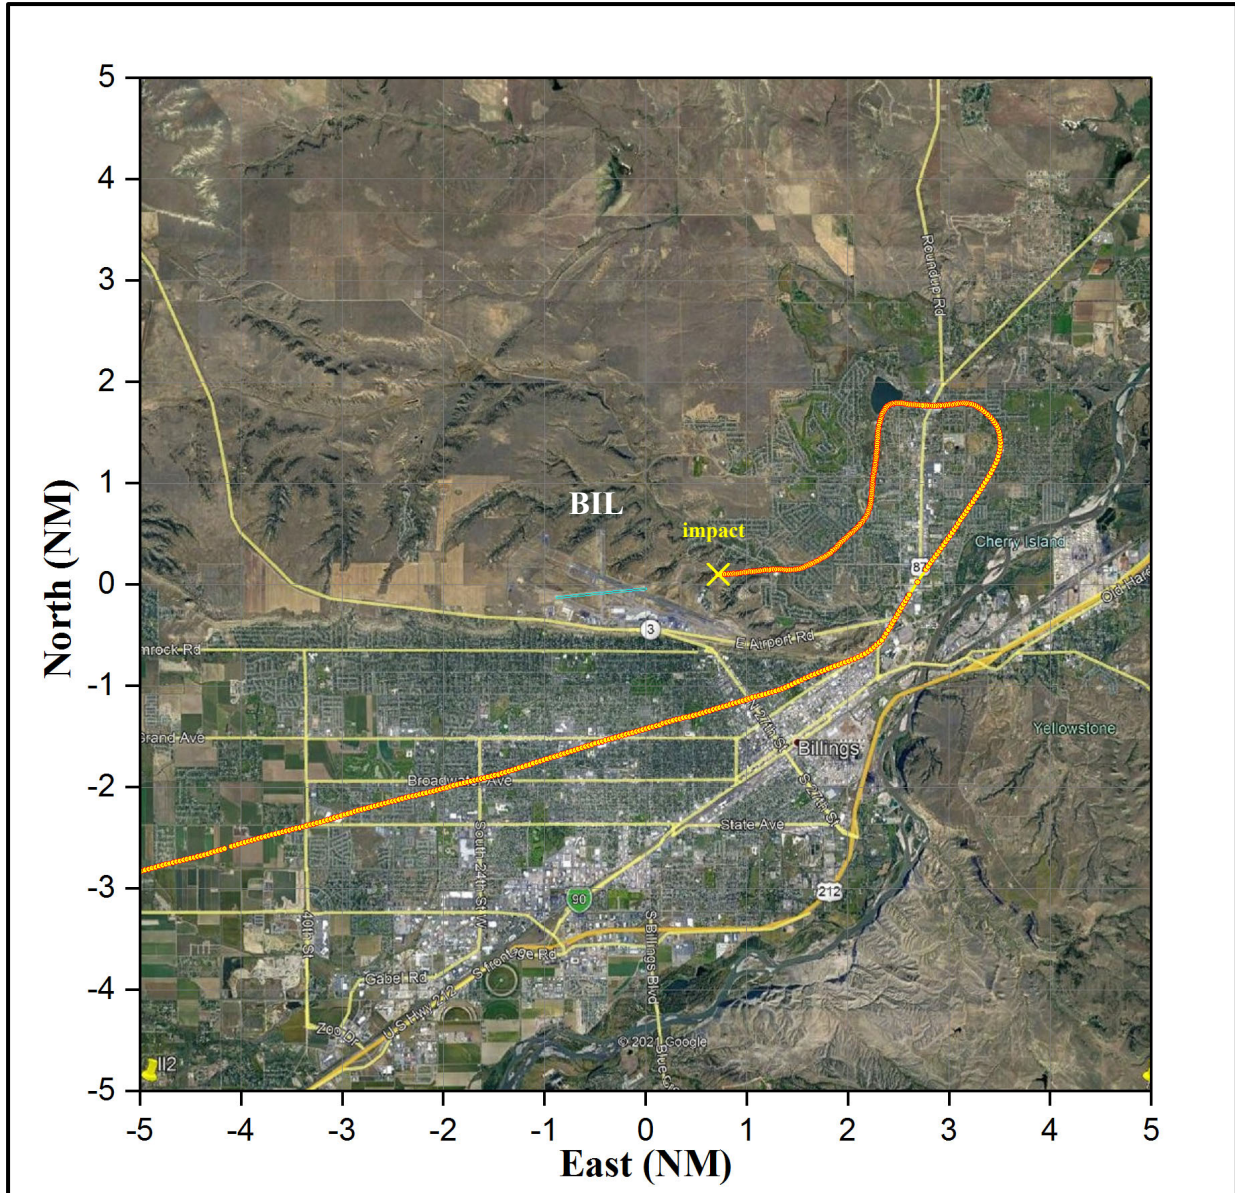
Figures 3 and 4 show the ADS-B ground track in the vicinity of the airport. The pilot reported to ATC that he was having difficulty making out the airport with other flashing lights in the area but, after some maneuvering, indicated that he had the airport in sight. The maneuvering is highlighted in Figure 3. The airplane was aligned with the runway for approximately the last nautical mile as shown in Figure 4.

Figure 3: ADS-B Ground Track (○○○) with Runway 25 (—) and Impact Site (X) Denoted

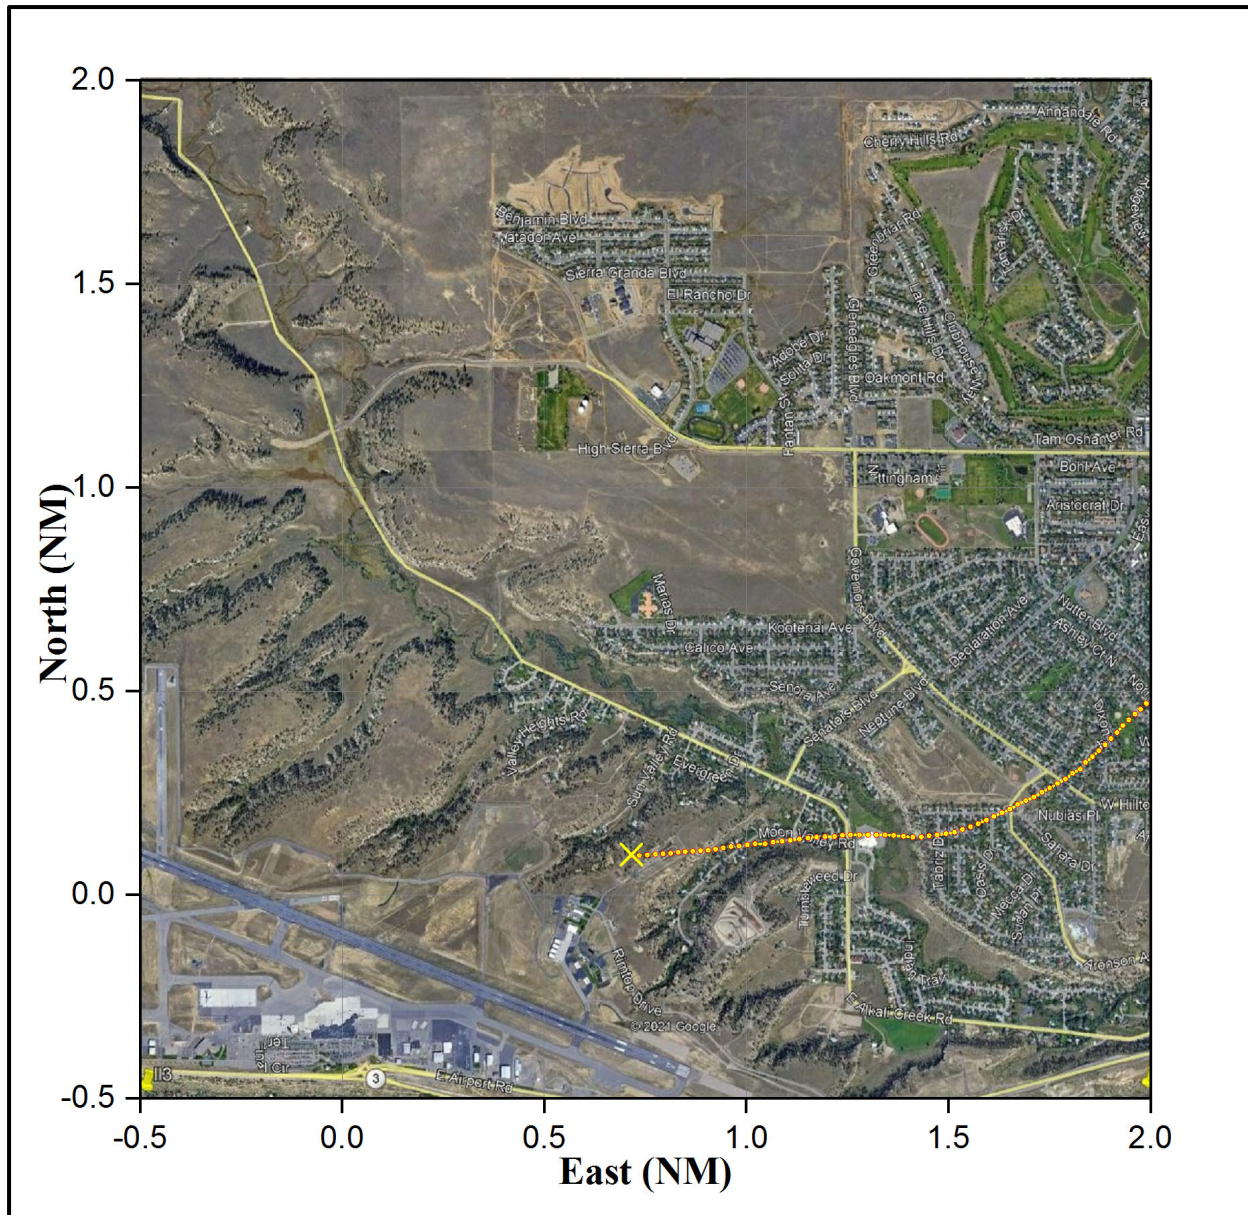
Figure 4: ADS-B Ground Track (●●●) and Impact Site (X) Closer to Airport

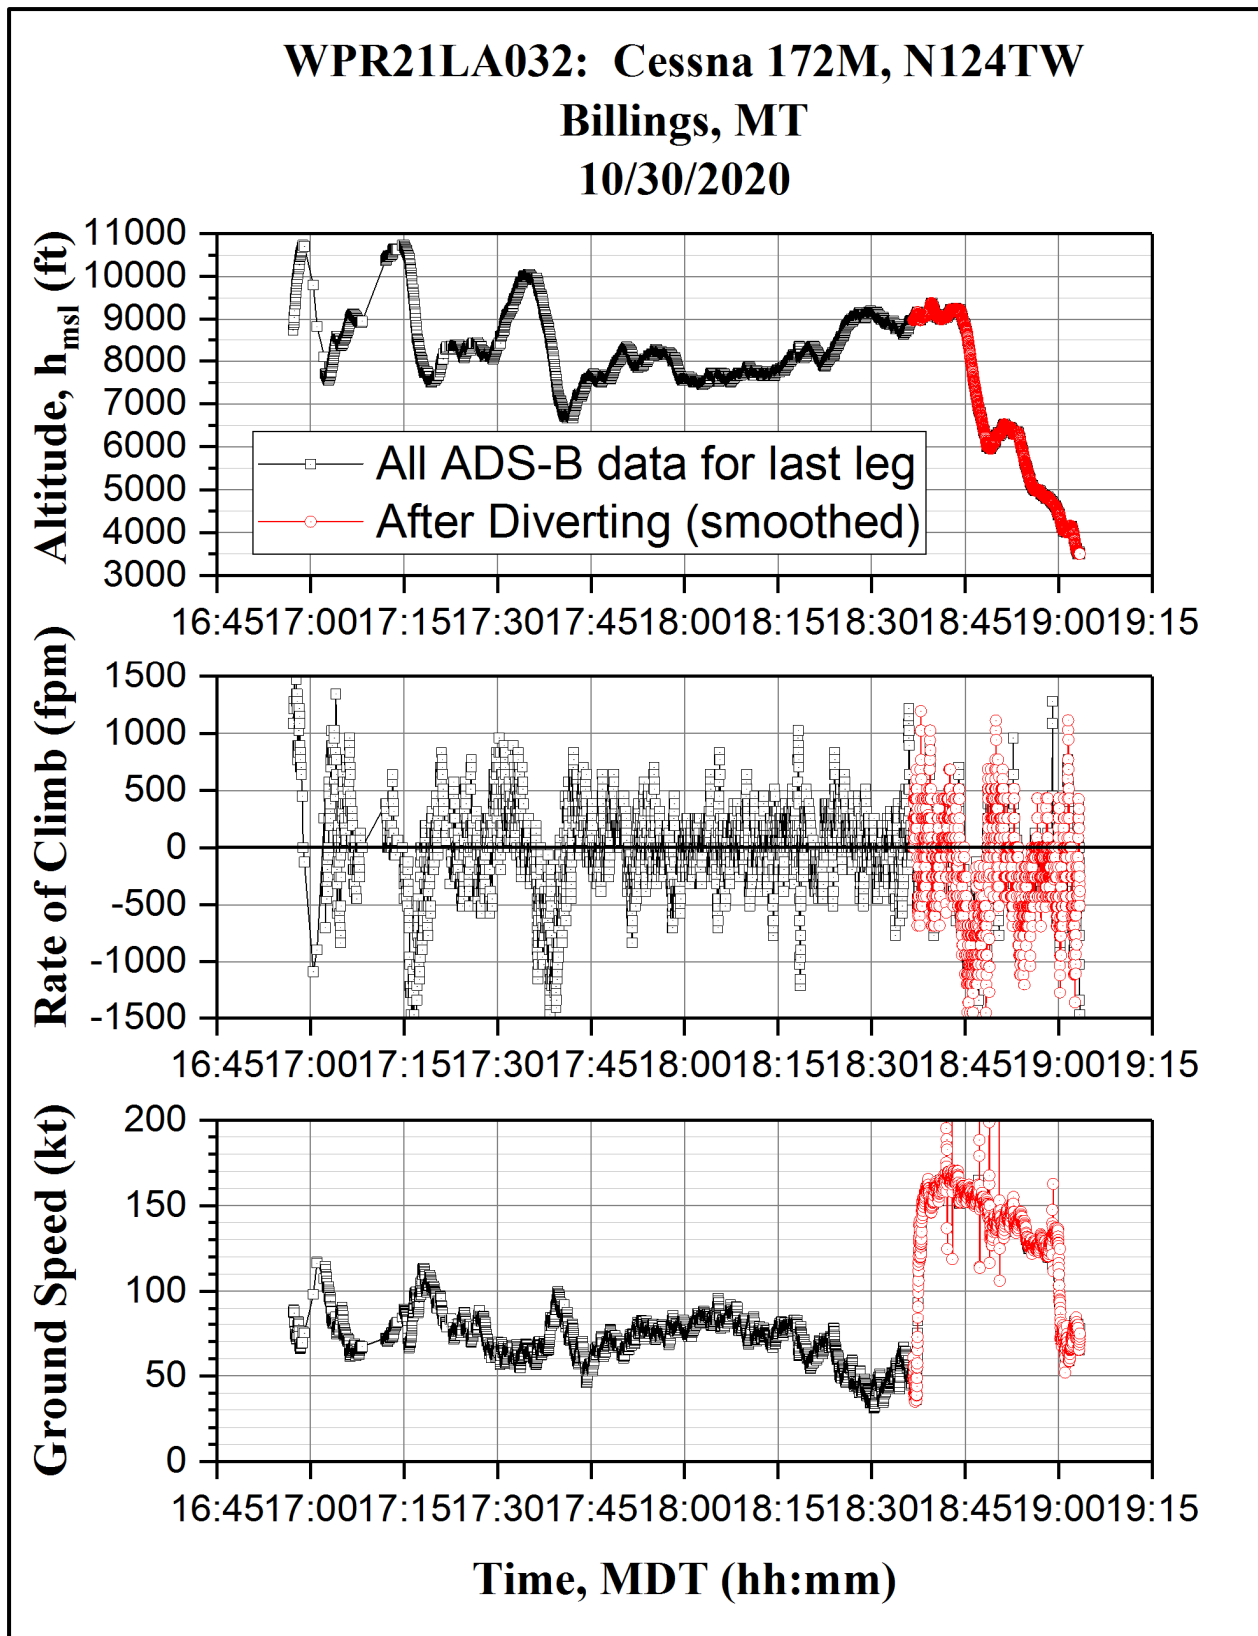
Figure 5 shows the ADS-B altitude and airspeed recorded on the two hour and six-minute flight from SHR. In addition, smoothed ADS-B data from the point the piloted diverted to BIL and that were used to estimate airplane attitude is highlighted in red. The time that elapsed from diverting until the accident was approximately 27 min.

Figure 5: All ADS-B Altitude and Ground Speed for Last Leg

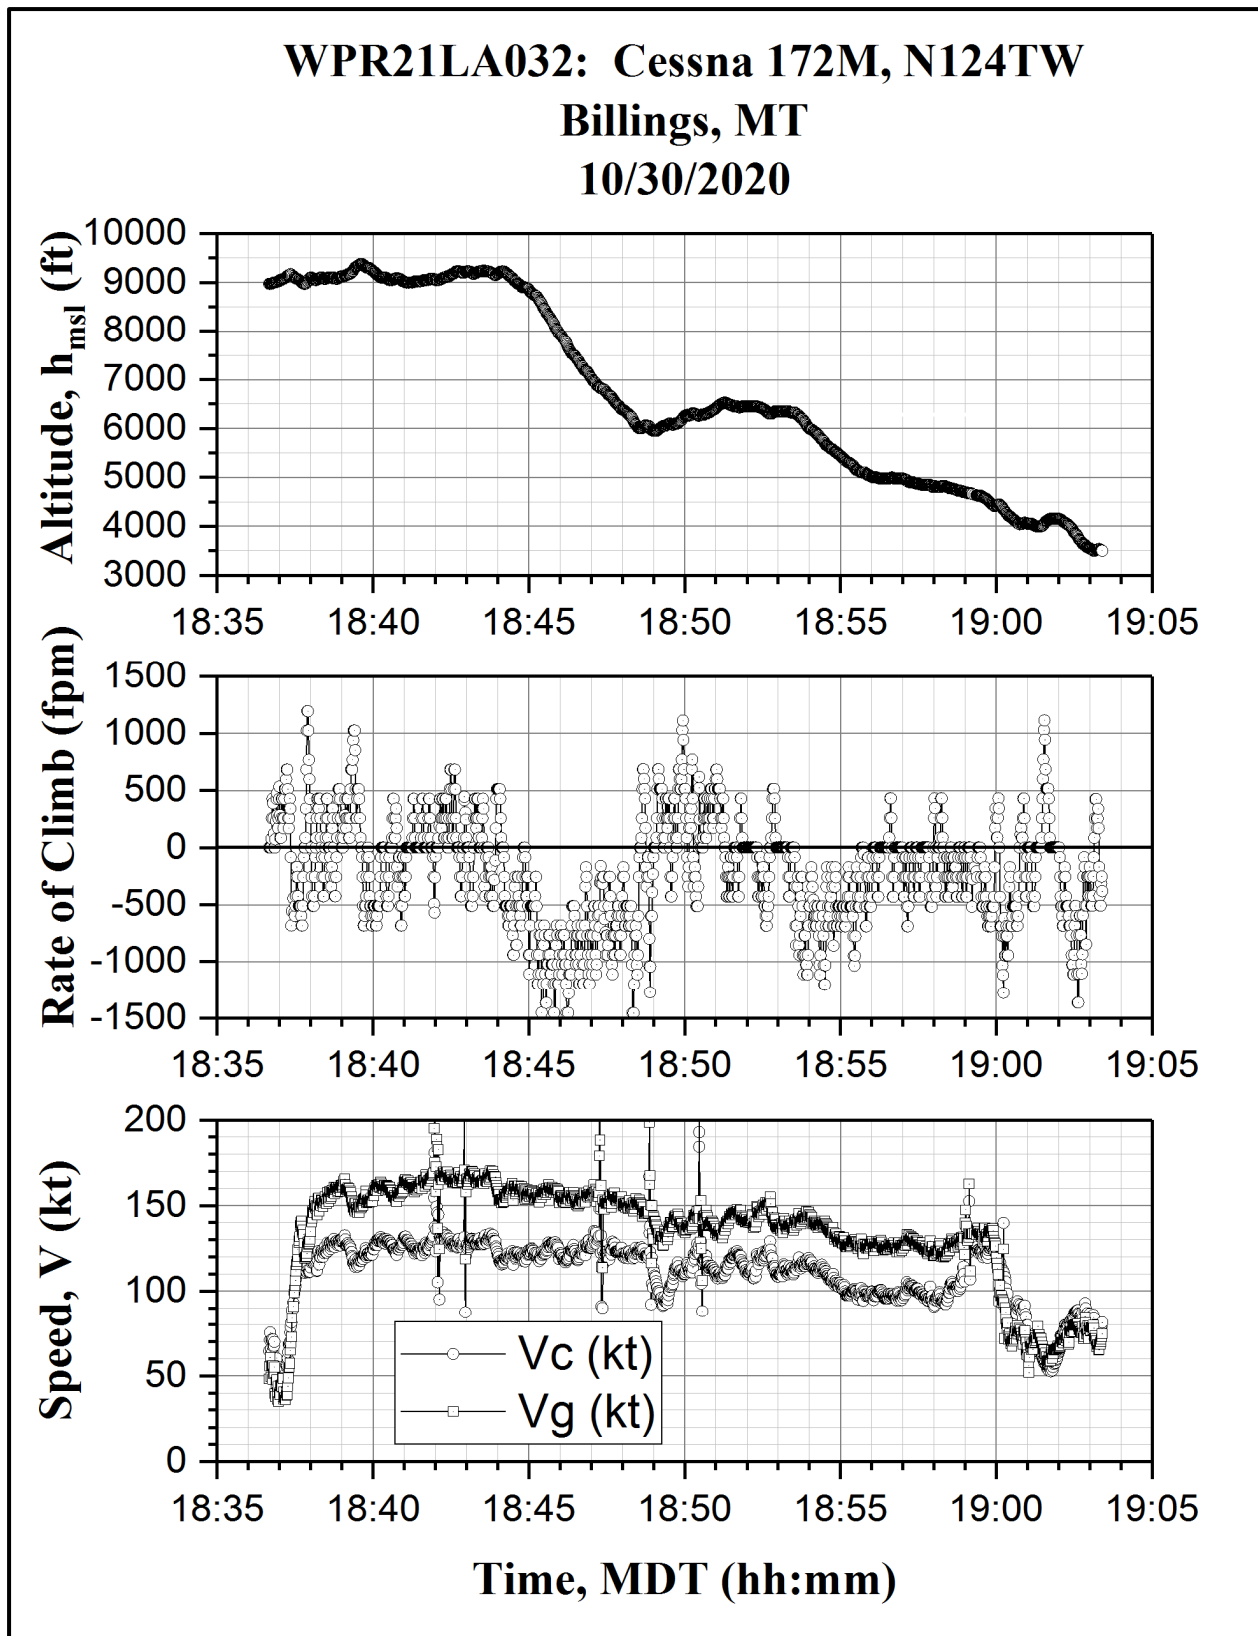
The ground speed (Vg) and calibrated airspeed (Vc) estimated from ADS-B and sounding data after the flight diverted to BIL are shown in Figure 6. The figure highlights an approximate 15 kt headwind right before diverting that transitioned to about a 30 kt tailwind after.

Figure 6: Estimated Groundspeed ( $V_g$ ) and Calibrated Airspeed ( $V_c$ ) After Diverting

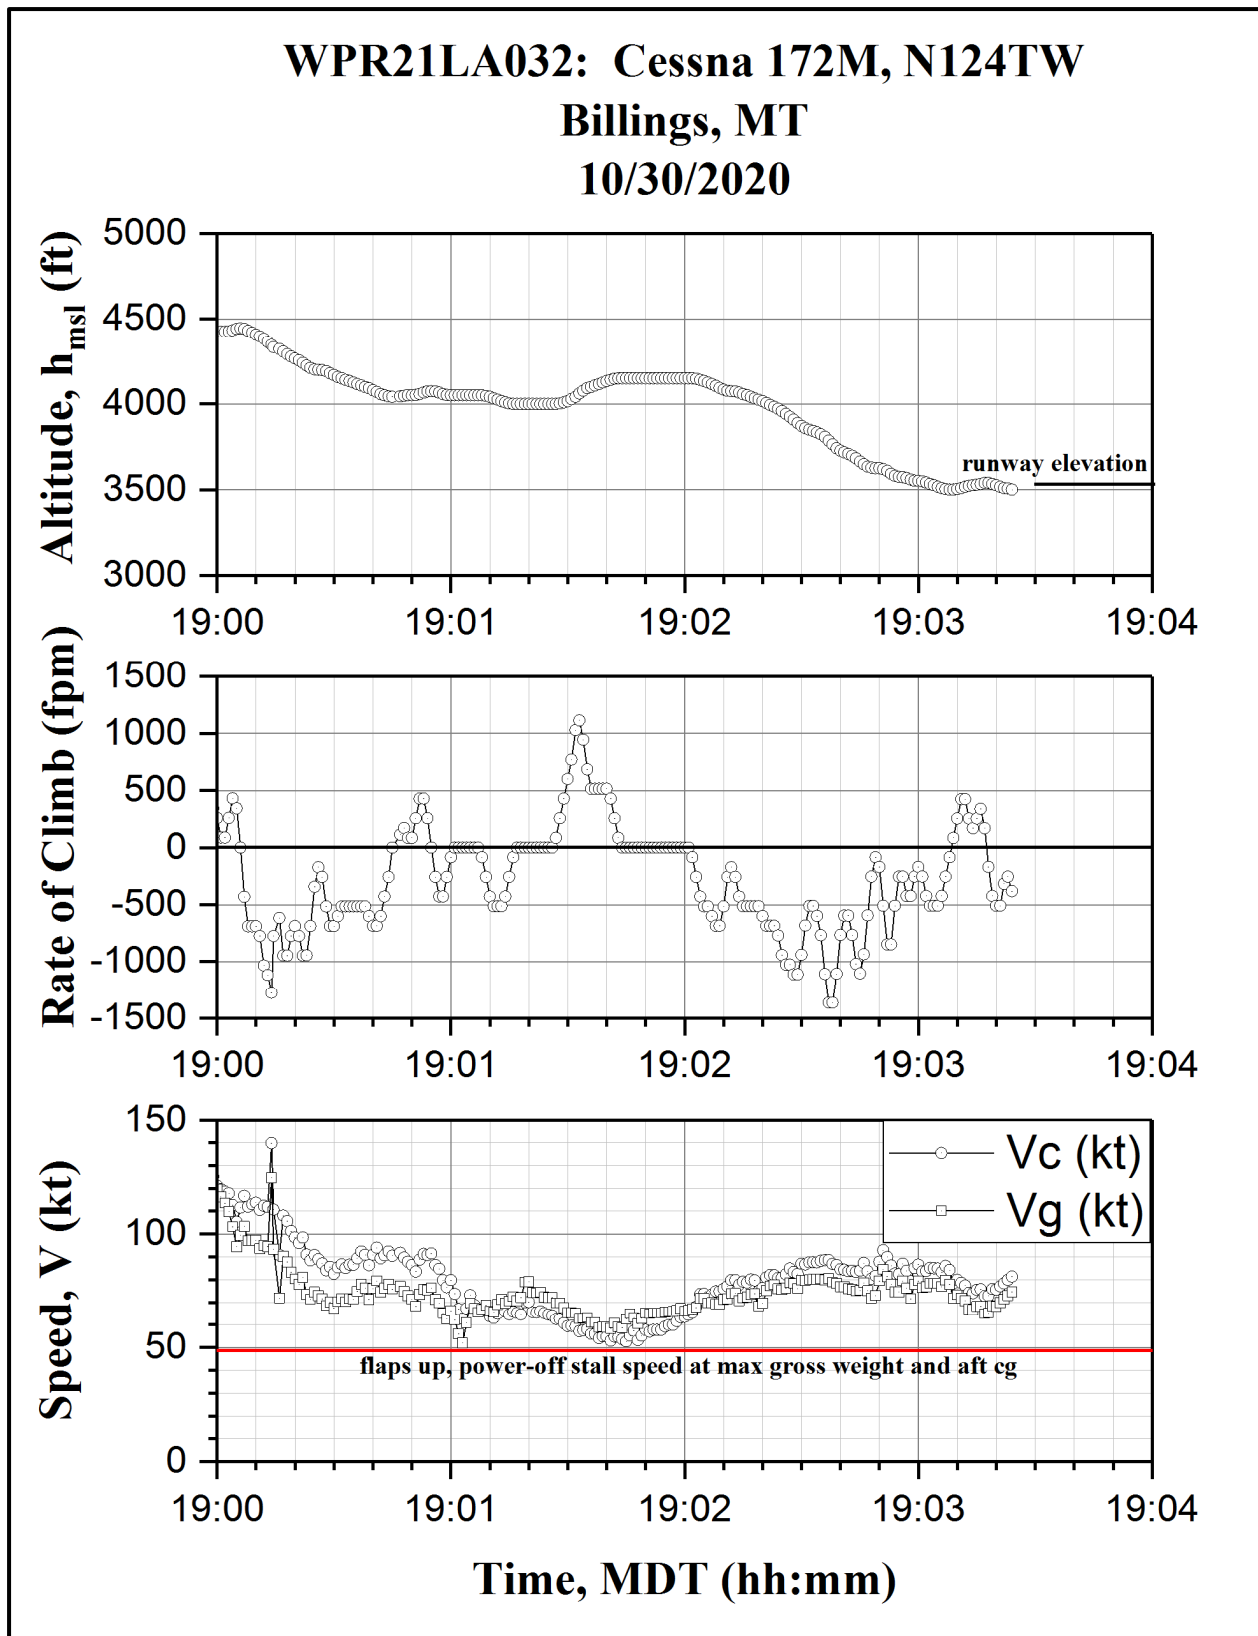
Figure 7 shows the estimated airspeed and altitude for the final three minutes of the accident flight. There does not appear to be any abrupt changes in altitude, and the airspeed was never slower than the flaps up, power-off, 1g stall speed<sup>3</sup> of 49 kt. The airplane was in a slight descent when it impacted trees and level terrain east of the airport.

Figure 7: Estimated Groundspeed ( $V_g$ ) and Calibrated Airspeed ( $V_c$ ) for Final Minutes

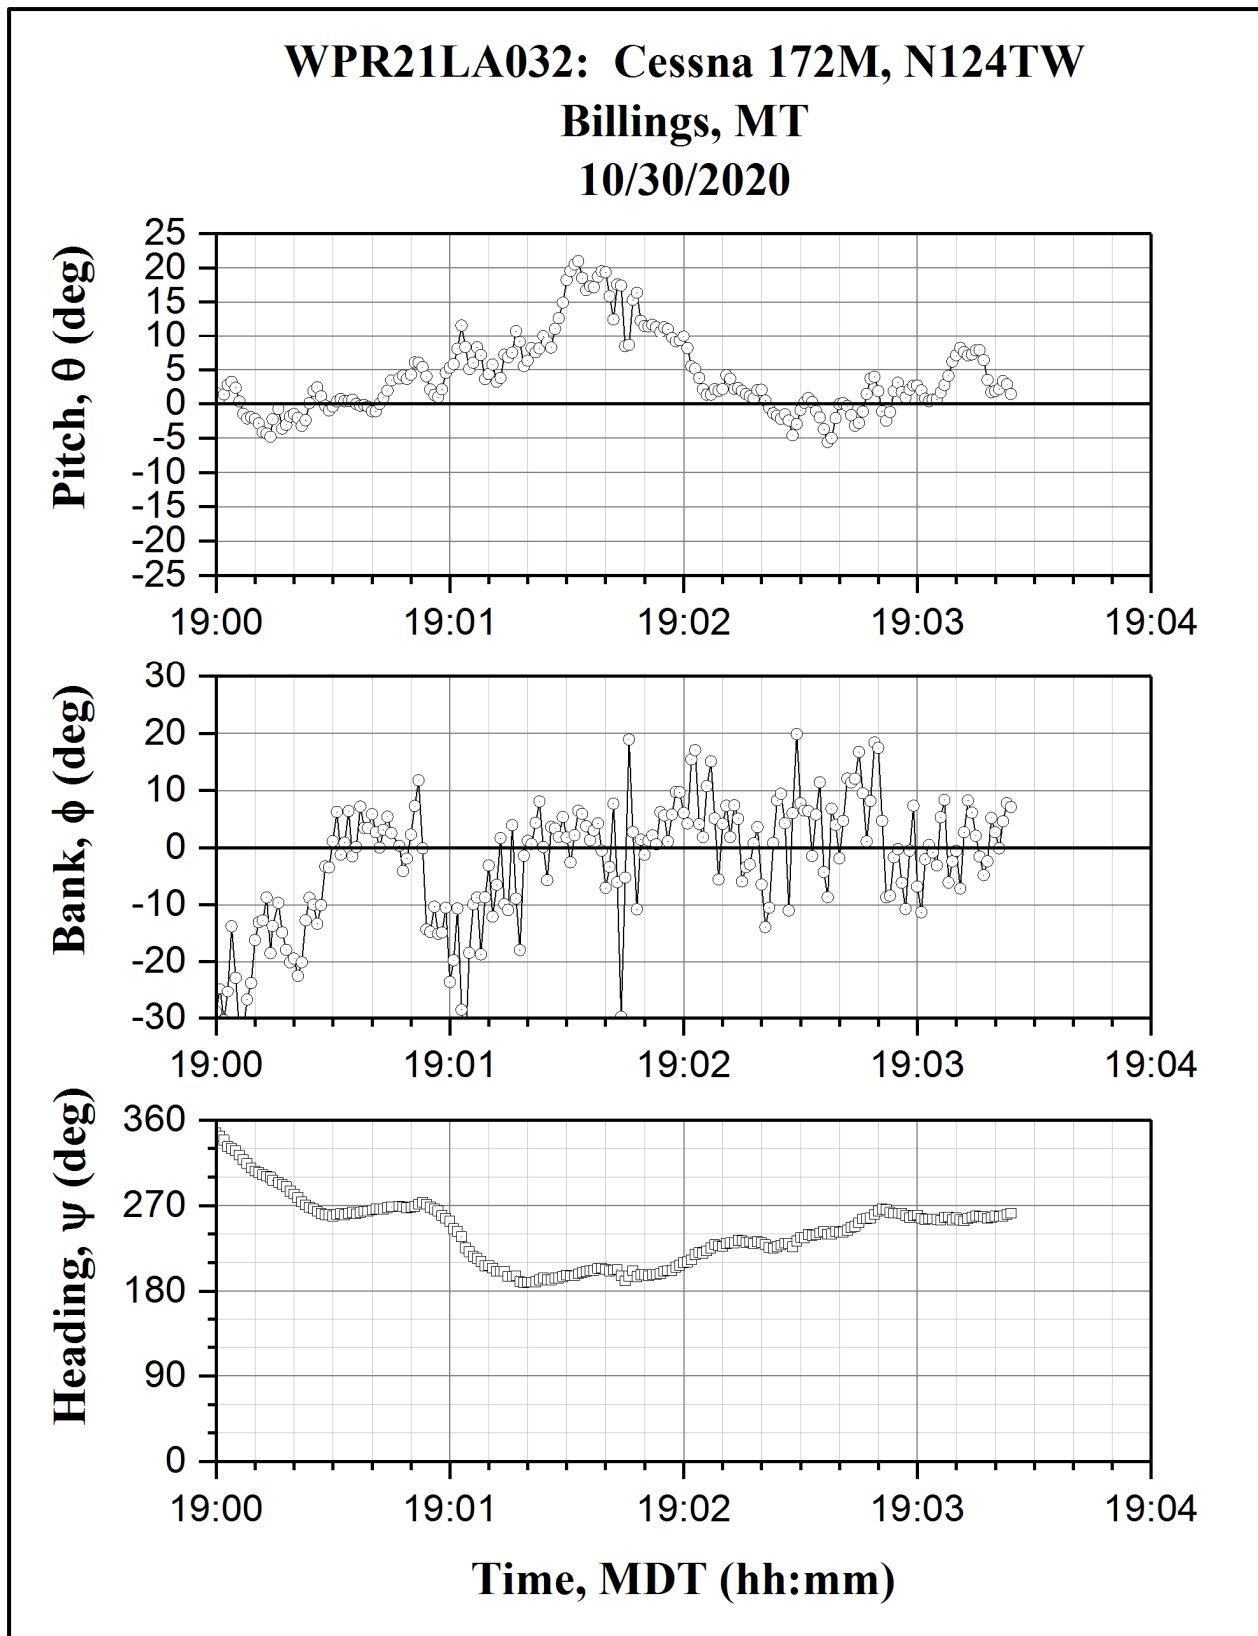
The estimated airplane attitude for the final minutes is shown in Figure 8. There were no abrupt changes in pitch attitude, and the bank angle in the final seconds was less than +/- 10°. The heading remained largely aligned with the runway 25 centerline until impact.

Figure 8: Estimated Pitch, Bank, and Heading for Final Minutes of Flight

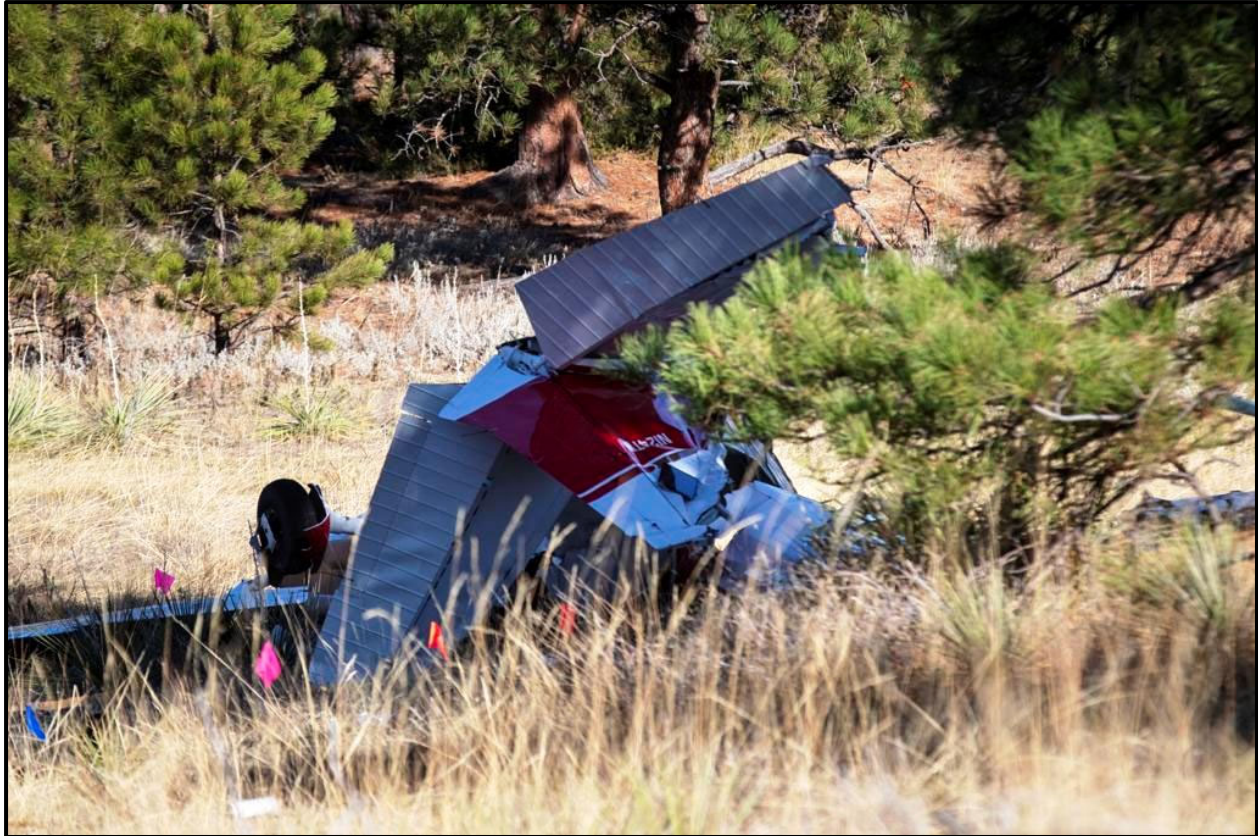
The airplane impacted trees and level terrain east of the airport, about 3/4-mile from the threshold for runway 25 and on the extended runway centerline. All major structural components of the airplane were located within the debris field.

Figure 9 shows the airplane in its final position.

**Figure 9: Picture of Wreckage**

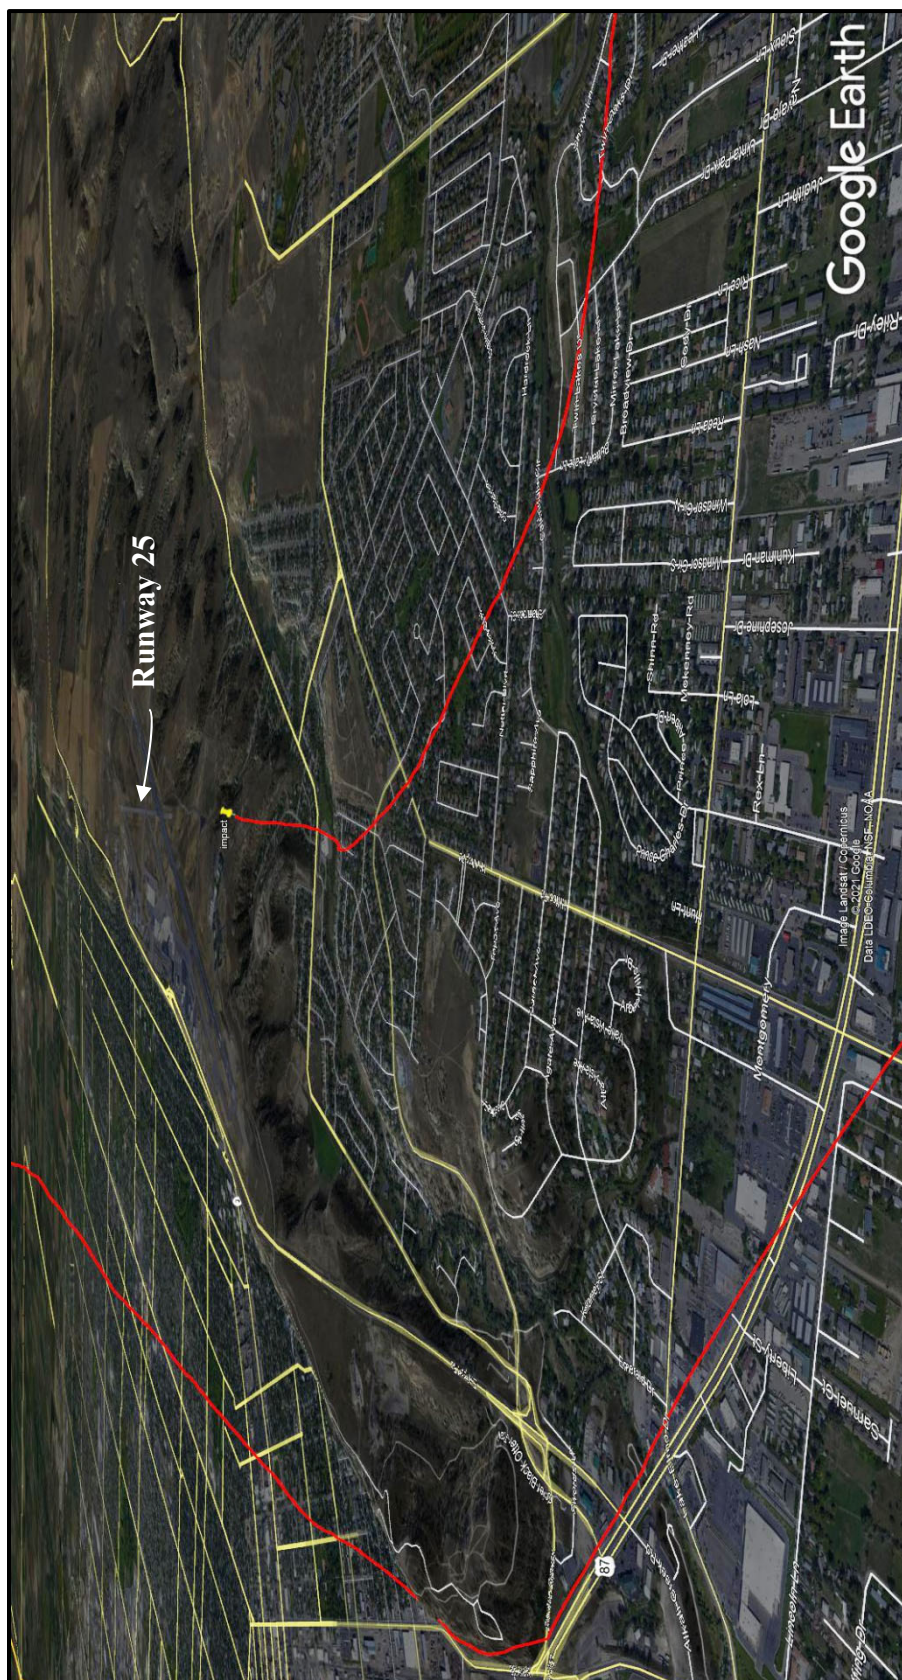
The handbook goes on to say that “flying over terrain with only a few lights makes the runway recede or appear farther away. With this situation, the tendency is to fly a lower-than-normal approach. If the runway has a city in the distance on higher terrain, the tendency is to fly a lower-than-normal approach.” Figure 11 shows the ADS-B ground track for N124TW and the surrounding terrain on final approach into Billings.

Figure 11: ADS-B Ground Track and Surrounding Terrain on Final Approach into BIL
