## **NATIONAL TRANSPORTATION SAFETY BOARD**

### **AIRFRAME EXAMINATION SUMMARY**

**WPR21LA032**

Location: Billings, Montana  
Date: October 30, 2020  
Aircraft: N124TW  
NTSB IIC: Andrew Swick

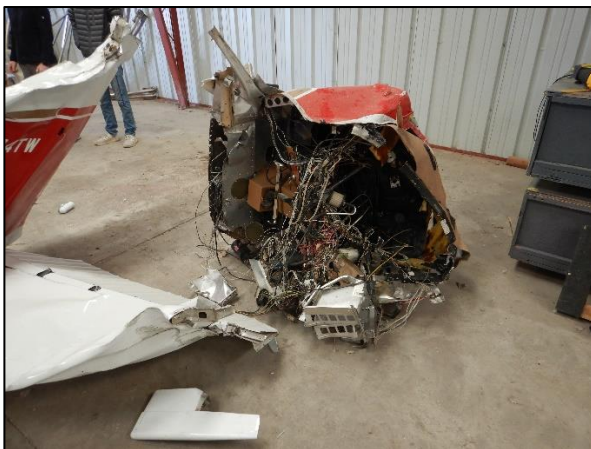
The propeller, engine, firewall, instrument panel, nose landing gear and forward fuselage remained attached and separated from the main wreckage during the accident sequence. The upper and lower engine cowling separated from the engine and remained partially attached to each other. The nose cowling separated and was found in several pieces. The propeller was removed from the engine and one blade was bent aft at its midsection and tip. The blade surfaces had scuff marks. The spinner was crushed.

Figure 1-Engine, firewall and instrument panel.

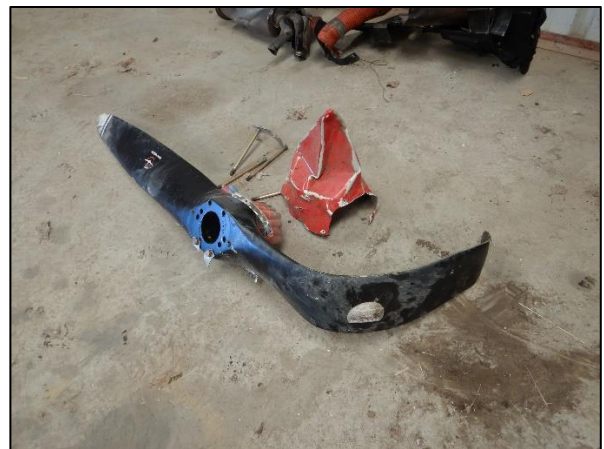
Figure 2-Propeller and spinner.

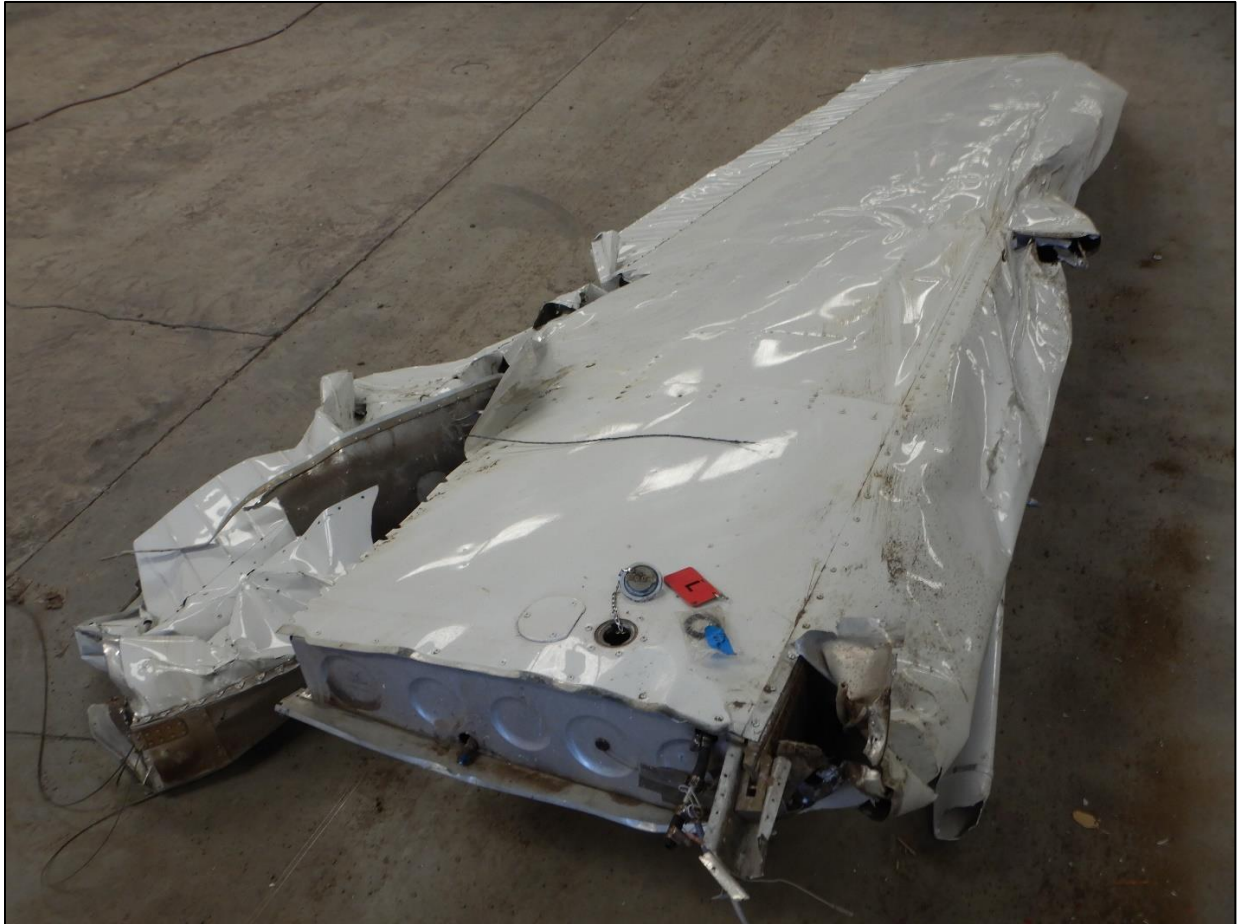
The wings separated from the main wreckage during the accident sequence. The left wing had leading edge damage and was buckled throughout. The wing tip fairing had impact damage and remained attached to the wing. A small section of the fuselage attachment remained attached to the spar attachment. The flap had impact damage, was partially attached and was found in the retracted position. The aileron remained attached to the wing and flight control cable continuity was established. The left wing fuel tank showed hydraulic deformation consistent with fuel in the tank during the accident sequence. A small bag with a cap seal was found in the main wreckage and was labeled “172 LH Tank.” The fuel tank cap was removed, and the Teflon and rubber seals were damaged and cracked.

Figure 3-Left wing.

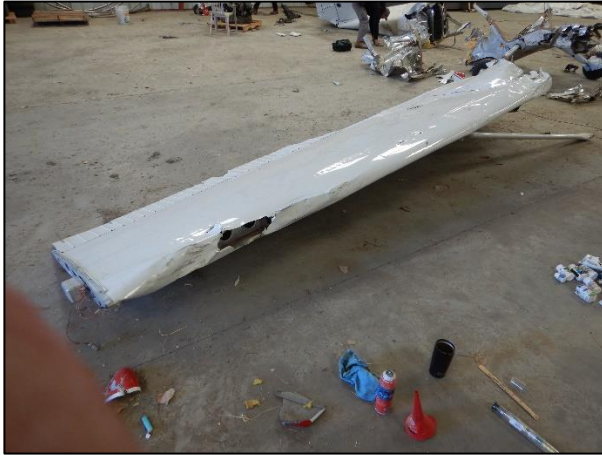
The right wing had leading edge damage near the tip and inboard section. The wing tip fairing separated from the wing. The right wing spar was bent aft near the wing root and wood debris was found in this area. The flap remained attached to the wing and was found in the retracted position. The aileron remained attached to the wing and flight control cable continuity was established. The right wing fuel tank showed hydraulic deformation consistent with fuel in the tank during the accident sequence.

Figure 4-Right wing.

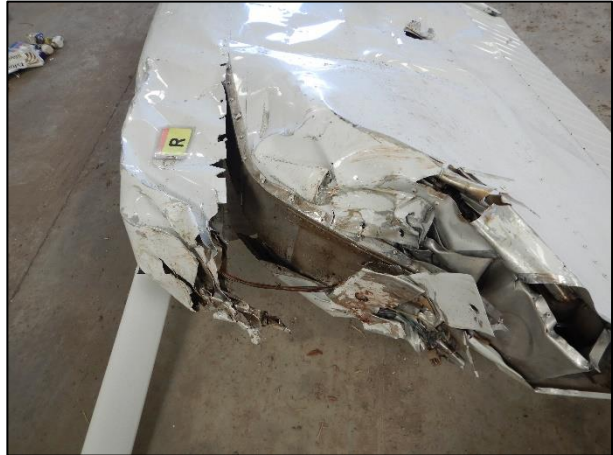
Figure 5-Right wing inboard spar.

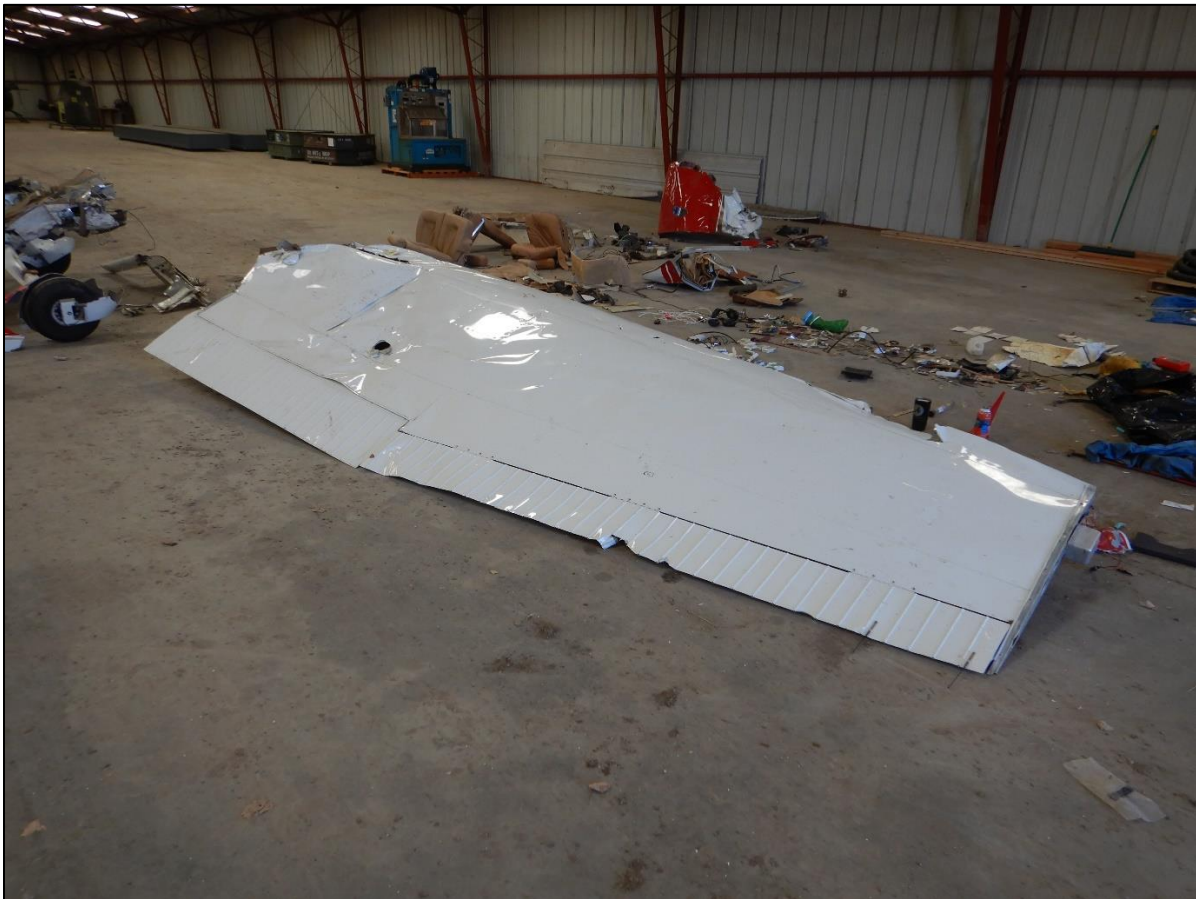
Figure 6-Right wing.

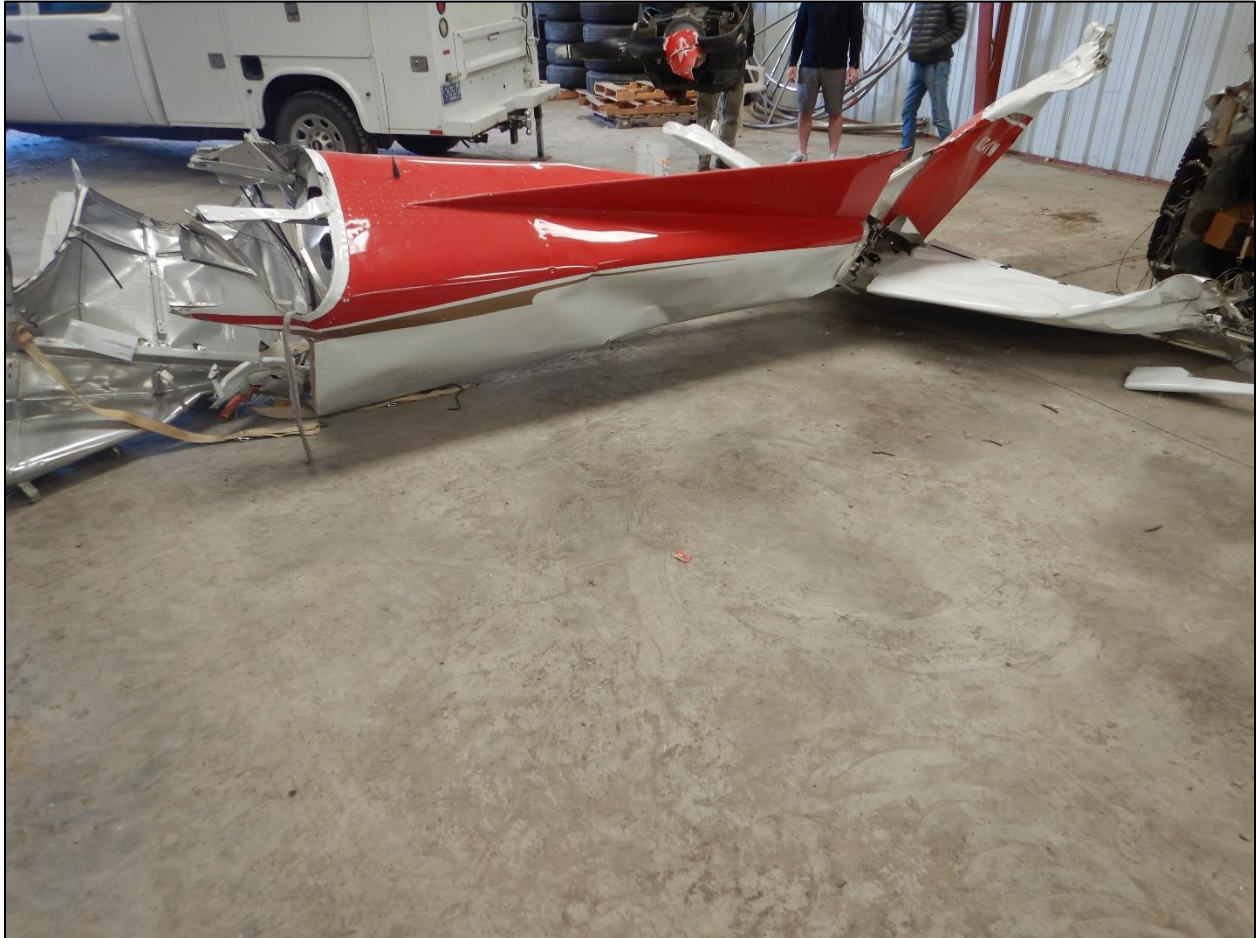
The empennage remained intact, separated from the main wreckage and had impact damage. The leading edges of the vertical and horizontal stabilizers had impact damage. The rudder and elevators remained attached to the empennage. Flight control cable continuity was established from the flight control connections to tension overload separations near the aft cabin area. The elevator trim actuator was extended to about 1.35 inches, which equates to the elevator tab in about a 5 degrees tab up position.

Figure 7-Empennage.

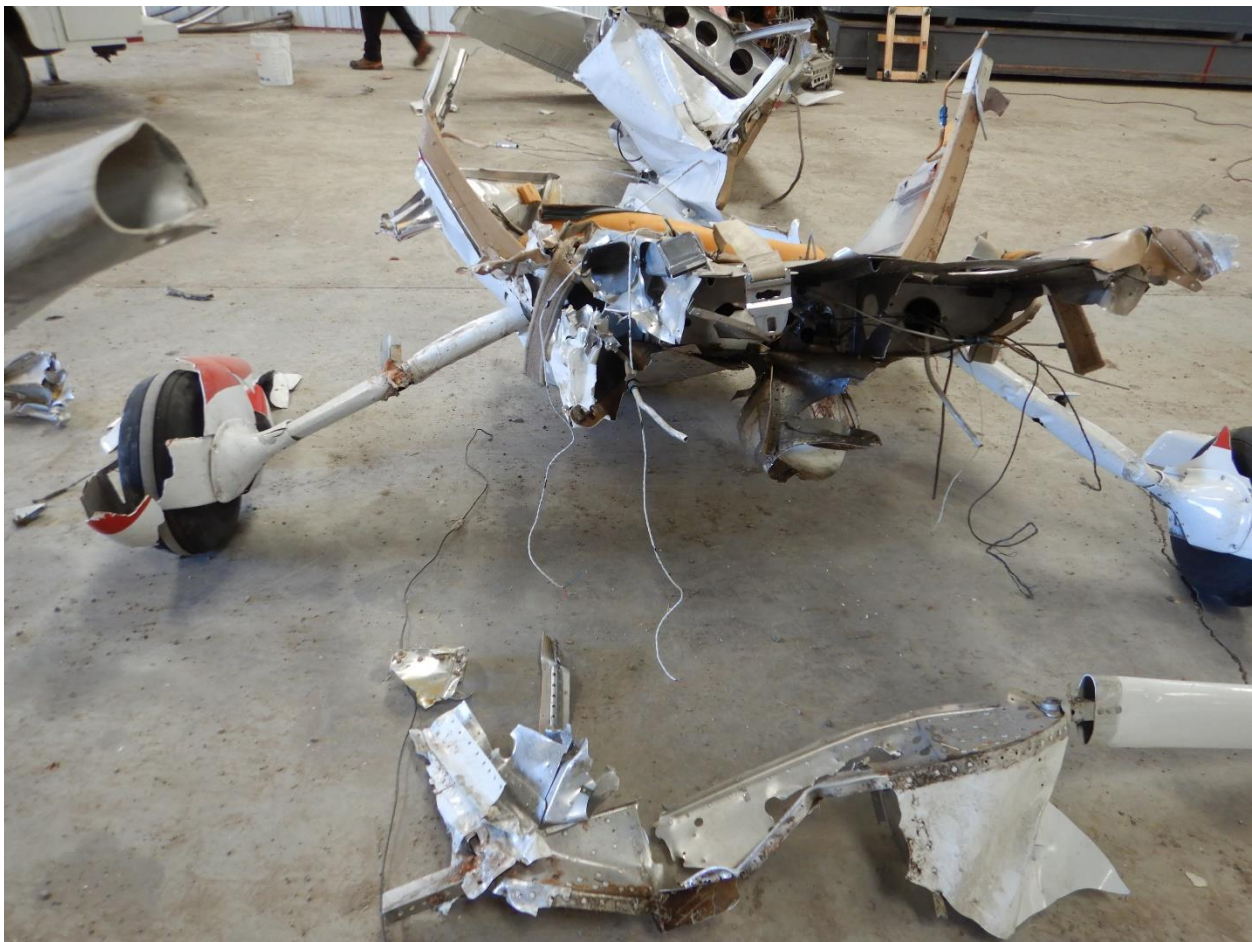
The cabin floor and lower fuselage structure remained attached to the main landing gear struts. The cabin doors and cabin seats separated from the fuselage structure. The forward right side of the right cabin floor area had extensive impact damage and wood material was found in this area. The right main landing gear strut and step had impact damage. Wood was embedded into the step's attachment mechanism. The strut and adjacent fuselage structure had a circular impact consistent with the impact of a large diameter tree. Both wheel pants had impact damage and most had separated from the landing gear. The seat tracks remained attached to the floor. The right forward lap belt stitching unraveled near the inboard attachment, consistent with the seat belt being used during a high impact accident sequence. The shoulder harnesses for both forward seats were found attached to the roof section of the cabin area. The shoulder harnesses were undamaged.

Figure 8-Fuselage displayed in the examination area.

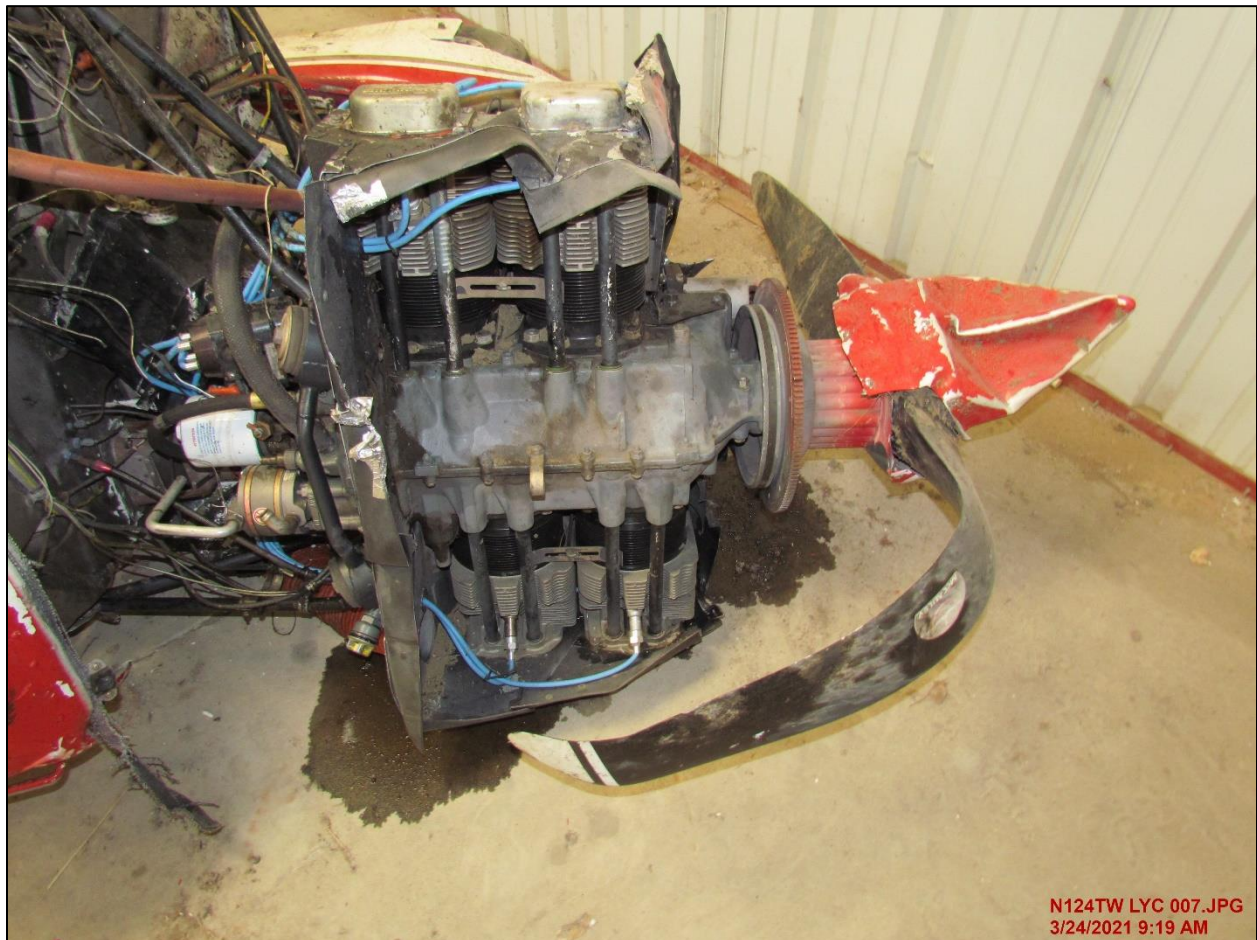
The engine was undamaged and removed from the engine mounts. The carburetor was removed and no anomalies were noted. The vacuum pump was removed and disassembled; no anomalies were noted. The upper spark plugs were removed, and the electrodes were undamaged and showed a normal amount of combustion deposits. The cylinders were boroscoped and no anomalies were noted. The crankshaft was rotated via the propeller assembly and gear continuity was attained to the accessory section. During the crankshaft rotation, the cylinders revealed compression and overhead valve movement. The magnetos were removed and spark was obtained from the ignition leads.

Figure 9-Engine and propeller assembly.
