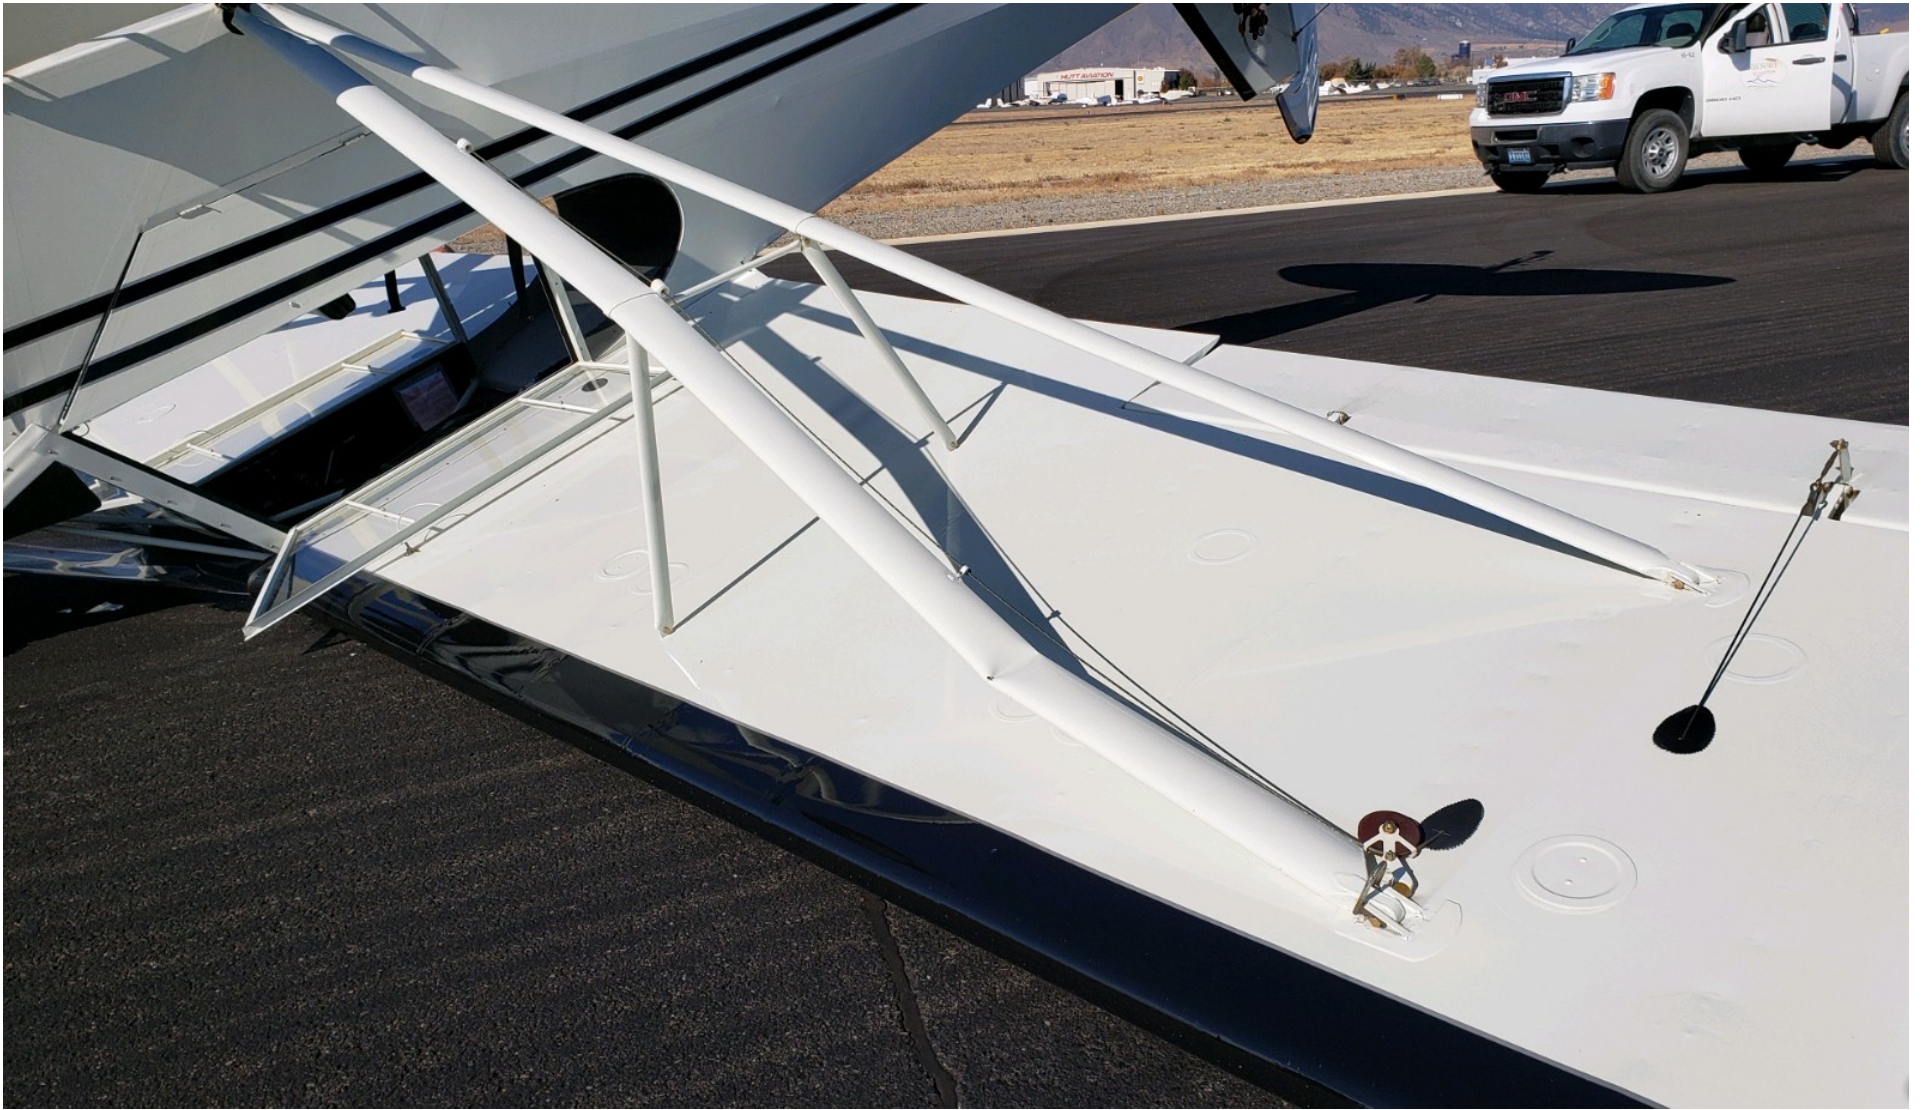
**Photo 1 – N755MG, showing substantial damage to the right-wing strut. Photo courtesy of the Operator**
