# NATIONAL TRANSPORTATION SAFETY BOARD

## MATERIALS LABORATORY FACTUAL REPORT

Report No. 21-065

Place : Glendale, Arizona  
Date : November 4, 2020  
Vehicle : Remos Aircraft GMBH Flugzeugbau GX, N87GX  
NTSB No. : WPR21LA037  
Investigator : Michael Hicks, ASI-WPR

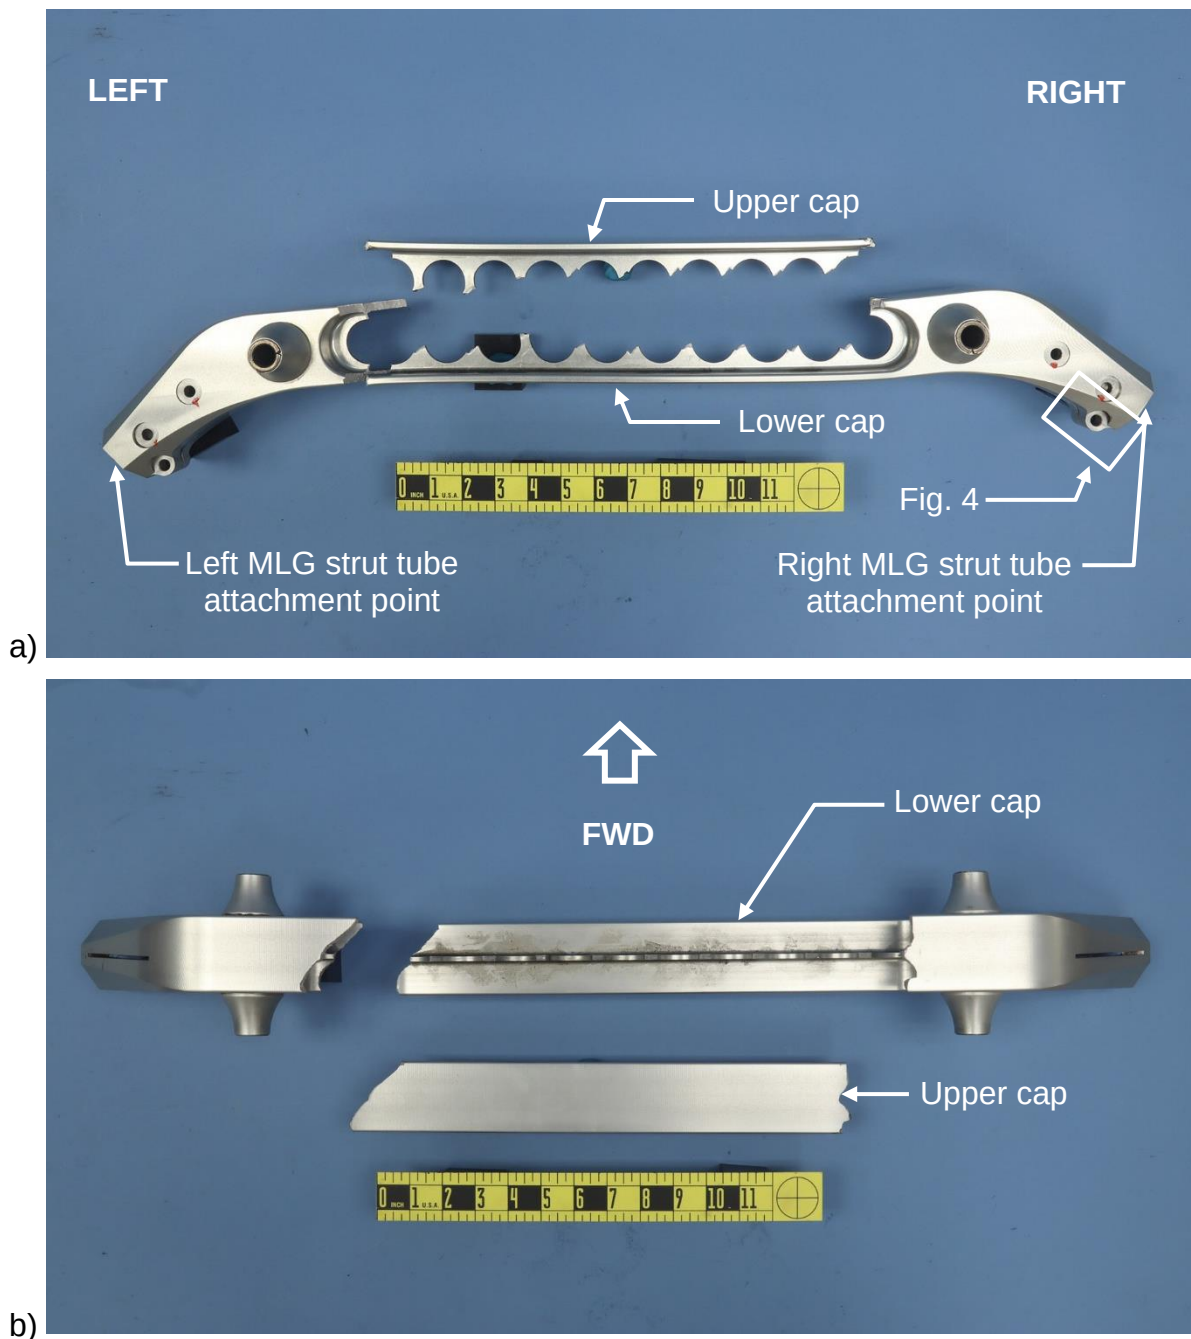
A carry-through spar, fractured into three pieces was submitted to the NTSB Materials Laboratory for examination, as shown in figures 1a and b. The spar consisted of a middle section that was composed of an upper cap, lower cap, and web with circular holes in it, as well as two end-sections used to attach left and right main landing gear (MLG) strut tubes to the carry-through. The lower cap was fractured at the left end of the middle section and the upper cap was fractured at both ends. Three of nine web ligaments (the material between the holes) were fractured in one location, while the remaining six, toward the right side of the spar, were fractured in multiple locations and those ligaments were missing. The spar was visibly bent at the transition from the middle section to the right MLG attachment sleeve section, such that the attachment arm had rotated counterclockwise (up) relative to the rest of the spar.

**Figure 1:** Images of the fractured carry-through: a) viewed from the aft direction looking forward and b) viewed from the top looking down.

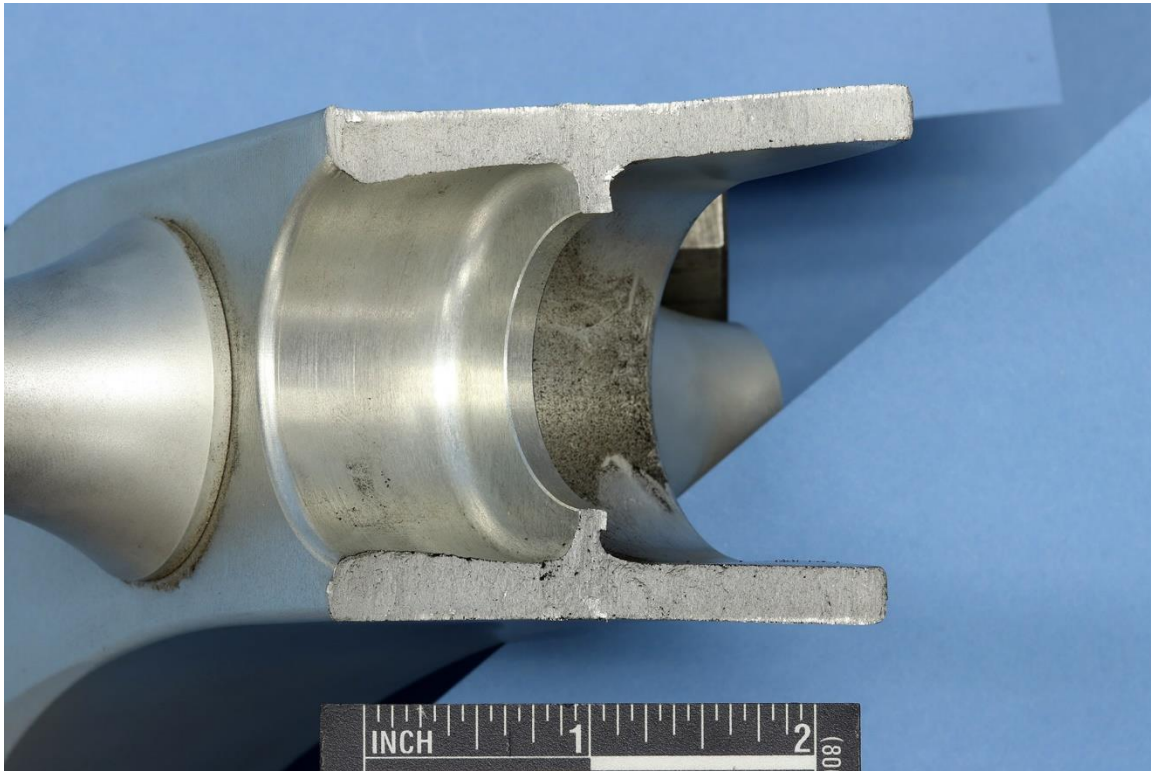
The upper and lower spar cap fracture surfaces were examined with the aid of a stereomicroscope and all surfaces exhibited a rough granular appearance, consistent with overstress fractures. The upper and lower cap fractures on the left side of the spar are shown in figure 2. The fractures intersected the top and bottom of the leftmost hole in the web (12 o'clock and 6 o'clock positions). As the fractures entered the upper and lower caps, they progressed along paths oriented approximately 45° to the longitudinal axis of the spar. The upper cap also exhibited slight upward bending deformation.

**Figure 2:** Image of the fracture surfaces on the left side of the carry-through. The fractures exhibited a rough granular appearance, consistent with an overstress fracture.

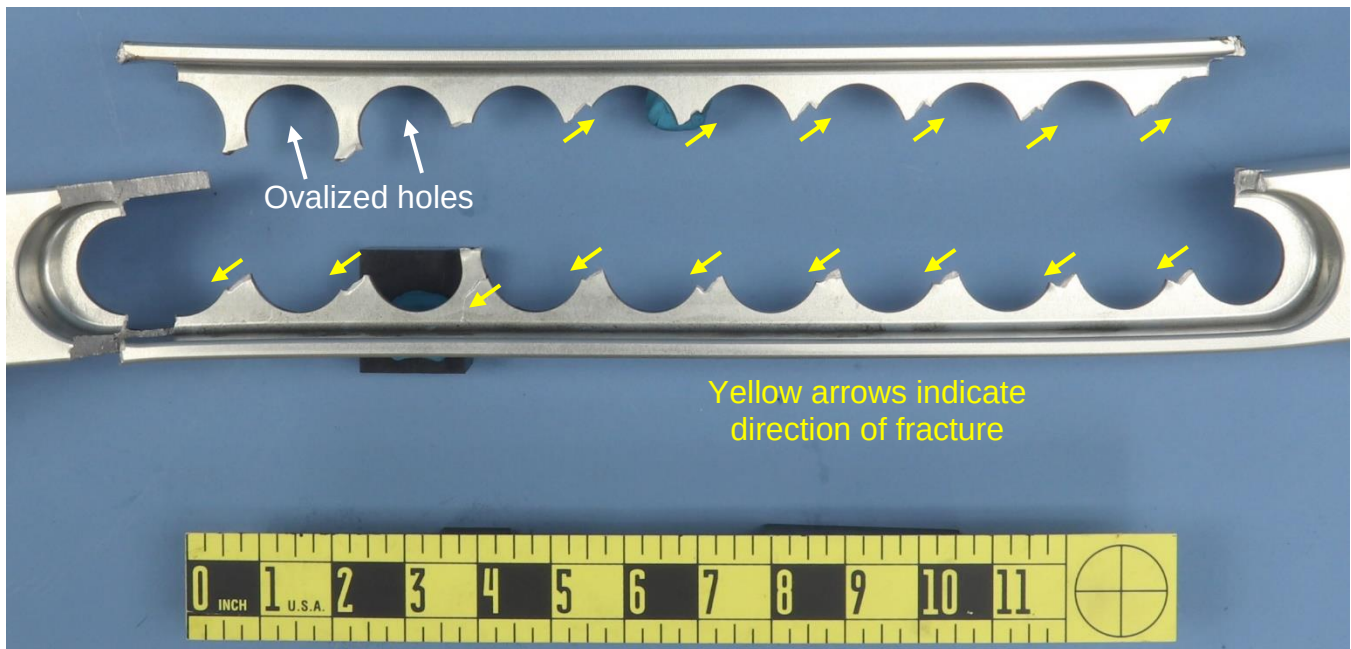
The ligament fractures in the spar web were examined for indications of fatigue but none were found. Instead, the ligaments typically exhibited an initial "V-shaped" fracture profile with a rough fracture morphology, which transitioned to a rubbed appearance at the point of final fracture that was also accompanied by an increase in the web thickness (plastic bulge) and a shear lip at the adjacent hole edge (plastic hinge). Figure 3 shows

the direction of crack growth and separation for the web ligaments. The web ligament fractures near the upper cap proceeded across each ligament from left to right and the fractures near the lower cap proceeded from right to left. The features were consistent with overstress due to a leftward shear displacement of the upper spar cap relative to the lower cap.

**Figure 3:** Image of the carry-through spar center section with arrows indicating the direction of crack growth through the web ligaments.

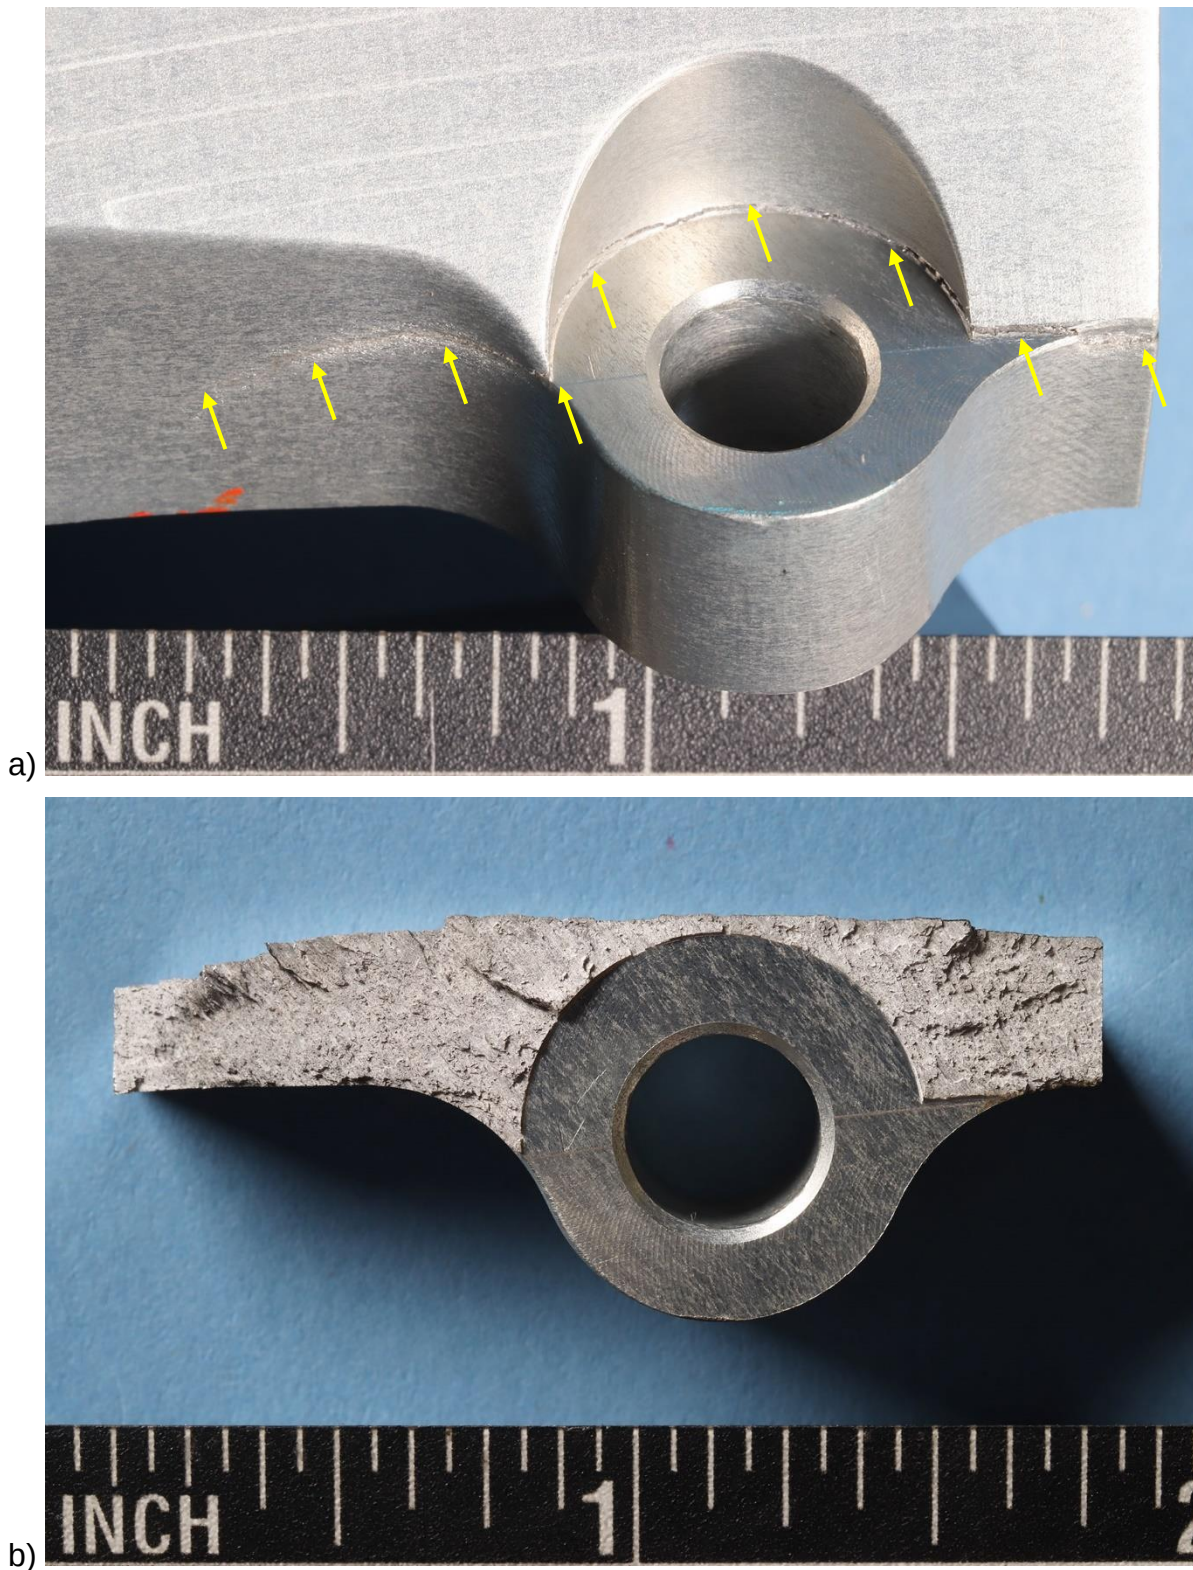
Additional examination of the carry-through revealed a crack at its right end in the sleeve used to secure the right MLG strut tube. An image of the crack is shown in figure 4a (also see figure 1 for reference). The crack ran along the edge of a lug through which a bolt was inserted and used to clamp the sleeve around the strut tube. The crack extended approximately 1.5 inch in the longitudinal direction and through the thickness of the sleeve. The sleeve was sectioned using a water-cooled abrasive saw in accordance with standard laboratory practices and the crack was opened for examination, as shown in figure 4b. As seen in the figure, the surface was clean and did not exhibit any notable dirt or debris. The fracture was then examined using a scanning electron microscope and the surface exhibited ductile dimples in all locations examined, consistent with an overstress fracture.

**Figure 4:** a) Image of the right main landing gear strut tube attachment sleeve showing a longitudinal crack near the clamping lug, as indicated by yellow arrows and b) image of the fracture surface after the crack was broken open.
