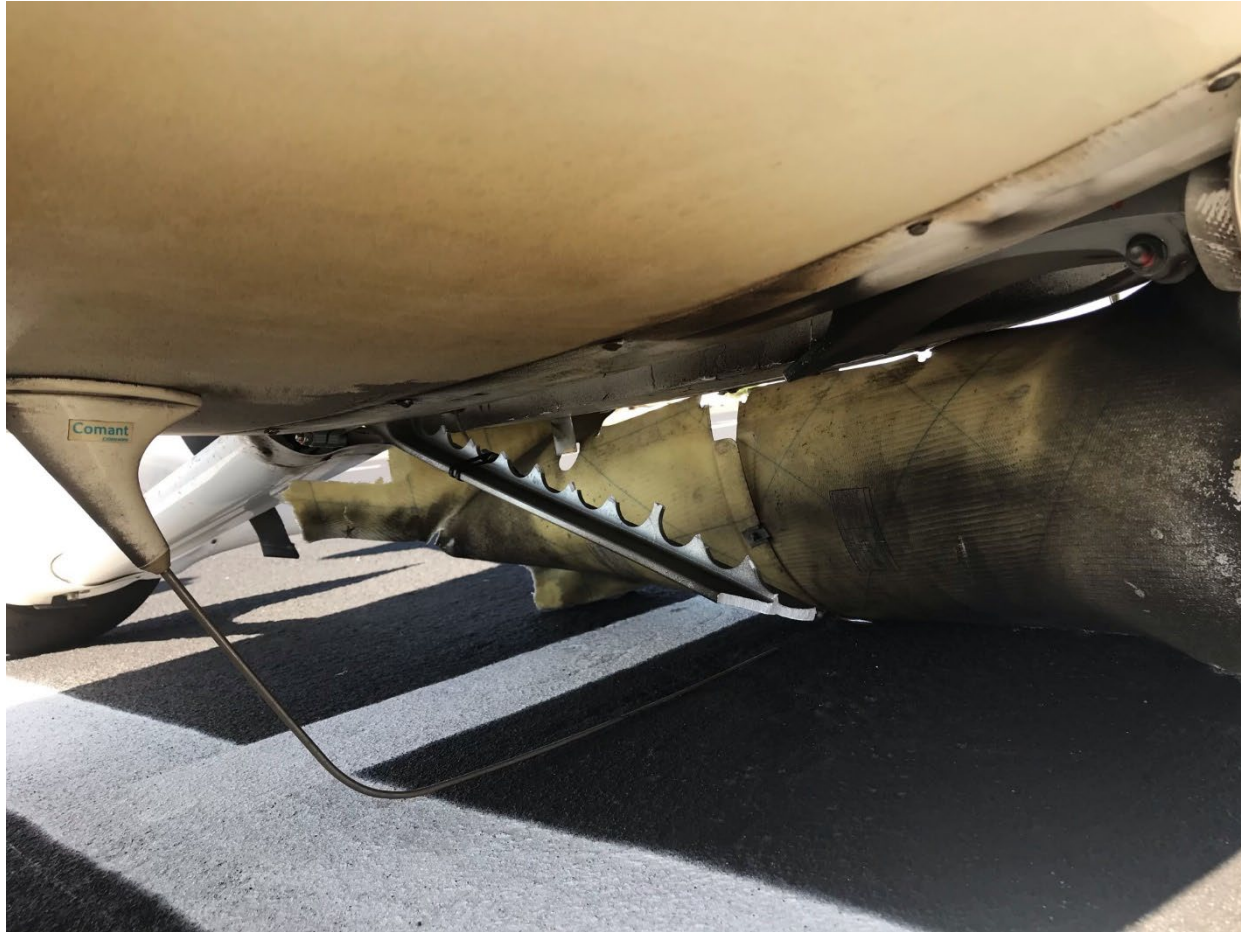
**Photo 1 – View of the failed carry through (Courtesy of Pilot)**

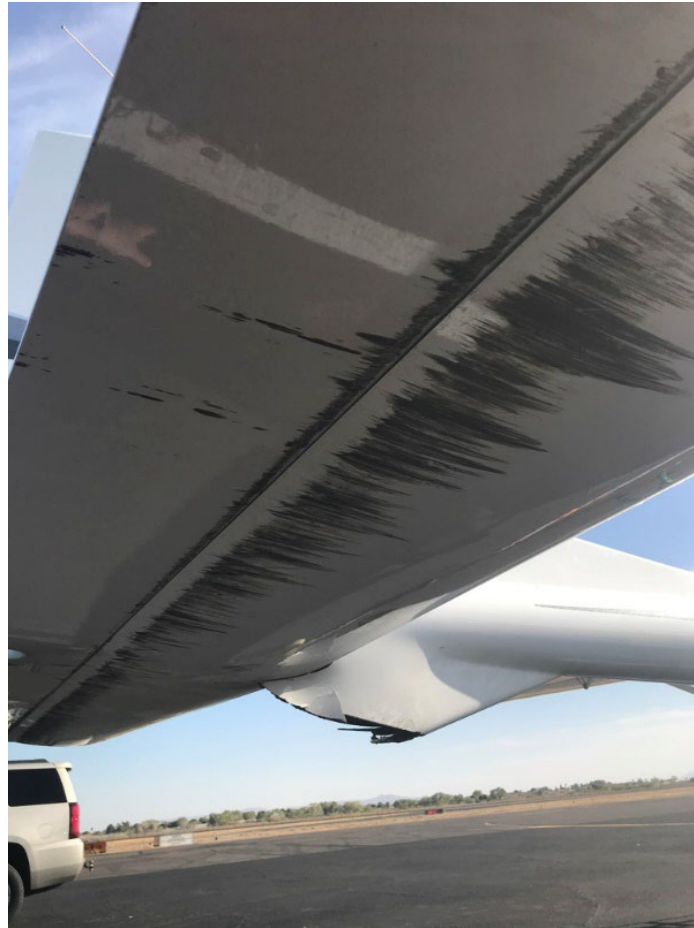
**Photo 2 – View of damage to the composite empennage (Courtesy of Pilot)**
