**[Docket No. FAA-2015-1937; Directorate Identifier 2014-SW-067-AD; Amendment 39-18171; AD 2015-11-08]**

#### **Airworthiness Directives; Agusta S.p.A. (Agusta) Helicopters**

**2015-11-08 Agusta S.p.A. Helicopters (Agusta):** Docket No. FAA-2015-1937; Amendment 39-18171, Directorate Identifier 2014-SW-067-AD.

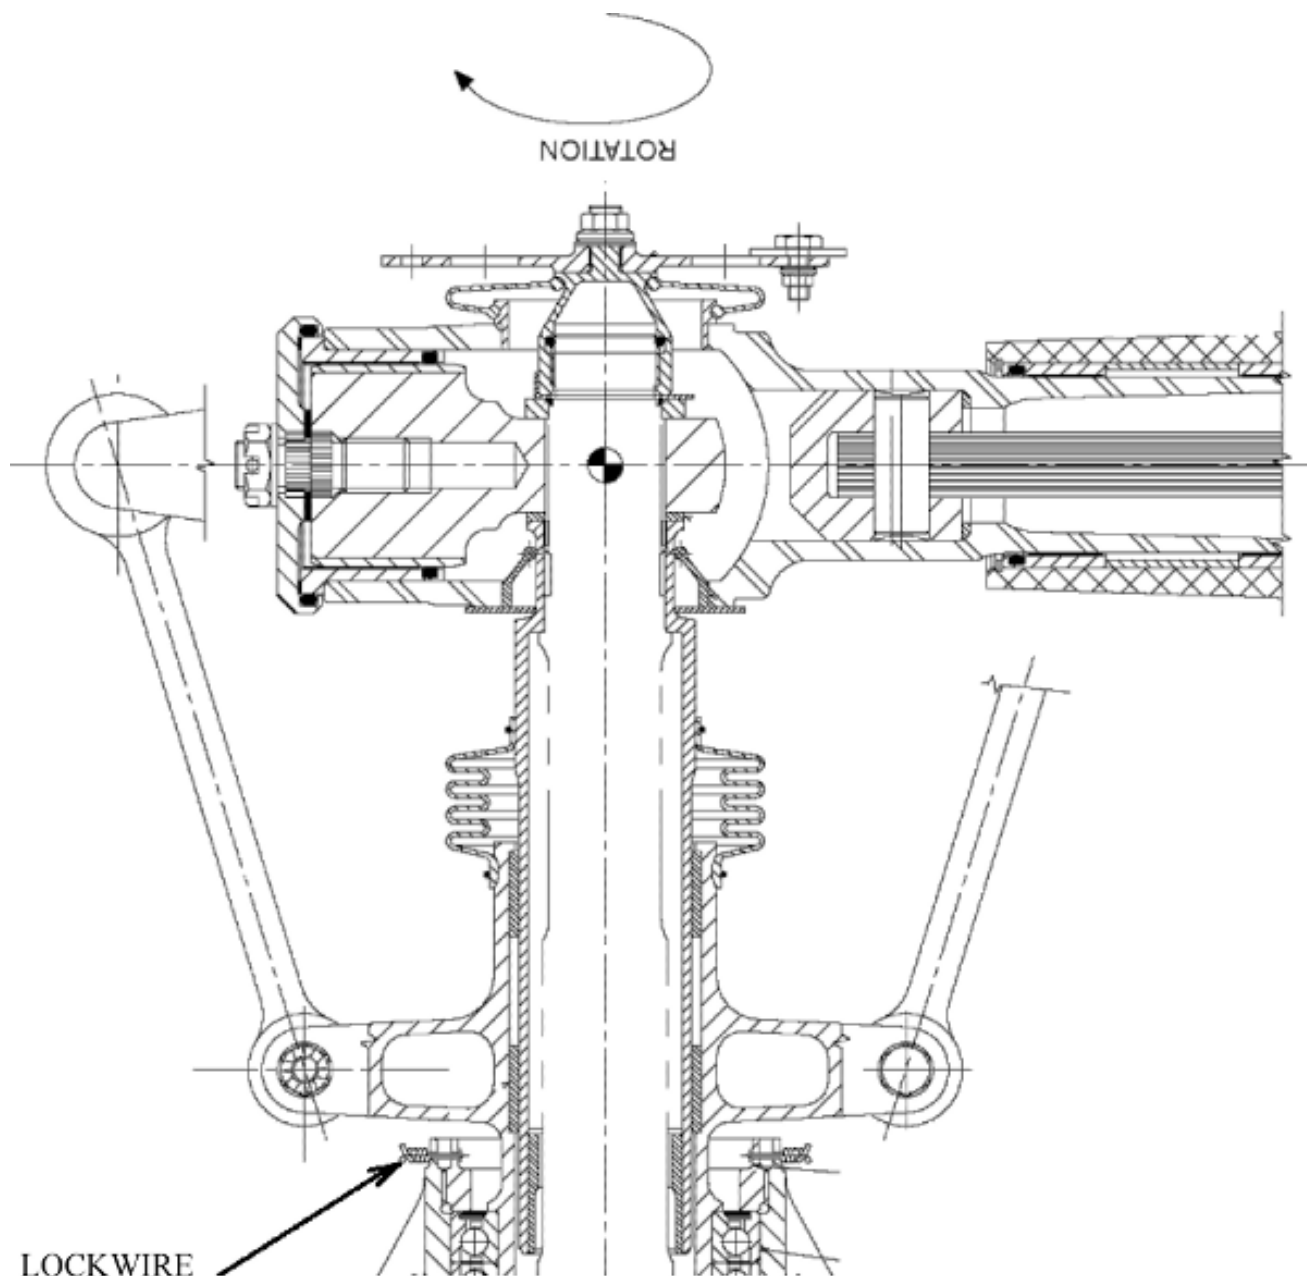
**Figure 1 of paragraph (f)(1)**

This AD defines the unsafe condition as a missing or broken lock wire securing the tail rotor (T/R) duplex bearing locking nut (locking nut). This condition could result in loosening of the locking nut, failure of the T/R, and subsequent loss of control of the helicopter.

(1) Within 24 hours and thereafter before the first flight of each day or at intervals not exceeding 24 hours, whichever occurs later, check each lock wire securing the T/R locking nut to the housing. The location of the housing wire is depicted in Figure 1 to paragraph (f)(1) of this AD.

(4) If one or both lock wires are missing or damaged, before further flight, remove and reassemble the housing and slider group of the T/R rotating controls.
