## **A109S N109EX – Wreckage Survey Follow-up** **Los Angeles (CA, USA)**

*December 23, 2020*

# A109S N109EX – Wreckage Survey Findings

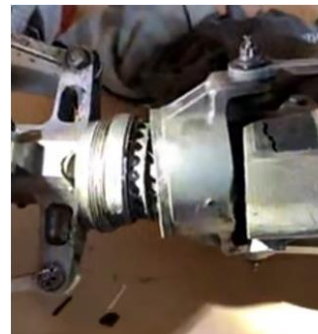
- The DAU was removed and prepared for shipping for data download.
  - Tail rotor assembly, rotating controls, and 90° gearbox were visually examined. The examination of the rotating controls revealed a ring nut (possibly part 109-0130-97-103) separated from the sleeve (possibly 109-0130-94-111). See enclosed photo. The 90° gearbox, tail rotor assembly, minus the paddles, and rotating controls were prepared for shipping to the NTSB Materials Lab for further examination.

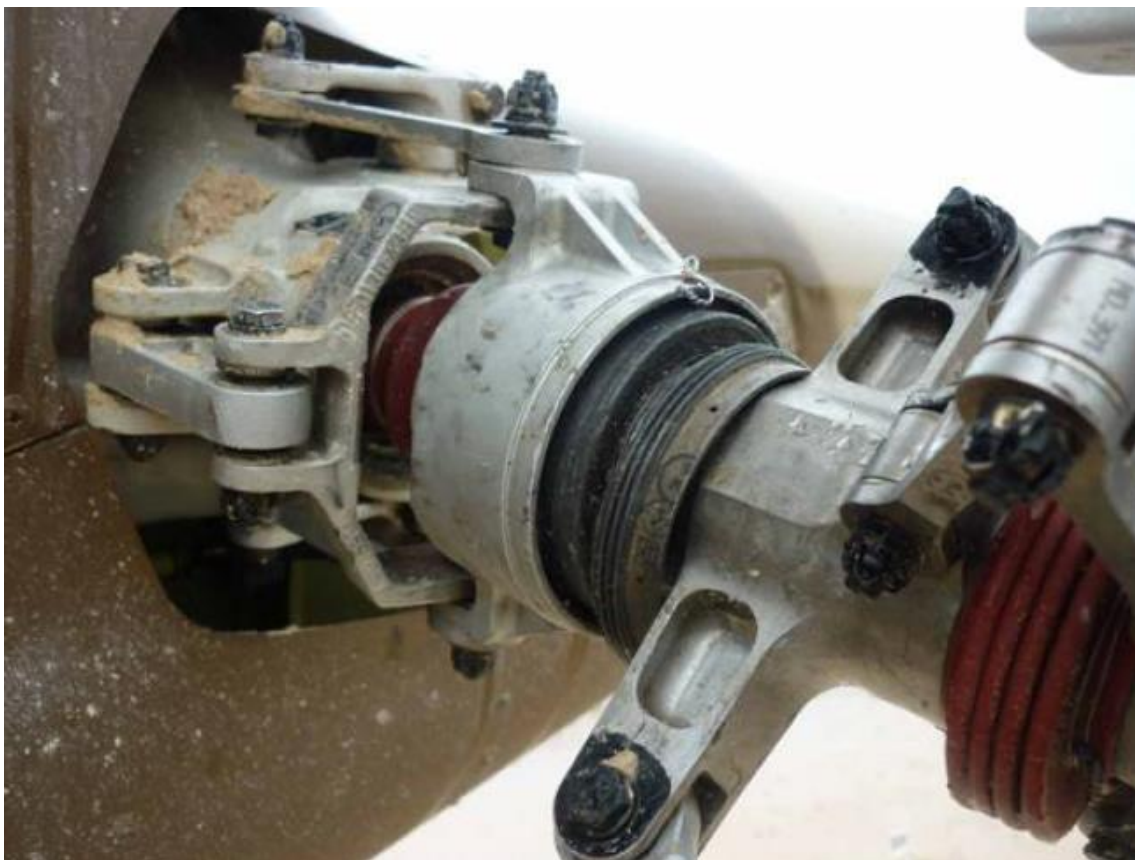
## A109LUH XXXXXX– 15th December 2010

Based on the above findings, LH takes the opportunity to highlight that the following cases events associated to loss of T/R control resulting from installation issues of the Ring Nut were notified, investigated and managed in the past:

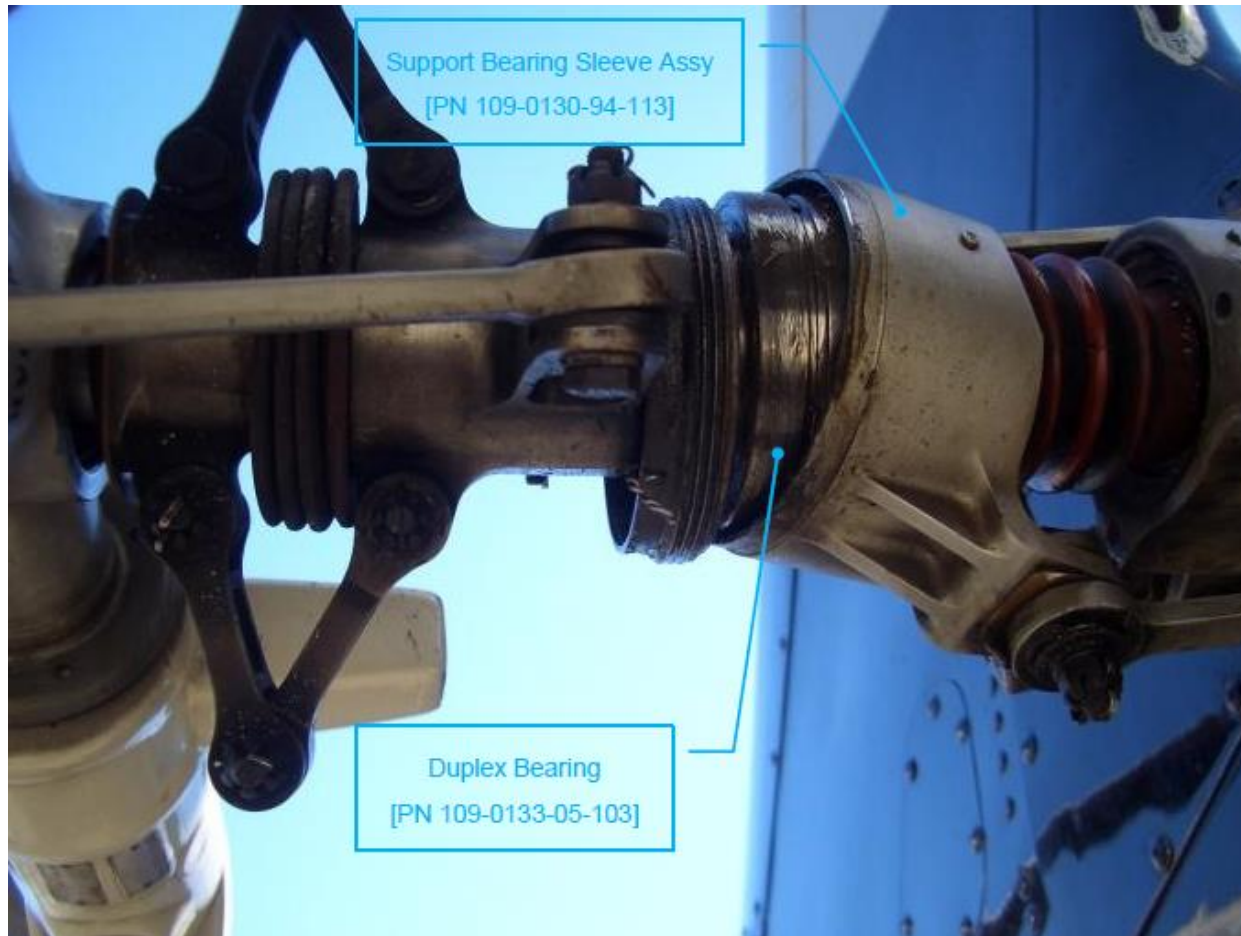
## A109E XXXXXX – 21th October 2014

- Since FAA issued AD 2014-02-08 (January 31, 2014), a failure of a T/R duplex bearing ring nut installation occurred after the housing and slider group of the T/R rotating controls had been reassembled ([4<sup>th</sup> event occurred on A109E XXXXXX – 21th October 2014](#)).
- Therefore, FAA superseded the AD 2014-02-08 with the [AD 2015-11-08](#) to **remove the “Disassembly and reassembly” as Terminating Action.**
- Because of this additional event of the loosening of the bearing locking nut, FAA also retains the 25-hour inspection.
- **FAA also requires a daily pilot check** to enhance detection of an impending failure of a T/R duplex bearing ring nut installation.
