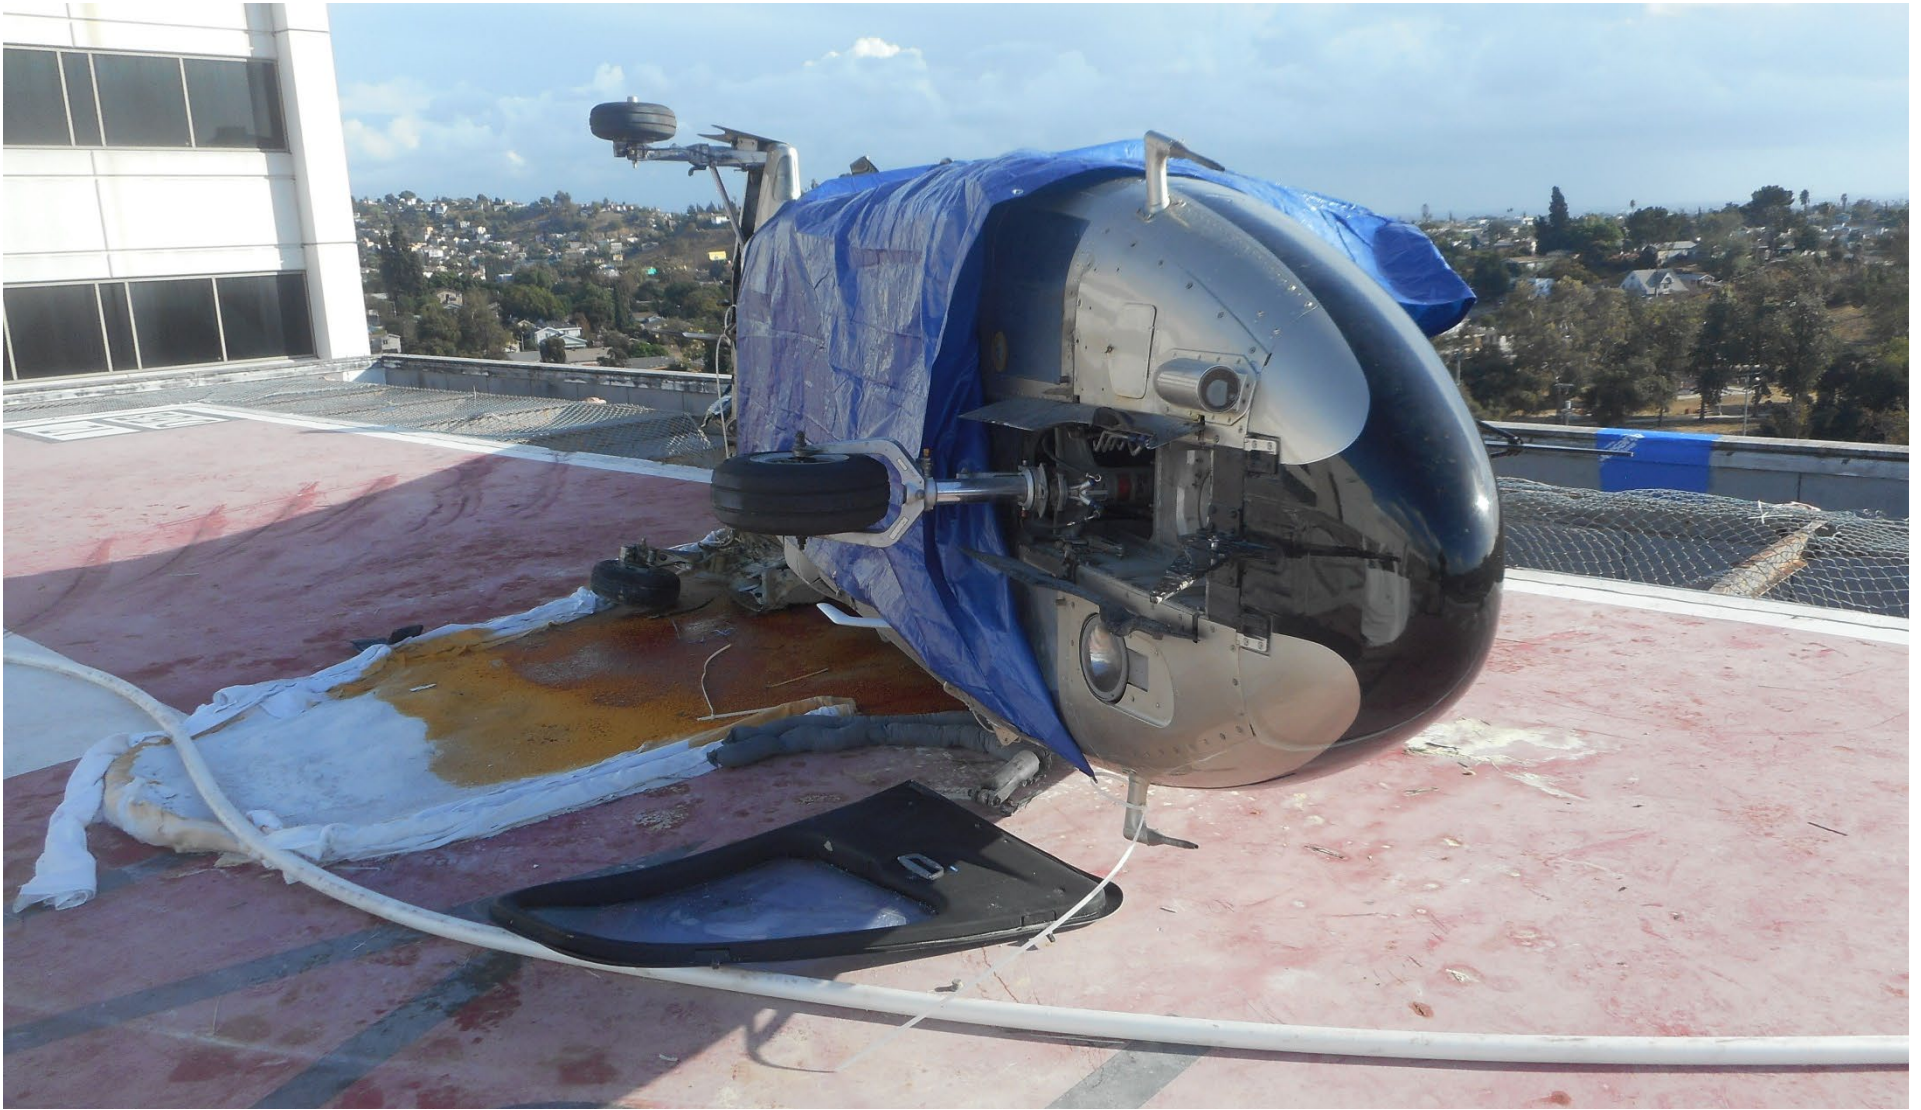
**Photo 1 – N109EX, front and underside view. Photo courtesy of the Operator.**

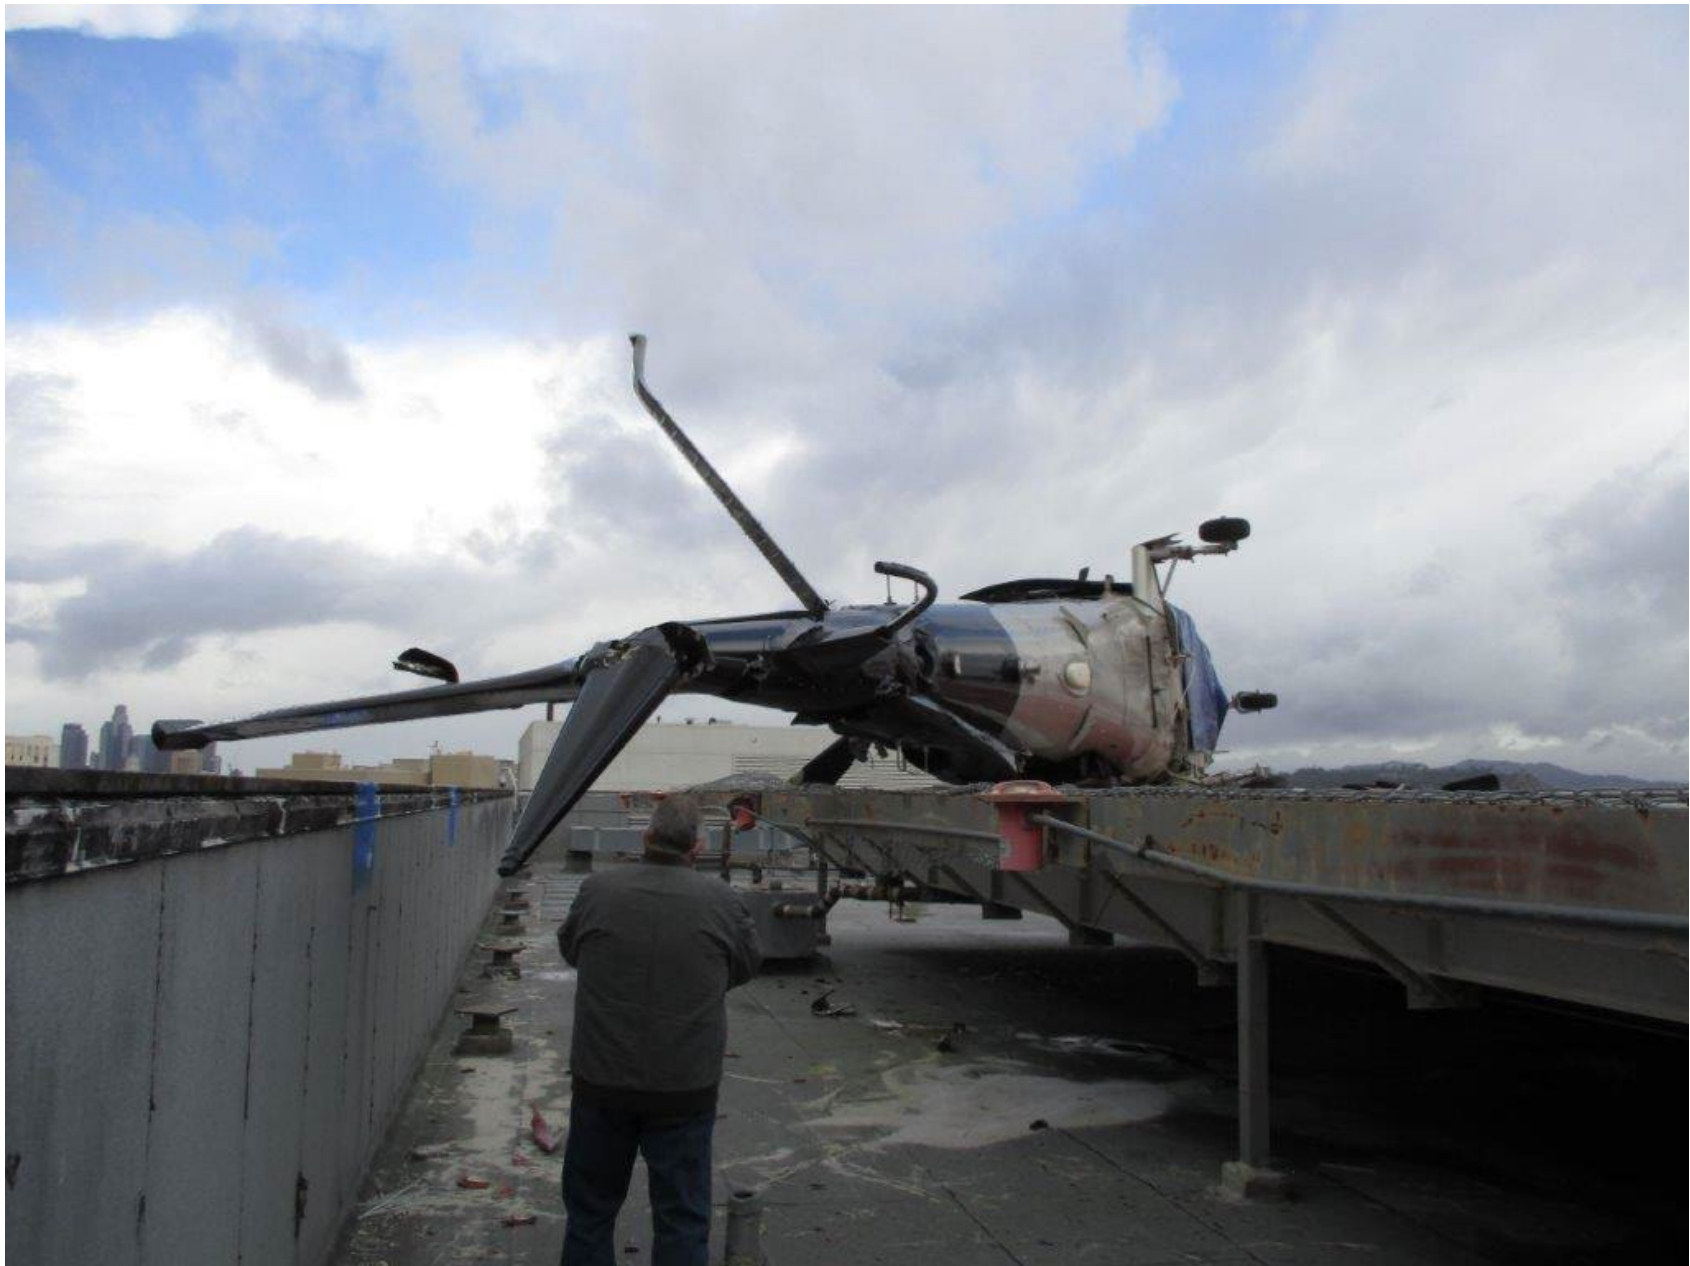
**Photo 2 -Rear view. Photo courtesy of the operator.**

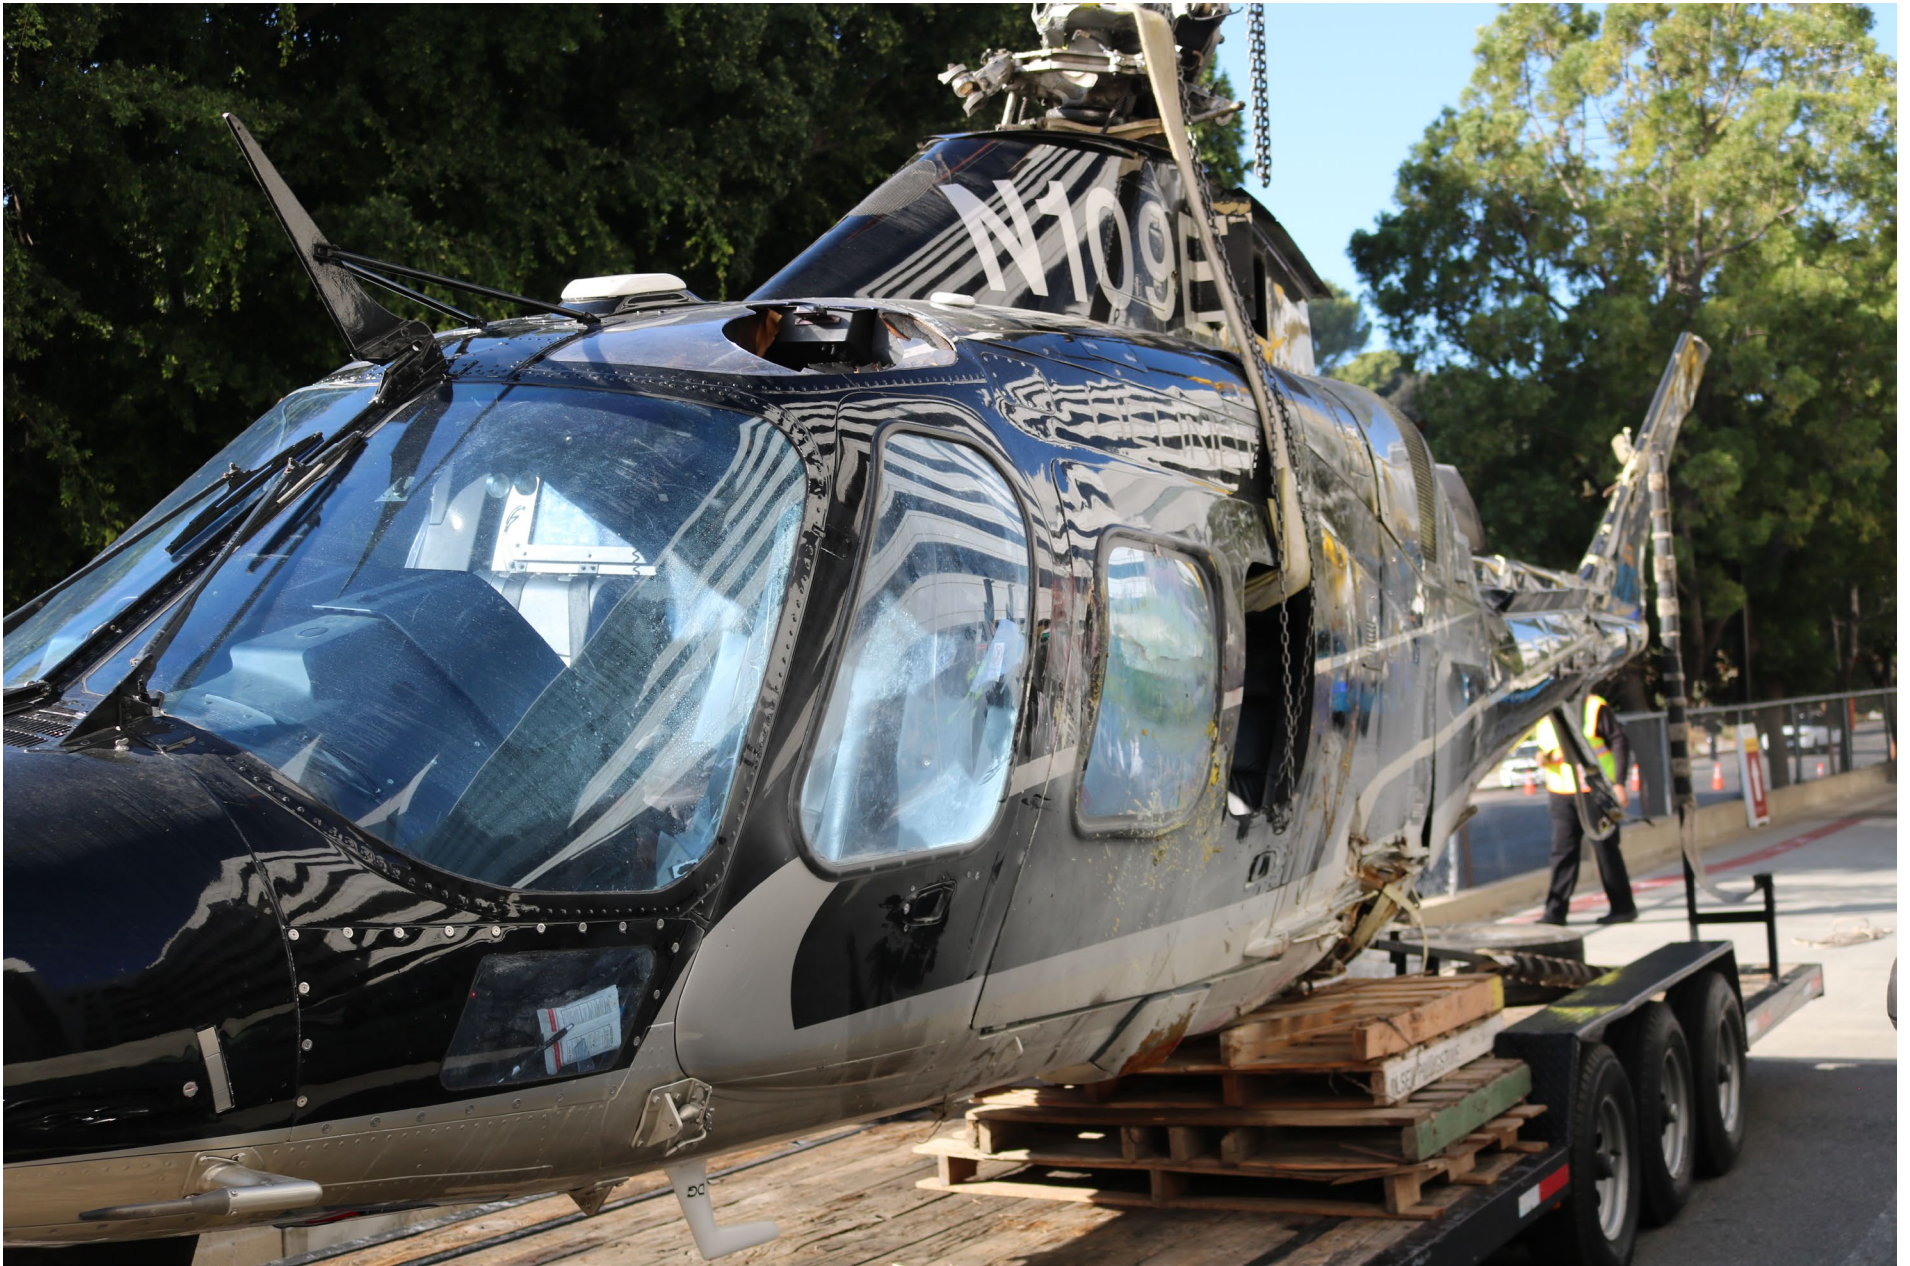
**Photo 3 – Left side view. Photo courtesy of the recovery agent.**

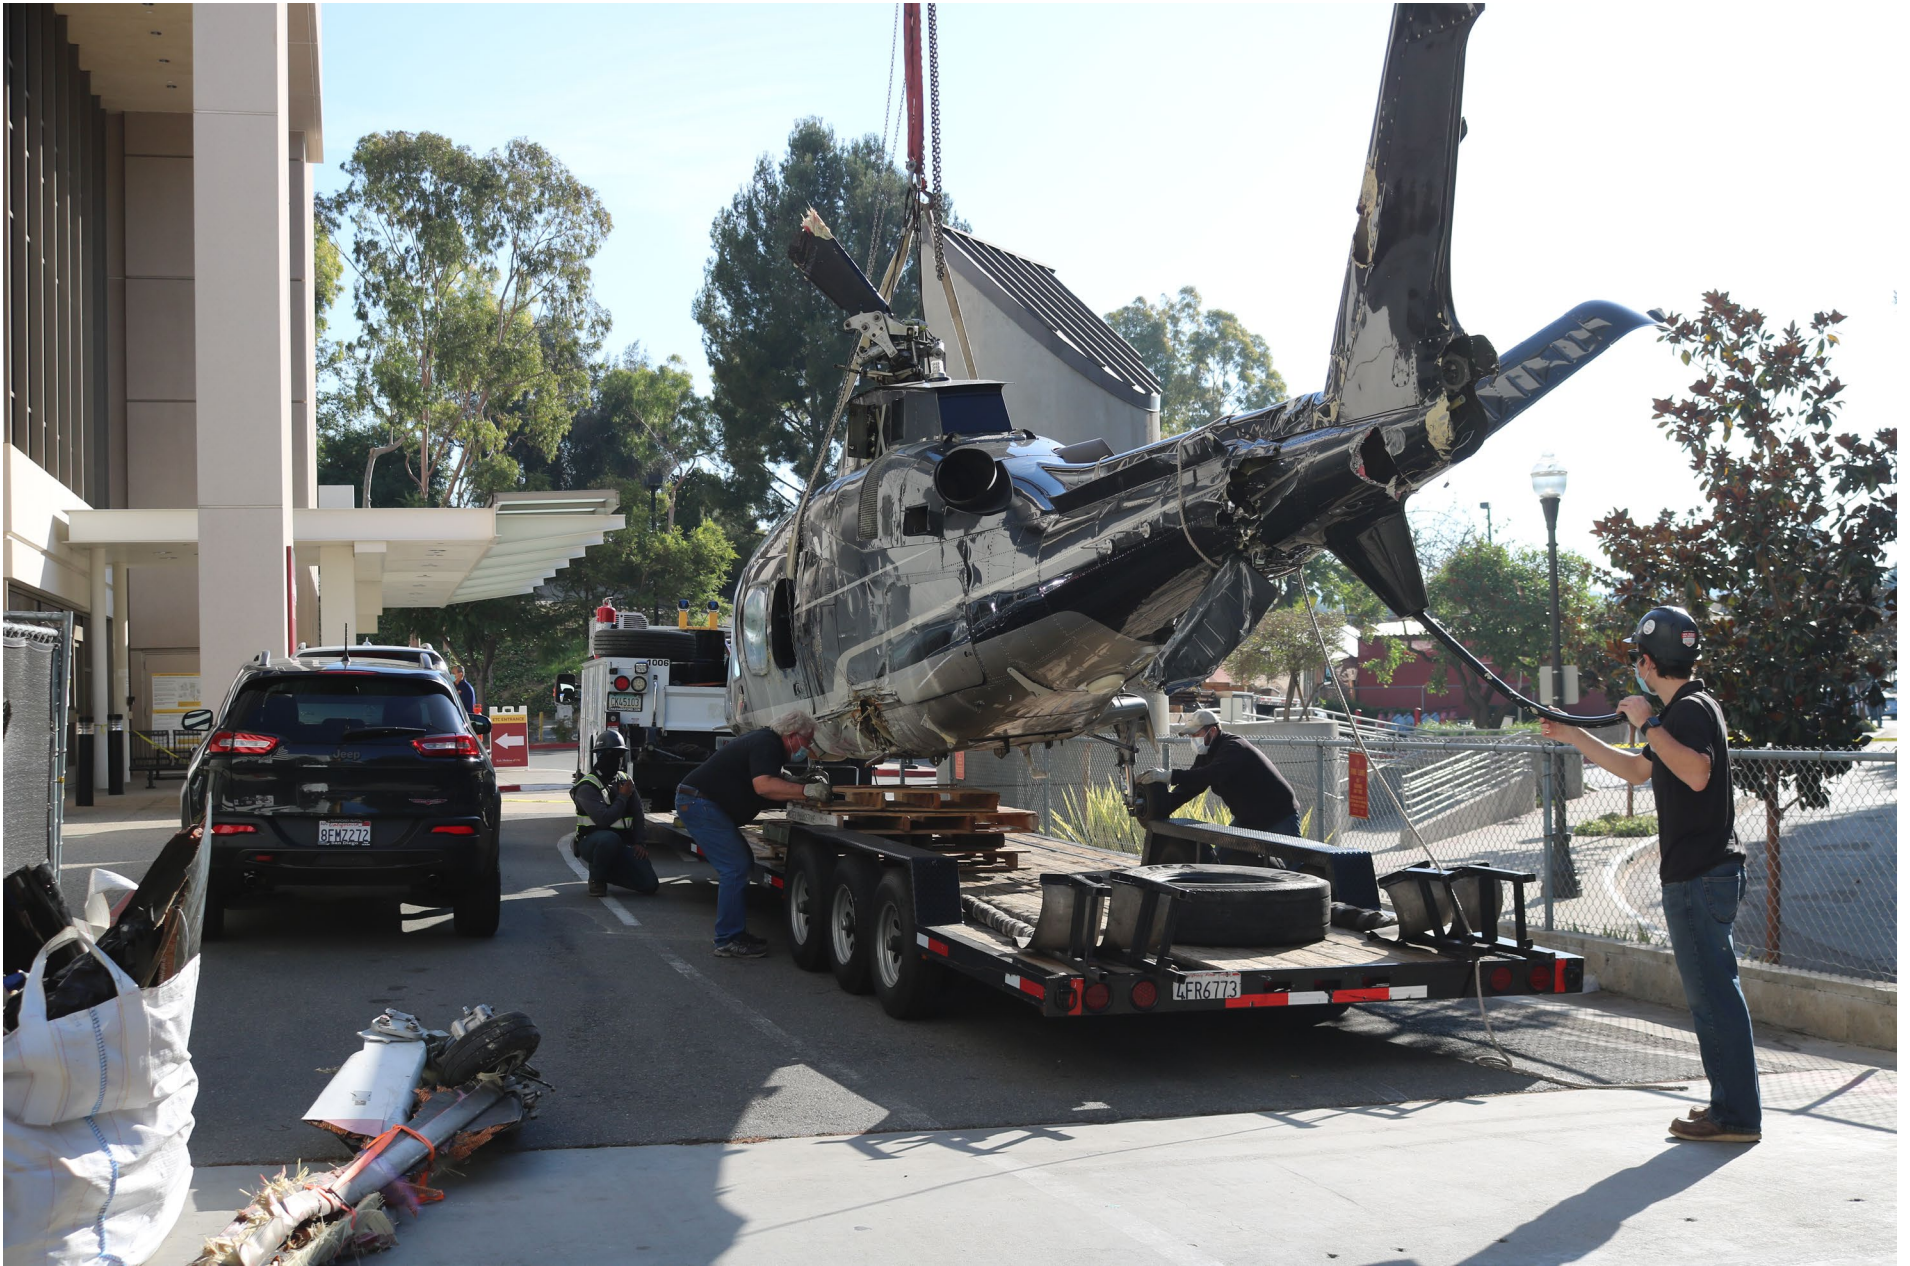
**Photo 4 – Left-rear view. Photo courtesy of the recovery agent.**

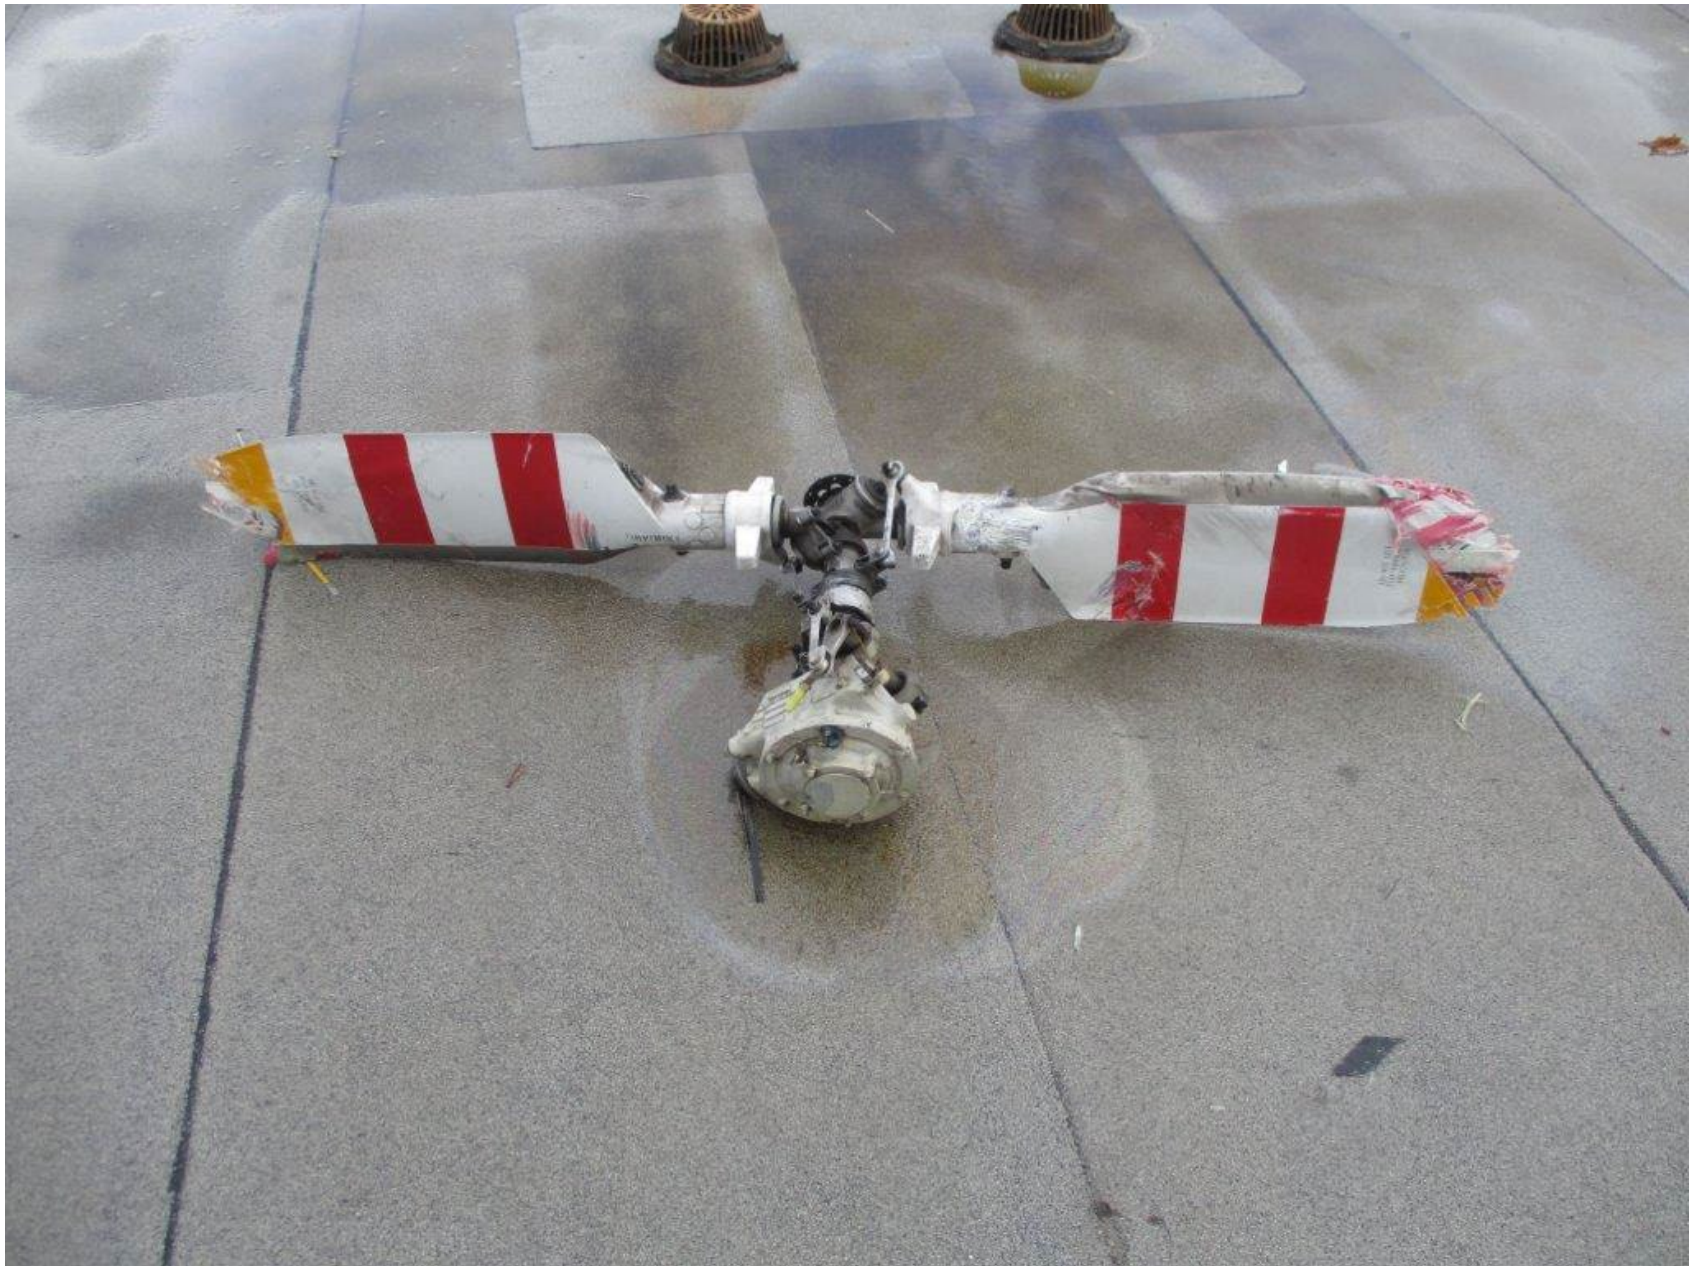
**Photo 5 – Tail rotor and 90-degrees gearbox. Photo courtesy of the operator.**

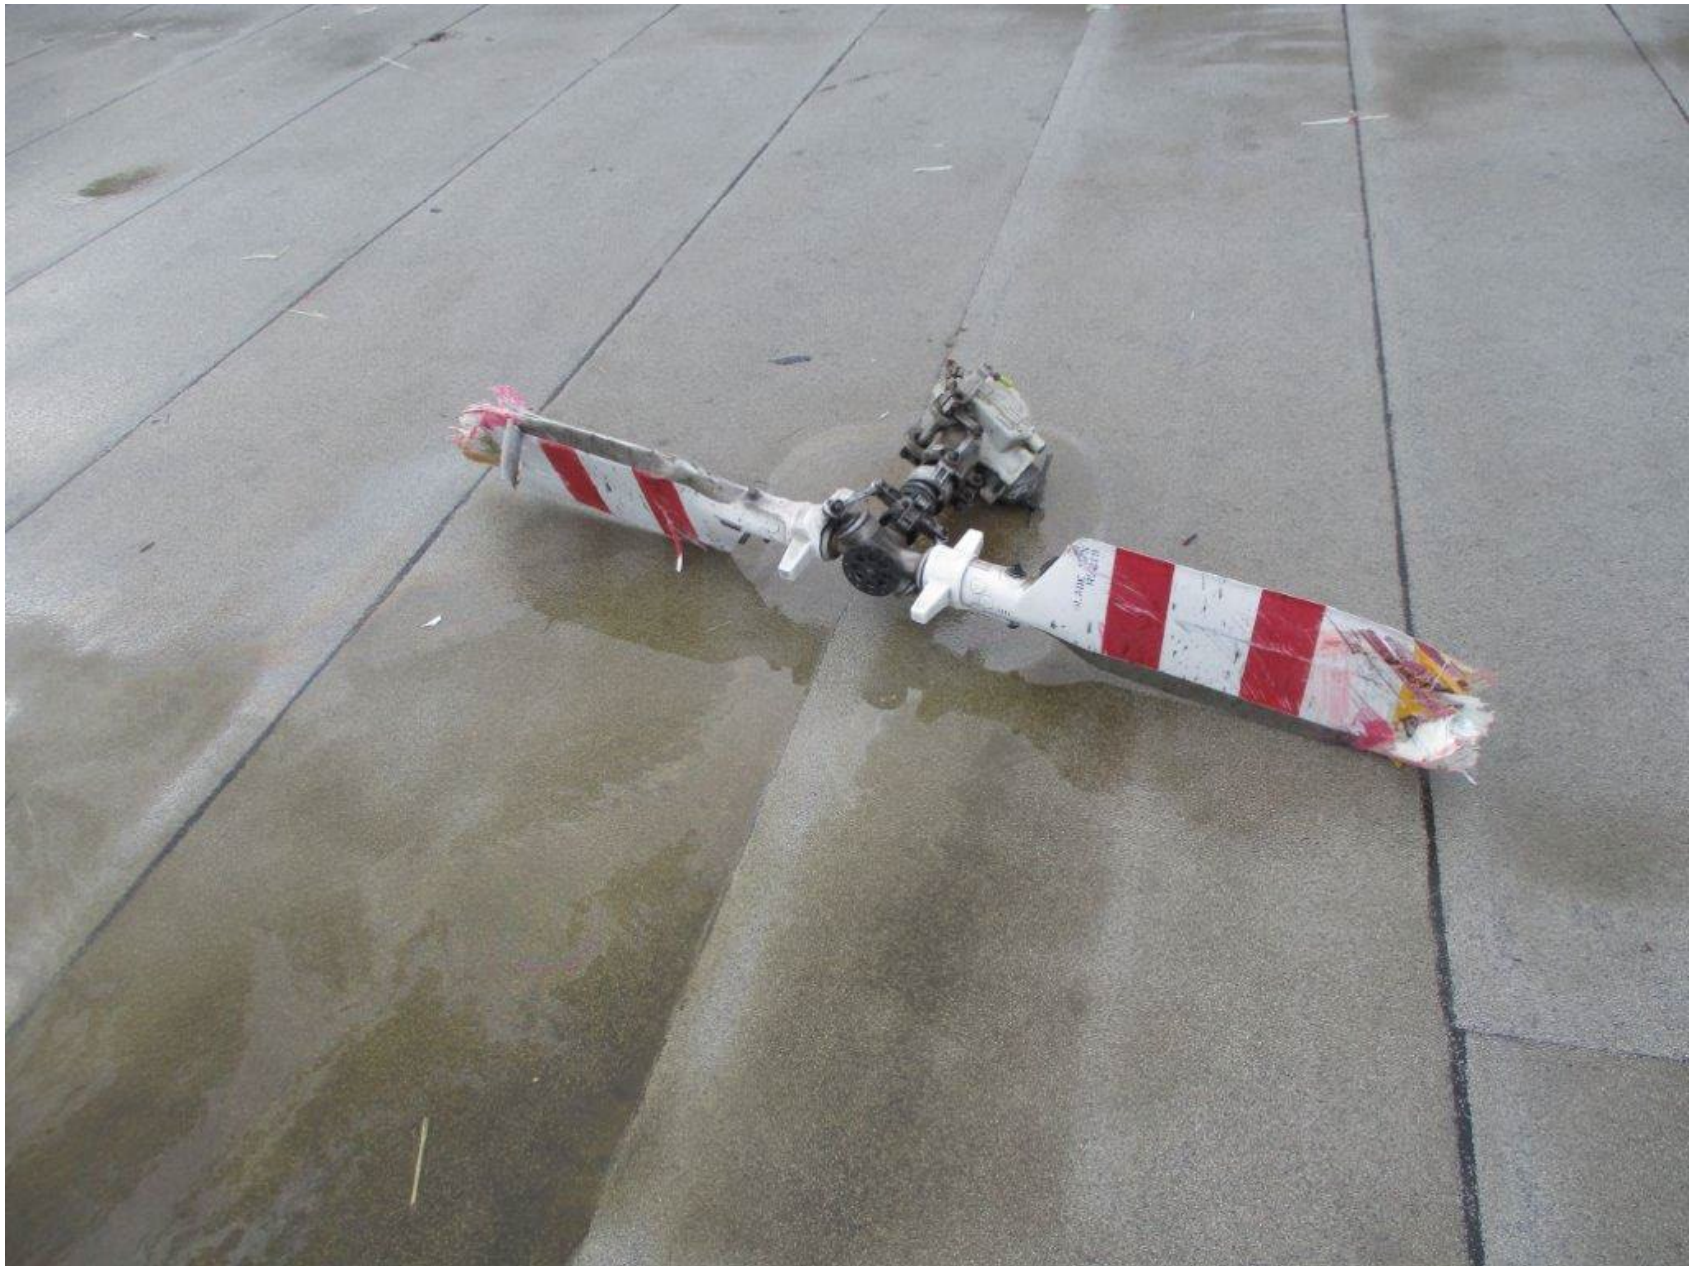
**Photo 6 – Tail rotor assembly and 90-degrees gearbox. Photo courtesy of the operator.**
