## **NATIONAL TRANSPORTATION SAFETY BOARD**

# **AIRFRAME AND ENGINE EXAMINATION**

**WPR21LA039**

Location: Los Angeles, California  
Date: November 6, 2020  
Aircraft: Agusta 109S / N109EX  
NTSB IIC: Fabian Salazar

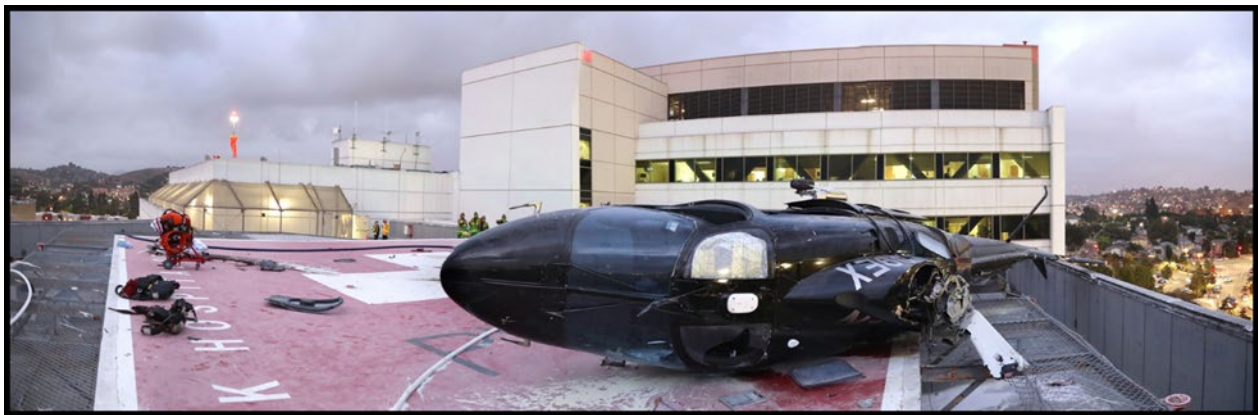
The helicopter came to rest on its left side on the helipad. All major components were in the wreckage area. The main rotor blades and the tail rotor assembly and 90° gearbox separated from the airframe.

Figure 1. View of N109EX at the accident site. Photo courtesy of the operator.

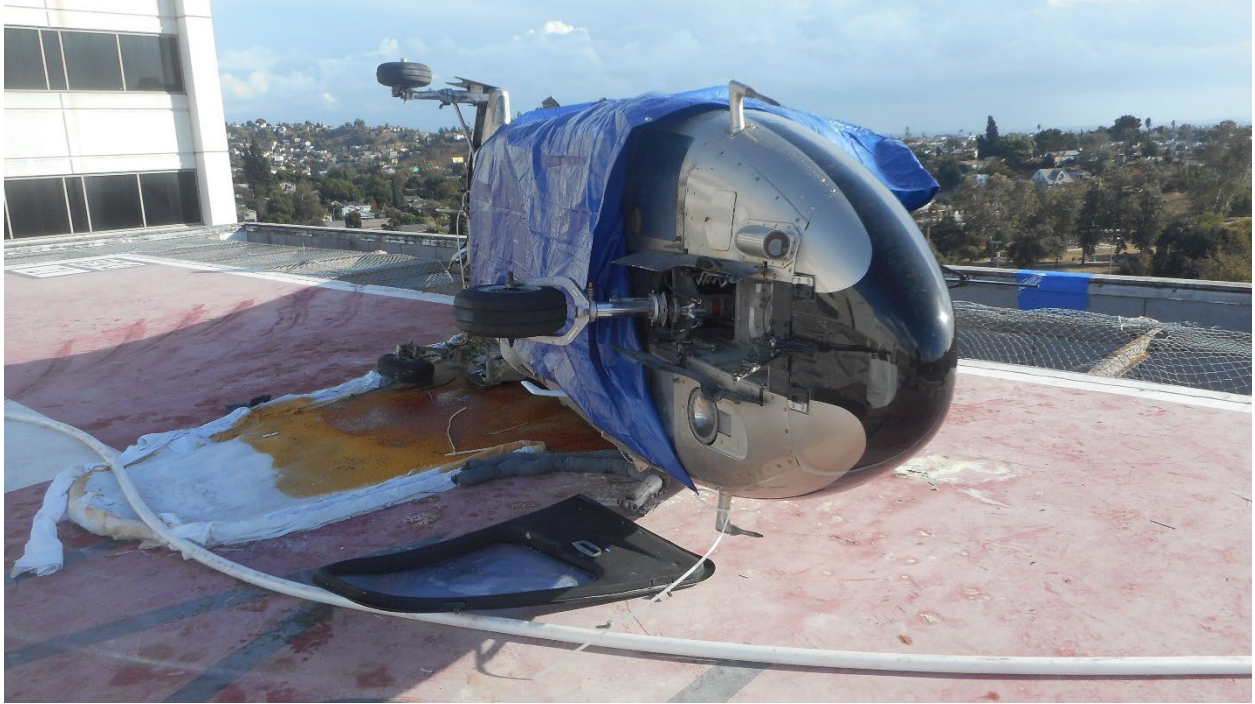
BOTTOM FUSELAGE. The bottom of the helicopter exhibited substantial damage in the area near the left main landing gear.

Figure 2. Underside view. Photo courtesy of the operator.

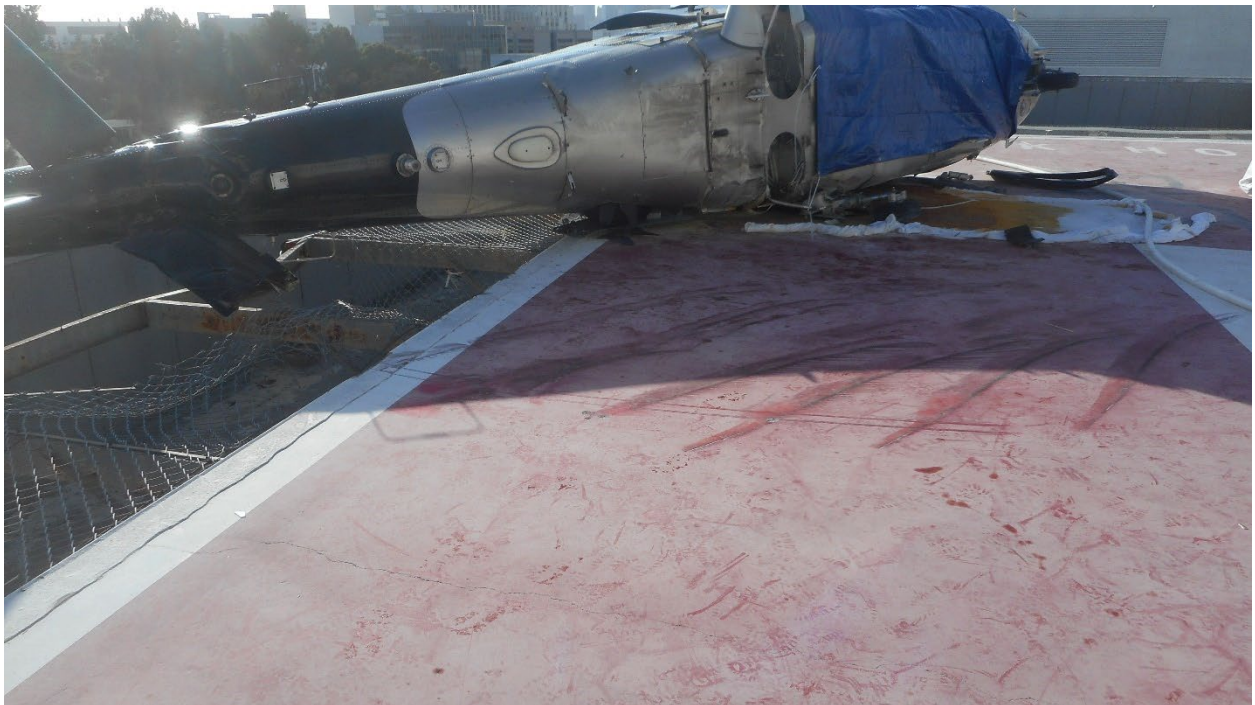
The right-side tailboom exhibited minor damage aft of the right-side sliding cabin door back to the horizontal elevator. Forward of the right-side horizontal elevator was an area of wrinkled sheet metal that extended down underneath the tail boom.

Figure 3. Underside view of the tailboom. Photo courtesy of the operator.

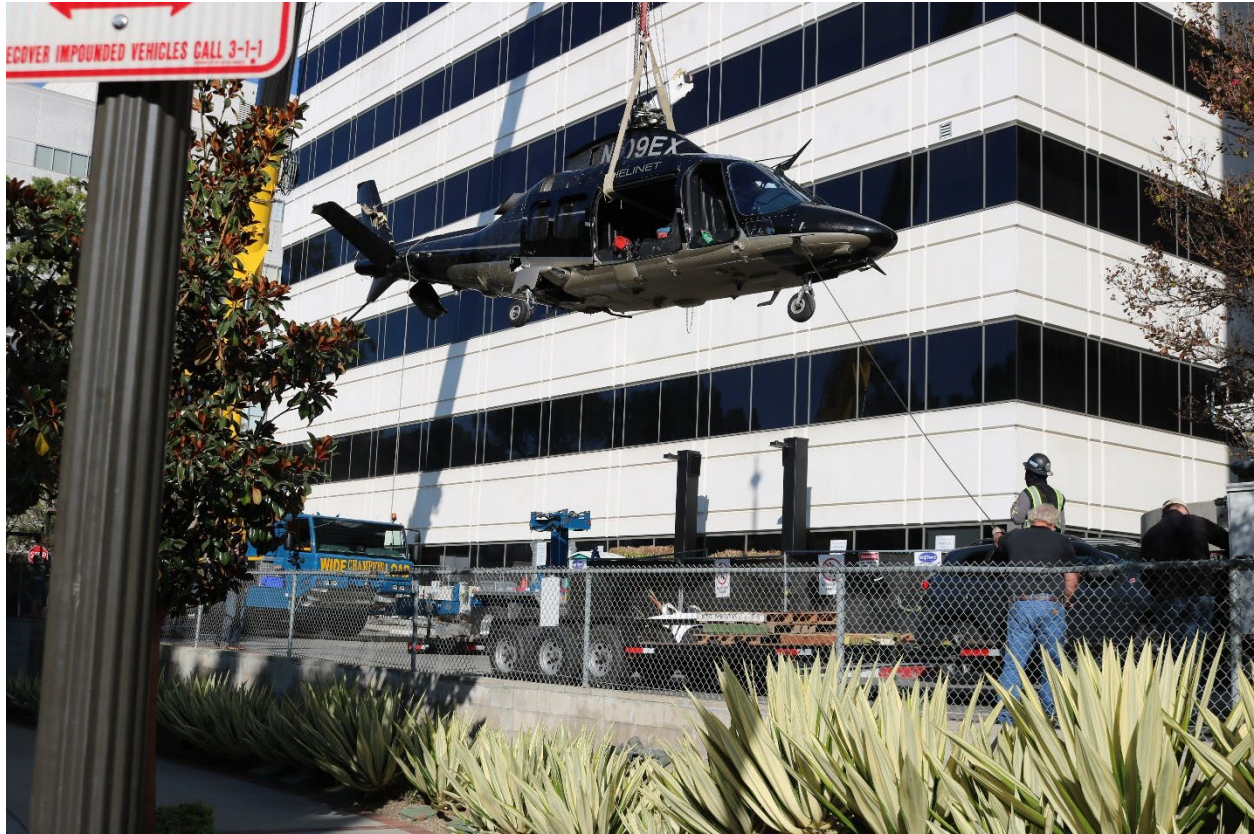
The right-side nose appeared undamaged. The right-side pilot's door was separated and was on the helipad. The right-side sliding door remained attached to the helicopter and was open. The right main landing gear remained attached to the helicopter at its mounts, appeared extended, and locked into place. The right wheel remained attached to the spindle. The right-side brakes appeared undamaged.

The right horizontal elevator remained attached to the tail boom and was displaced upwards. The end of the tail boom, or tail cone, was partially separated from the tailboom. The vertical stabilizer exhibited a hole about mid-span. The tail skid remained attached to the lower section of the tailboom and exhibited minor damage. The right-side of the vertical stabilizer exhibited substantial damage and had a large hole about mid-span.

Figure 4. Right-side view. Photo courtesy of the recovery agent.

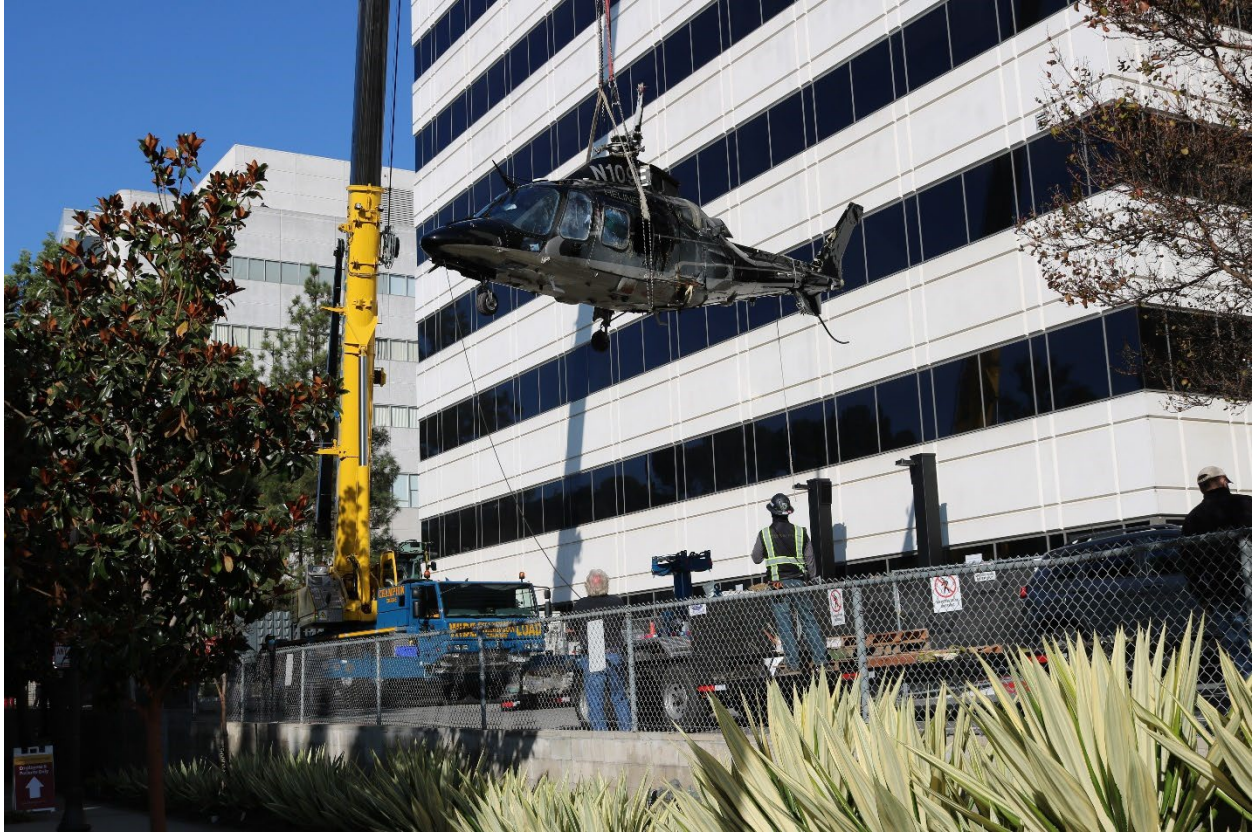
The left side of the vertical stabilizer exhibited a large hole about mid-span. A second large hole was evident forward of the tail cone. The left side of the fuselage exhibited substantial damage in the area near the left main landing gear. The left side of the tail boom exhibited substantial damage near the horizontal elevator. The remaining left side exhibited minor damage throughout.

The left-side horizontal elevator remained attached to the tailboom and was displaced downward. The outer tip inboard about mid-span had separated.

The left main landing gear partially separated from the helicopter at its mounts. The wheel remained attached at the spindle. The hydraulic brake line separated from the caliper.

Figure 5. Left-side view. Photo courtesy of the recovery agent.

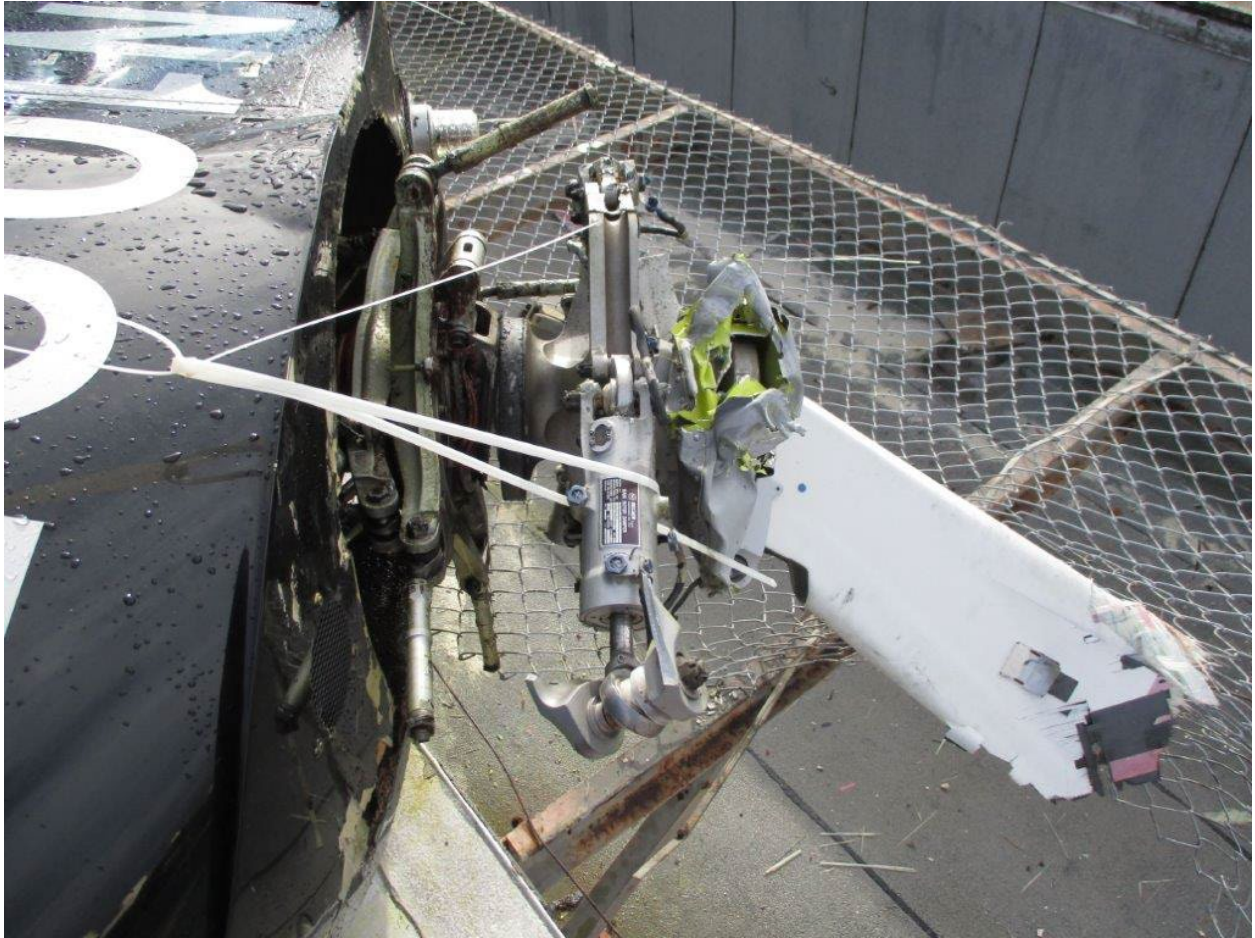
Main rotor system. The main rotor system exhibited substantial damage. Three of the four rotor blades separated at the hub, along with their respective blade grips. One section of one blade (blue blade) remained attached to the hub and extended outward from the hub about 15 inches. One blade, serial number R2013, was located on the helipad with the blade grip attached. The pitch change link rod end bearing remained attached to the pitch horn. The remaining section of

Three of the four blade dampers remained attached to the hub at their respective mounts. The area where the fourth blade damper would have been exhibited a fracture of the damper retention tab and a separated section of said tab.

All but one pitch change links separated from the blade pitch horns but remained attached to the rotating swashplate.

Figure 6. Main rotor head. Photo courtesy of the recovery agent.

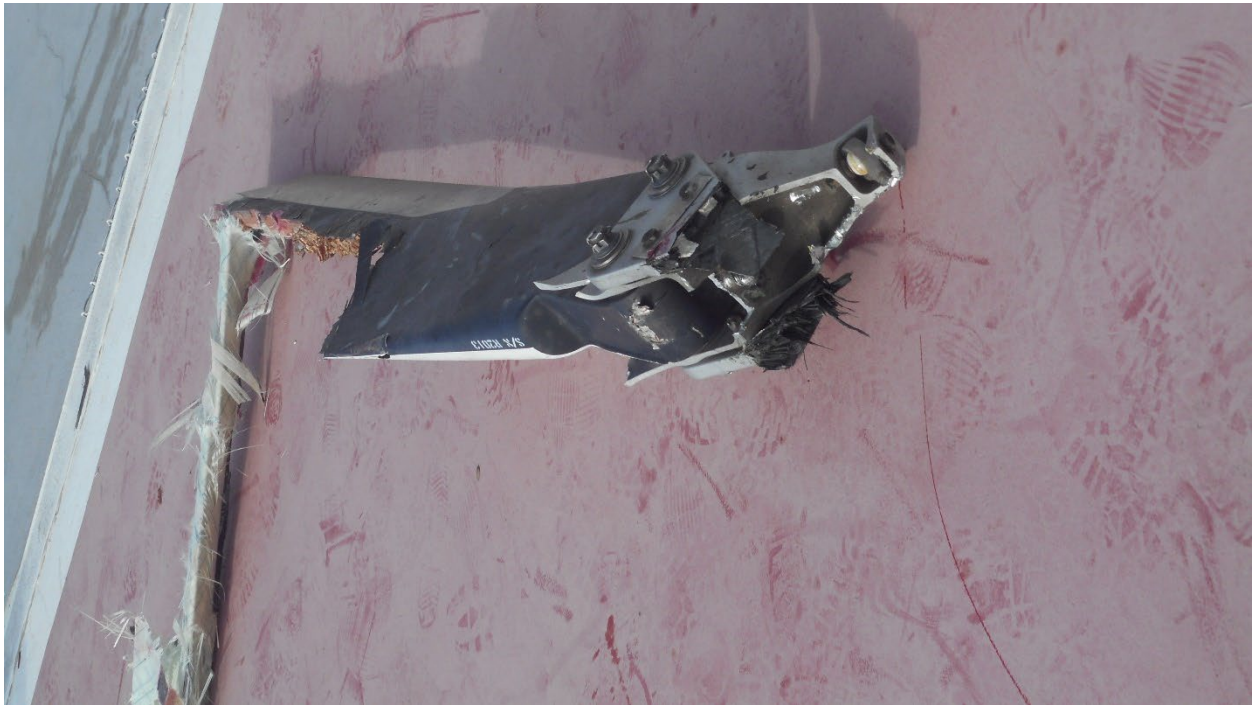
the blade exhibited complete separation of the afterbody from the spar. There was a fracture and sharp bend outboard of the metal leading edge. A section of a third main rotor blade (unknown color) was found on the helipad. The blade grip remained attached to this blade. The blade extended from the blade grip about 36 inches and did not retain much afterbody. A long section of a main rotor blade lay across it. One blade serial number R-2040, the red blade, was found on the helipad. The blade grip remained attached to the blade root. The pitch change rod end bearing remained attached to the pitch change horn. The steel leading edge remained attached but the after body had separated. The rod end bearing to the blade damper remained attached to the blade grip.

Figure 7. Main rotor blade. Photo courtesy of the recovery agent.

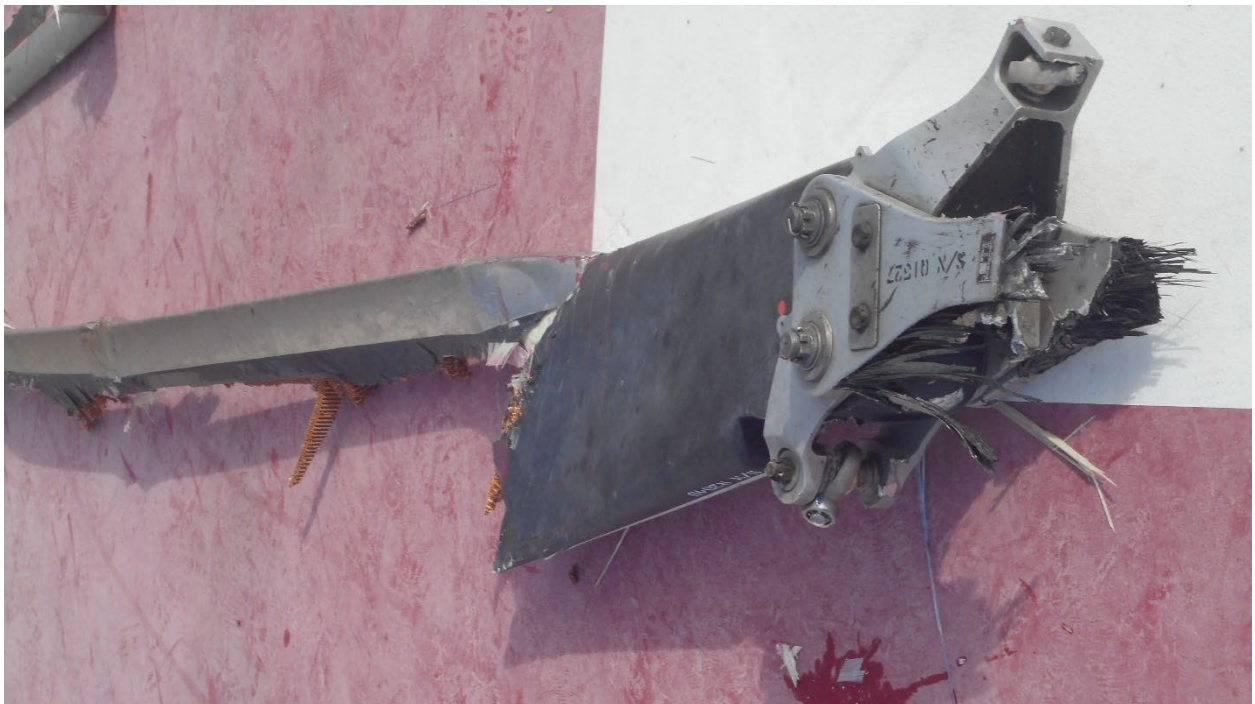
Figure 8. Red main rotor blade. Photo courtesy of the operator.

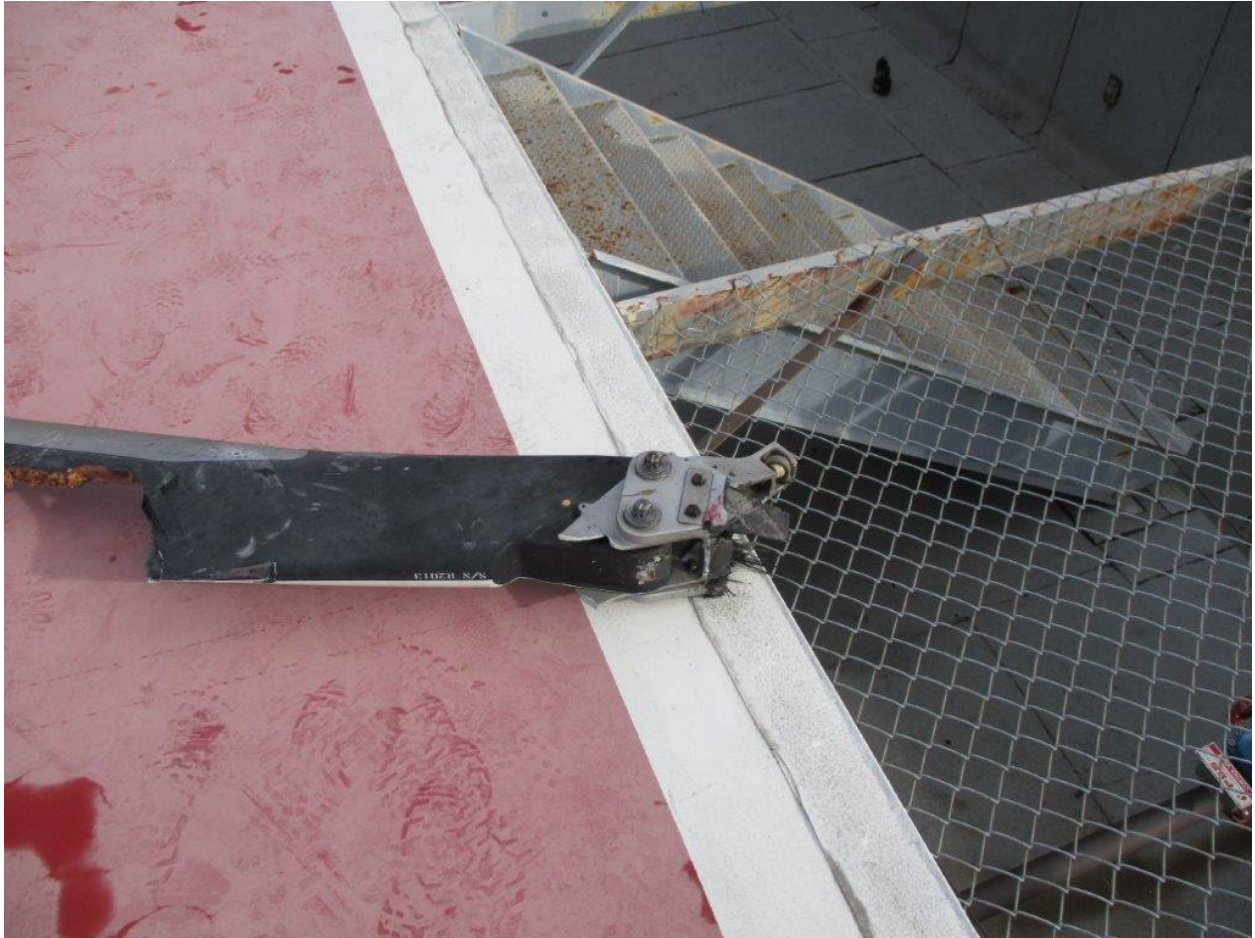
Figure 9. Yellow main rotor blade. Photo courtesy of the recovery agent.

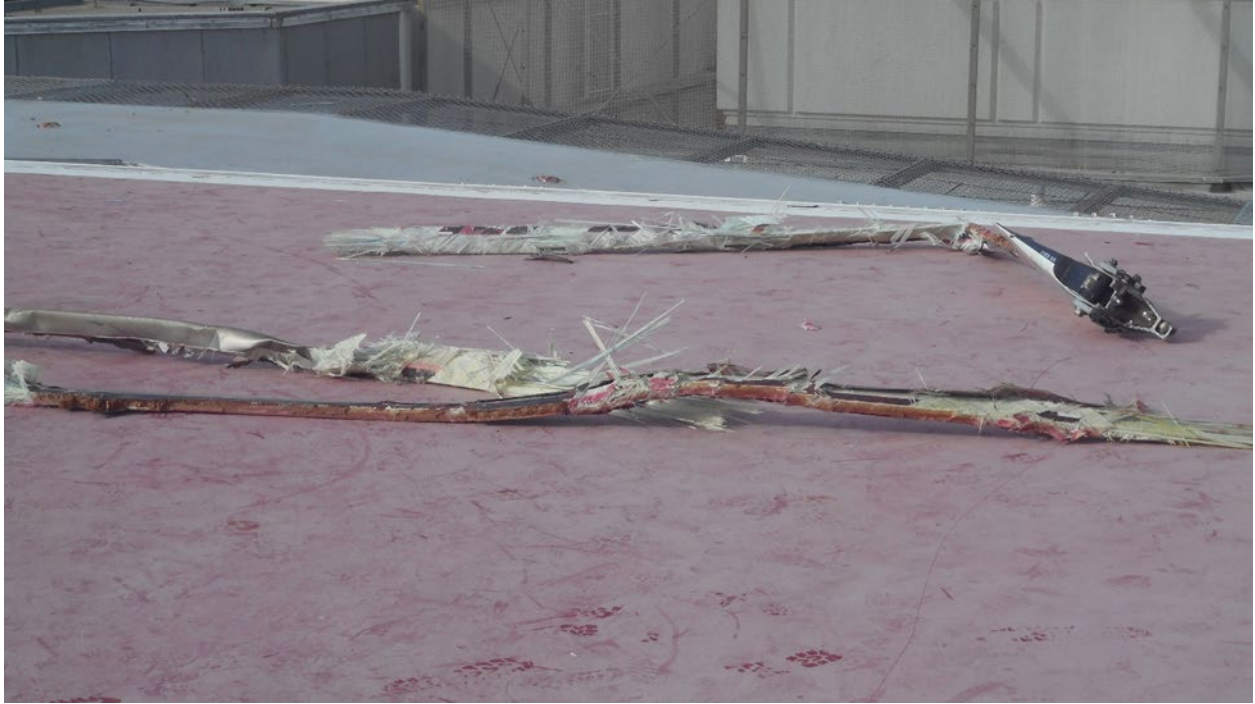
Figure 10. Two main rotor blades. Photo courtesy of the recovery agent.

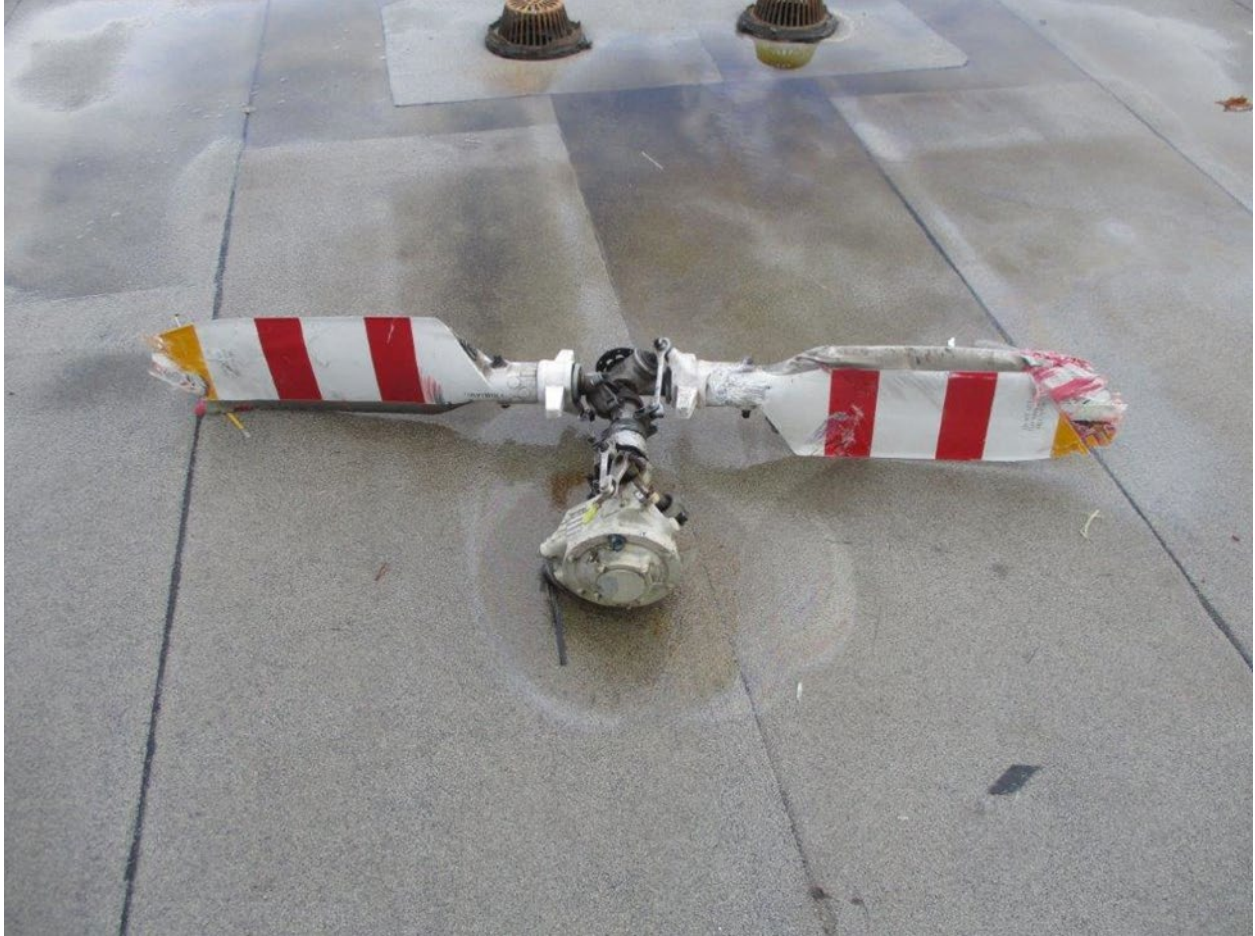
The tail rotor and 90° gearbox separated from the helicopter and was off the helipad on the roof of the hospital. Both composite blades remained attached to the hub and exhibited substantial damage at the tips but retained a significant amount of the yellow paint, consistent with not losing a large amount of the blade tips. One blade exhibited a large dent in the leading edge. One exhibited red paint smearing near the tip. Both pitch change links remained attached at their respective attachment points. A small section of the pitch change push-pull tube and the rod end bearing remained attached to the bellcrank at the 90° gear box.

Figure 11. Tail rotor assembly and 90° gear box, Photo courtesy of the recovery agent.

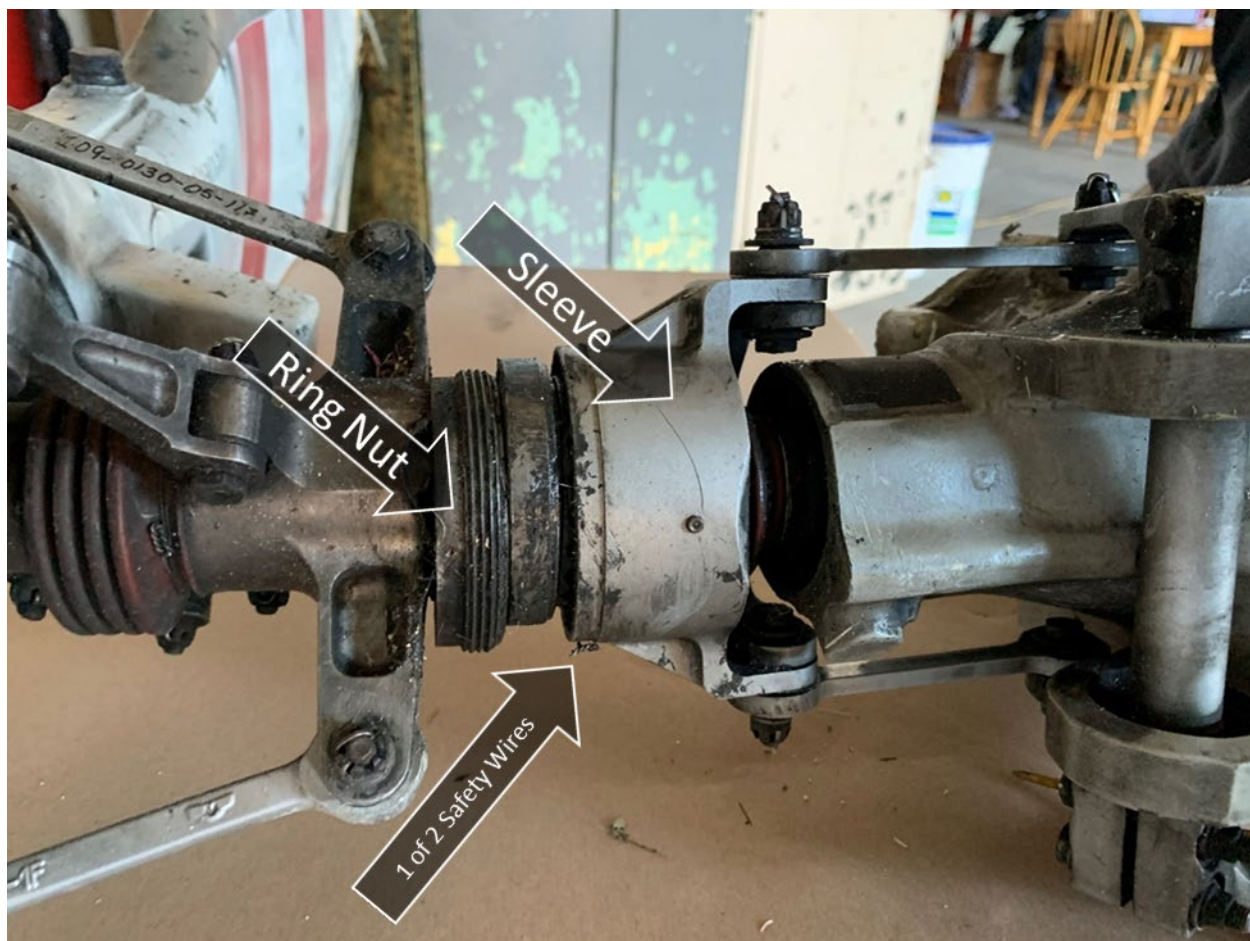
clockwise about the vertical axis, all major components of the anti-torque system were recovered for further examination. Those components are identified in the report. A visual examination of the rotating controls of the tail rotor assembly revealed the ring nut, part number 109-0130-97-103, had separated from the thrust sleeve, part number 109-0130-94-111, A109S/AW109SP IETP 25<sup>th</sup> issue. The helicopter was equipped with an Appareo Vision-1000 video recorder. The recorder and the video memory card were shipped to the NTSB Recorders Laboratory. Download of the video revealed a momentary torques spike and nothing to further aid the investigation.

A photo of the rotating controls of the tail rotor assembly revealed the ring nut separated from the thrust sleeve. A bearing race with no ball bearings was visible. A safety wire fragment was visible, attached to the thrust sleeve. The drive link was attached at both respective attachment points.

Figure 12. Photo of the rotating controls taken at the recovery site. One of the two safety wires is visible at the bottom of the thrust sleeve.

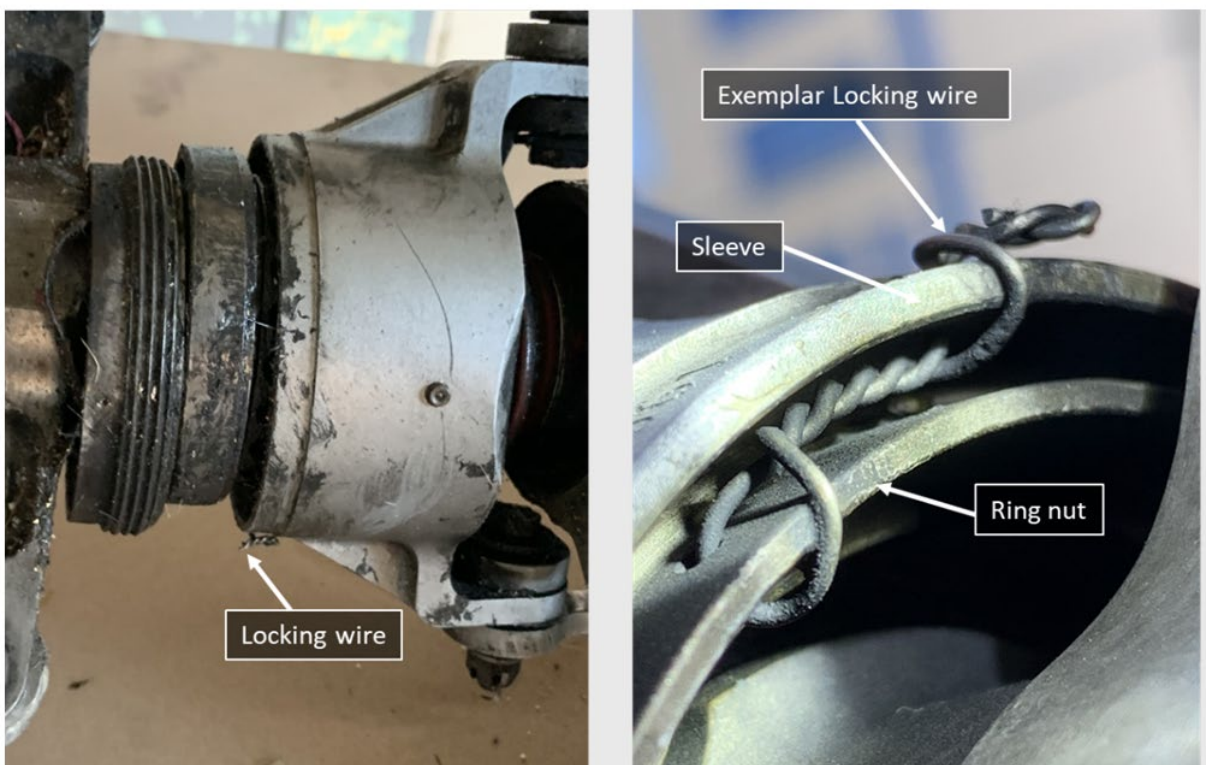
Figure 14. Photo showing part of one locking wire attached to the accident sleeve (left), and a photo that shows an exemplar locking wire from a different helicopter (right). Photo of the accident ring and sleeve, courtesy of the FAA.

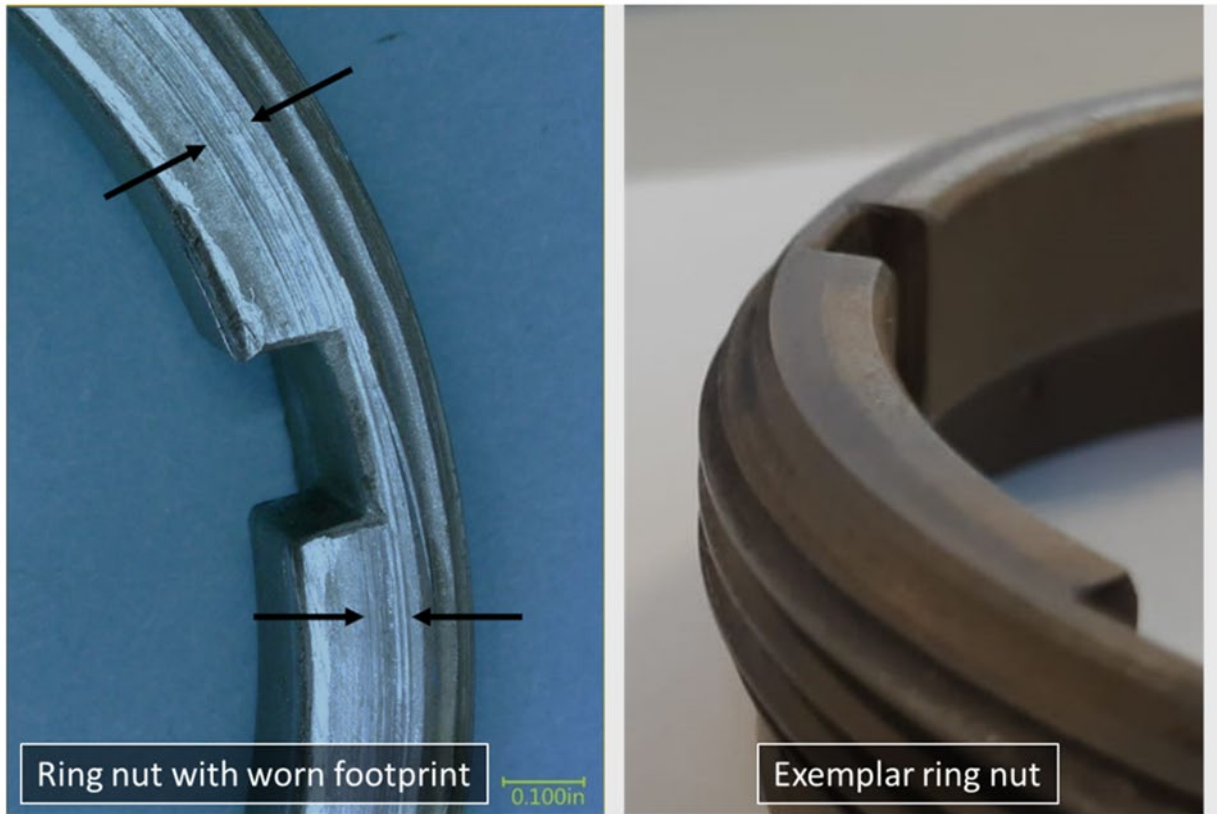
Figure 15. Image showing the step or worn footprint on the accident ring nut, and an exemplar ring nut. Photo of the exemplar ring nut courtesy of the airframe manufacturer.

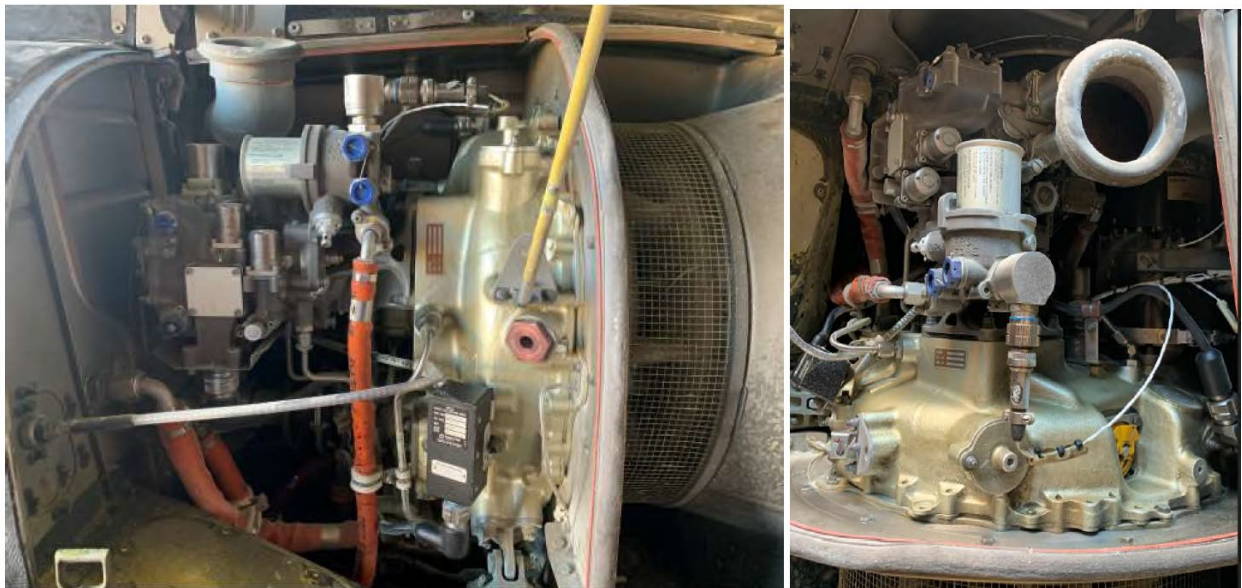
The left-hand engine, model PW207C, serial number: PCE-BH0383, was manufactured in March 2009. The DCU for this engine was model number 3054276-02, serial number DP09-6065. A visual exam of the engine revealed no mechanical malfunctions or failures that would have precluded normal operation.

Figure 16. Left hand Engine, PCE-BH0383, reduction gearbox and output shaft. Photo courtesy of Pratt & Whitney Canada.

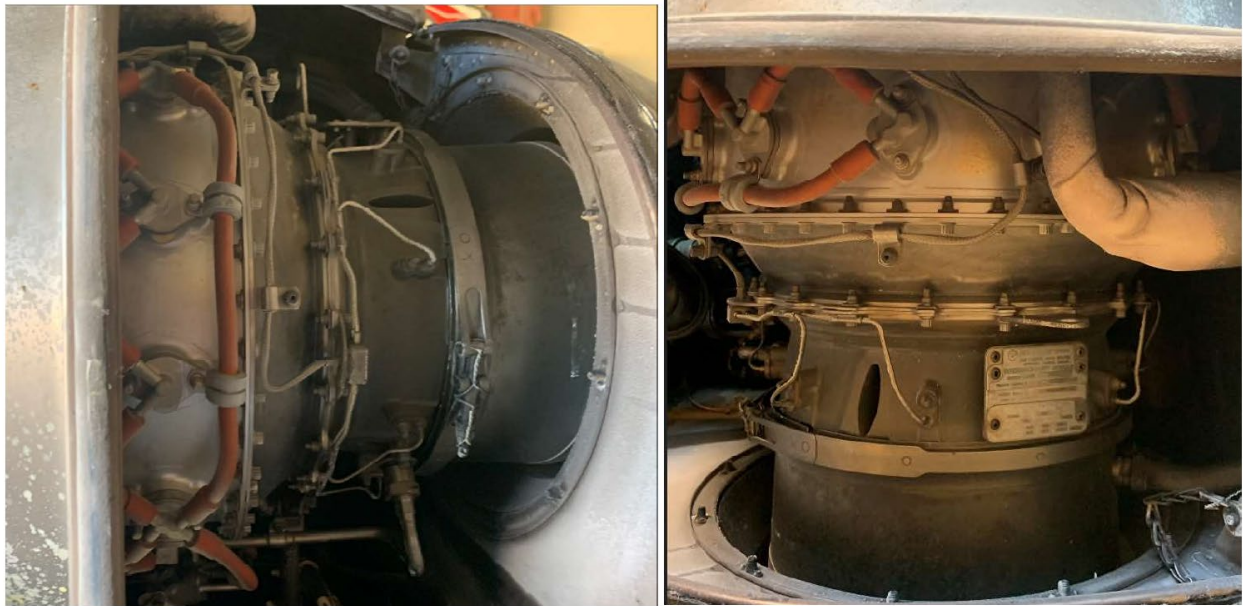
Figure 17. Left hand engine gas generator case and exhaust case. Photo courtesy of Pratt & Whitney Canada.

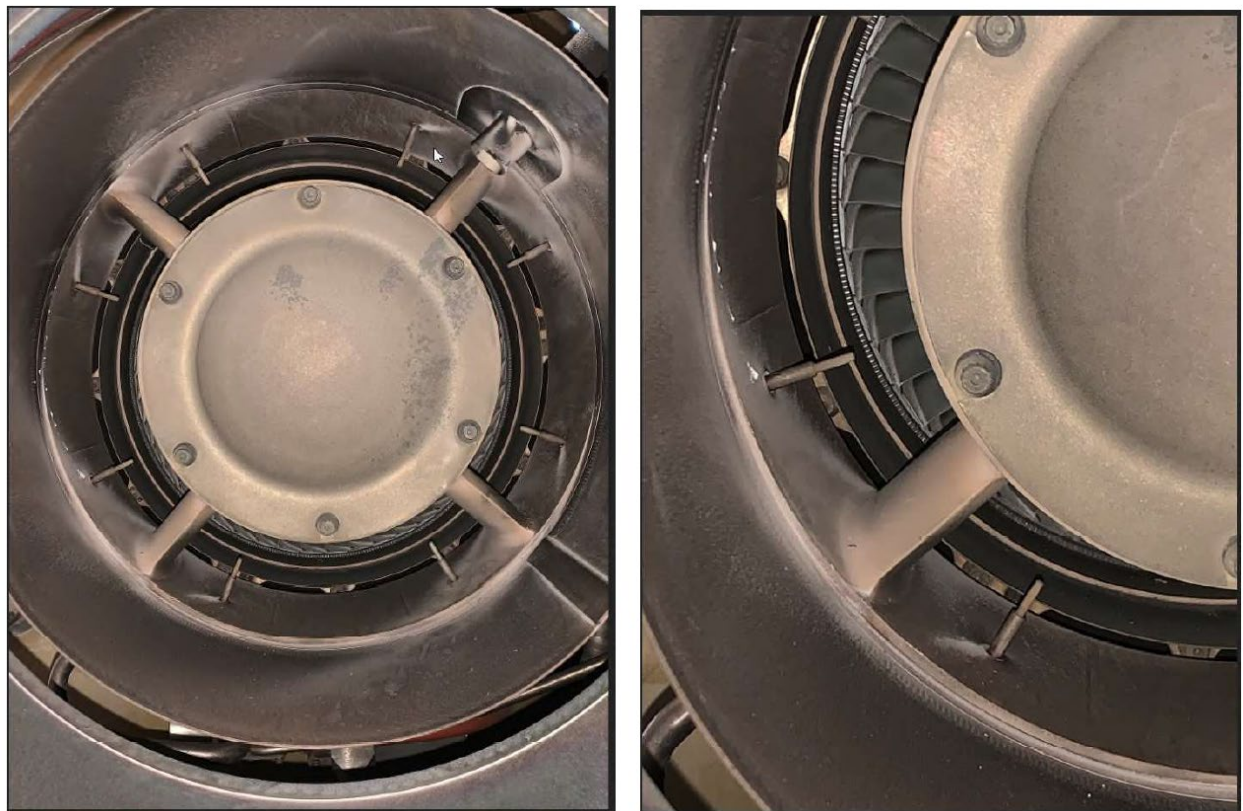
Figure 18. Left hand engine power turbine blades. Photo courtesy of Pratt & Whitney Canada.

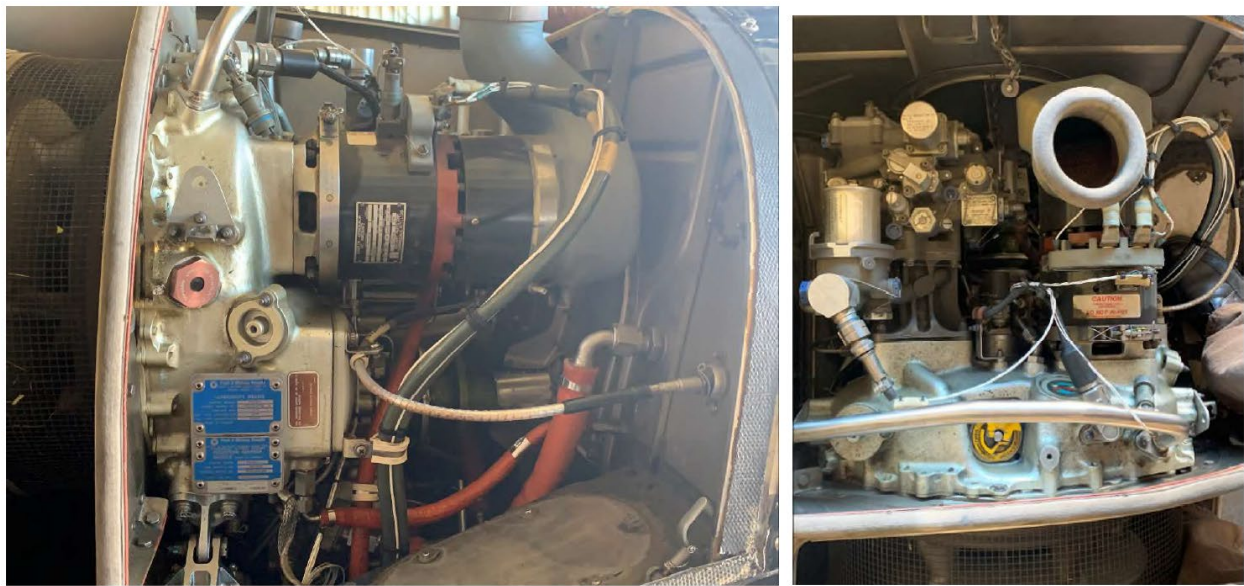
The right-hand engine, model number PW207C, serial number: PCE- BH0396, was manufactured in 2009. The DCU for this engine was model number 3054276-02, serial number DP09-5973. A visual exam of the engine revealed no mechanical malfunctions or failures that would have precluded normal operation.

Figure 19. Right hand engine, PCE-BH0396, reduction gearbox and output shaft. Photo courtesy of Pratt & Whitney Canada.

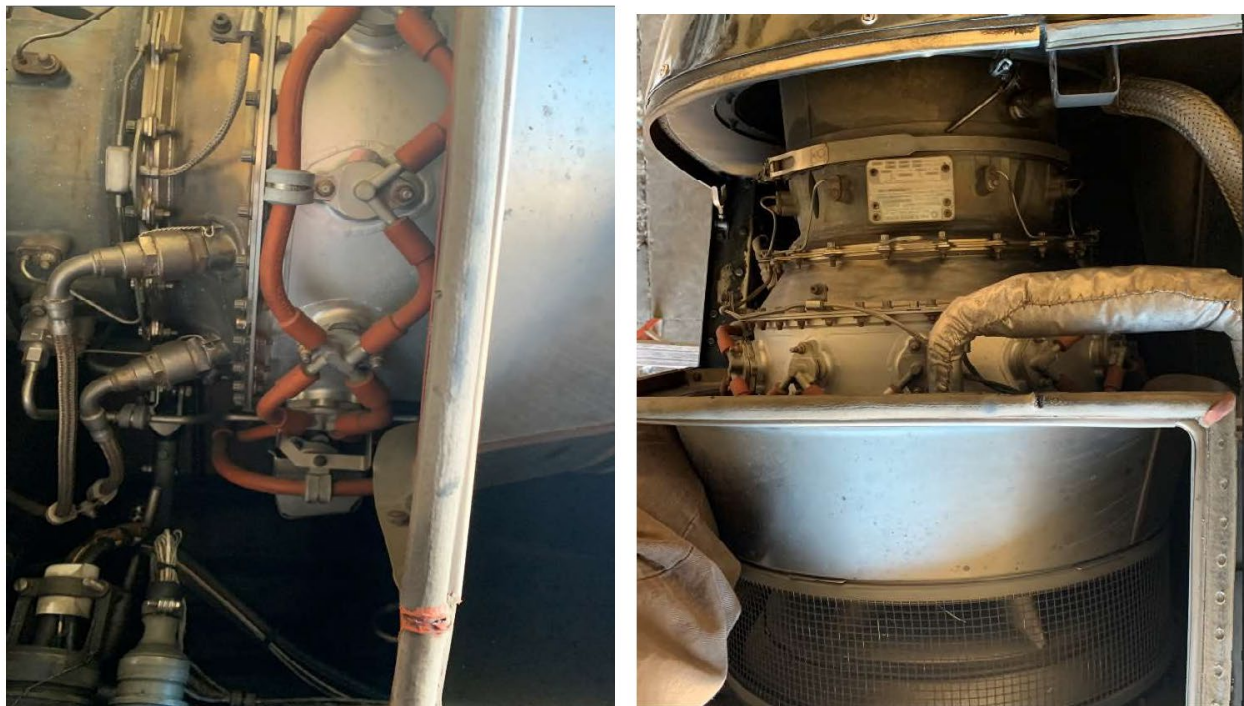
Figure 20. Right hand engine, gas generator case and exhaust case. Photo courtesy of Pratt & Whitney Canada.

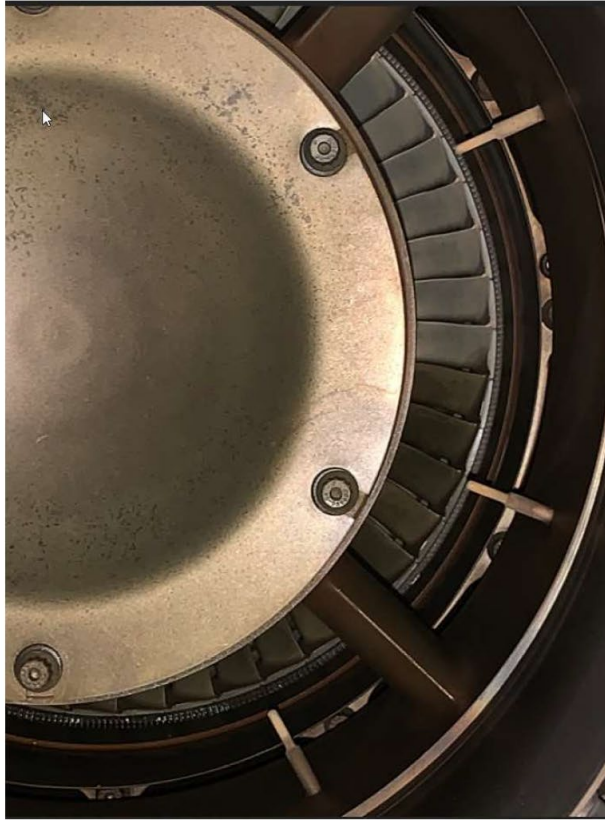
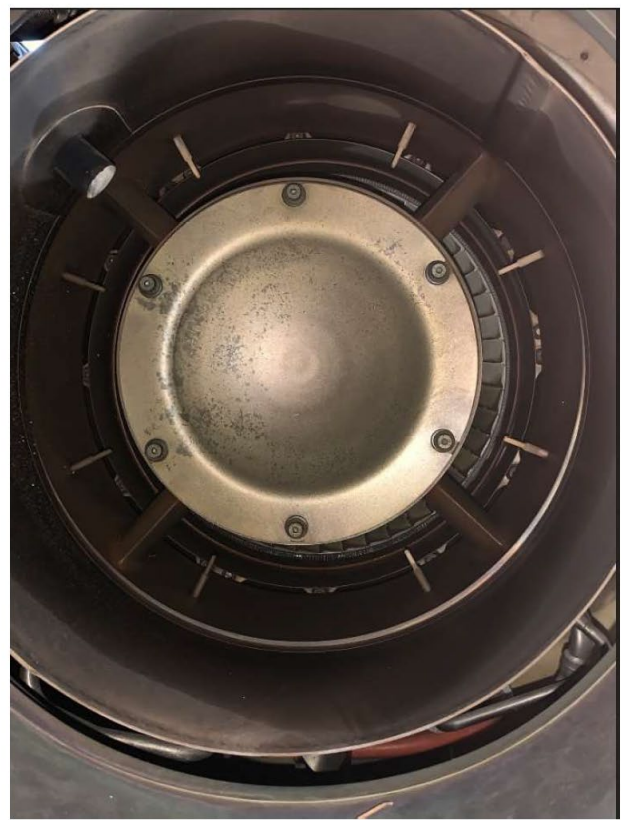
Figure 21. Right hand engine, power turbine blades. Photo courtesy of Pratt & Whitney Canada.
