# NATIONAL TRANSPORTATION SAFETY BOARD

## MATERIALS LABORATORY FACTUAL REPORT

Report No. 20-060

Place : Los Angeles, California  
Date : 11/6/2020  
Vehicle : Agusta A109 (N109EX)  
NTSB No. : WPR21LA039  
Investigator : Fabian Salazar

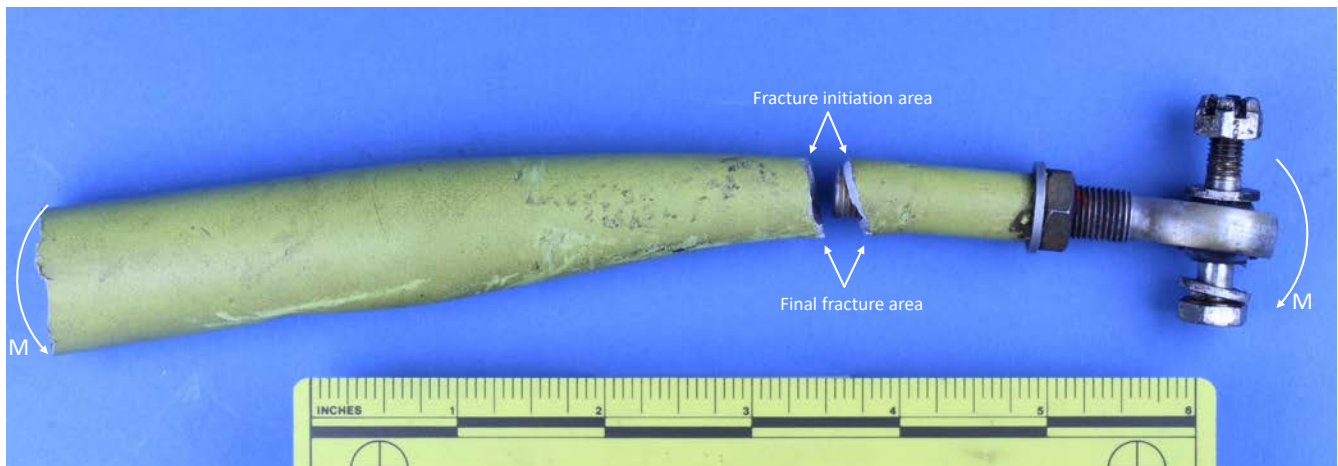
The as-received pieces of the tail rotor push-pull tube with rod end are shown in Figure 1. Close views of the fracture are shown in Figure 2. All fracture and deformation features are consistent with bending overstress fracture in the tapered section of the aluminum push-pull tube adjacent to the rod end internal threads. No pre-existing corrosion damage was observed.

Figure 1 Image of the as-received pieces of fractured tail rotor push-pull tube and rod end. The image has been annotated to reveal the initiation and final fracture areas and the direction of the bending moment,  $M$ , to open the crack.

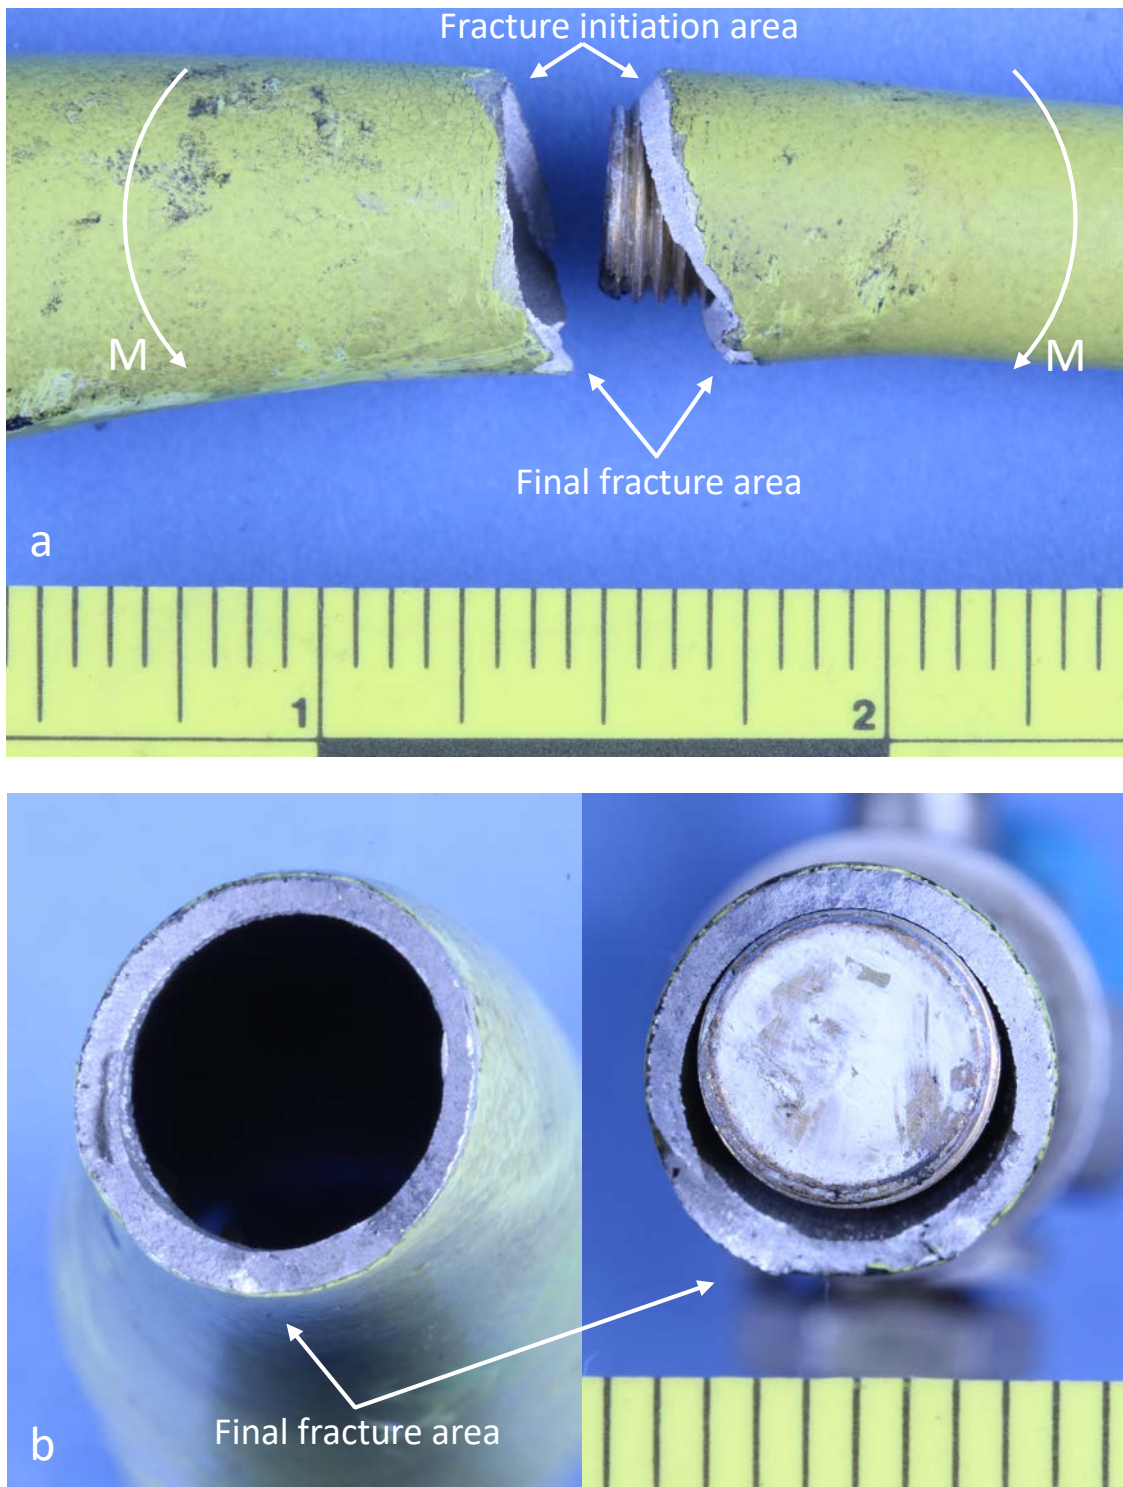
Figure 2 Closer views of the fracture in the tail rotor push-pull tube. View (a) is a side view. View (b) shows both halves of the fracture from top down.
