## BOLLETTINO TECNICO

N° **109S-48**

DATE September 21, 2012

**SUBJECT:** TAIL ROTOR DUPLEX BEARING RING NUT P/N 109-0130-97-103  
INSPECTION.

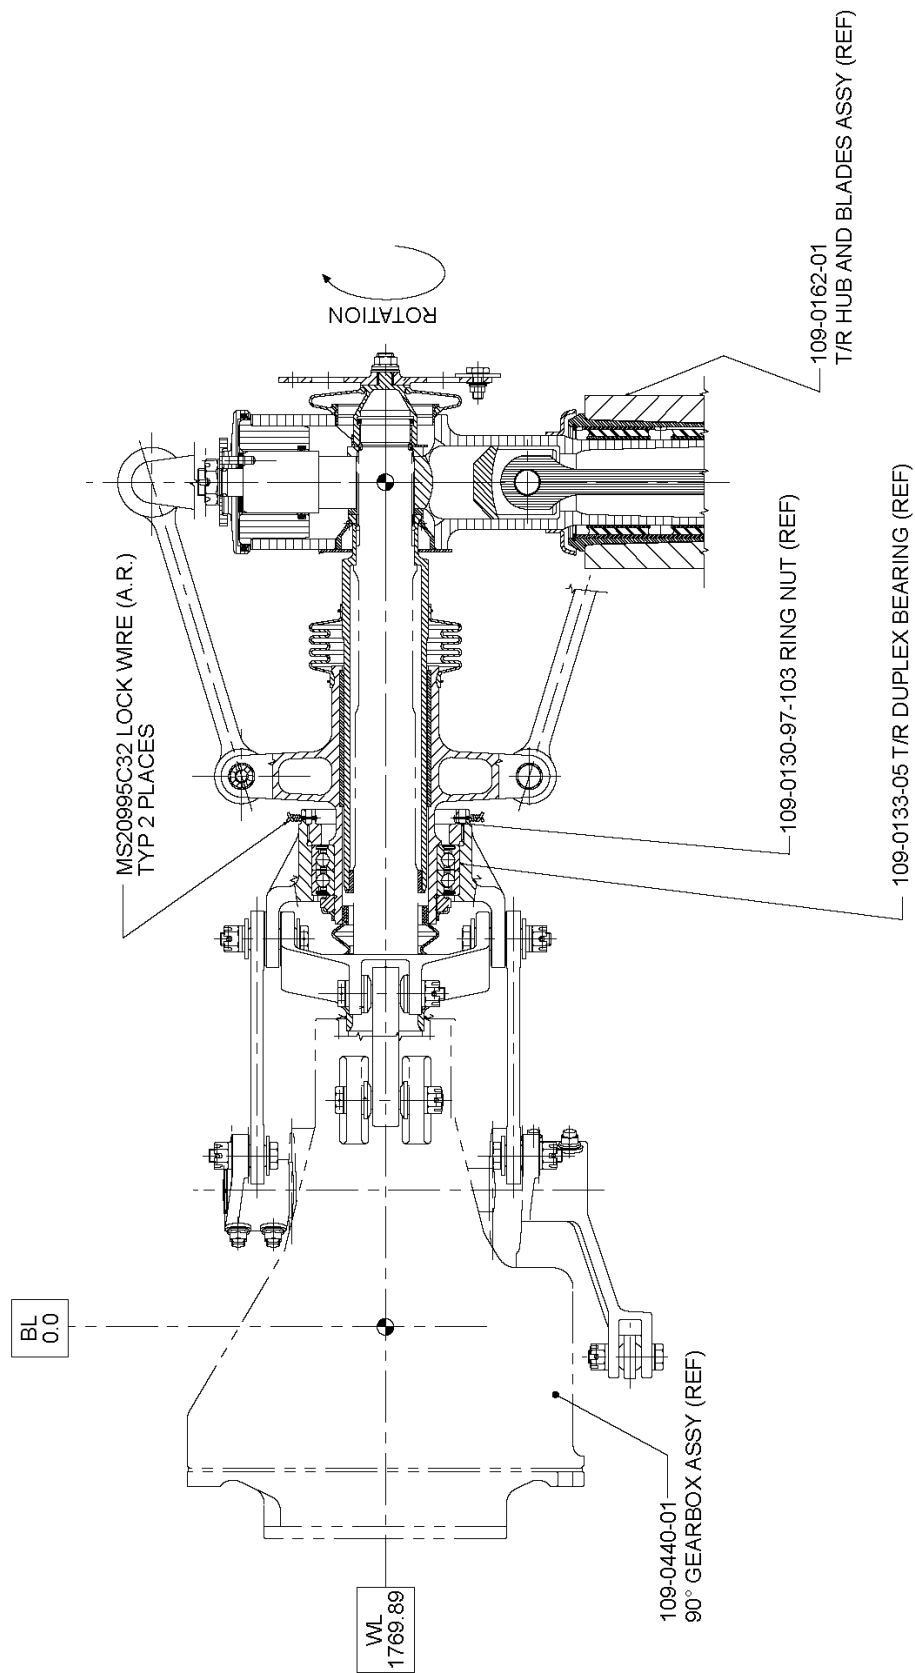
**FIGURE 1**

1. Prepare the helicopter on ground for a safe maintenance, disconnect any power supply.
2. Gain access to the tail rotor rotating controls P/N 109-0136-01 and visually inspect the two MS20995C32 lockwires, securing

the duplex bearing locking nut P/N 109-0130-97-103 to the housing, for presence and condition (ref. figure 1).

- 2.1. If one or both the MS20995C32 lockwires are damaged, immediately proceed as described in step 2 and following steps of PART III^ of this Bollettino.
- 2.2. If only one MS20995C32 lockwire is present and on it no damage is reported, install the missing locking by means of an appropriate length of MS20995C32 lockwire and proceed as described in the step 3 and 4.
- 2.3. If the two MS20995C32 lockwires are present and no damage is reported, proceed as described in the following steps.
3. Return the helicopter in service.
4. Record compliance with PART I^ of this Bollettino in the helicopter log book.

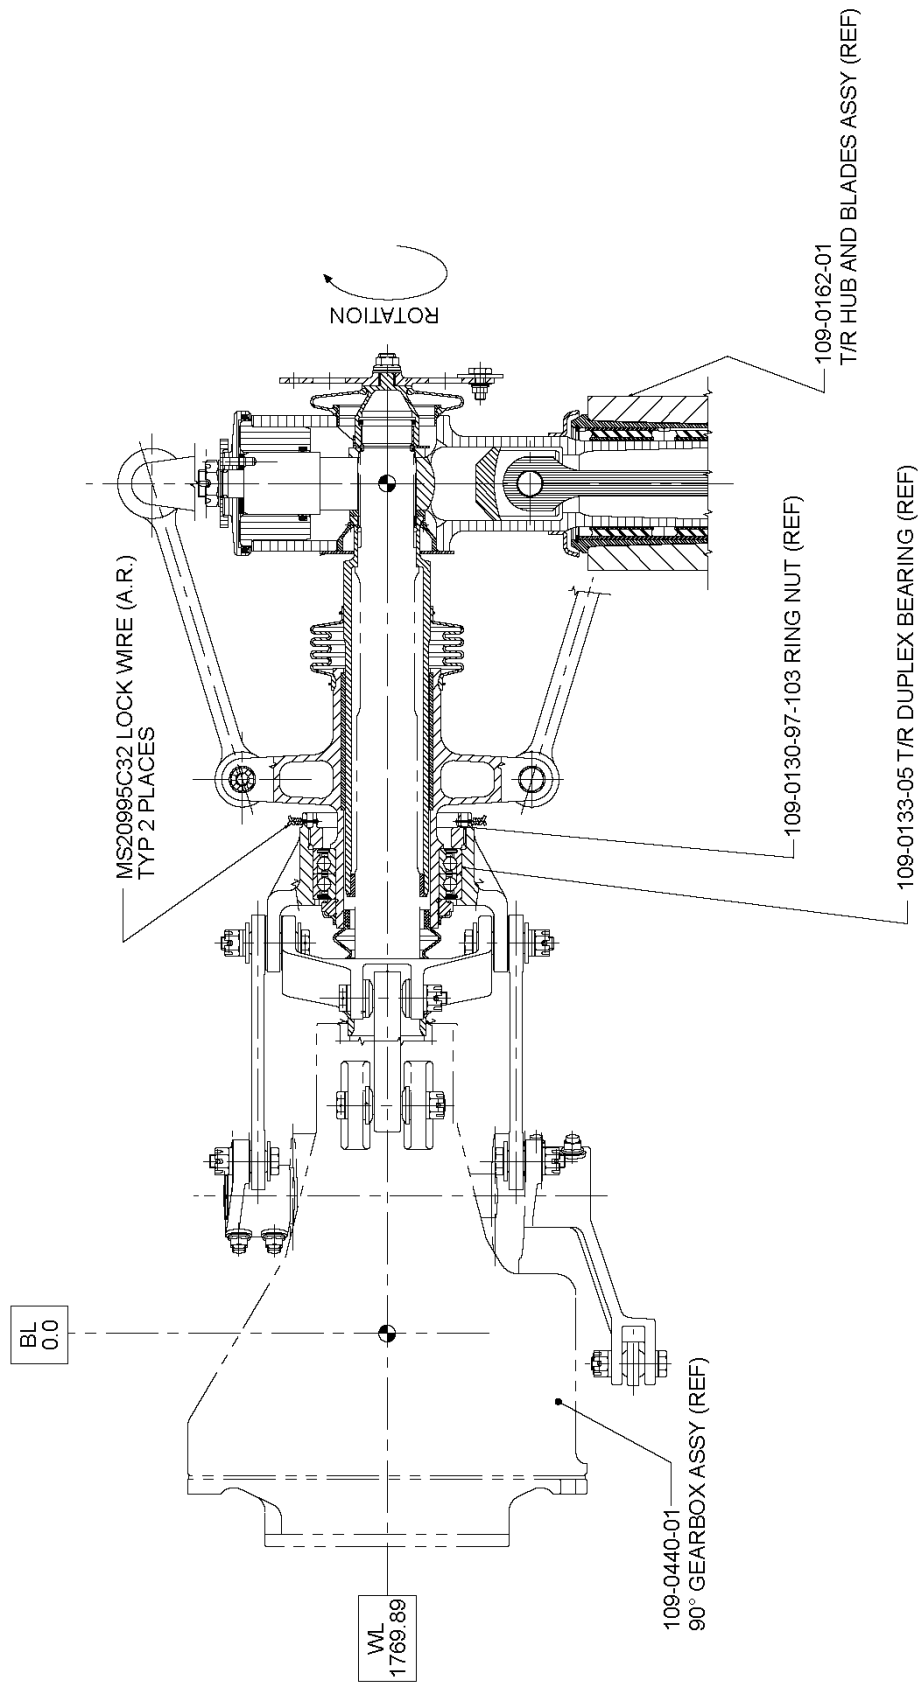
**FIGURE 1**

2. Gain access to the tail rotor rotating controls P/N 109-0136-01 and visually inspect the two MS20995C32 lockwires, securing the duplex bearing locking nut P/N 109-0130-97-103 to the housing, for presence and condition (ref. figure 1).
- 2.1. If one or both the MS20995C32 lockwires are damaged, immediately proceed as described in step 2 and following steps of PART III^ of this Bollettino.
- 2.2. If only one MS20995C32 lockwire is present and on it no damage is reported, install the missing locking by means of an appropriate length of MS20995C32 lockwire and proceed as described in the step 3 and 4.
- 2.3. If the two MS20995C32 lockwires are present and no damage is reported, proceed as described in the following steps.
3. Return the helicopter in service.
4. Record compliance with PART I^ of this Bollettino in the helicopter log book.

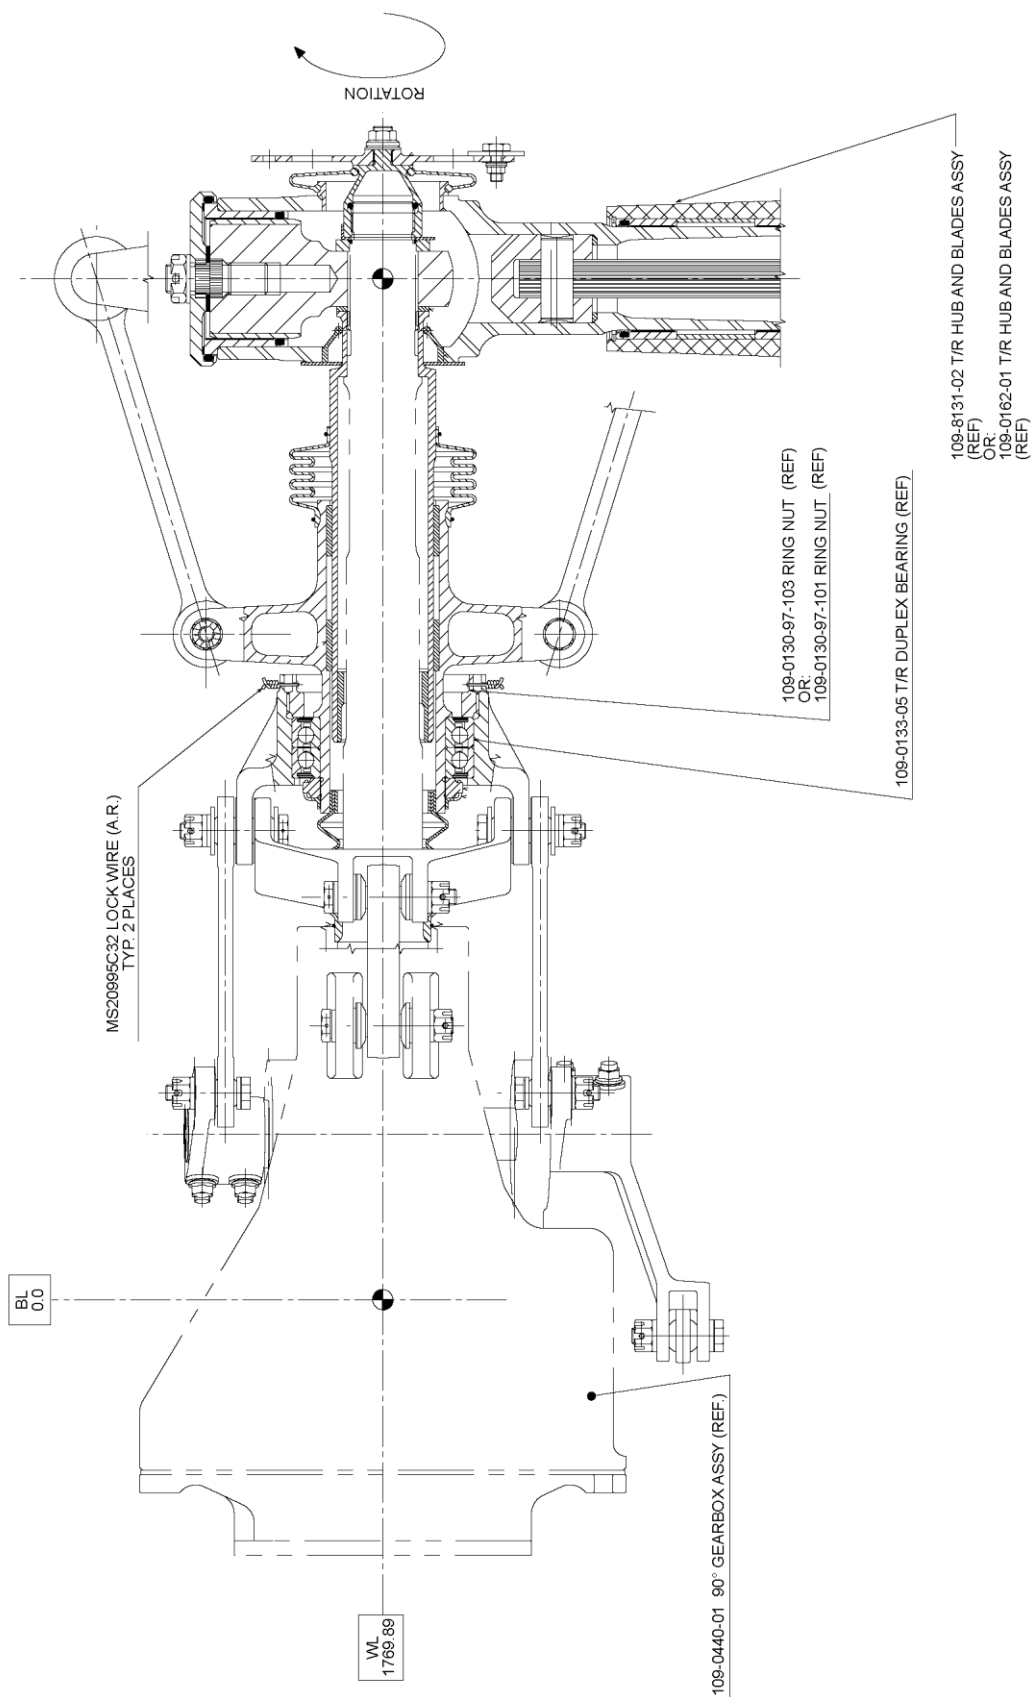
**FIGURE 1**

1. Prepare the helicopter on ground for a safe maintenance, disconnect any power supply.
2. Gain access to the tail rotor rotating controls P/N 109-0133-01 and visually inspect the two MS20995C32 lockwires, securing

the duplex bearing locking nut P/N 109-0130-97-101 or -103 to the housing, for presence and condition (ref. figure 1).

- 2.1. If one or both the MS20995C32 lockwires are damaged, immediately proceed as described in step 2 and following steps of PART III^ of this Bollettino.
- 2.2. If only one MS20995C32 lockwire is present and on it no damage is reported, install the missing locking by means of an appropriate length of MS20995C32 lockwire and proceed as described in the step 3 and 4.
- 2.3. If the two MS20995C32 lockwires are present and no damage is reported, proceed as described in the following steps.
3. Return the helicopter in service.
4. Record compliance with PART I^ of this Bollettino in the helicopter log book.

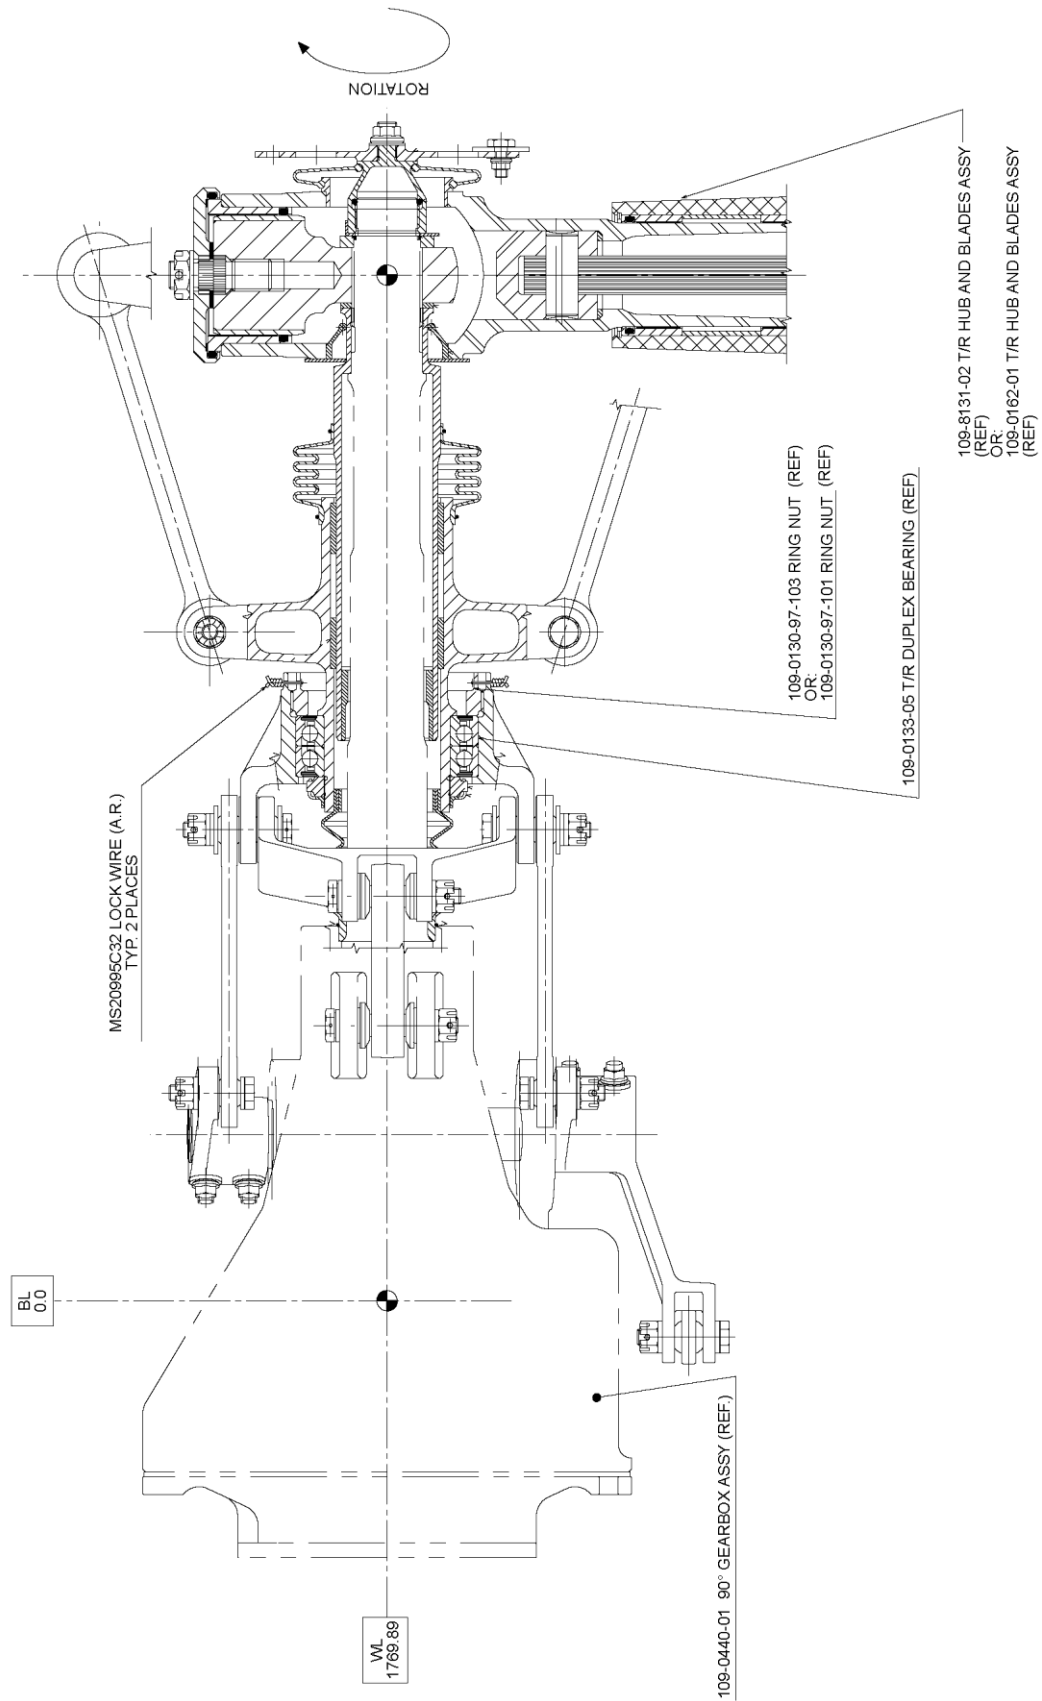
**FIGURE 1**

1. Prepare the helicopter on ground for a safe maintenance, disconnect any power supply.
2. Gain access to the tail rotor rotating controls P/N 109-0133-01 or P/N 109-0136-02 and visually inspect the two MS20995C32

lockwires, securing the duplex bearing locking nut P/N 109-0130-97-101 or -103 to the housing, for presence and condition (ref. figure 1).

- 2.1. If one or both the MS20995C32 lockwires are damaged, immediately proceed as described in step 2 and following steps of PART III^ of this Bollettino.
- 2.2. If only one MS20995C32 lockwire is present and on it no damage is reported, install the missing locking by means of an appropriate length of MS20995C32 lockwire and proceed as described in the step 3 and 4.
- 2.3. If the two MS20995C32 lockwires are present and no damage is reported, proceed as described in the following steps.
3. Return the helicopter in service.
4. Record compliance with PART I^ of this Bollettino in the helicopter log book.

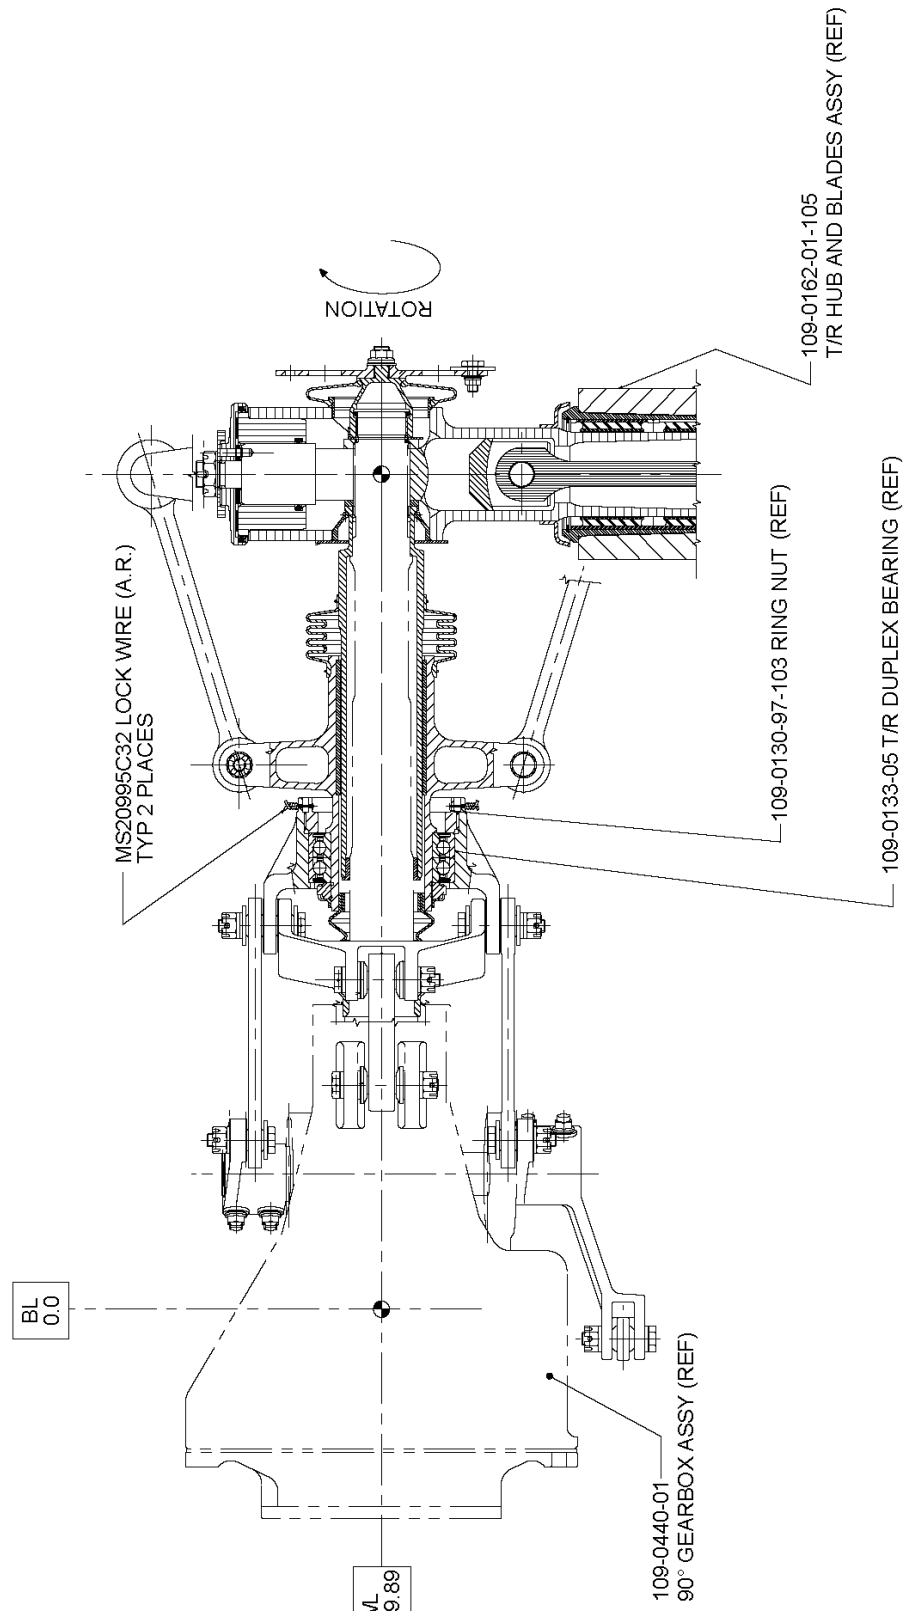
**FIGURE 2**

1. Prepare the helicopter on ground for a safe maintenance, disconnect any power supply.
2. Gain access to the tail rotor rotating controls P/N 109-0133-01 or P/N 109-0136-02 and visually inspect the two MS20995C32 lockwires, securing the duplex bearing locking nut P/N 109-0130-97-101 or -103 to the housing, for presence and conditions (ref. figure 1).
- 2.1. If one or both the MS20995C32 lockwires are damaged, immediately proceed as described in step 2 and following steps of PART III^ of this Bollettino.
- 2.2. If the two MS20995C32 lockwires are present and no damages are reported, proceed as described in the following steps.
3. Return the helicopter in service.
4. Record compliance with PART II^ of this Bollettino in the helicopter log book.

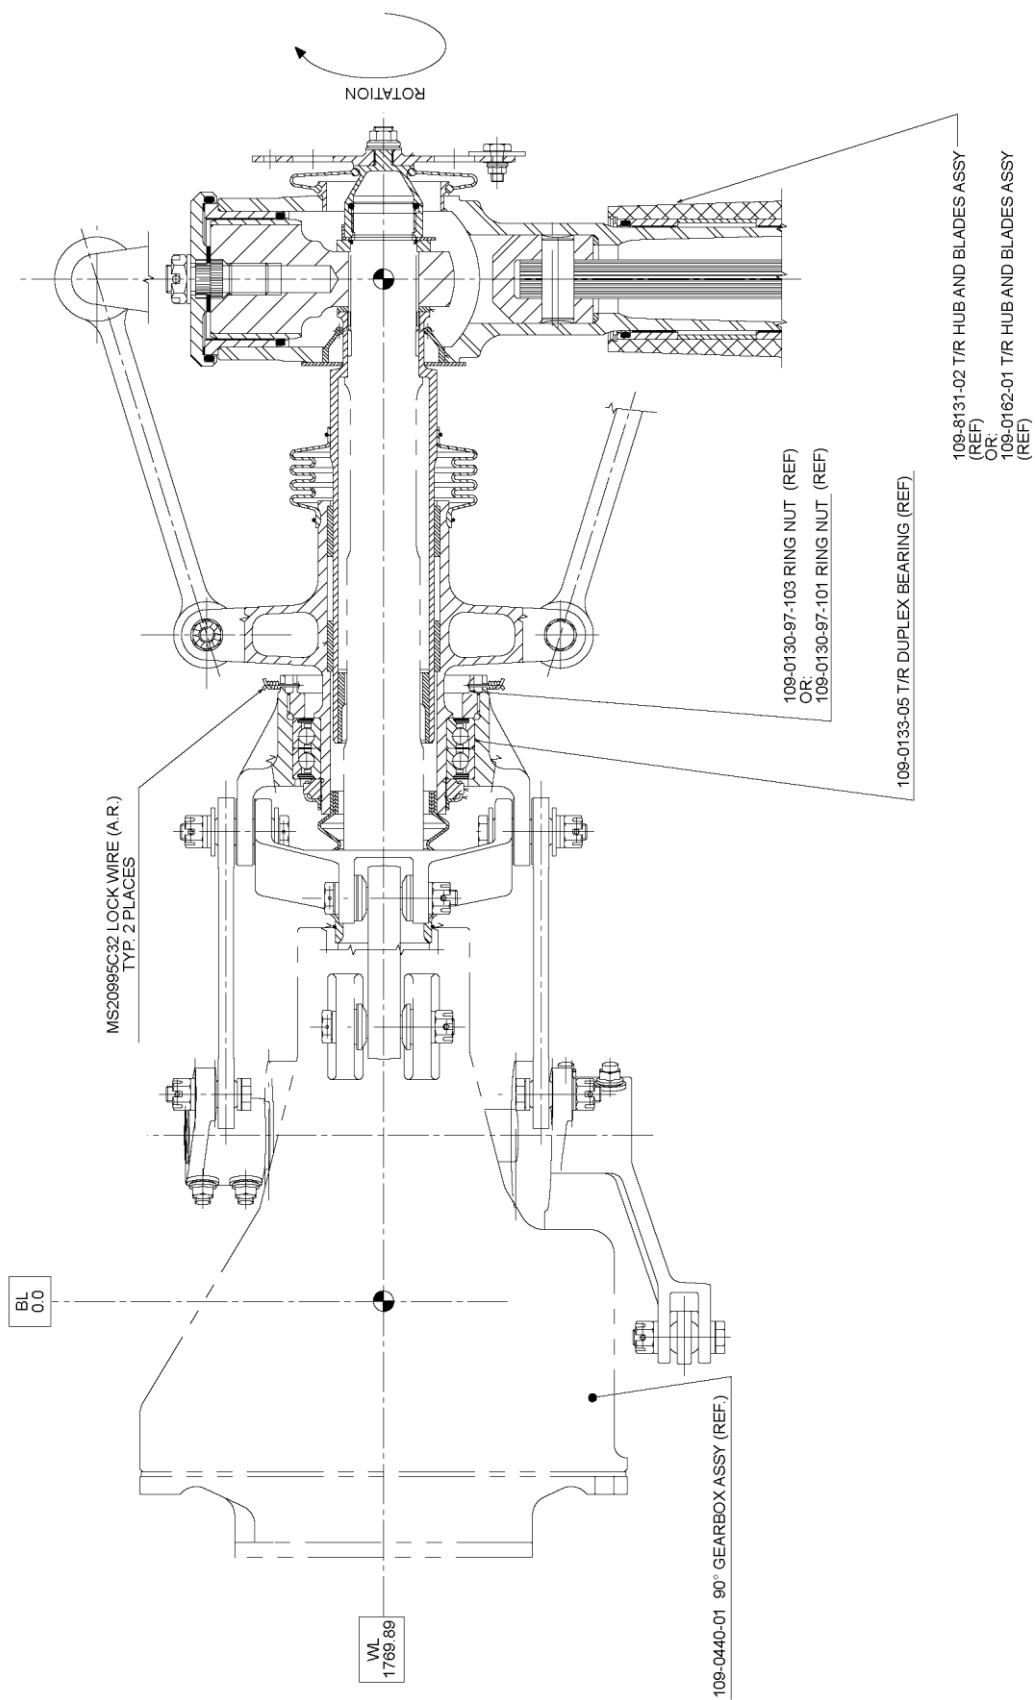
**FIGURE 1**

2. Gain access to the tail rotor rotating controls P/N 109-0133-01 and visually inspect the two MS20995C32 lockwires, securing the duplex bearing locking nut P/N 109-0130-97-101 or -103 to the housing, for presence and condition (ref. figure 1).
- 2.1. If one or both the MS20995C32 lockwires are damaged, immediately proceed as described in step 2 and following steps of PART III^ of this Bollettino.
- 2.2. If only one MS20995C32 lockwire is present and on it no damage is reported, install the missing locking by means of an appropriate length of MS20995C32 lockwire and proceed as described in the step 3 and 4.
- 2.3. If the two MS20995C32 lockwires are present and no damage is reported, proceed as described in the following steps.
3. Return the helicopter in service.
4. Record compliance with PART I^ of this Bollettino in the helicopter log book.

4. In accordance with the instructions given in the A109C Maintenance Manual reassemble and install the housing and slider group of the tail rotor rotating controls.
5. In accordance with the instructions given in the A109C Maintenance Manual reinstall the access panels P6 and P12 and the tail rotor hub and blades assy.
6. In accordance with the instructions given in the A109C Maintenance Manual perform the tail rotor dynamic balance.
7. Return the helicopter in service.
8. Record compliance with PART III<sup>^</sup> of this Bollettino in the helicopter log book.
