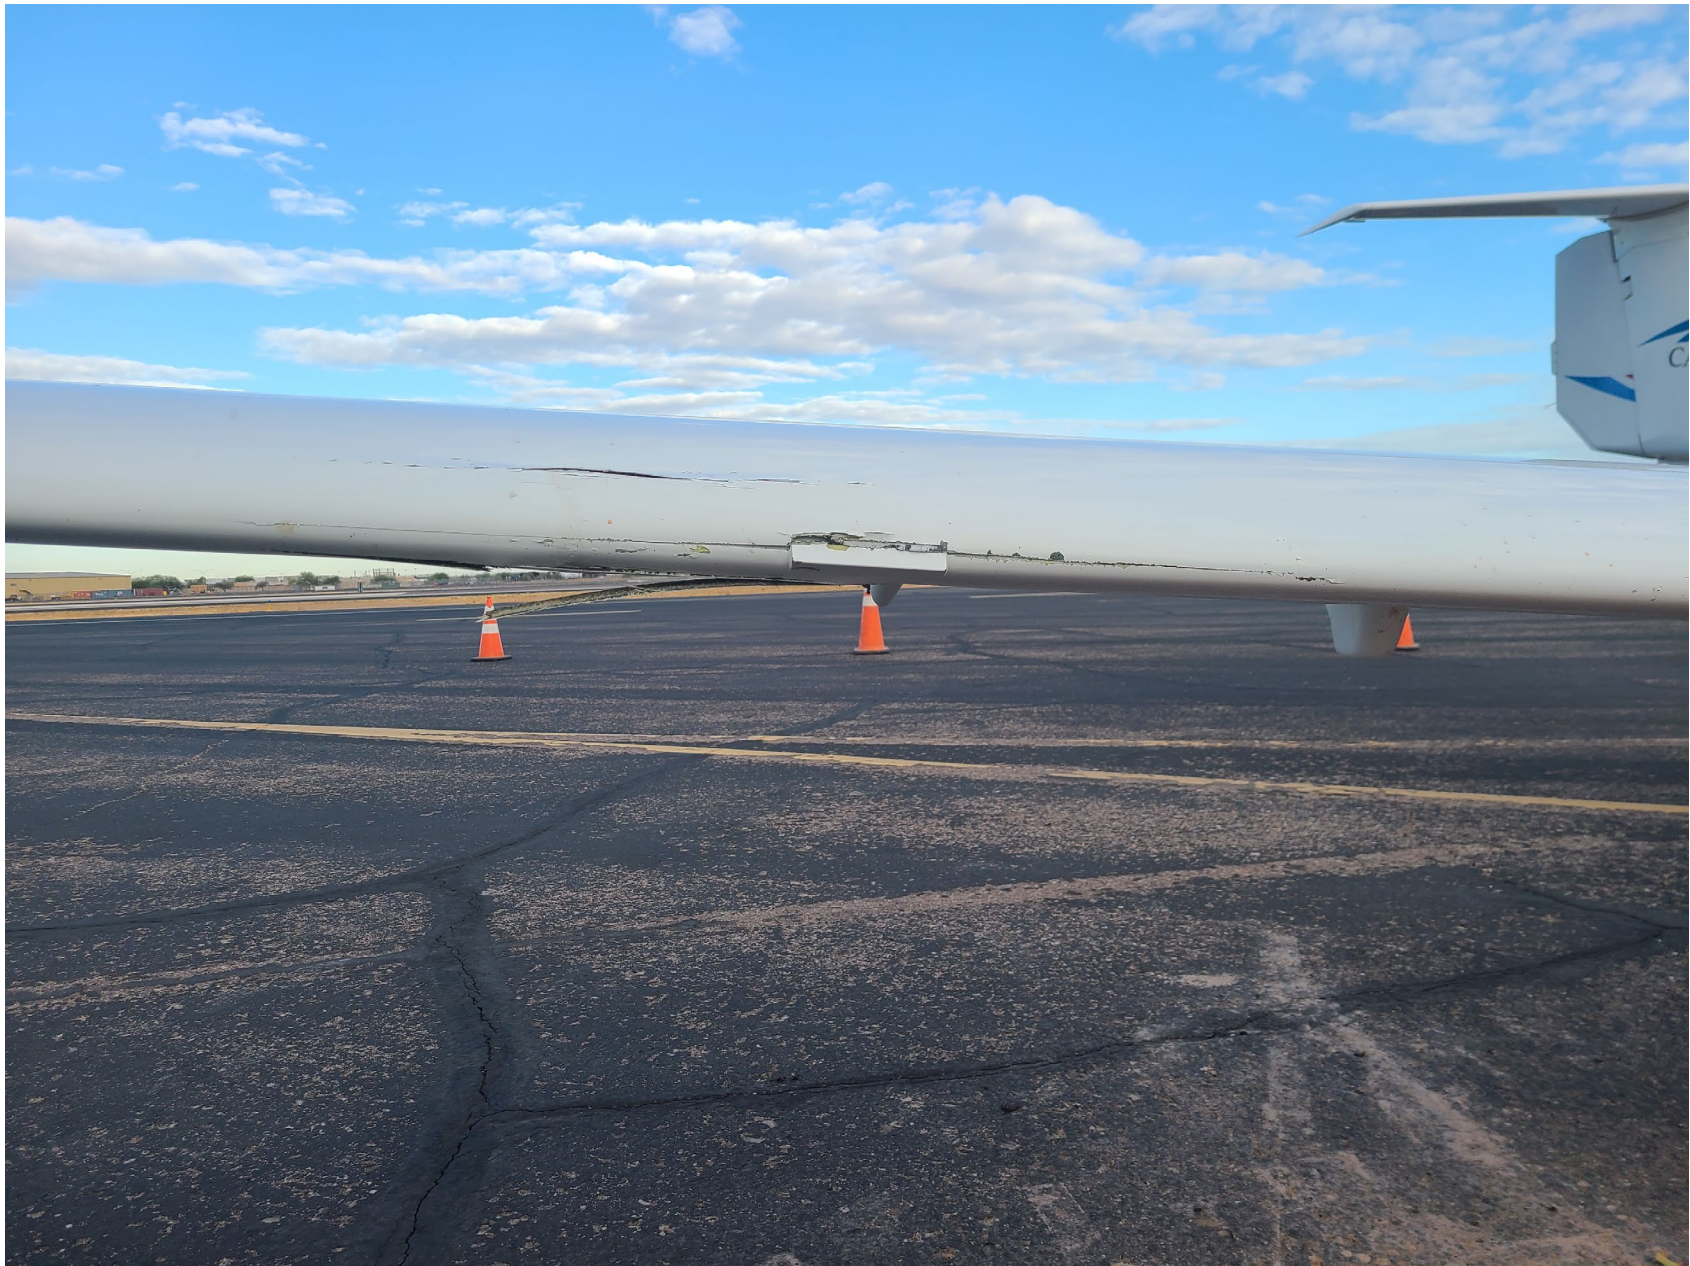
**Photo 1 – photo of damage to leading edge of right wing (courtesy of CAE Aviation Academy)**
