# NATIONAL TRANSPORTATION SAFETY BOARD

## MATERIALS LABORATORY FACTUAL REPORT

Report No. 21-028

Place : Byron, California  
Date : November 6, 2020  
Vehicle : Vans RV-12, N975G  
NTSB No. : WPR21LA049  
Investigator : James Bledsoe, AS-WPR

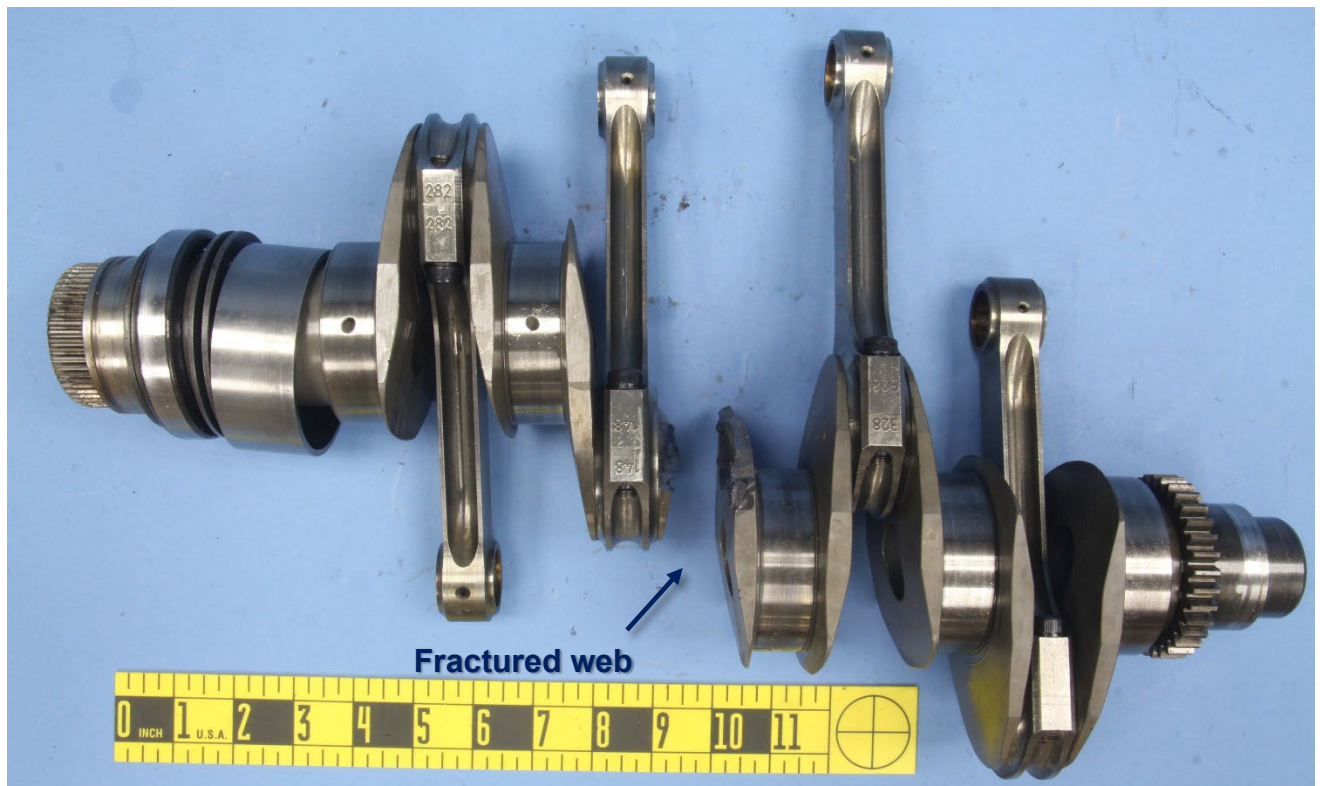
Figure 1 shows the two crankshaft remnants, as received. These remnants were positioned in their relative locations at fracture, with the forward position facing to the left in the figure. The four connecting rod journals still had their respective rods and caps attached. In all cases, these parts were able to be easily rotated about their respective journals. The side faces of the rods and caps were each marked, and from forward to aft stated: '282', '148', '328', and '074'.

Figure 1 – View of the fractured crankshaft, as received. The fractured web location is labeled.

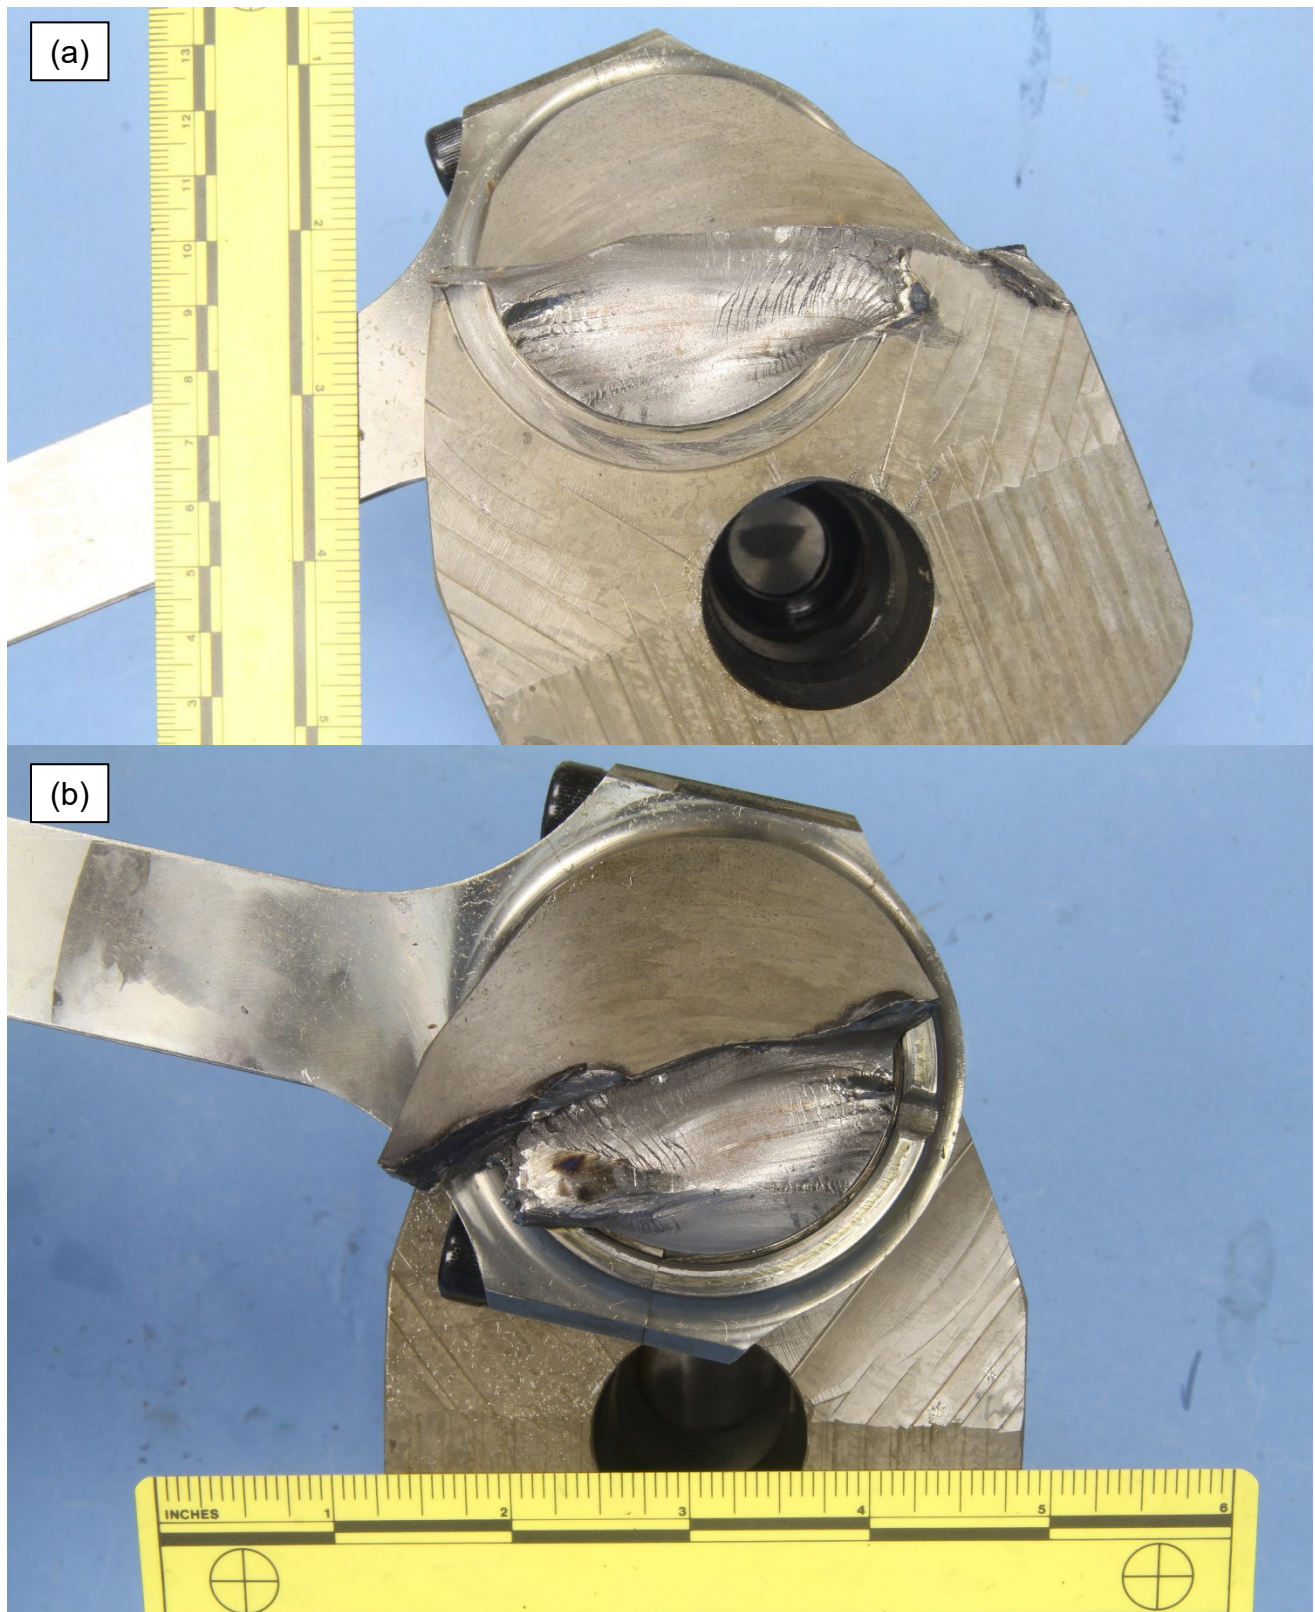
The crankshaft had fractured at a web just aft of the journal with the '148' connecting rod. Figure 2 shows both mating faces of the fracture surface, as received. The fracture exhibited a half-moon shape, having proceeded through approximately half the web. The fracture surface was relatively shiny and reflective, with some areas of heat tinting on the forward face (Figure 2b).

Figure 2 – The fracture surface of the crankshaft viewed from (a) aft and (b) forward sides.

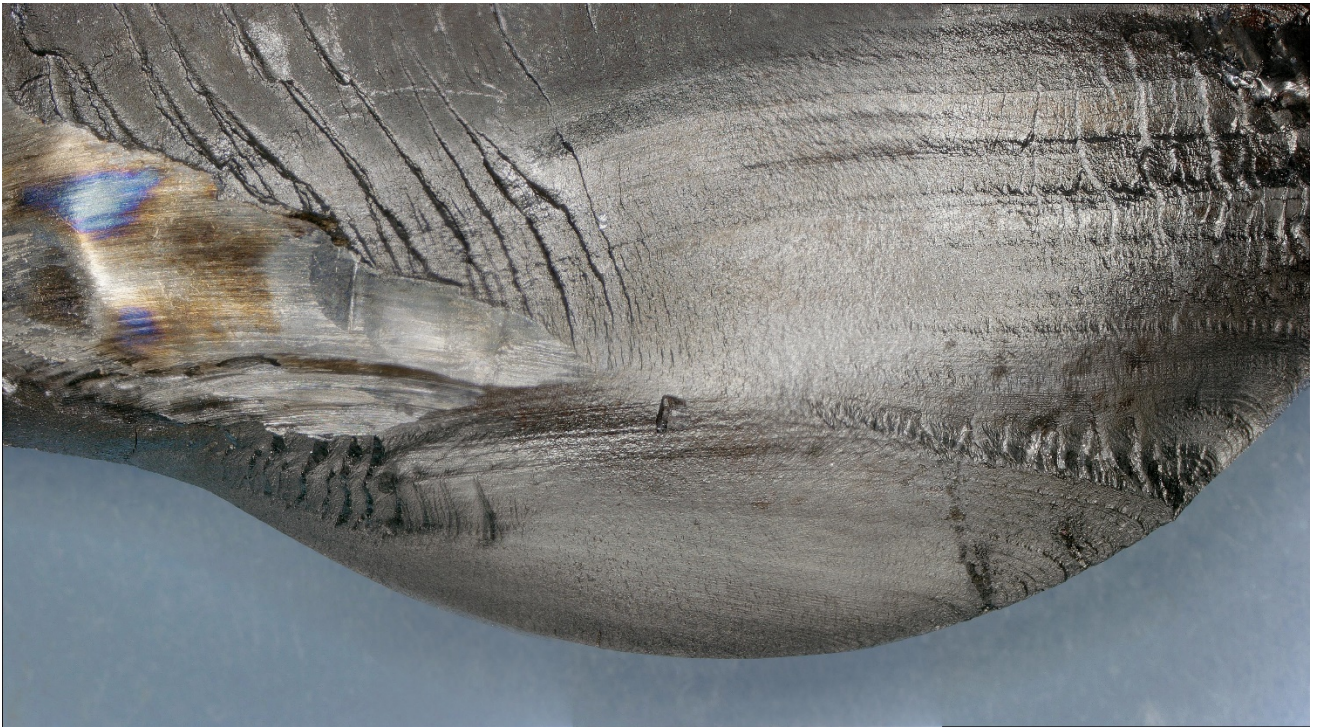
Figure 3 shows a series of repeating banded marks, consistent with crack arrest or beach marks. These features were consistent with progressive crack growth later determined to be fatigue. Tiny perpendicular marks were present, particularly near the initial areas of the fracture. These features were ratchet marks, consistent with multiple crack initiation sites.

Figure 3 – Closer view of the forward mating fracture surface, after sectioning and cleaning.

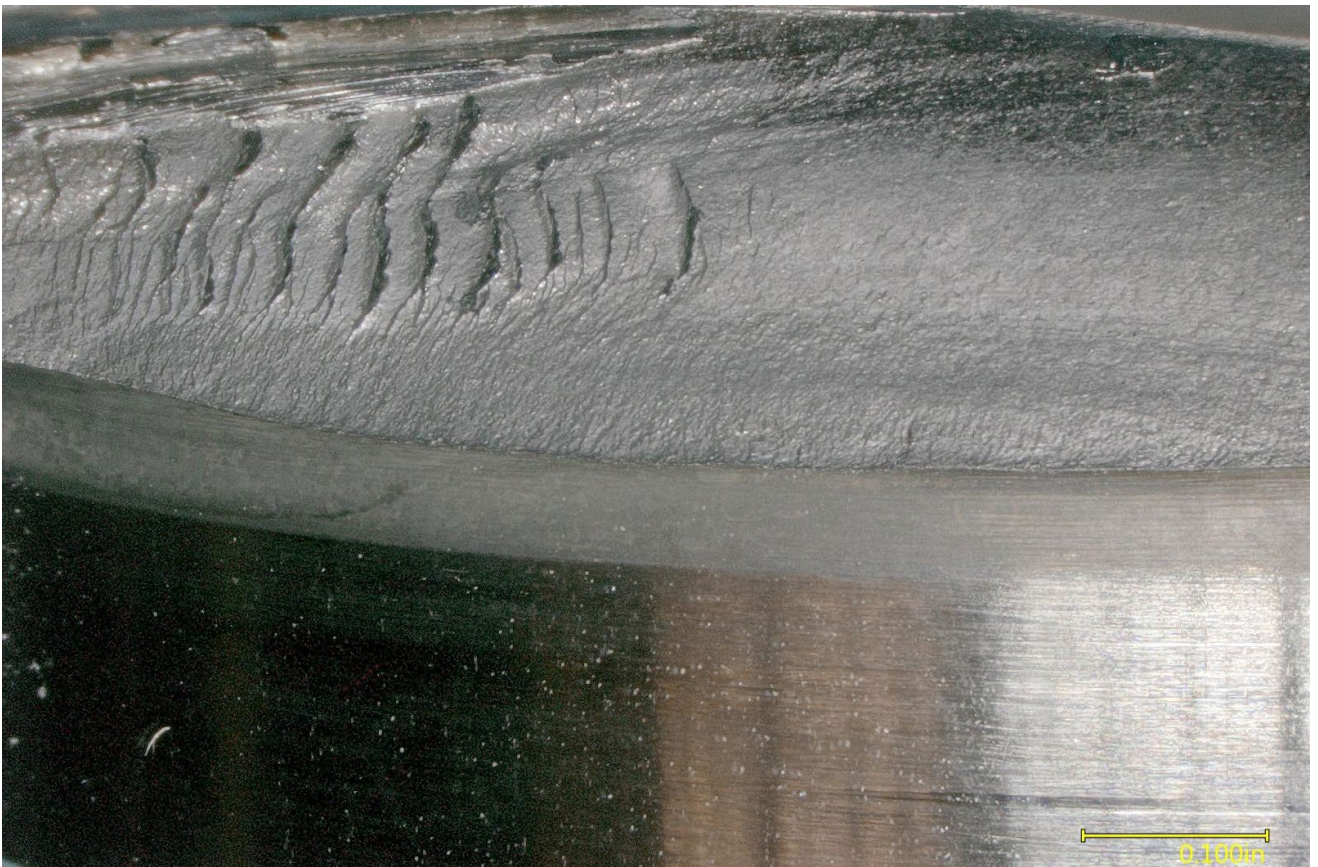
These initiation sites were located along the edge of the fracture surface at the radius near the connecting rod journal surface. Figure 4 shows an angled view of the crack initiation sites and the adjacent journal surface. While the majority of the connecting rod journals were reflective with some circumferential wear marks, the region 0.05 inches closest to the radius (and fracture) were dull and visually distinctive. This contrast was exemplified in Figure 5, showing increased wear marks in this region.

Figure 4 – View of the journal surface adjacent to the crack initiation sites of the fracture.

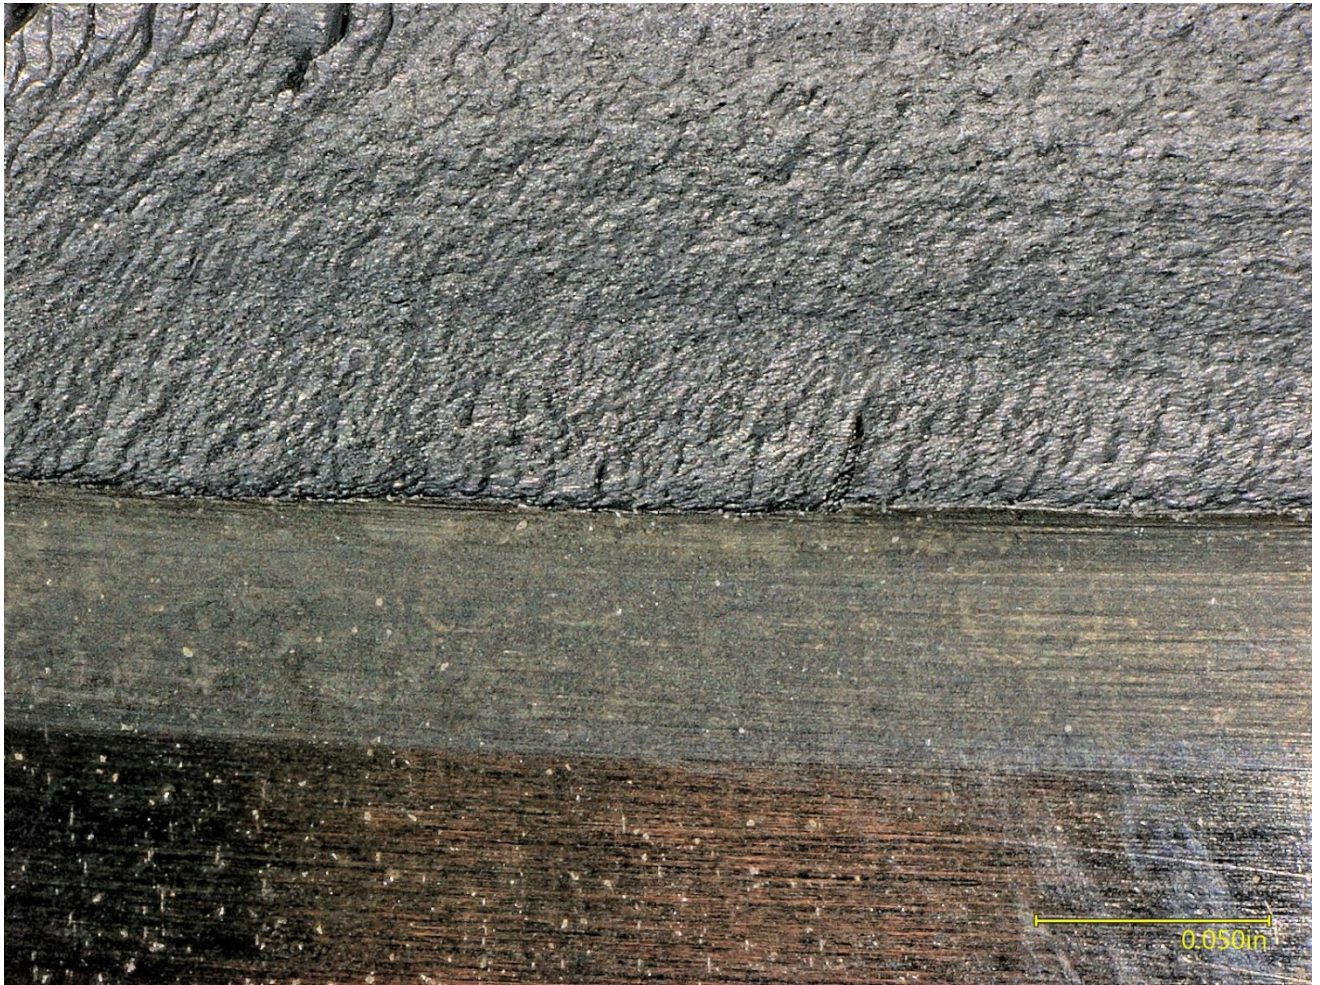
Figure 5 – Closer view of the connecting rod journal near the forward fracture surface initiation sites, showing the contrast of the two circumferential wear areas.

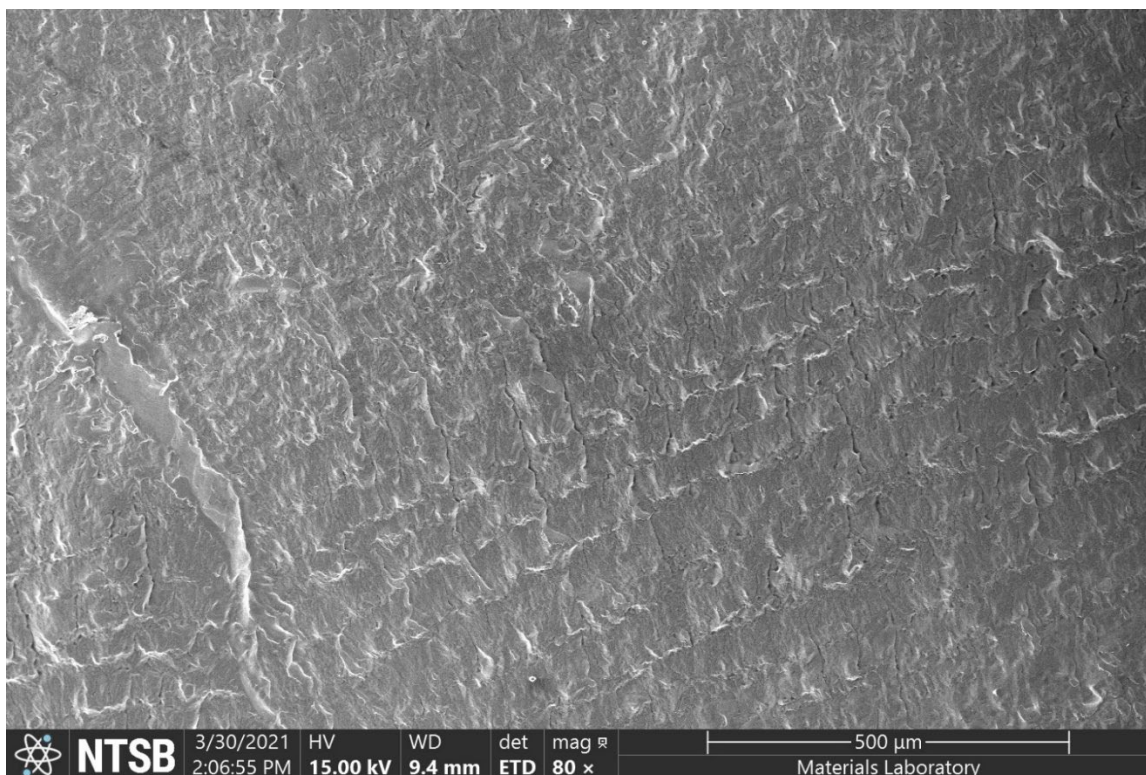
The sectioned and cleaned fracture surface was examined using a scanning electron microscope (SEM). Figure 6 shows a typical area of the fracture surface. These features were consistent with crack arrest marks. A closer examination found more distinctive striations, as depicted in Figure 7. These features were consistent with fatigue crack propagation.

Figure 6 – Secondary electron (SE) micrograph of crack arrest marks on the crankshaft fracture surface.

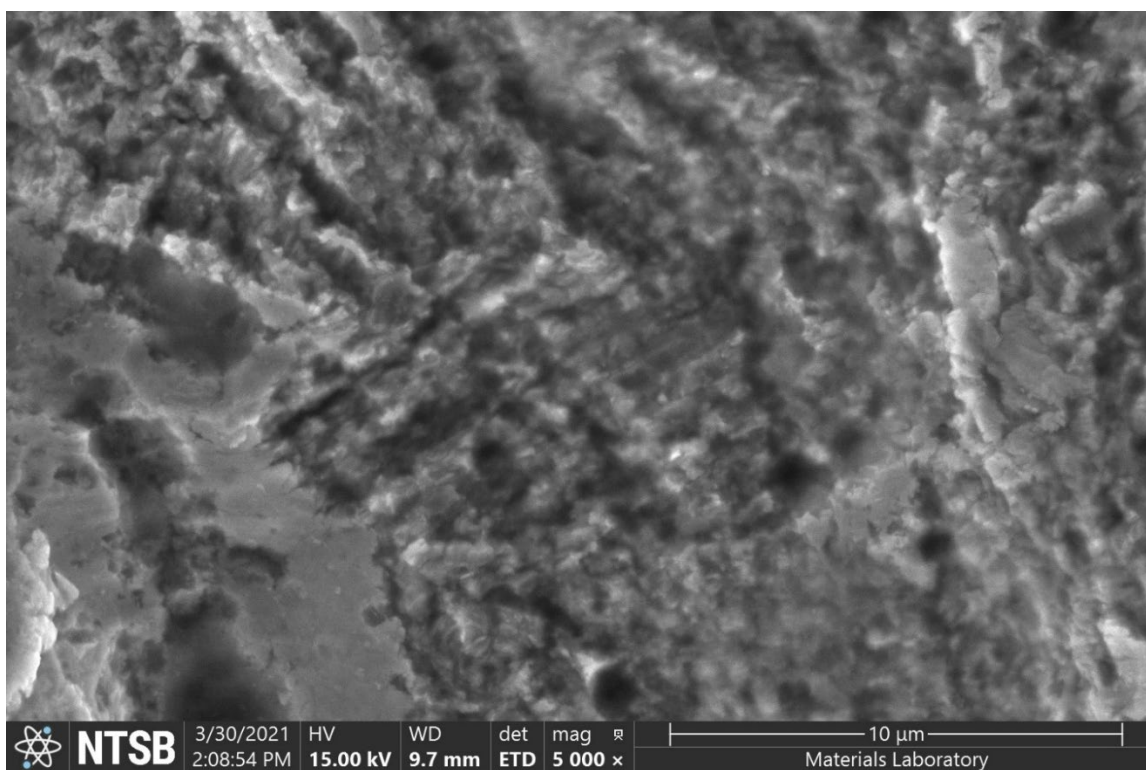
Figure 7 – SE micrograph of fatigue striations on the crankshaft fracture surface.

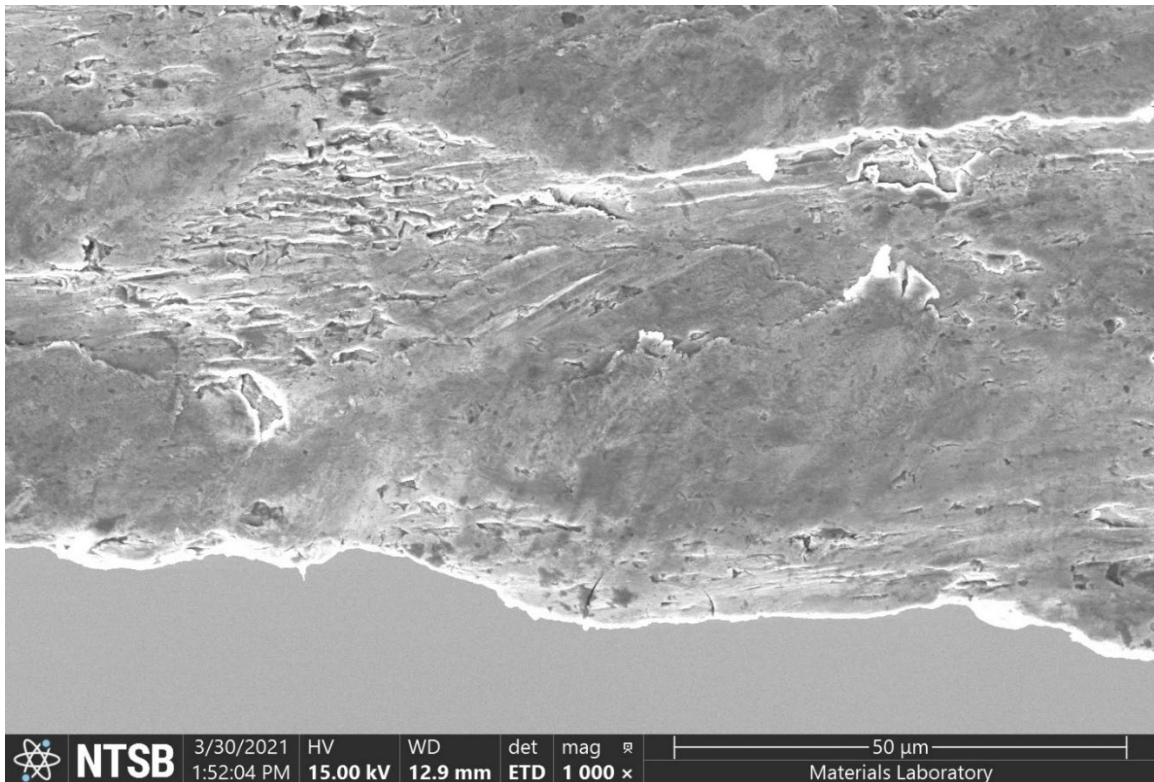
While observable by visual examination as shown in Figure 5, the fatigue crack initiation sites themselves had generally been obliterated by smearing, or post-fracture damage. Figure 8 typifies one such fatigue crack initiation site. Isolated areas of fatigue striations were present and oriented parallel to the fracture edge, consistent with having initiated at the journal radius surface.

Figure 8 – SE micrograph of one of the fatigue crack initiation sites, showing post-fracture smearing among isolated areas of striations.

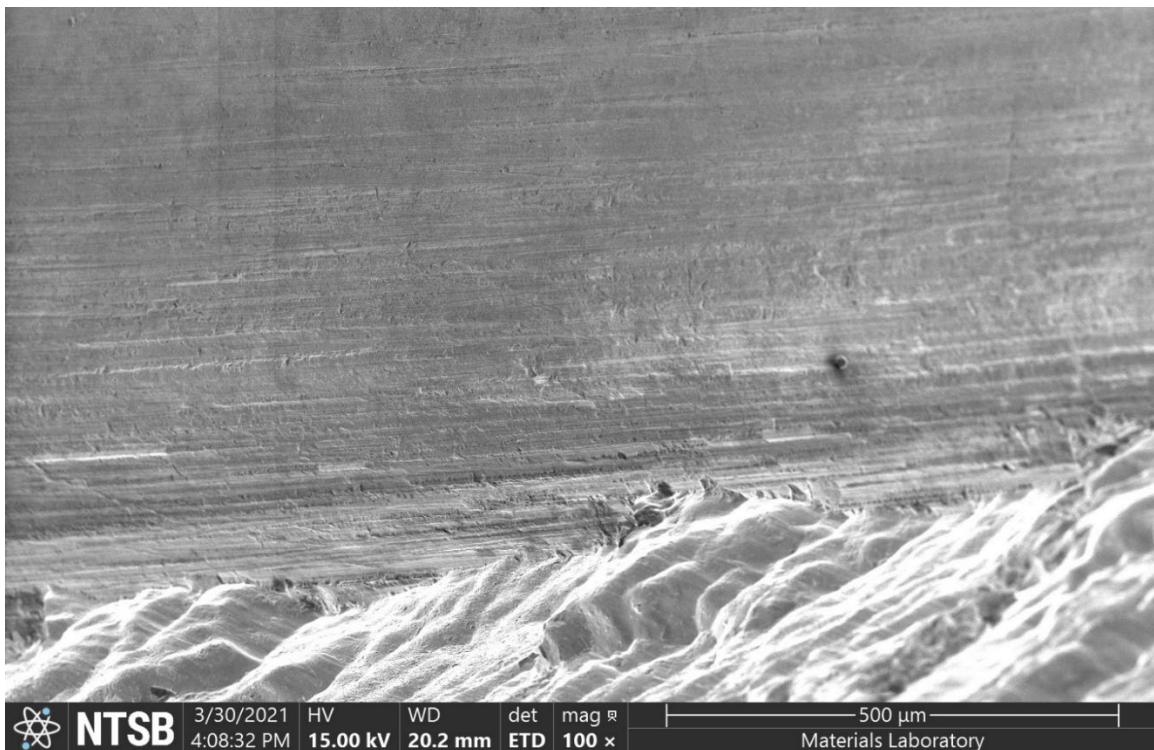
The specimen was rotated to examine the connecting rod journal surface adjacent to the web fracture. Figure 9 shows a typical area of the fracture edge near the fatigue crack initiation region (inverted such that the fracture surface was on the bottom of the figure). As shown in the figure, the journal surface exhibited circumferentially oriented microscopic gouge marks. A closer view found these gouge marks present up to the edge, as well as near one fatigue crack initiation site (Figure 10). Examination of the journal surface away from the fracture surface did find wear marks. However, as illustrated in Figure 11, there were no gouge marks or deep valleys such as seen in Figures 9 and 10.

Figure 9 – SE micrograph of the journal adjacent to several crack initiation sites (bottom).

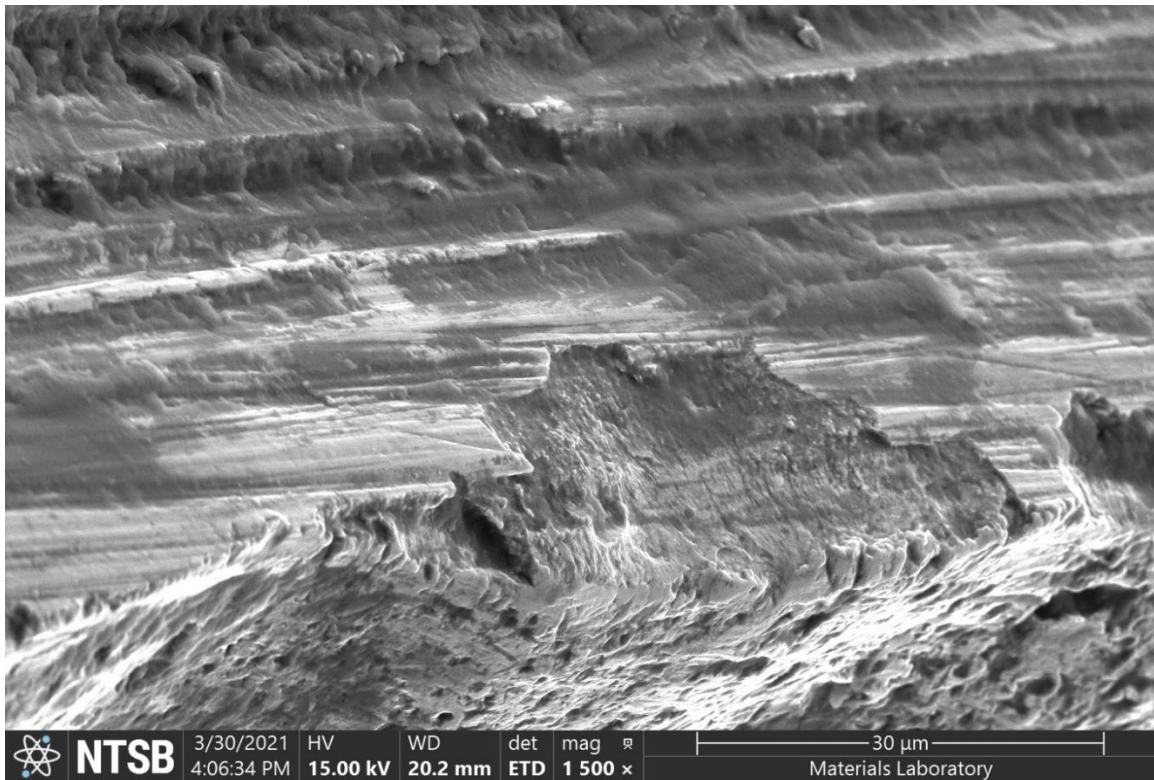
Figure 10 – SE micrograph of the more damaged journal surface, adjacent to a crack initiation site of the fracture surface.

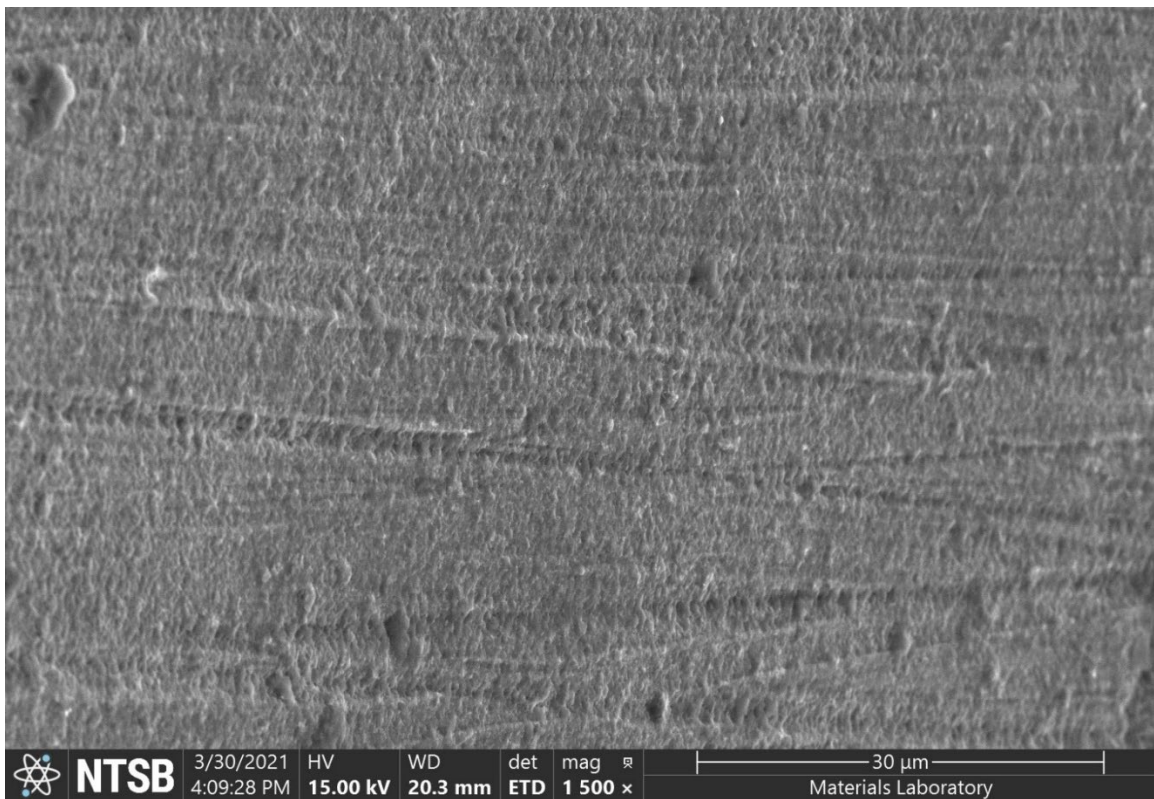
Figure 11 – SE micrograph of the journal surface away from the damaged region.

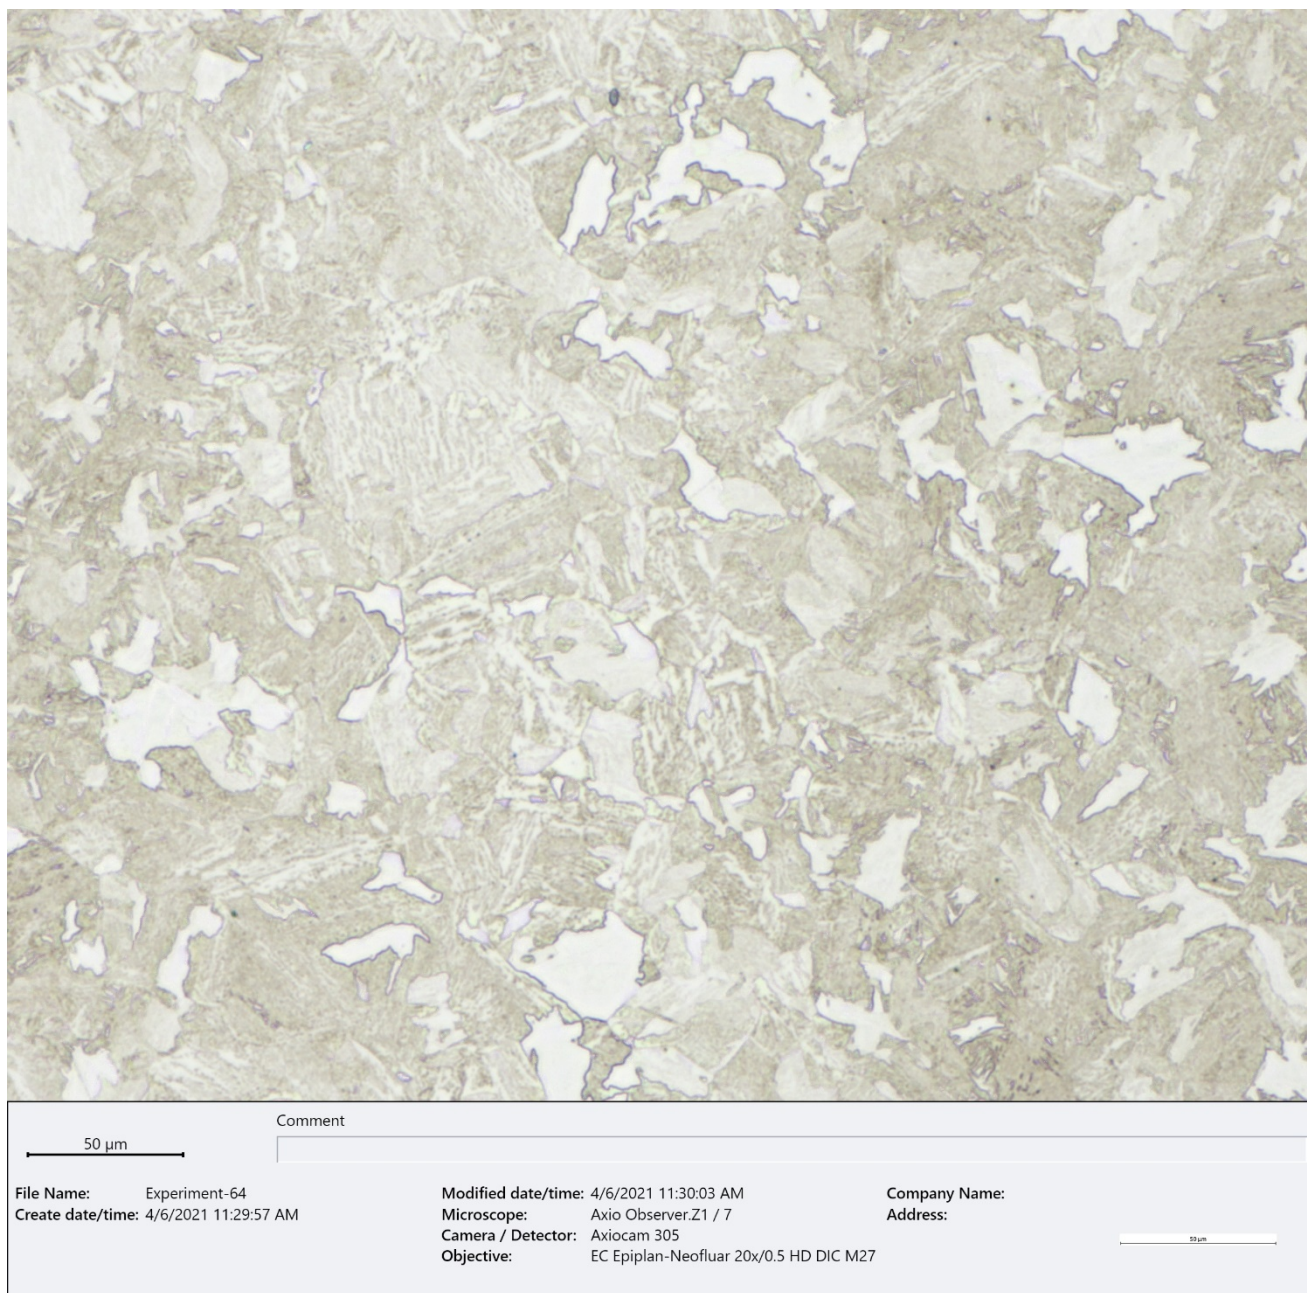
A cross section was taken through the journal and fracture surface. This section was mounted, polished, and etched using a 2% Nital solution.<sup>2</sup> Figure 12 shows a typical area of the crankshaft microstructure, located away from the surfaces. This microstructure

exhibited equiaxed grains of ferrite and darker areas with a lath structure, consistent with tempered martensite.

Figure 12 – BF optical micrograph of a typical area of the core crankshaft microstructure (~500X, etched 2% Nital).

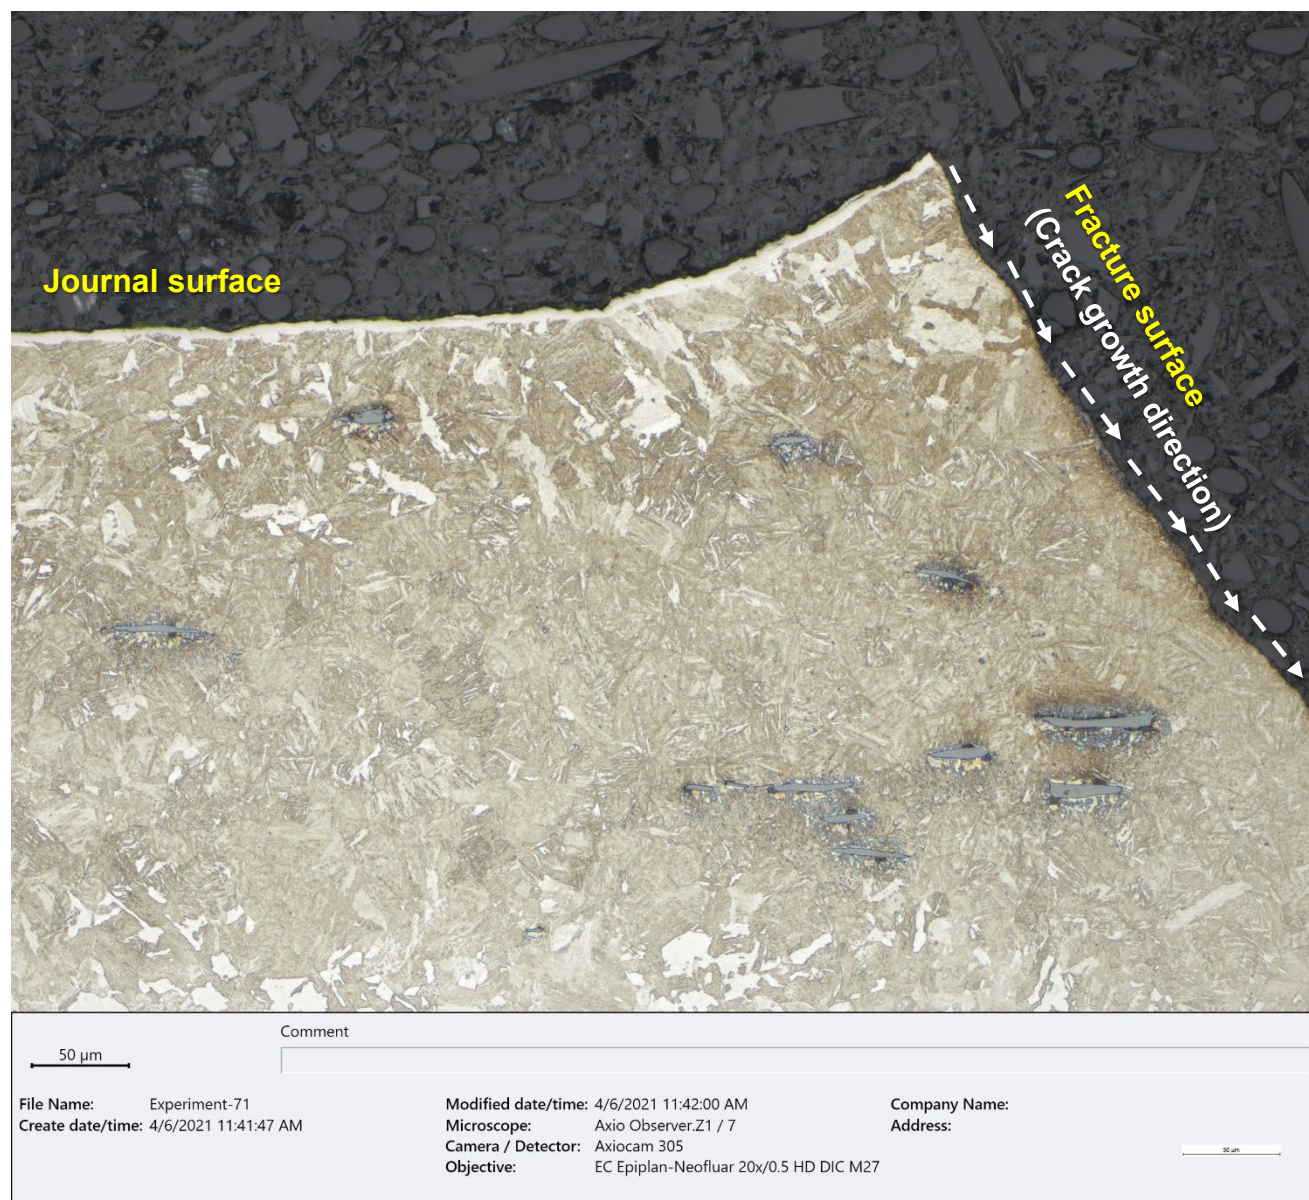
Adjacent to the fracture surface, the microstructure exhibited a different structure, as illustrated in Figure 13. This figure shows the journal surface and radius adjacent to the fracture surface. The crack growth direction of the fatigue fracture is annotated on the figure for demonstration purposes. The flat journal surface was curving upward at the location of the fatigue starting, consistent with crack initiation at the radius between the journal and the web.

Figure 13 – BF optical micrograph of a cross section of the journal and the fracture surface, showing a surface white layer and different microstructure (~200X, etched 2% Nital).

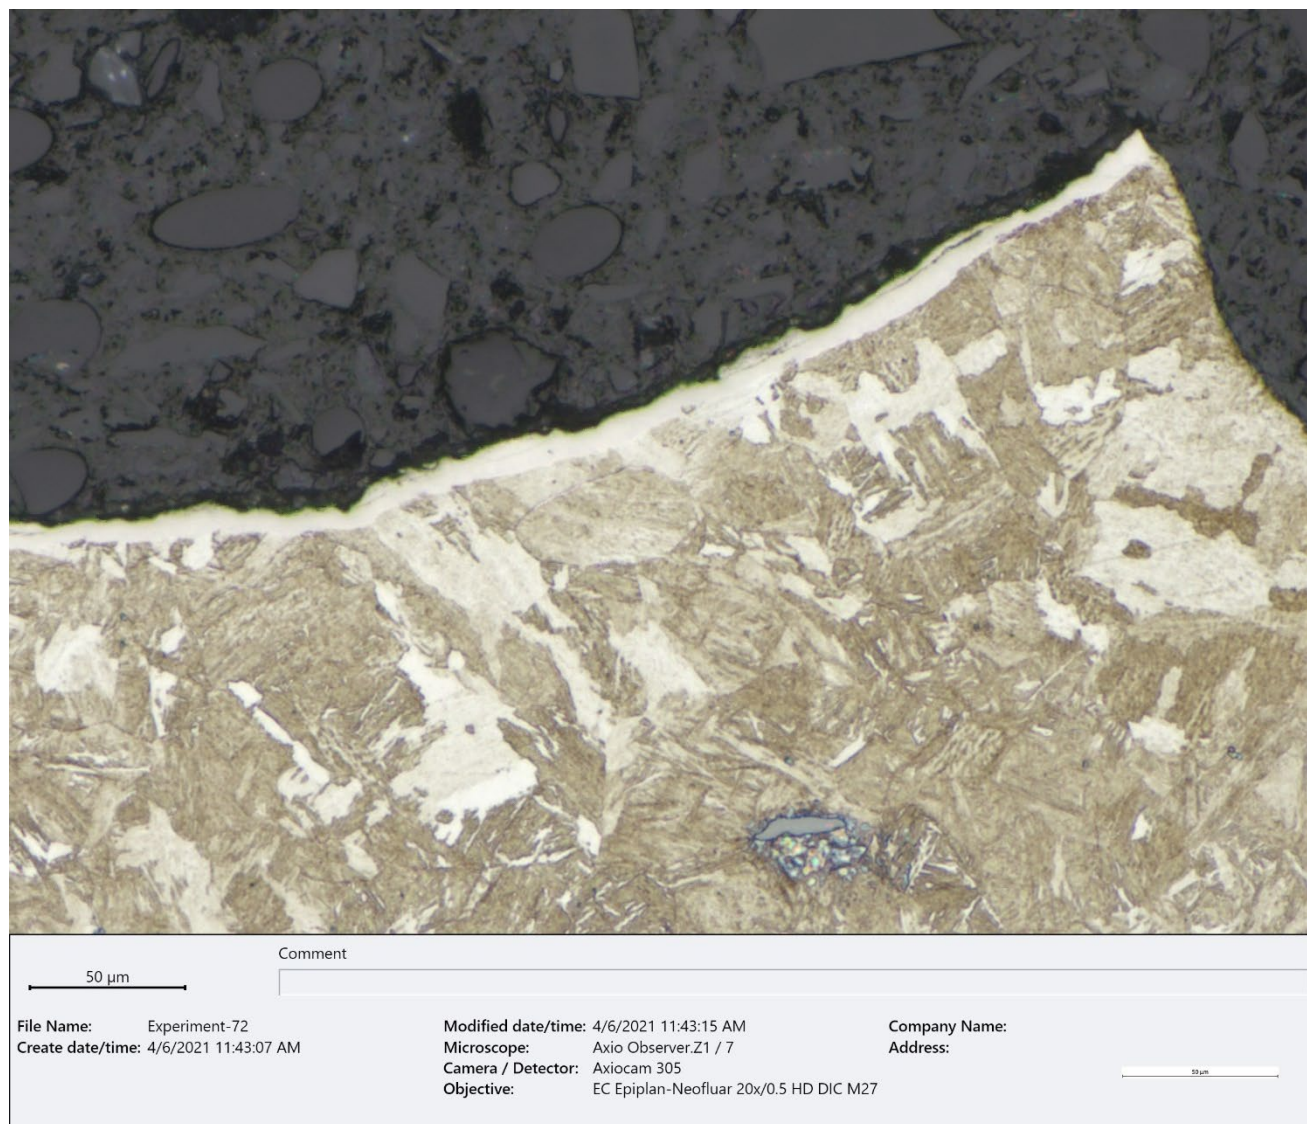
Figure 14 shows a thin white layer at the surface of the journal, as well as along the radius surface. This surface layer was approximately 10-20  $\mu\text{m}$  (0.0004-0.0008 inches) in thickness. Examination with EDS found the area to contain nitrogen, indicating the part had been case hardened by nitriding. The underlying microstructural constituents had etched darker in many of the lath areas but revealed some lighter grains and features as well. Away from the radius, this nitride layer continued to be present on the journal surface, with some cracking present, parallel to the surface (see Figure 15).

Figure 14 – BF optical micrograph of the edge of the fracture surface and damage area of the adjacent journal (~500X, etched 2% Nital). The white nitride layer exhibited cracking parallel to the surface.

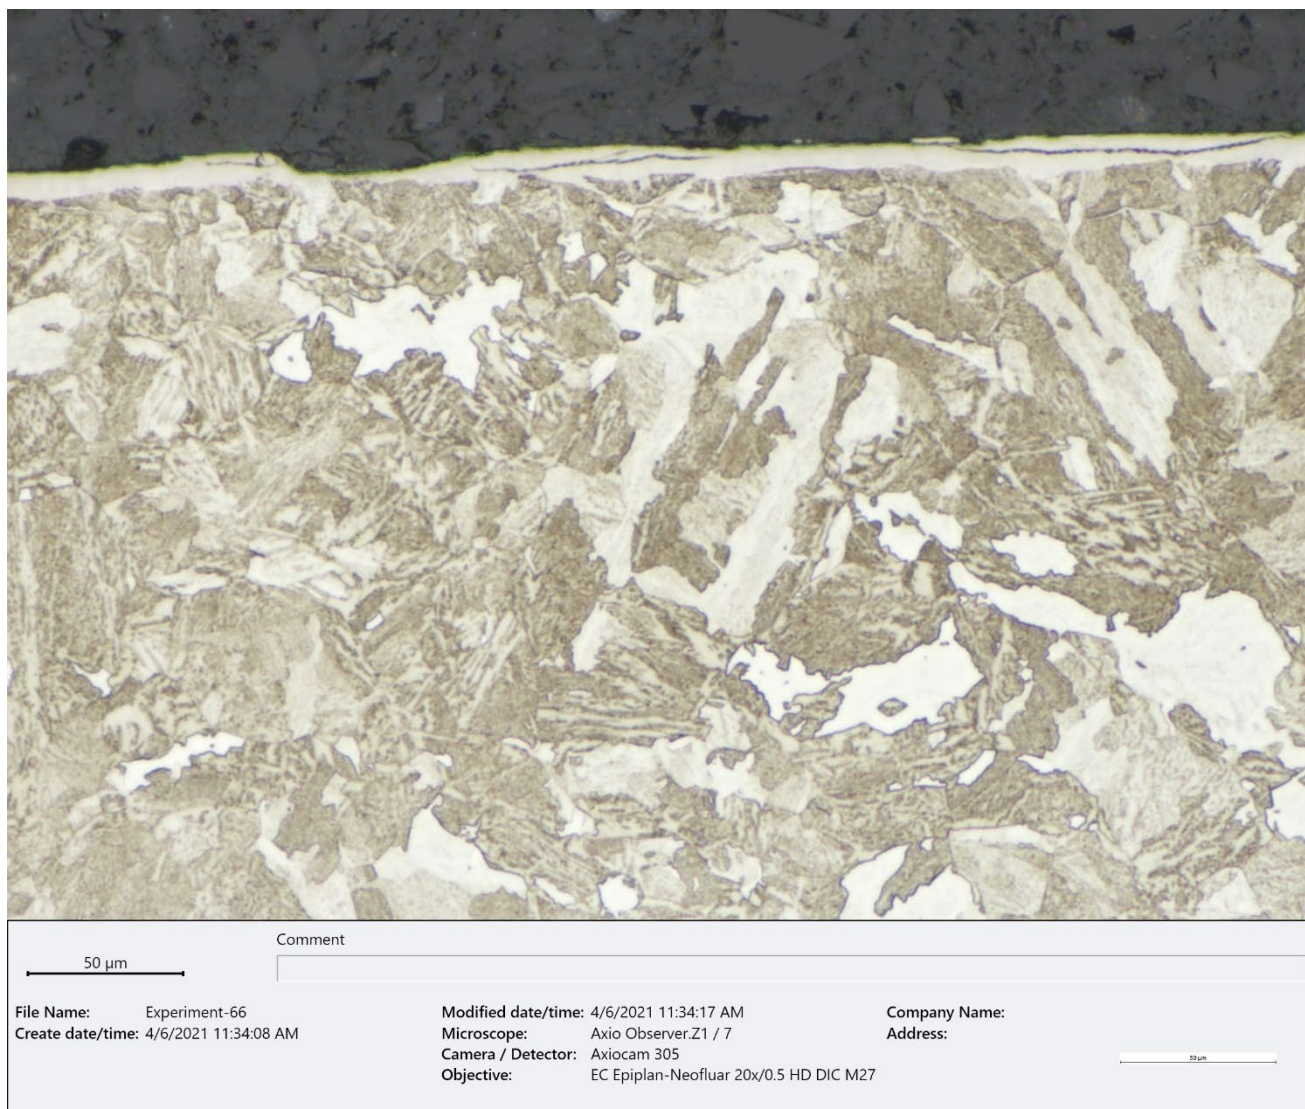
Figure 15 – BF optical micrograph of a cross section of the journal surface closer to the fracture surface edge (~500X, etched 2% Nital). The white nitride layer exhibited cracking parallel to the surface.

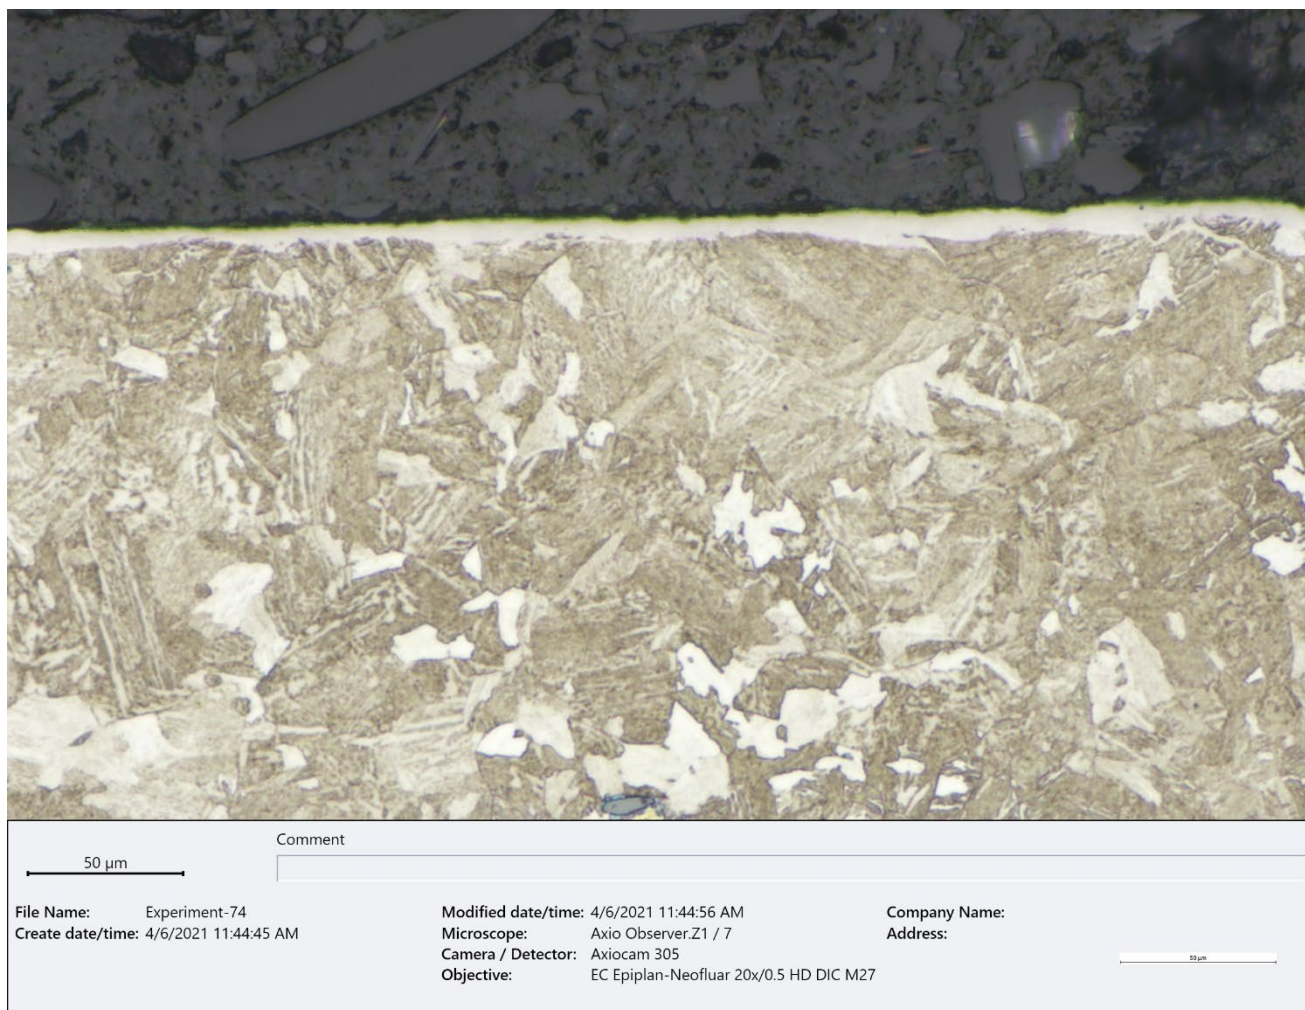
Along the journal surface away from the fracture surface, the nitride layer was present, but thinner in depth (5-10  $\mu\text{m}$  or 0.0002-0.0004 inches). There were also no indications of cracking, and the surface exhibited a lower roughness (compare Figure 16 to Figure 15).

Figure 16 – BF optical micrograph of a cross section of the journal surface away from the fracture surface edge (~500X, etched 2% Nital). The surface exhibited a thin white nitride layer.

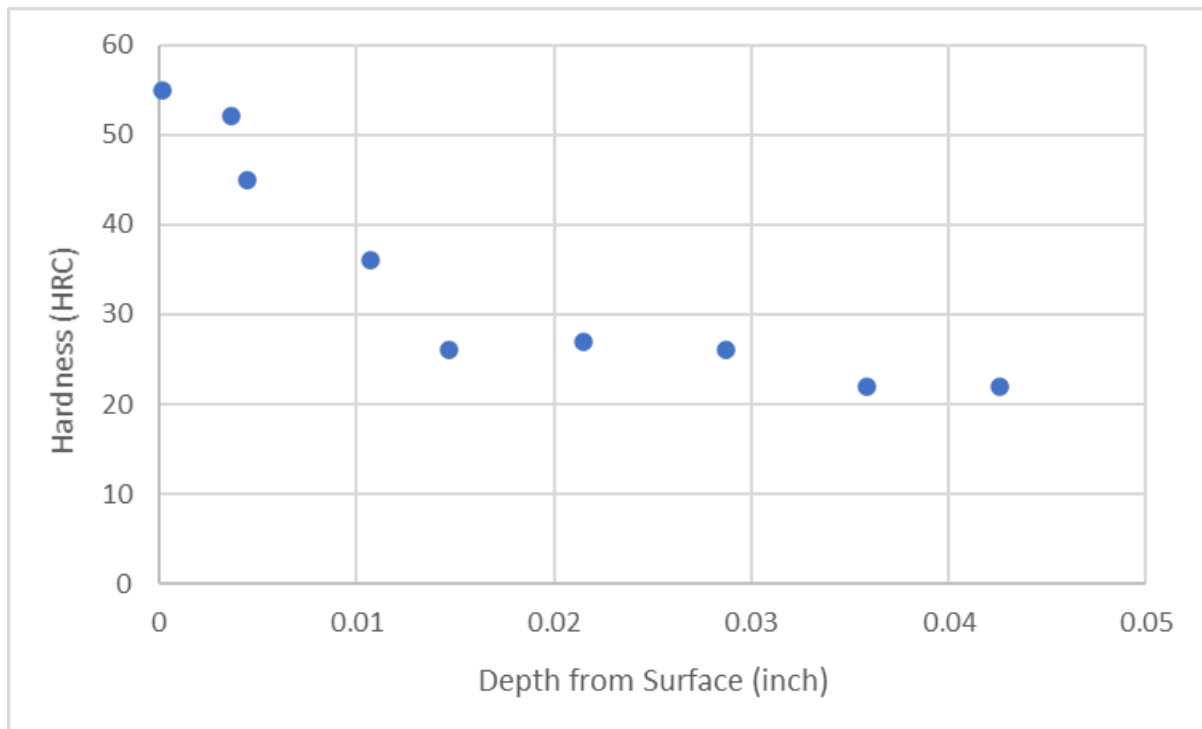
The hardness of the cross section was examined using automatic microindentation hardness, per ASTM E384.<sup>3</sup> A chart of the individual indent data is shown in Figure 17. This shows that the surface hardness was up to 55 HRC (630 HK<sub>500</sub>) but dropped to an average of 26 HRC past a depth of 0.015 inches. These hardness data were consistent with those typical of a case hardening (nitriding) treatment on an alloy steel.

Figure 17 – Chart of microindentation hardness data from indents taken sequentially from the journal surface inward, in HRC (converted from HV<sub>500</sub>).
