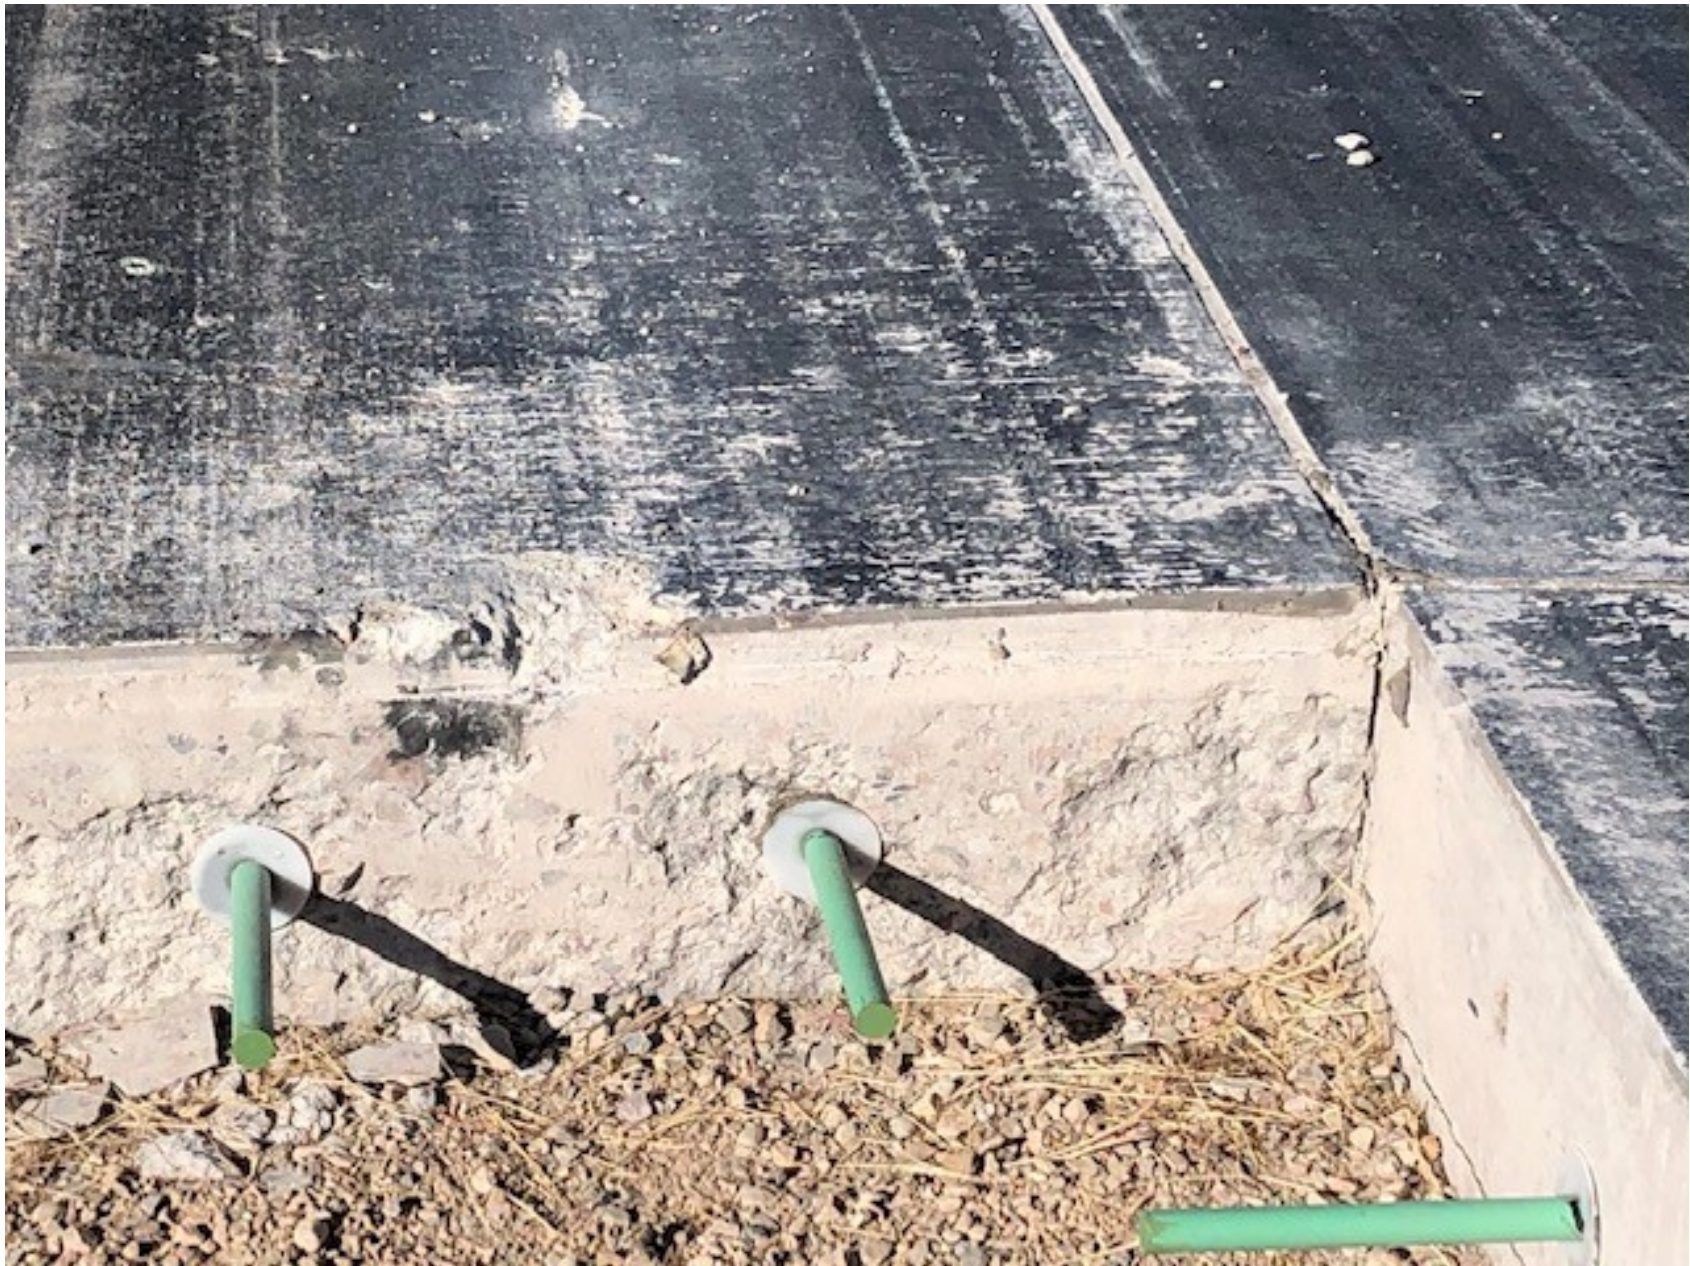
**Photo 1 – View of runway trench which the left wheel struck during an attempted go around (courtesy of the operator)**
