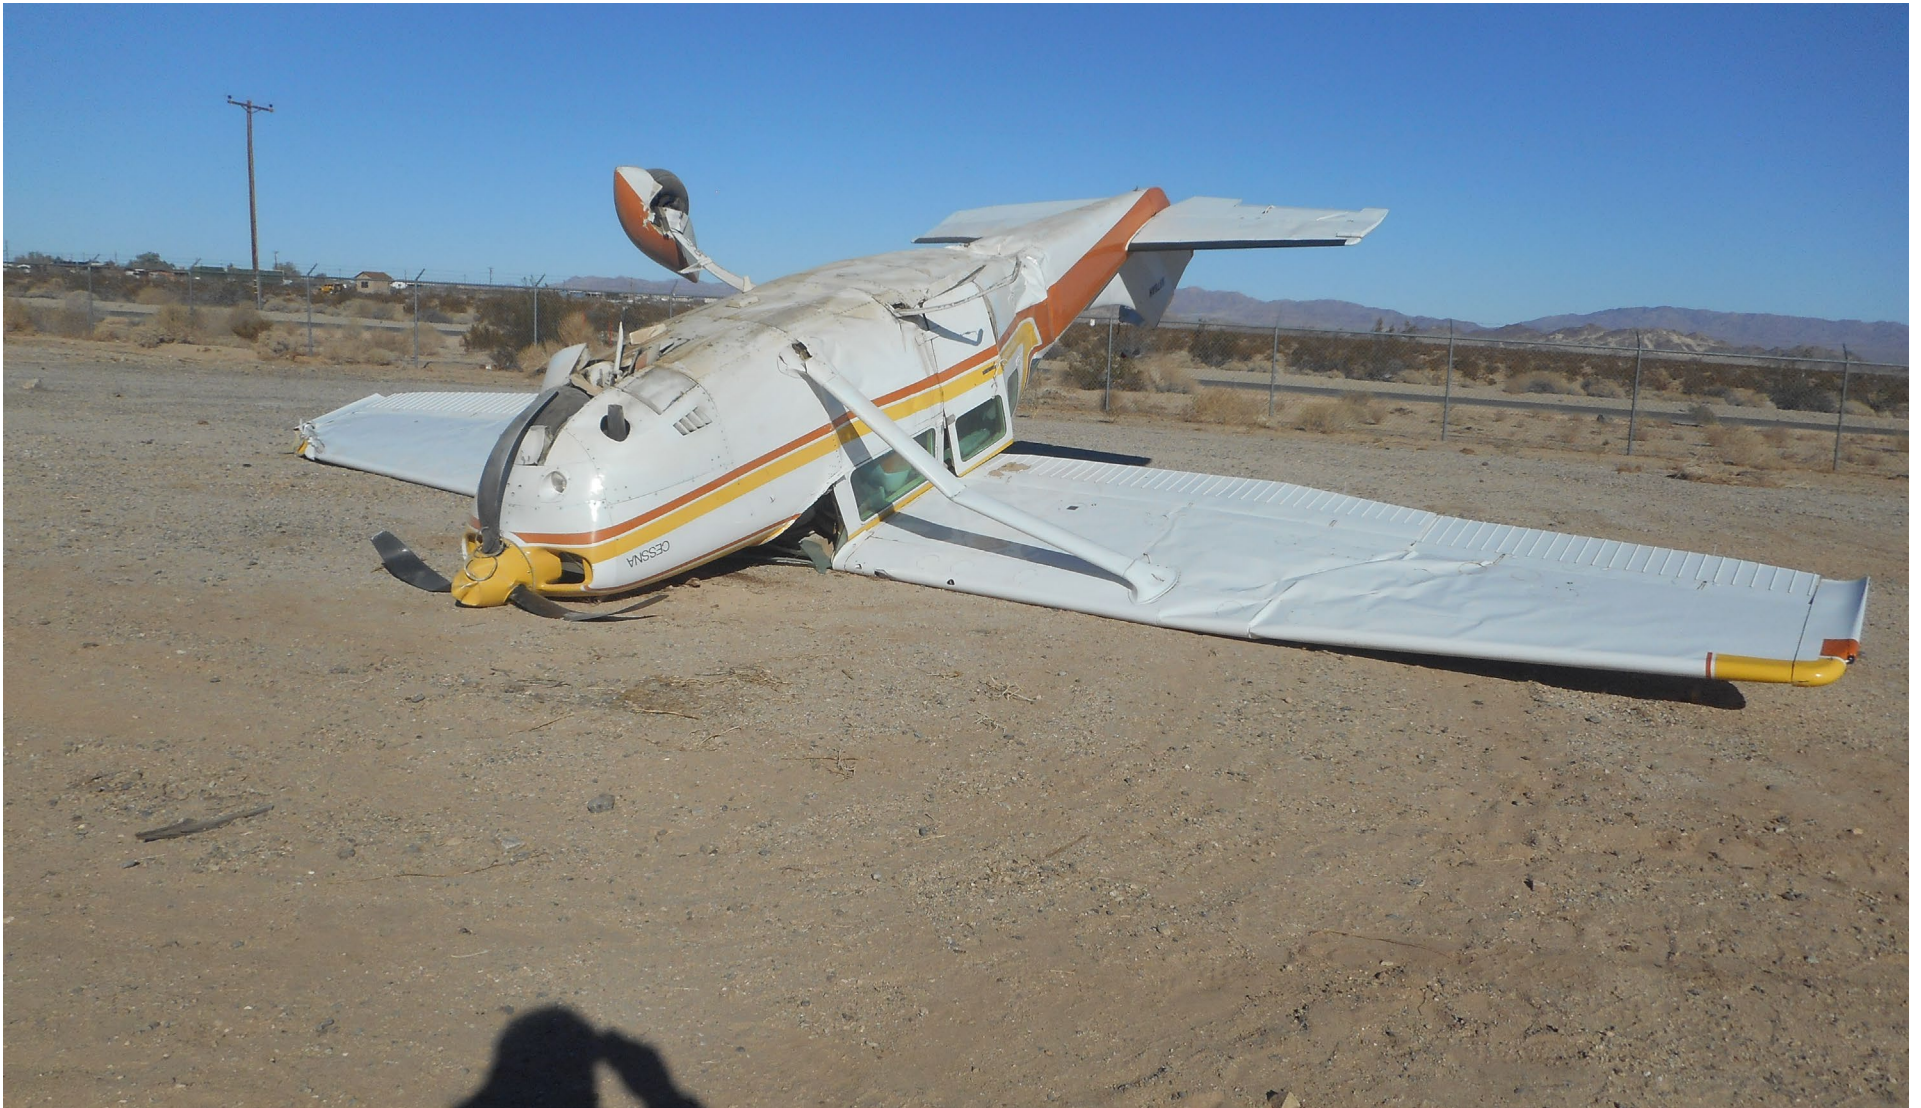
**Photo 1 – View of substantial damage sustained to the right wing and wing lift strut (Courtesy of FAA)**
