## **NATIONAL TRANSPORTATION SAFETY BOARD**

### **FOLLOW UP ENGINE EXAMINATION**

**WPR21LA068**

Location: Ogden, Utah  
Date: December 10, 2021  
Aircraft: Cirrus SR22 / N577CP  
NTSB IIC: Josh Cawthra

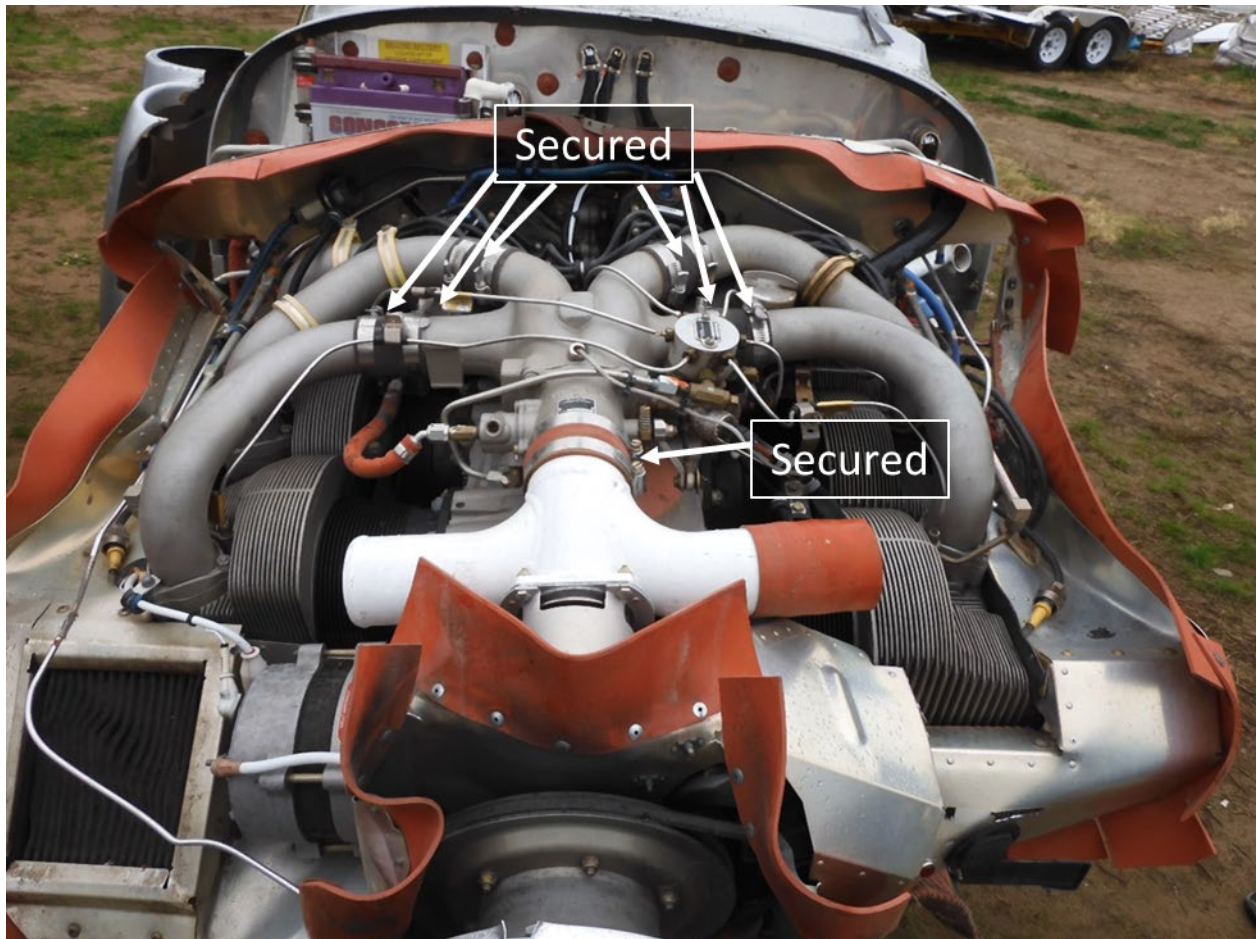
Examination of the air induction system after the throttle body revealed all were secured with clamps that appeared to be properly secured behind the raised ends of the tubes.

**Figure 5. Front view, showing the secured sleeves**

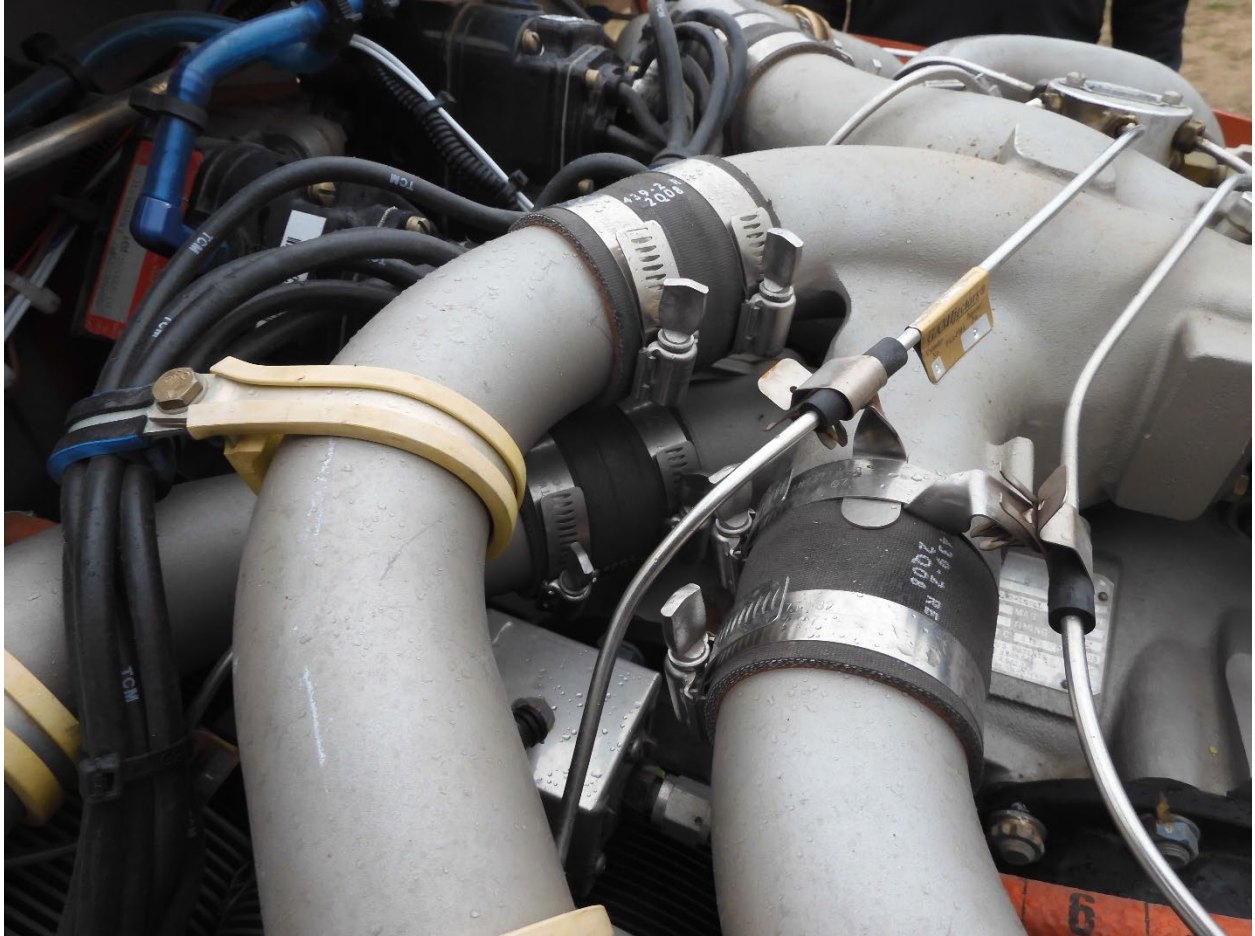
**Figure 6. Close up of sleeves on the right side of the engine.**

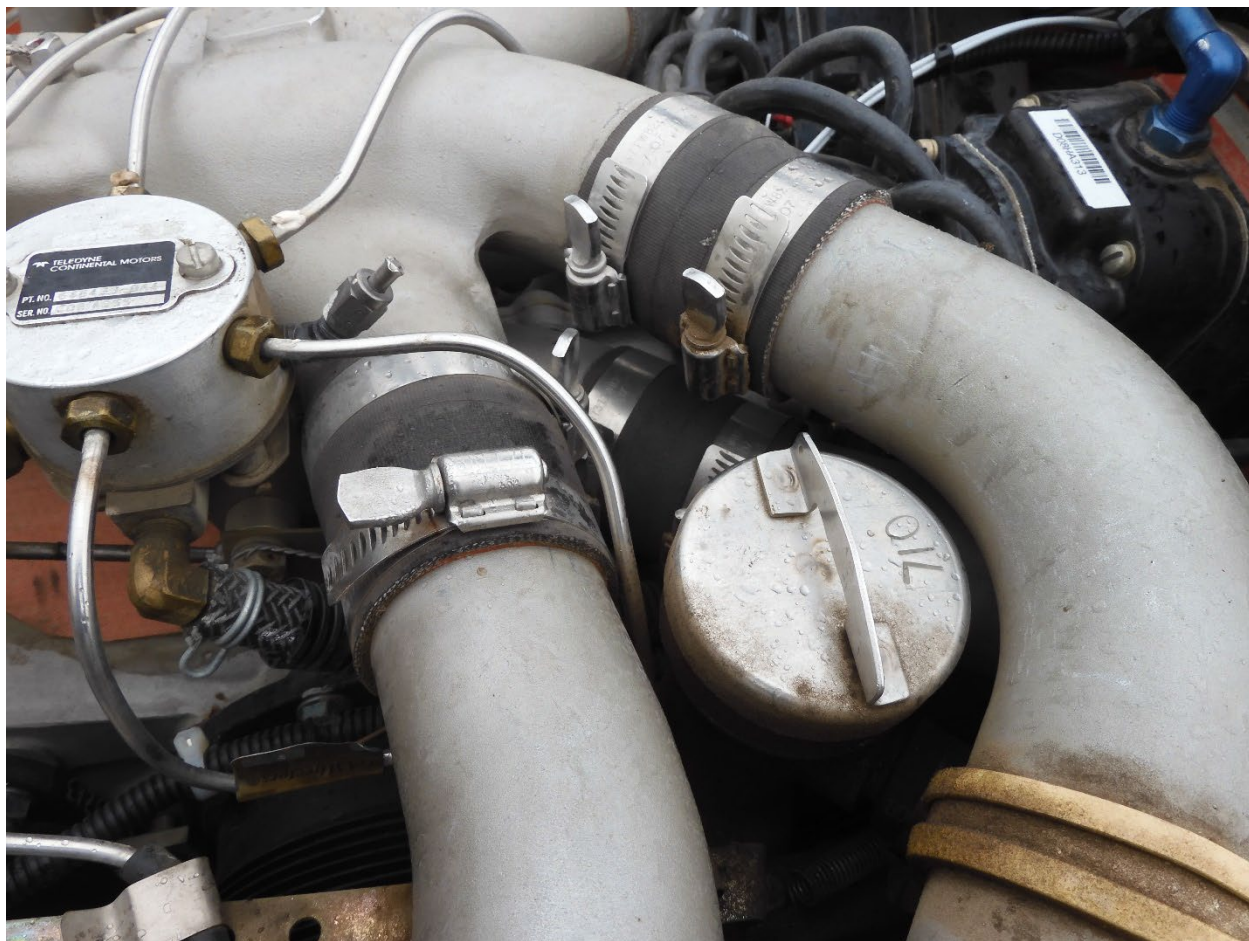
**Figure 7. Close up of the sleeves on the left side of the engine.**

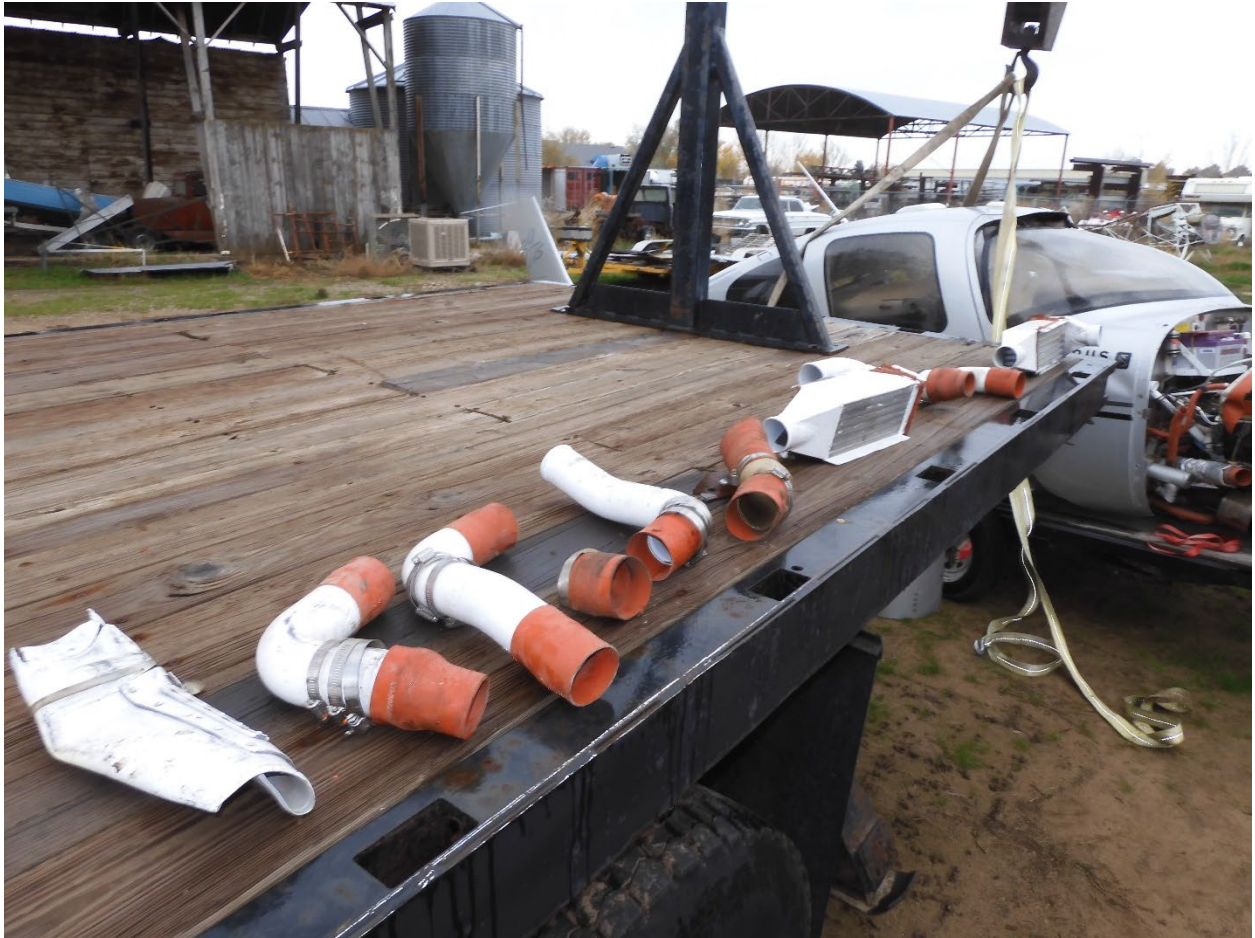
Removal of the upper engine cowling revealed the twin intercooler systems had been removed from the airplane, hindering the intent of the examination, which was to examine each of the sleeve clamps for security and the location of the clamps on the induction tubes. All the induction tubes were accounted for. One was crushed, and the remaining ones exhibited minor damage. Some of the sleeves exhibited scuffing, and rips which appeared consistent with the accident.

**Figure 8. Air induction tubes, intercoolers, and sleeves removed.**

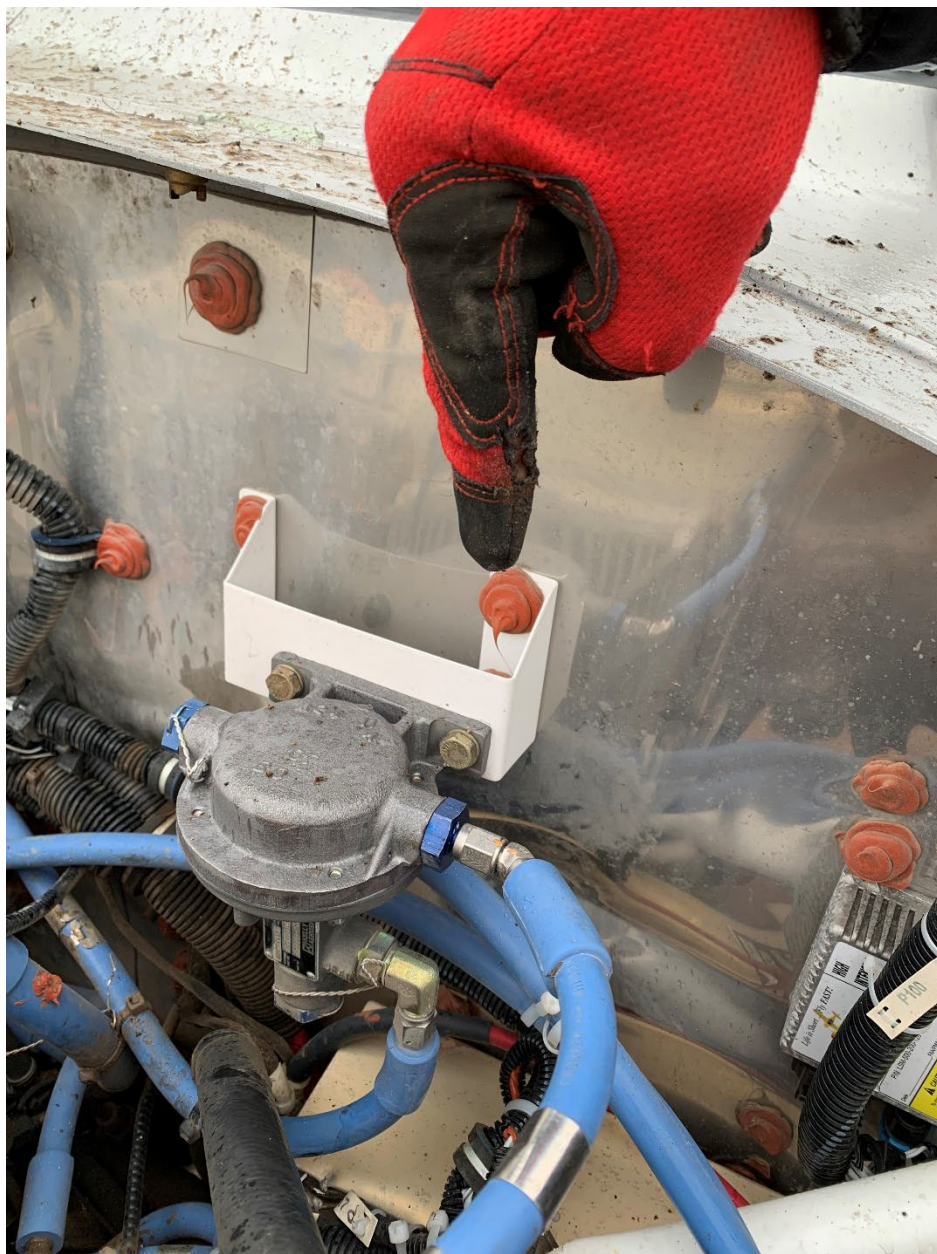
According to the recovery agent, the loose tubing, identified in Figure 9, was loose due to the initial engine examination process, or the recovery process.

**Figure 9. Airline found loose.**
