February 18, 2021

Subject: Cessna 172N N5098E [Aircraft Accident - WPR21LA069]

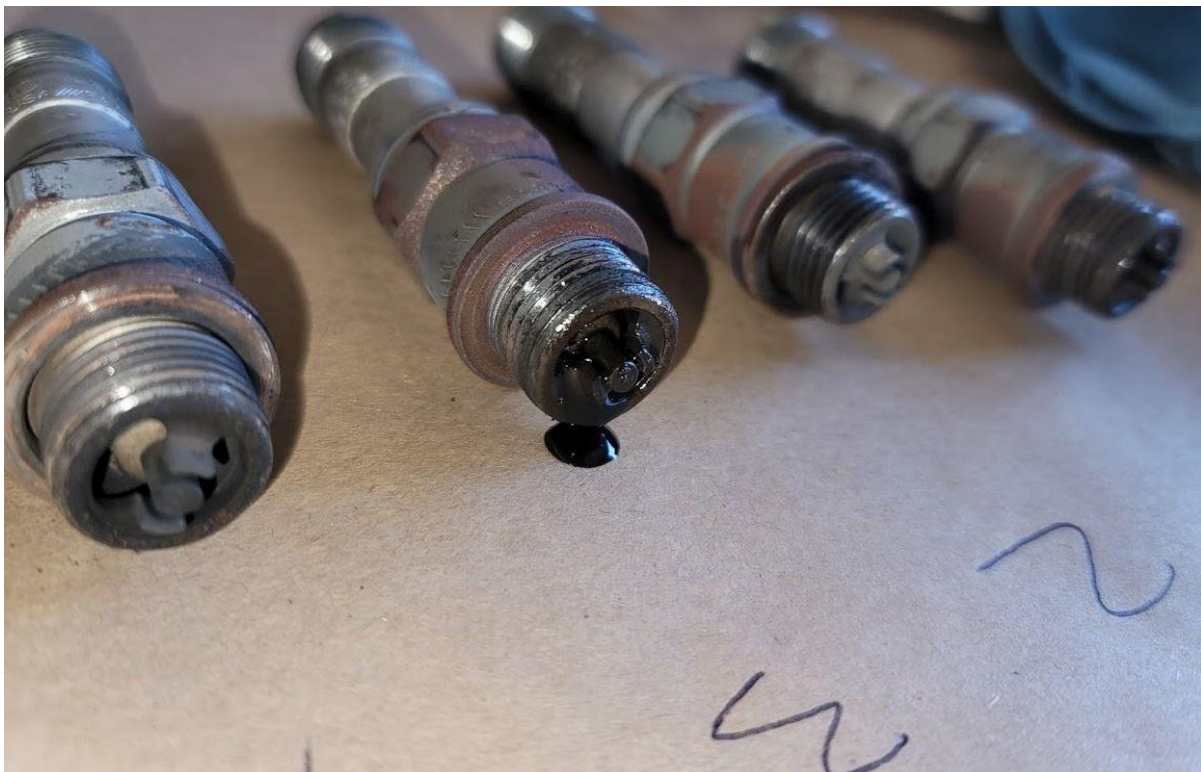
Upon initial inspection of the wreckage, it was found that the propeller appeared straight with no major damage. The engine was intact with no observed holes or damage, the propeller was turned through by hand backwards rotation and normal compression resistance was felt. The lower spark plugs were removed and cylinder numbers 1,2, and 4 plugs were dry but the number 3 was oil fouled.

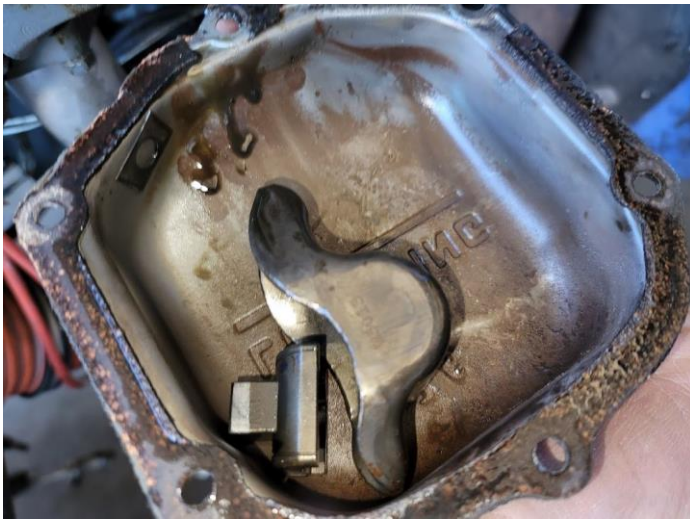
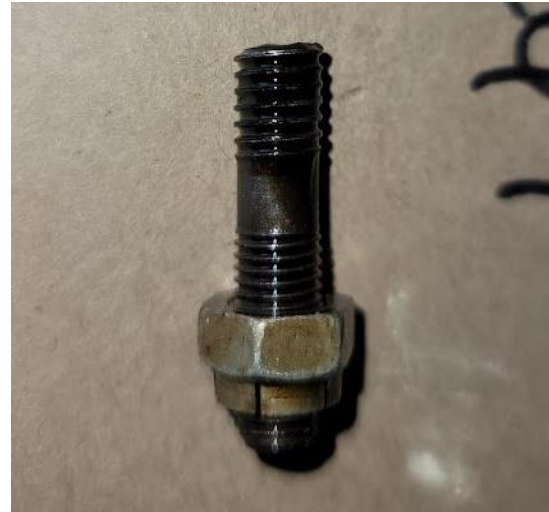
With the ignition harness loose, the magneto was function checked by verifying and observing good spark from each harness lead in the correct firing order. With a closer look of the top of the engine it was found to have the number three cylinder's intake push rod tube bent. Upon removal of the rocker covers it was found that the number three cylinder's exhaust valve rocker arm retention stud had sheared off.

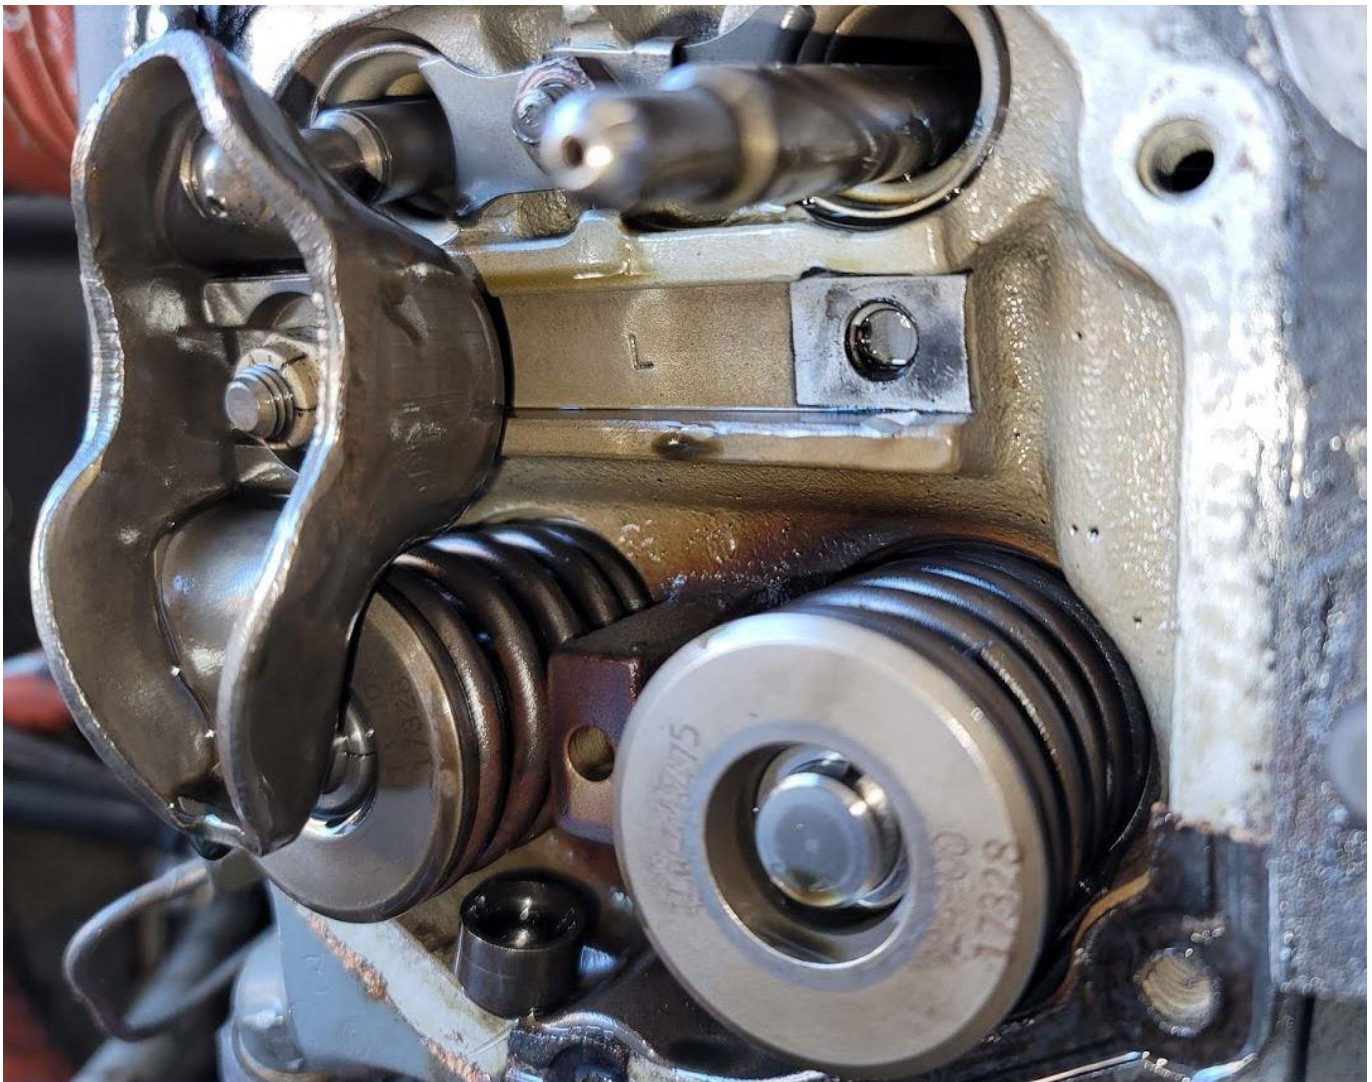
The broken pieces and parts moving around in the rocker box cover could have lodged under the intake rocker arm and cause the push rod and push rod tube to bend.

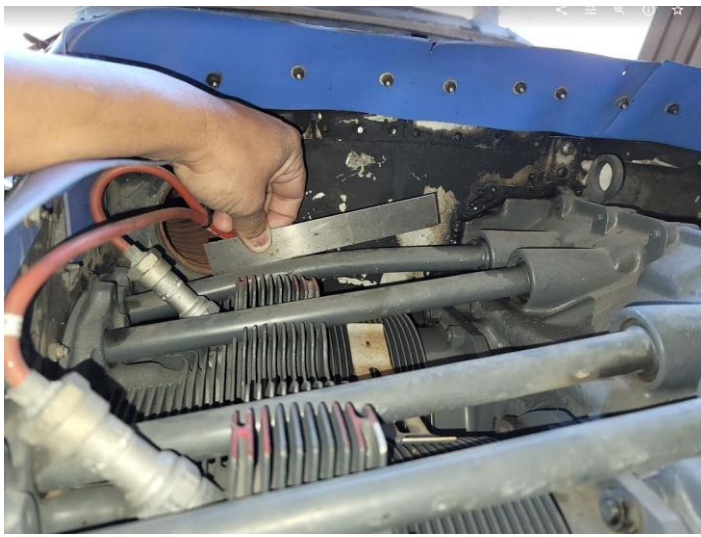
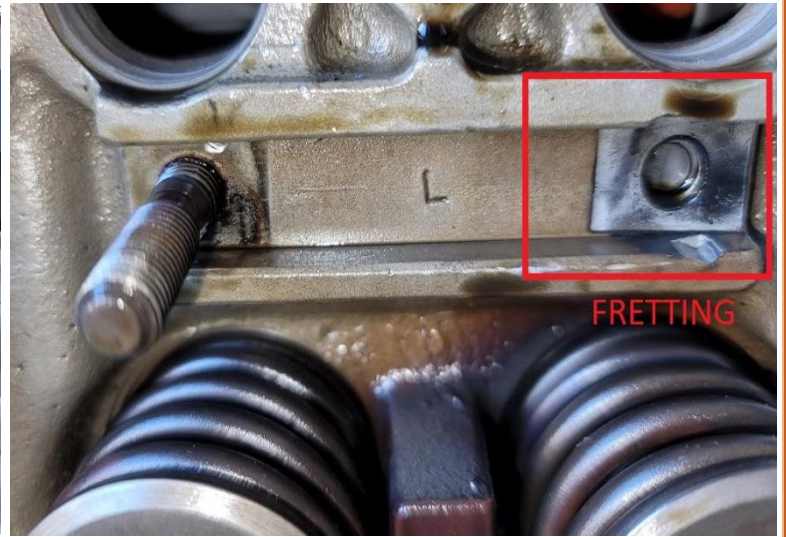
Fretting was observed at the mating surface for the rocker arm seat, this damage is induced under load and in the presence of repeated relative surface motion, as induced for example by vibration from the possibility of improper torque. Rotating the engine to determine valve train operation, it was observed that all rocker arms showed excessive toe to valve stem clearances due to deterioration of camshaft and lifters. Upon further examination of the camshaft and lifters, extreme spalling wear was observed on all lifters and camshaft lobes.

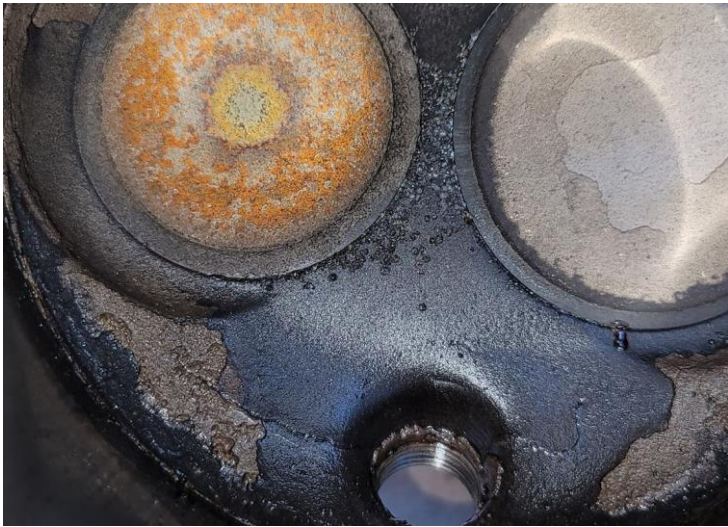
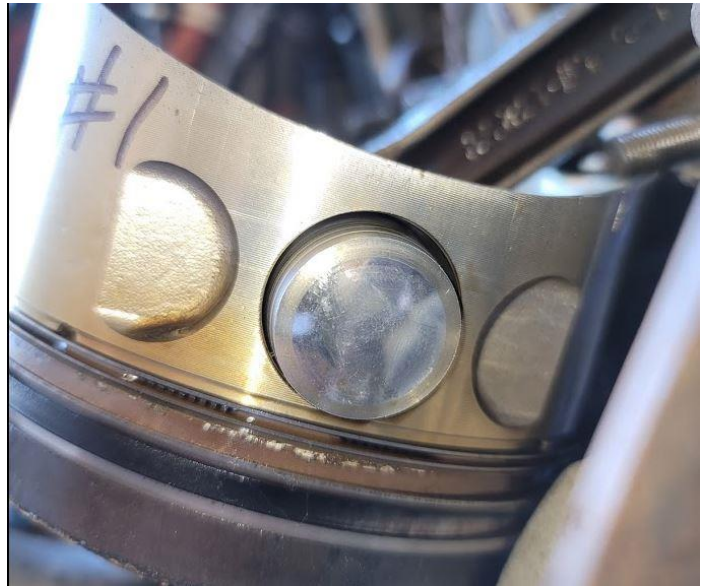
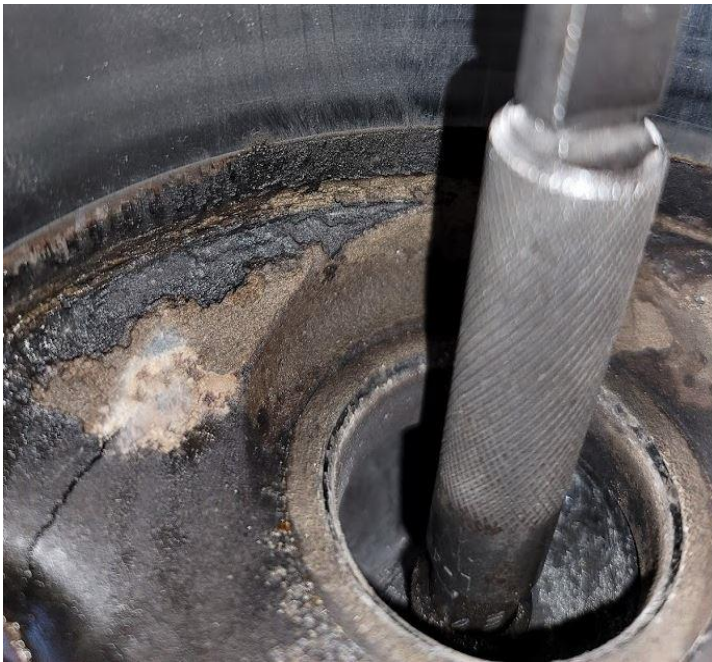
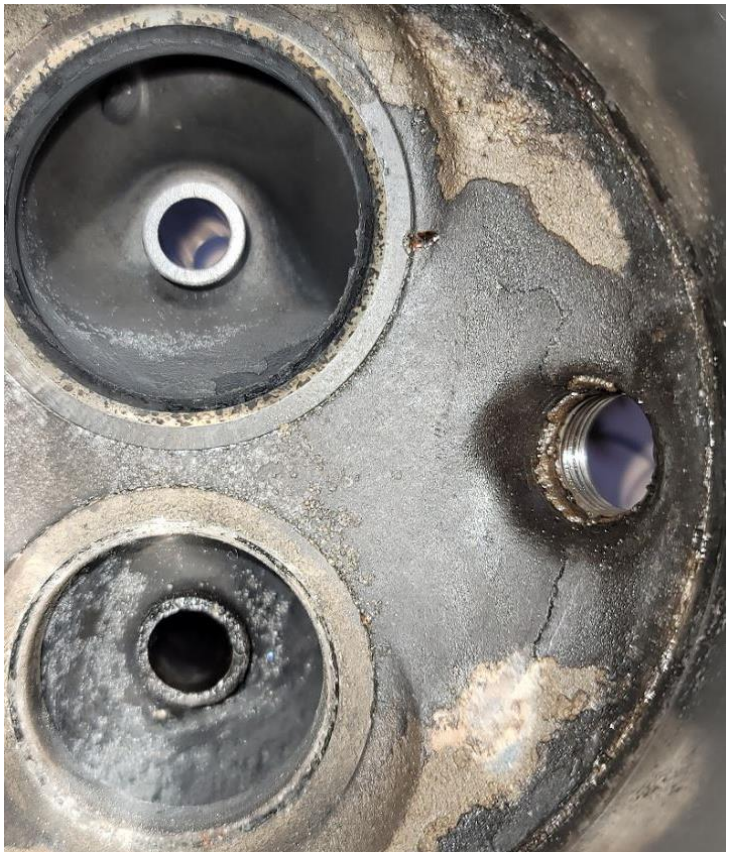
Cylinder barrel scoring was noticed on the numbers one and three cylinders which were removed to view the internals of the engine. The number three cylinder has a severe crack in the lower spark plug boss. Aluminum piston pin plugs were installed and the aft pin plug of the number three cylinder and the forward pin plug from the number one cylinders were severely worn. The cylinder number three valves were removed and did not appear stuck in any way, the exhaust valve guide was found worn beyond limits and was verified using and Lycoming go no-go gauge.

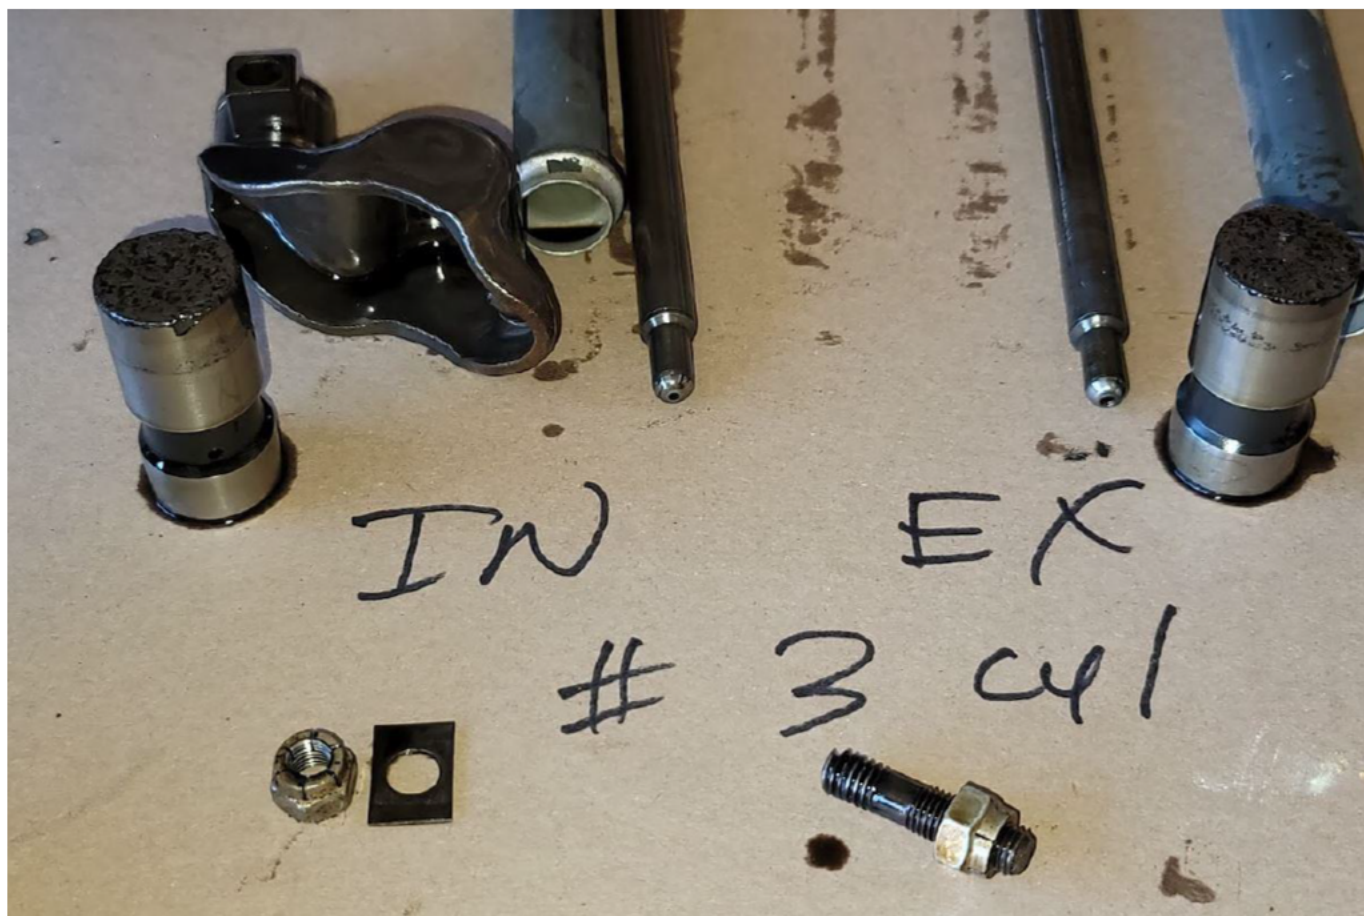
In summary this engine was found to be in need of repair or overhaul and was producing substantial metal internally. It is my opinion that the amount of wear on the camshaft lobes and lifters along with the wear from the pistons and piston pin plugs that this engine has been producing metal in the last 100 plus hours. This metal should be significant enough to be found during normal oil change and maintenance upon visual inspection of the oil and filter. The amount of wear to the camshaft lobes and lifters cause excessive rocker clearances would have caused a deterioration of power over time due to valves not opening a sufficient amount. The failure of the number three exhaust valve rocker arm retention stud would have caused a sudden degradation of power additionally. The failure of the exhaust valve rocker arm retention stud in my opinion could have been caused by the fretting of the rocker arm seat to the seat boss of the cylinder head. This wear would have loosened up the mating surfaces enough to cause the stud to break under load and vibration.
