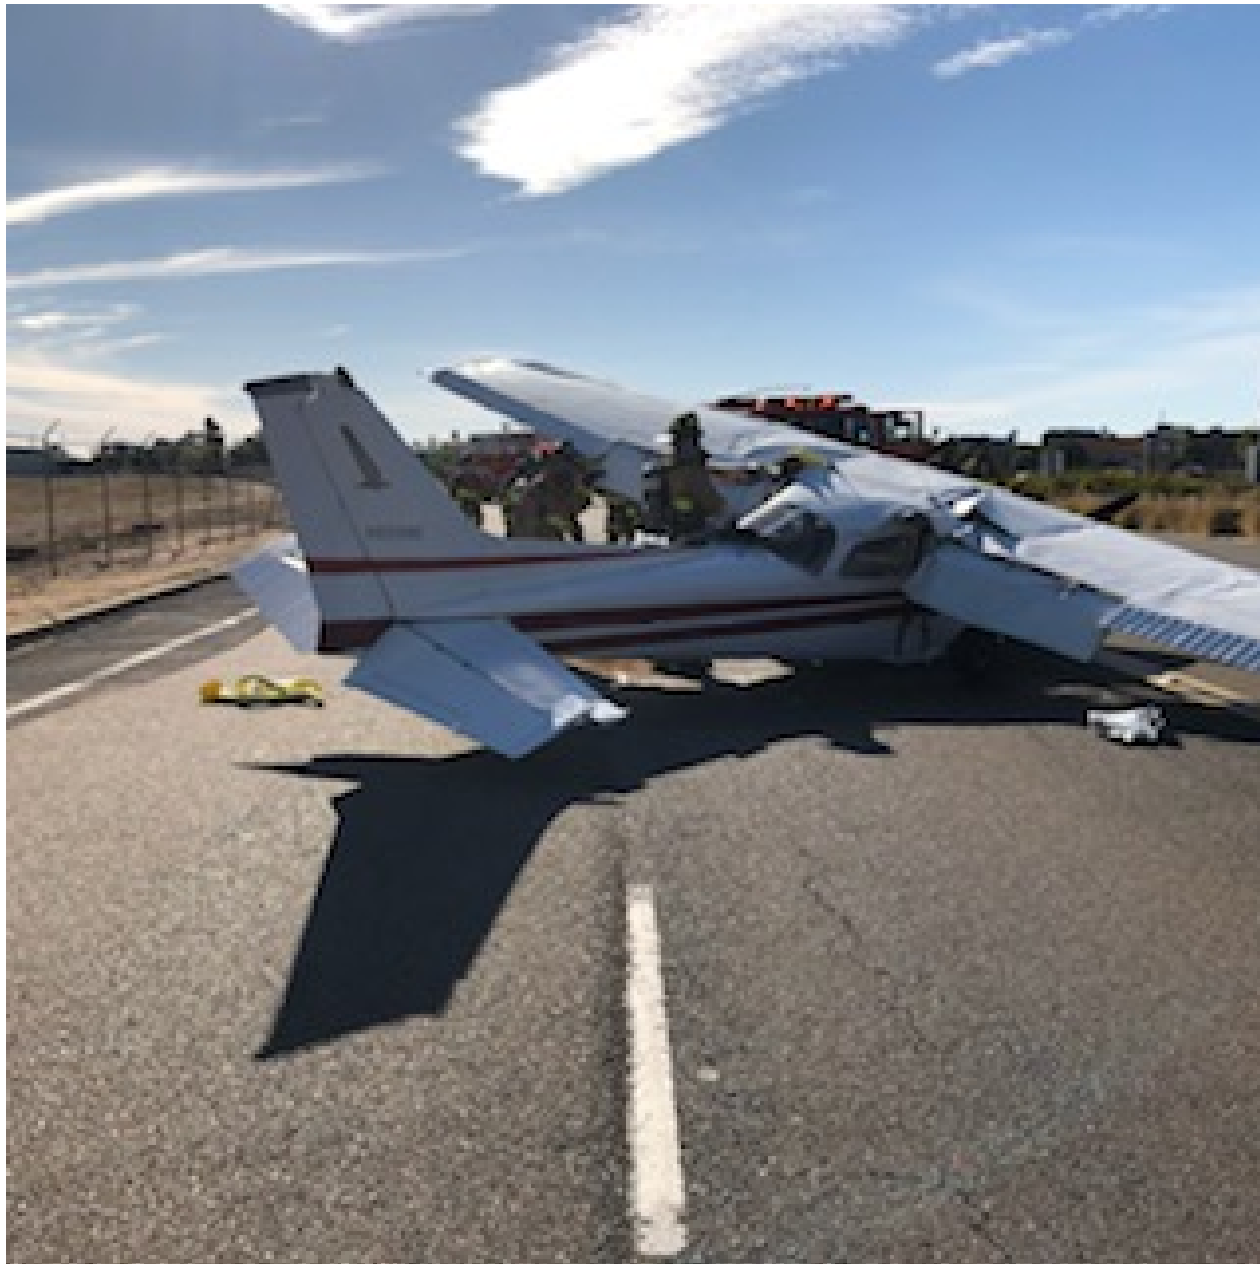
**Photo 1 – View of left and right wing damage (photo courtesy of the FAA)**

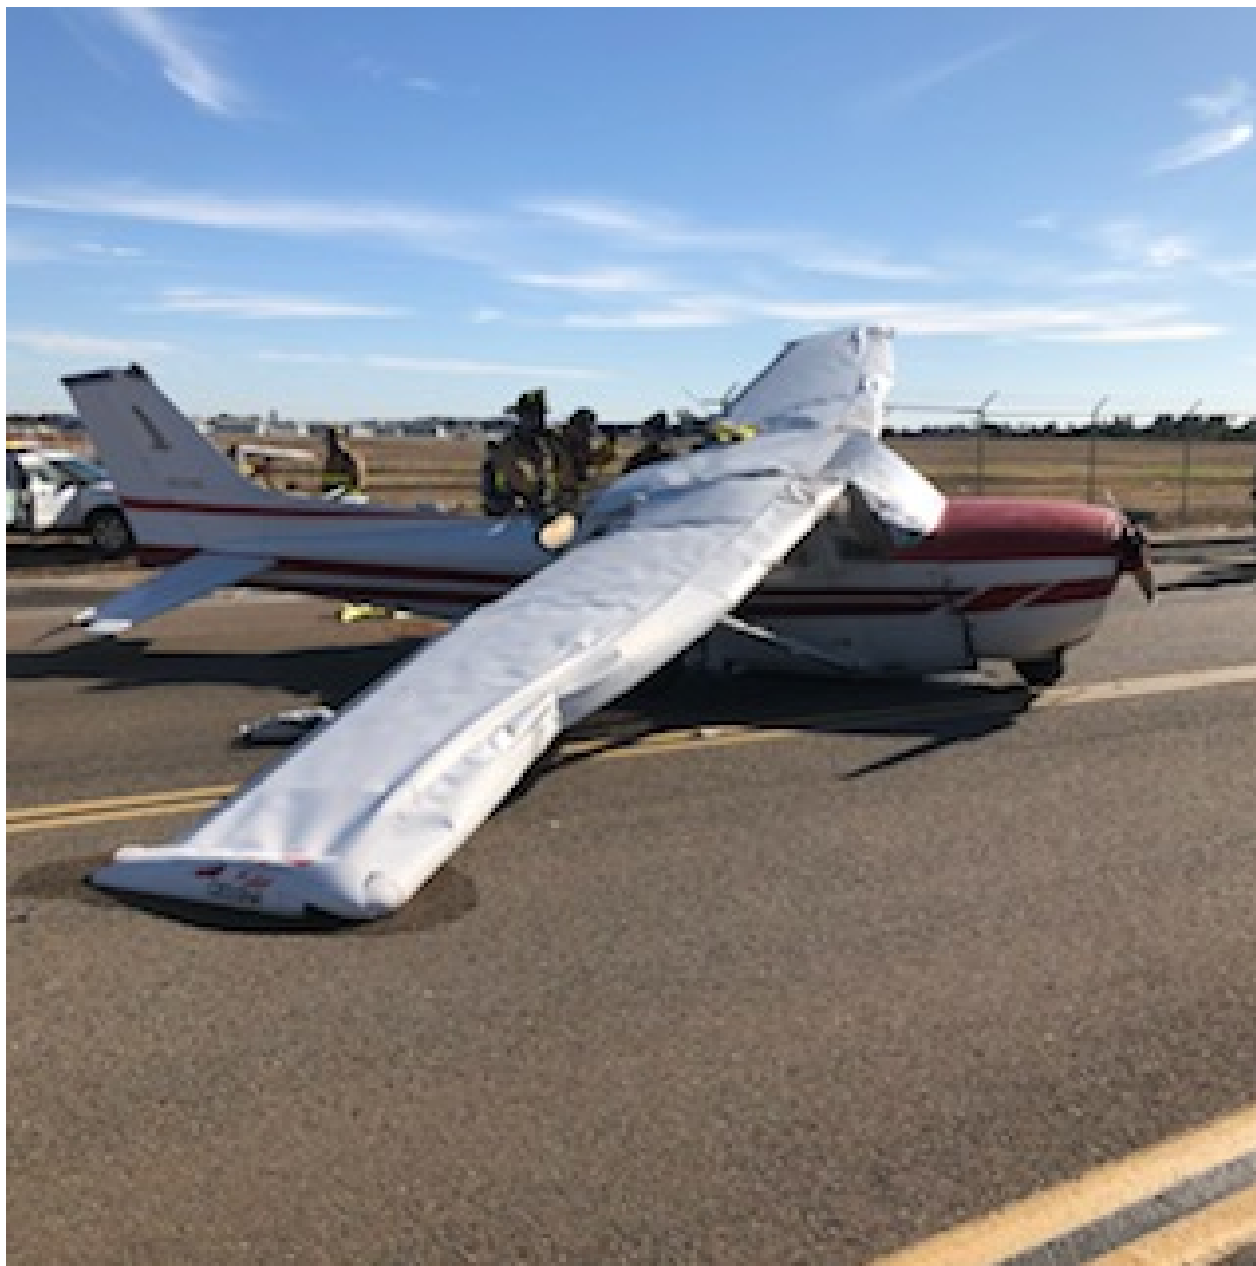
**Photo 2 - View of right wing damage (photo courtesy of the FAA)**

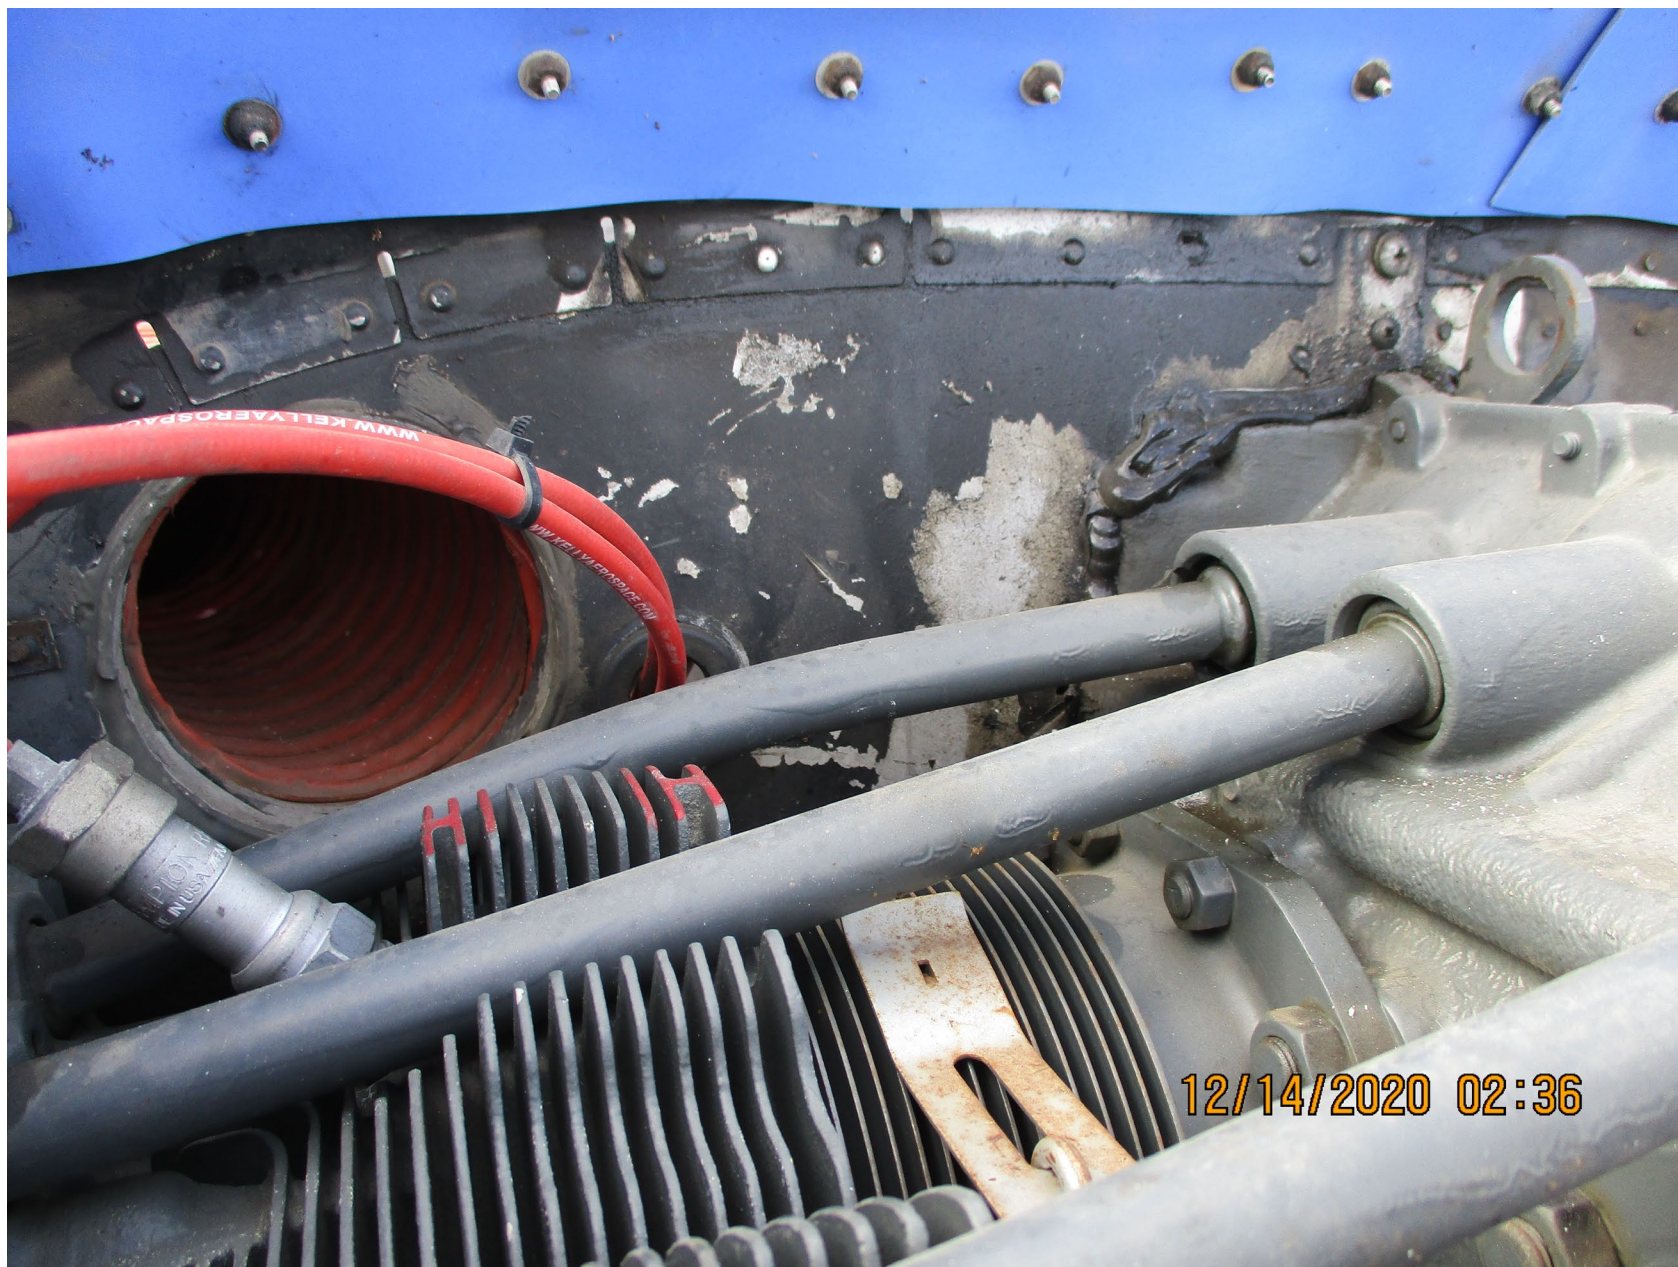
**Photo 3 – View of the bent push rod tub on the number 3 cylinder (photo courtesy of the FAA)**

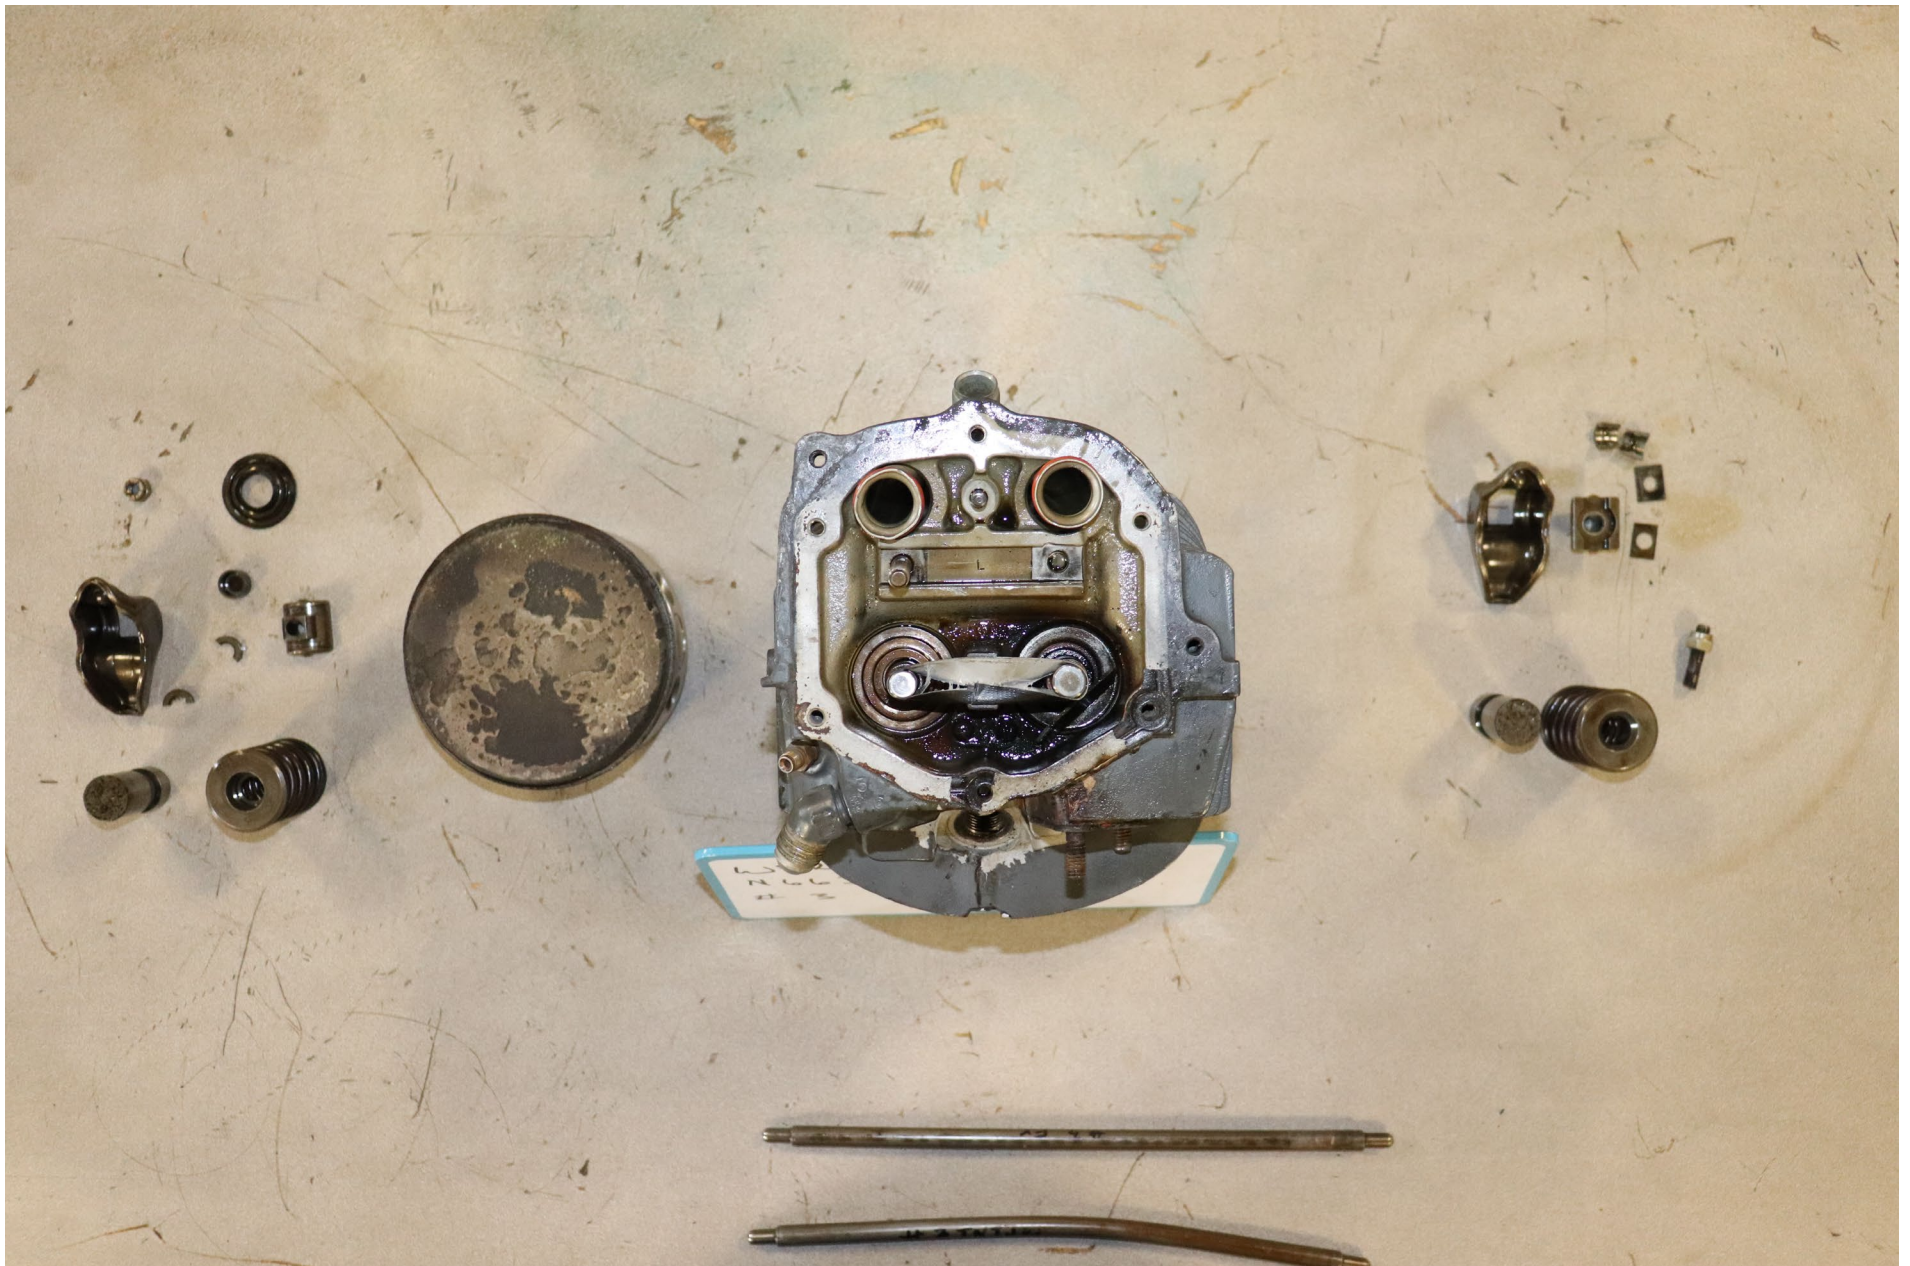
**Photo 4 - View of the number 3 cylinder, push rods and piston from above (photo courtesy of the NTSB)**

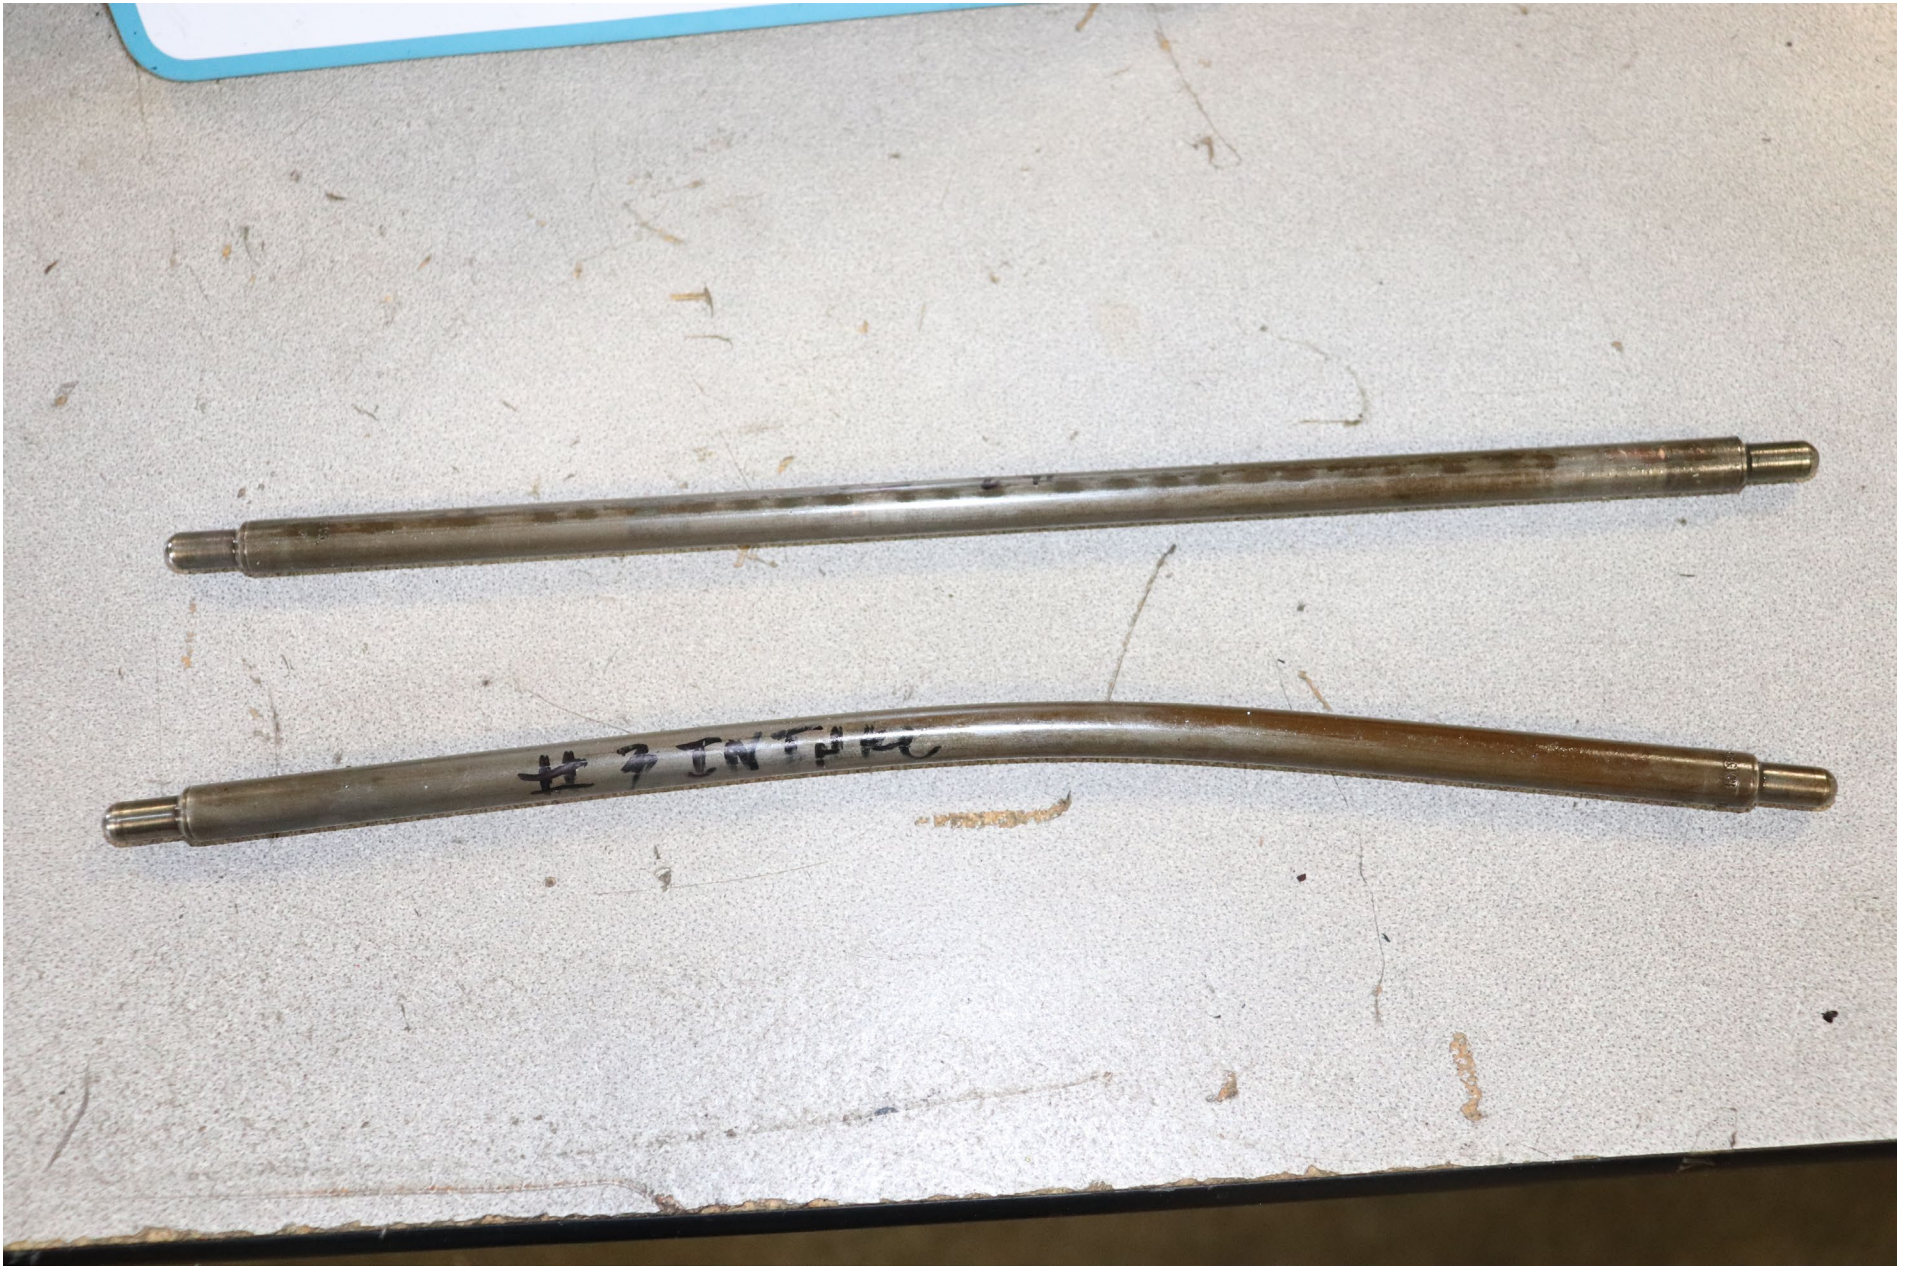
**Photo 5 - View of the number 3 cylinder push rods (photo courtesy of the NTSB)**

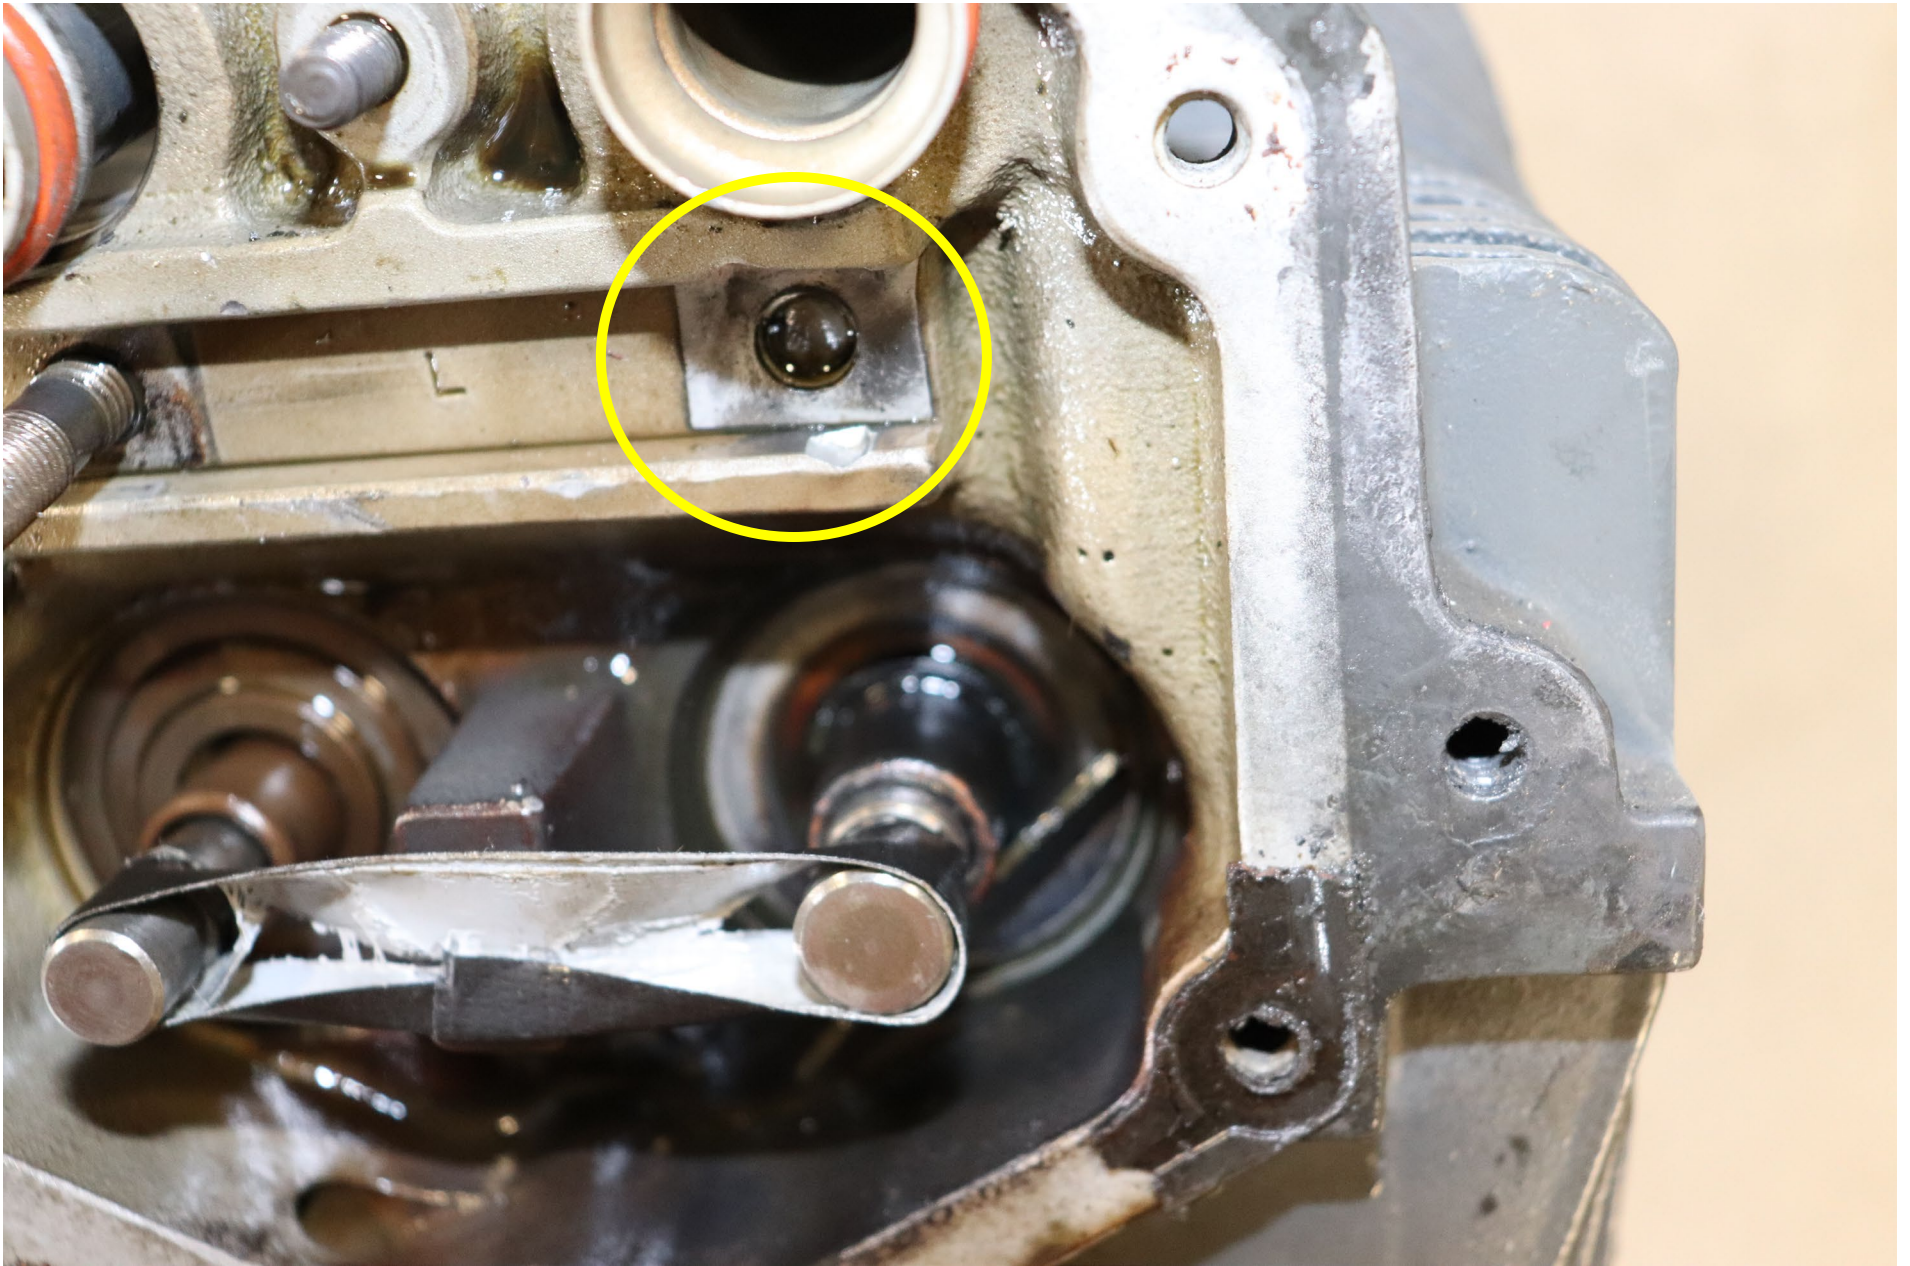
**Photo 6 - View of fretting to the seat boss of the number 3 cylinder (photo courtesy of the NTSB)**
