# NATIONAL TRANSPORTATION SAFETY BOARD

## MATERIALS LABORATORY FACTUAL REPORT

Report No. 21-063

Place : San Diego, California  
Date : December 13, 2020  
Vehicle : Cessna 172N, N5098E  
NTSB No. : WPR21LA069  
Investigator : Eric Gutierrez, AS-WPR

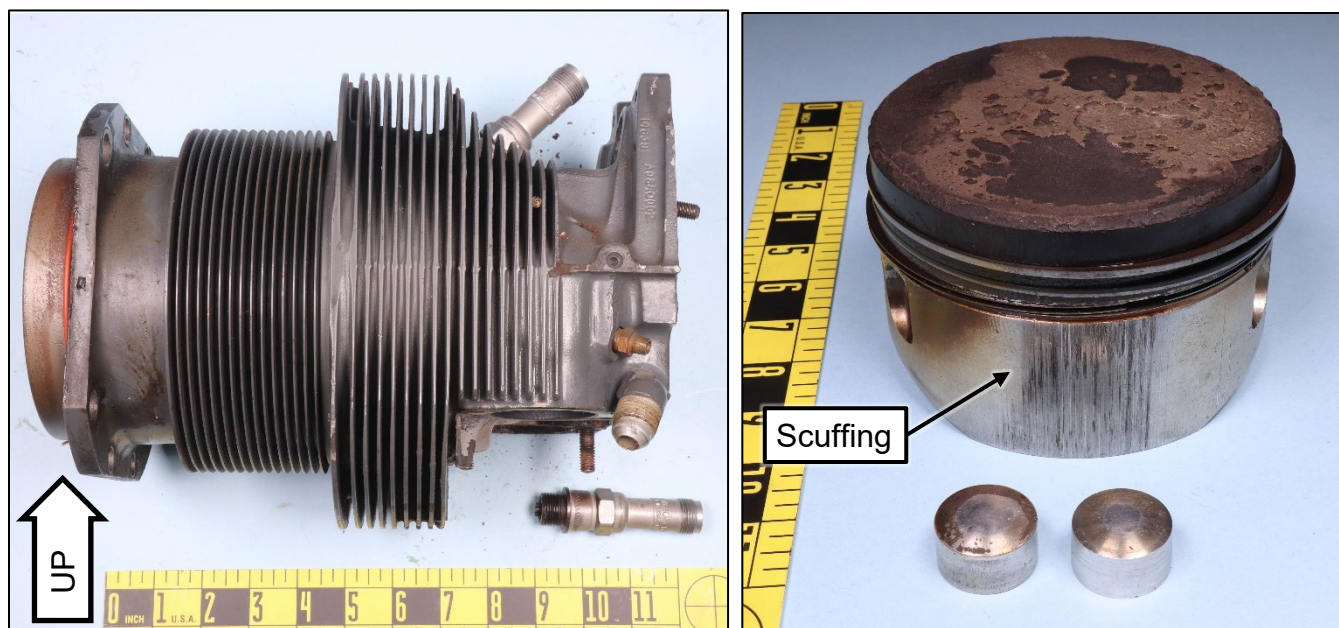
Overall views of the submitted components are shown in figures 1 and 2. The intake and exhaust valves, not visible in figure 1, were retained in the valve guides and were held in place for shipment with tape. The piston skirt had dark scoring damage on one side as shown in figure 1 consistent with piston skirt scuffing, and corresponding scoring damage was observed on the upper side of the piston barrel. The rocker attachment stud for the exhaust rocker arm was fractured, and the outboard end with the nut is shown in figure 2. The intake pushrod and corresponding shroud tube were bent, and the intake and exhaust hydraulic lifters were spalled.

Figure 1. Overall views of the cylinder assembly with the disassembled lower spark plug (left) and the piston assembly with piston pin plugs (right) as received.

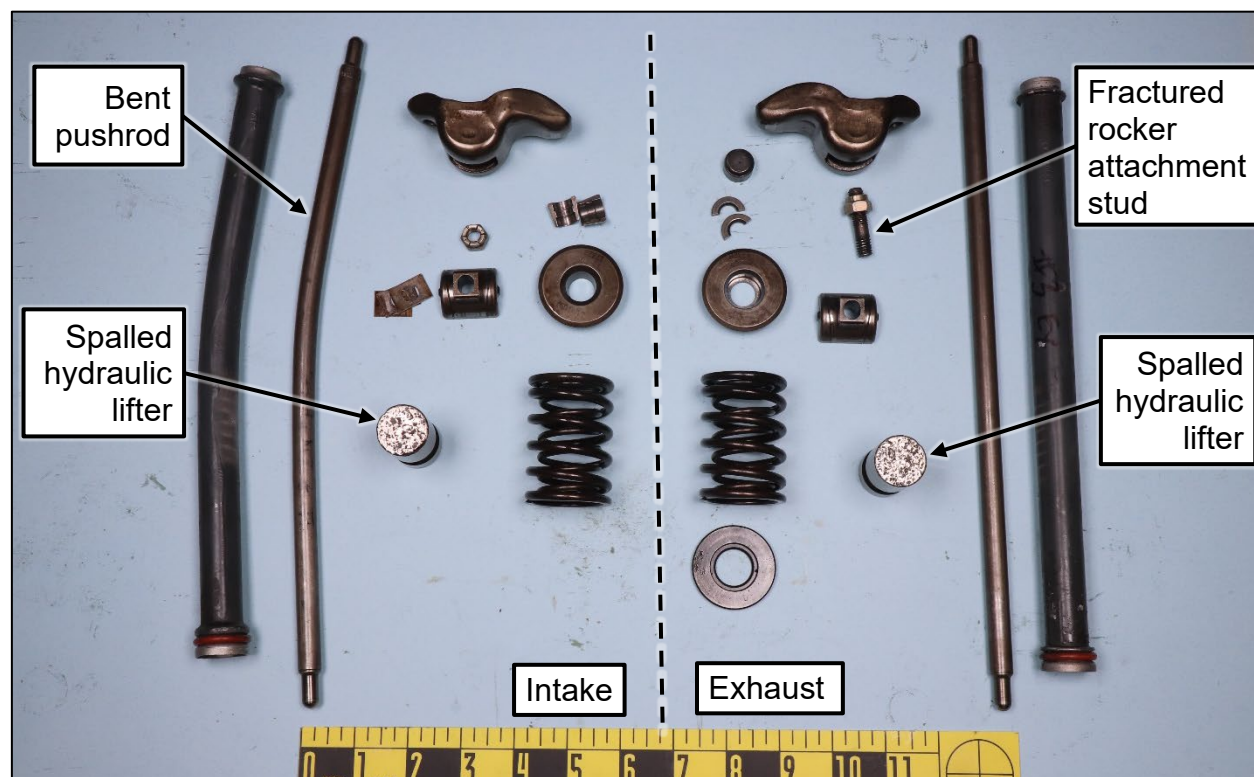
The mating side of the exhaust rocker arm attachment stud and attached nut (see figure 2) were submerged in a bath of acetone and cleaned using an ultrasonic cleaner.

Figure 2. Overall view of the broken exhaust rocker attachment stud and disassembled valve train components as received.

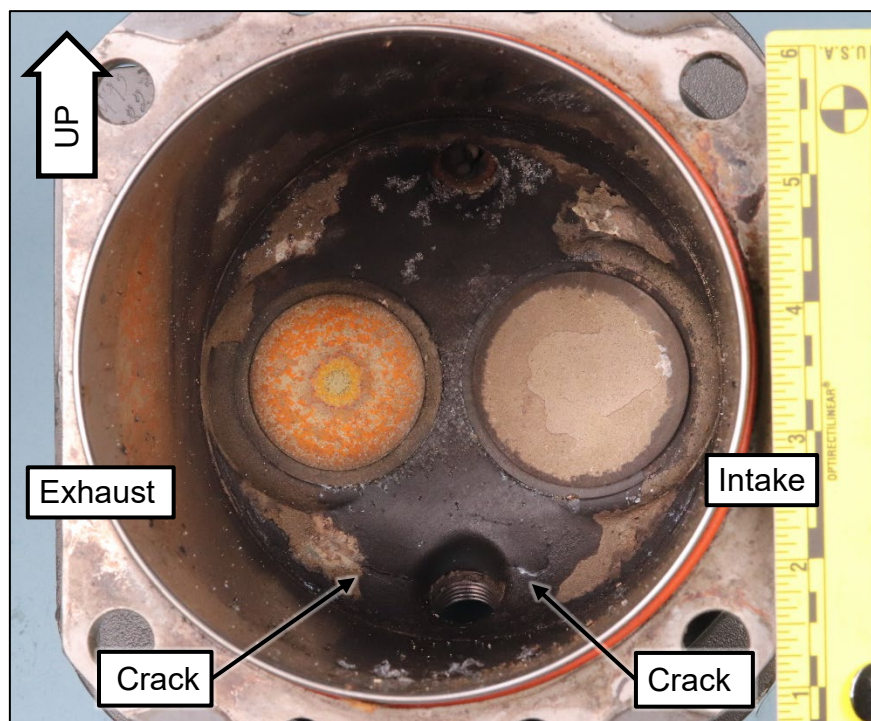
A view of the cylinder interior is shown in figure 3, and views of the rocker box are shown in figure 4. The interior surface of the cylinder head was covered with mostly dark deposits, and the exhaust valve had an oxidation pattern with circular symmetry. Cracks were observed in the cylinder head at the lower spark plug port. Dark deposits consistent with coked oil were observed in the rocker box around the exhaust valve guide. The inboard end of the fractured exhaust rocker attachment stud was retained in the cylinder head, and the fracture surface is shown in the close view in figure 4. A portion of the fracture surface was in a flat plane with curving crack arrest lines, features consistent with fatigue. The fatigue features emanated from a broad origin area at the forward side of the stud as indicated in figure 4.

Figure 3. Interior of the cylinder.

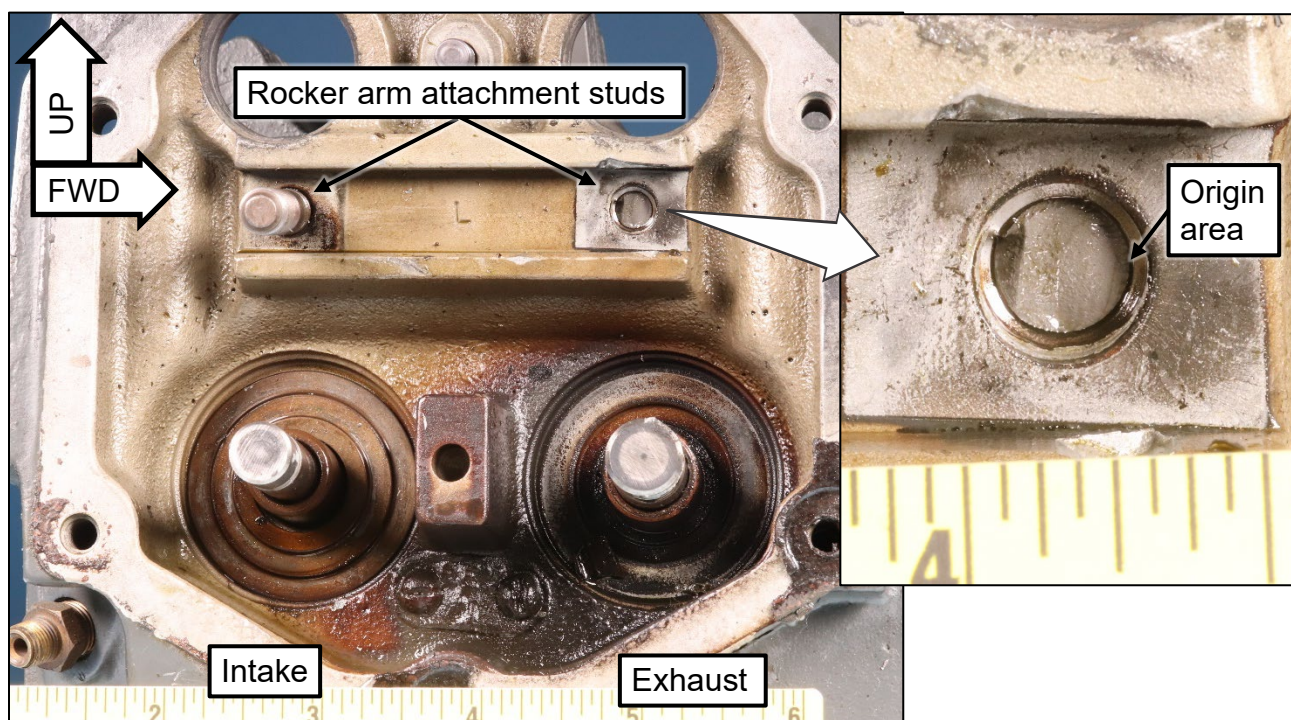
Figure 4. Overall view of the rocker box showing coked oil deposits around the exhaust valve and a closer view of the fractured exhaust rocker arm attachment stud.

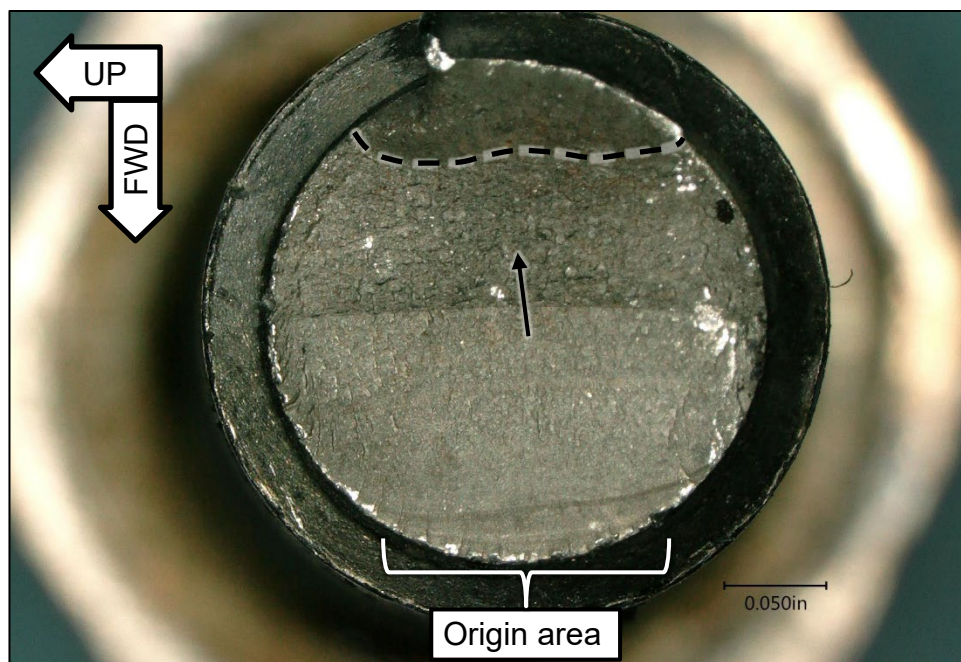
An optical image of the cleaned fracture surface is shown in figure 5. Ratchet marks were observed on the forward side of the fracture surface consistent with multiple fatigue origins in the area indicated with a bracket in figure 5. The fatigue region extended across approximately 90 percent of the cross-sectional area to the boundary delineated with a dashed line in figure 5. An unlabeled arrow in figure 5 indicates the general direction of fatigue crack growth. The fracture surface of the cleaned stud was further examined using a scanning electron microscope (SEM), and the fatigue region showed features consistent with fatigue crack growth in steel (see figure 6).

Figure 5. Optical image of the fracture surface on the exhaust rocker arm attachment stud piece shown in figure 2 after cleaning with an ultrasonic cleaner while submerged in acetone. An unlabeled arrow indicates the fatigue crack growth direction, and a dashed line indicates the fatigue boundary.

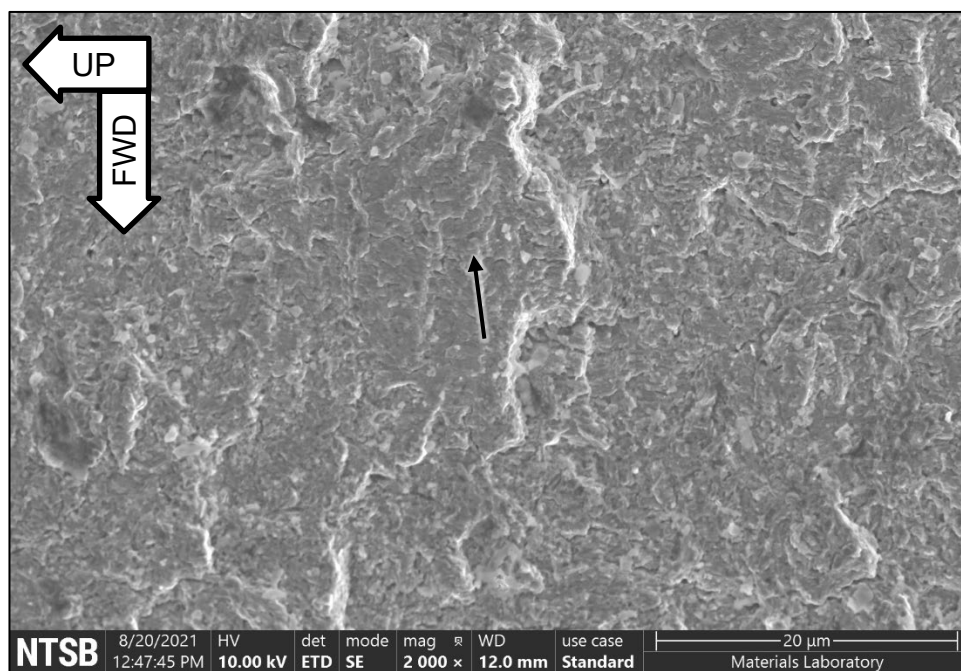
Figure 6. SEM image of fatigue features on the cleaned exhaust rocker attachment stud piece. An unlabeled arrow indicates the fatigue crack growth direction.

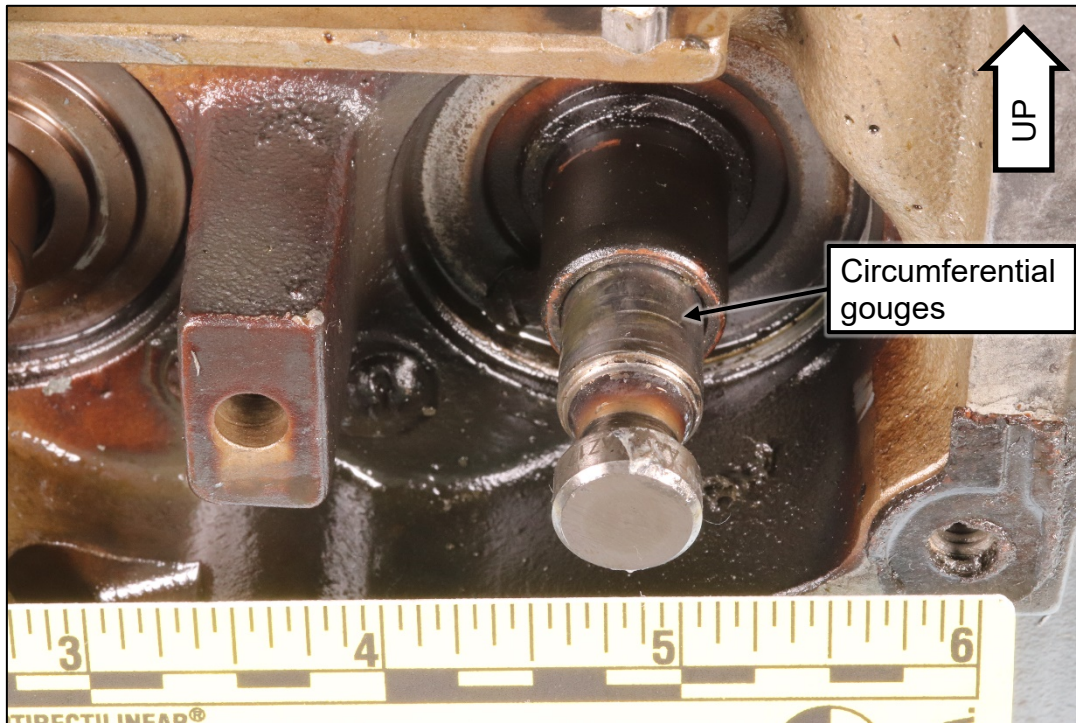
An oblique view of the cylinder rocker box at the exhaust valve guide is shown in figure 7 after the tape holding the valves in place was removed. Note remnants of tape adhesive are visible on the valve tip when photographed. Circumferential gouges were observed on the side of the exhaust valve near the valve tip corresponding to contact with the edge of the valve guide. Next, the tape residue was wiped from the intake and exhaust valve tips, and the valves were removed from the cylinder as shown in figure 8. Thick black deposits were observed on the back side of the intake valve head, and tan deposits were observed on the back side of the exhaust valve head. Further up the exhaust valve stem, raised black deposits were observed as indicated in figure 9. Multiple circumferential gouges on the side of the stem near the tip are also shown.

Figure 7. Exhaust valve tip before removal from the cylinder assembly.

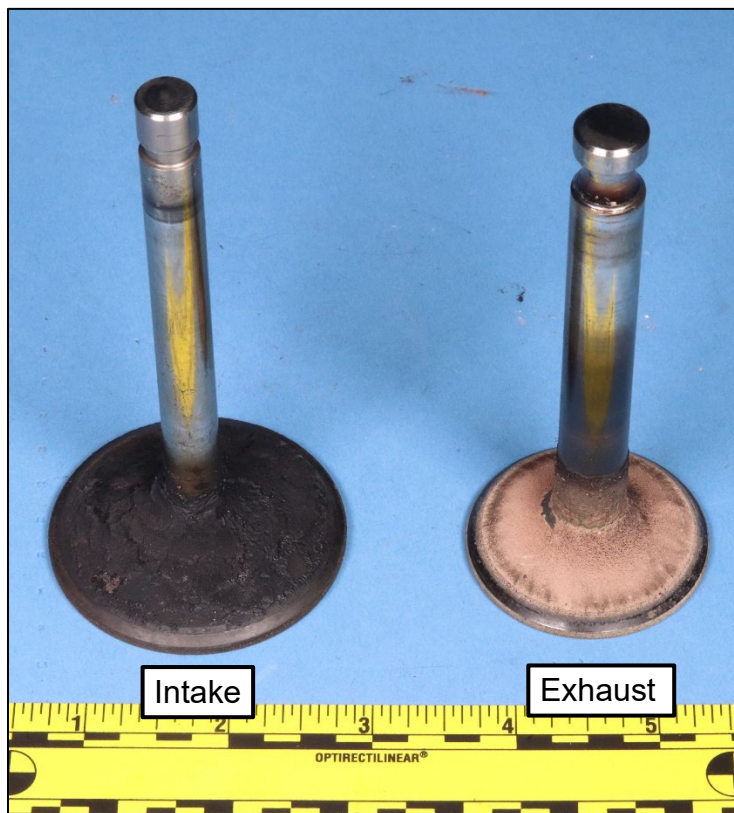
Figure 8. Intake and exhaust valves after removal from the cylinder assembly.

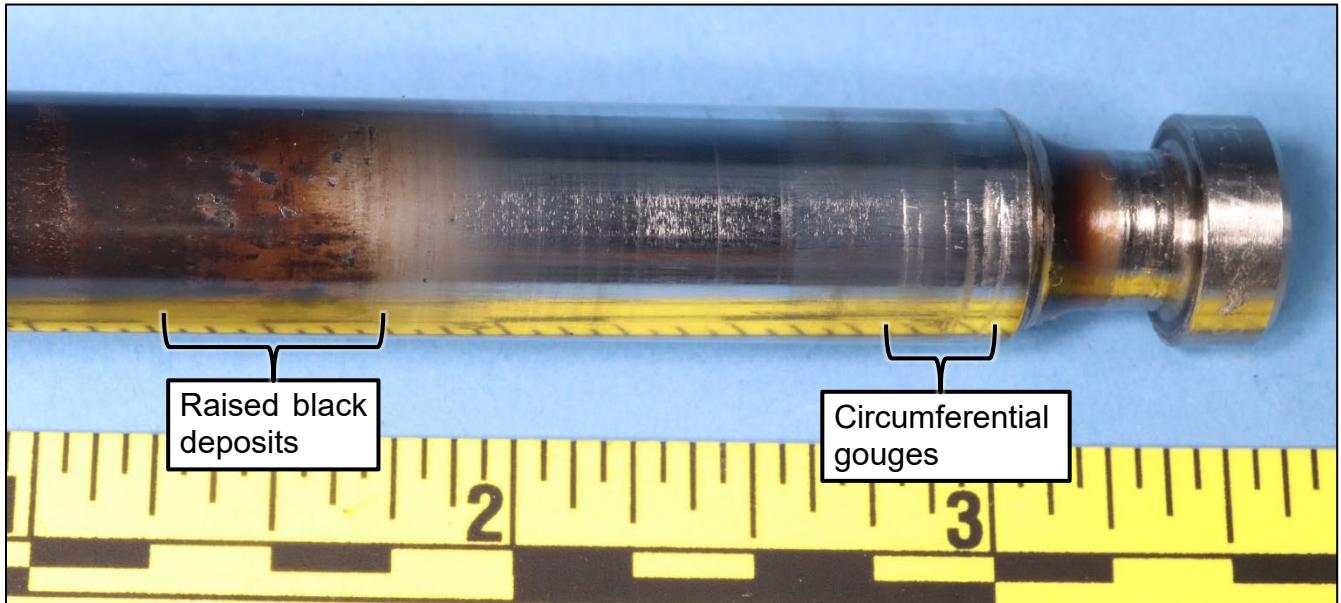
Figure 9. Close view of the exhaust valve stem.

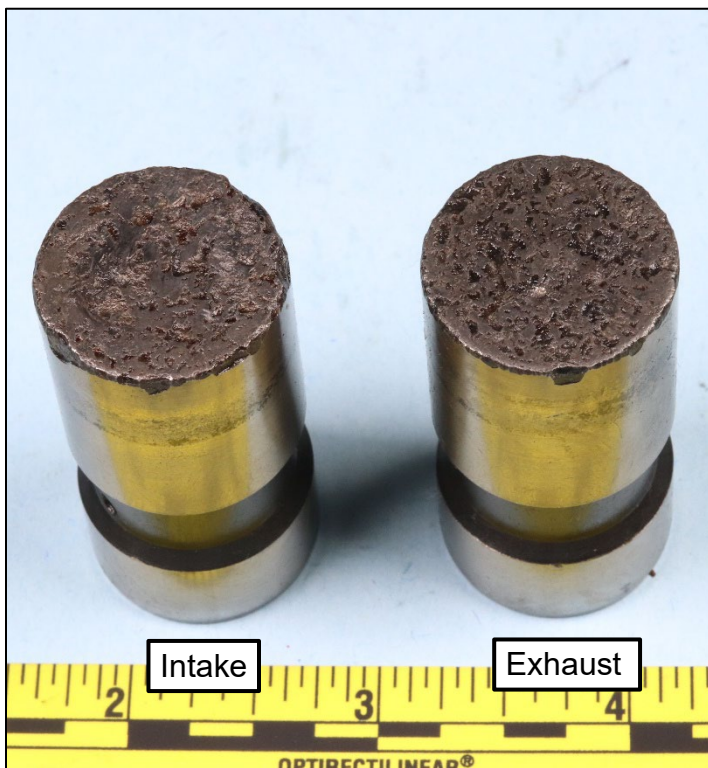
A close view of the hydraulic lifters is shown in figure 10. The camshaft contact faces were rough and pitted consistent with substantial spalling damage.

Figure 10. Spalled surfaces on the intake and exhaust hydraulic lifters.
