## **NATIONAL TRANSPORTATION SAFETY BOARD**

# **AIRFRAME AND ENGINE EXAMINATION**

**WPR21LA070**

Location: Heber, Utah  
Date: December 16, 2020  
Aircraft: SilverLight Aviation AR-1  
NTSB IIC: Fabian Salazar

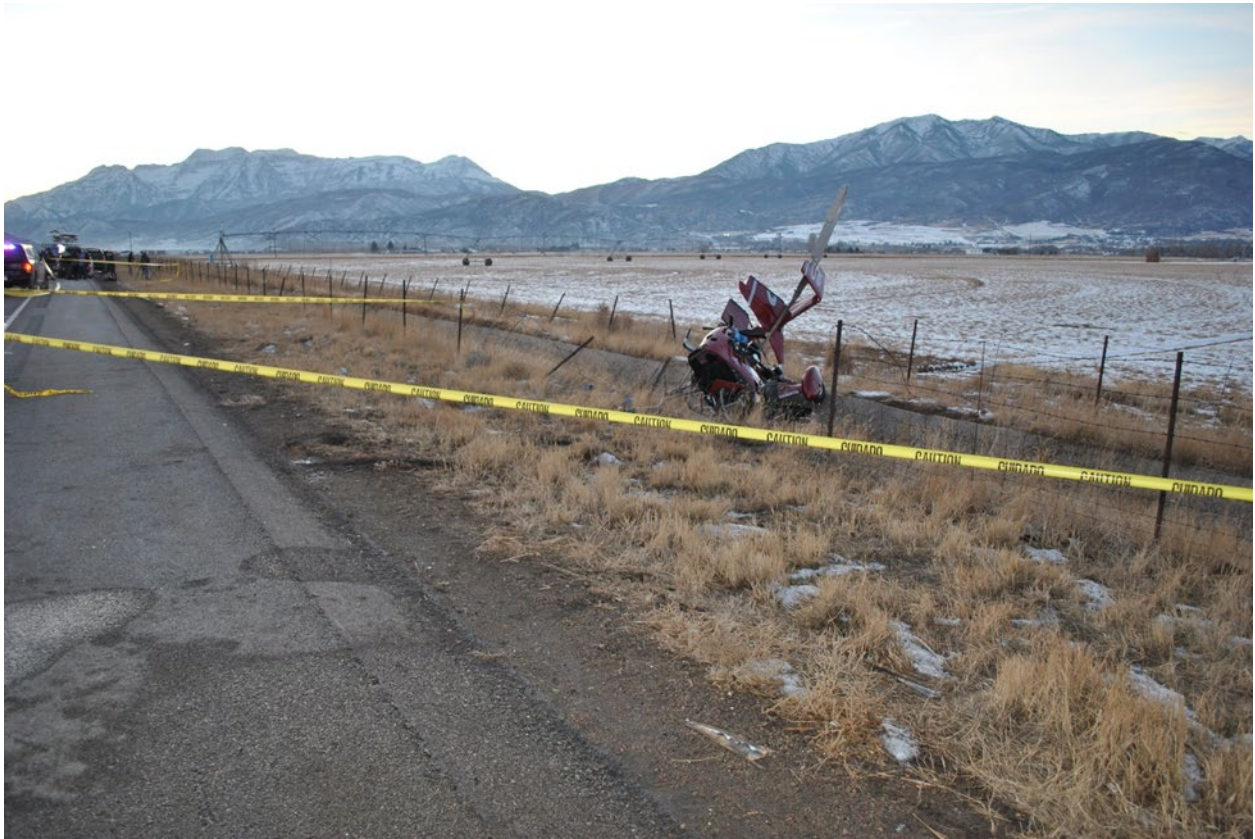
Figure 1. Front-left view of N261MD. Photo Sheriff's Department.

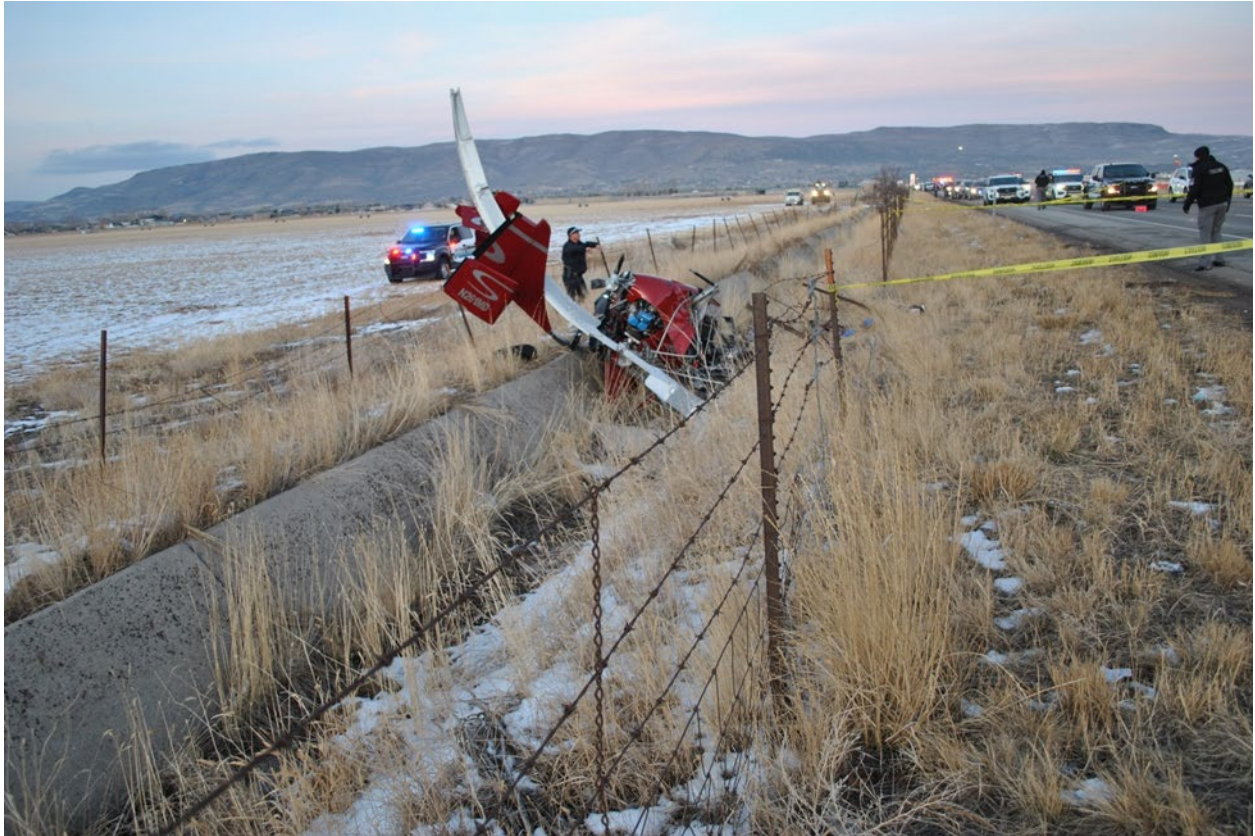
Figure 2. Right-side view of N261MD. Photo Sheriff's Department.

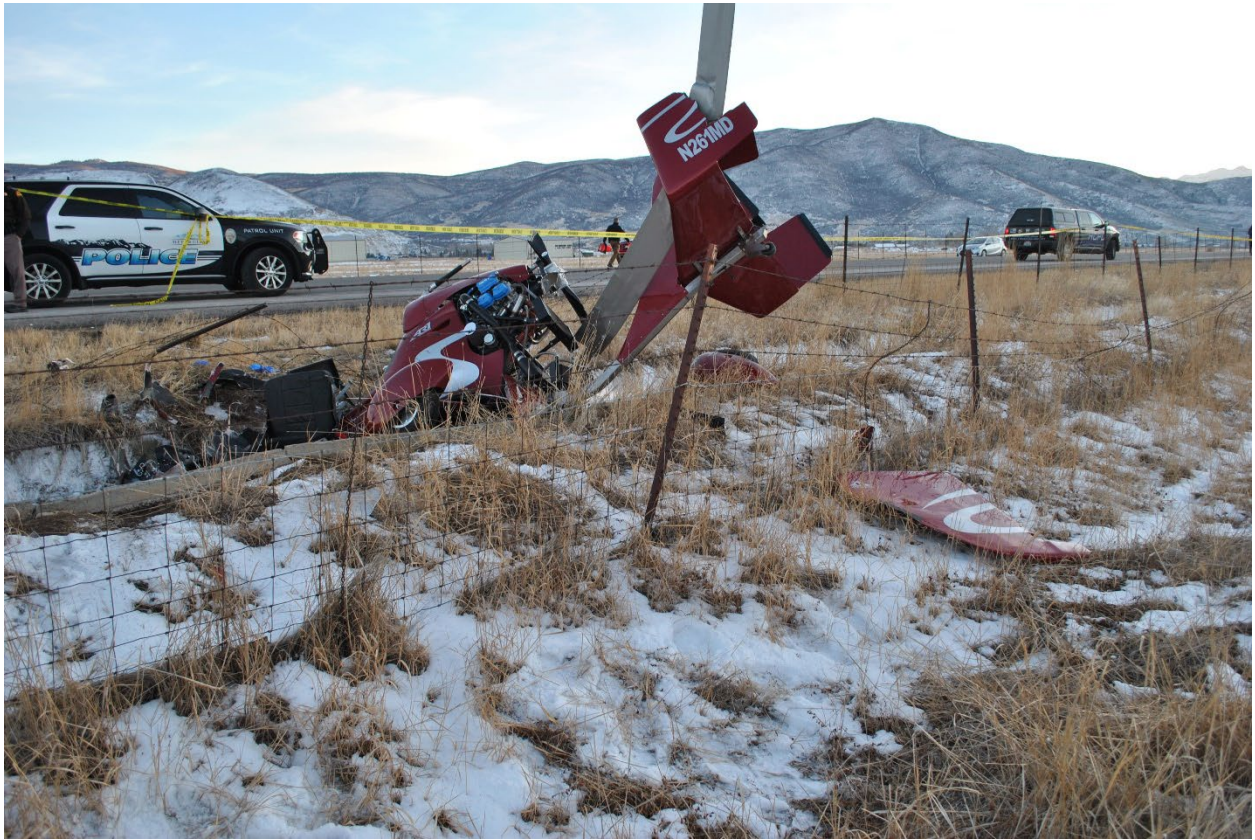
Figure 3. Left-rear view. Photo Sheriff's Department.

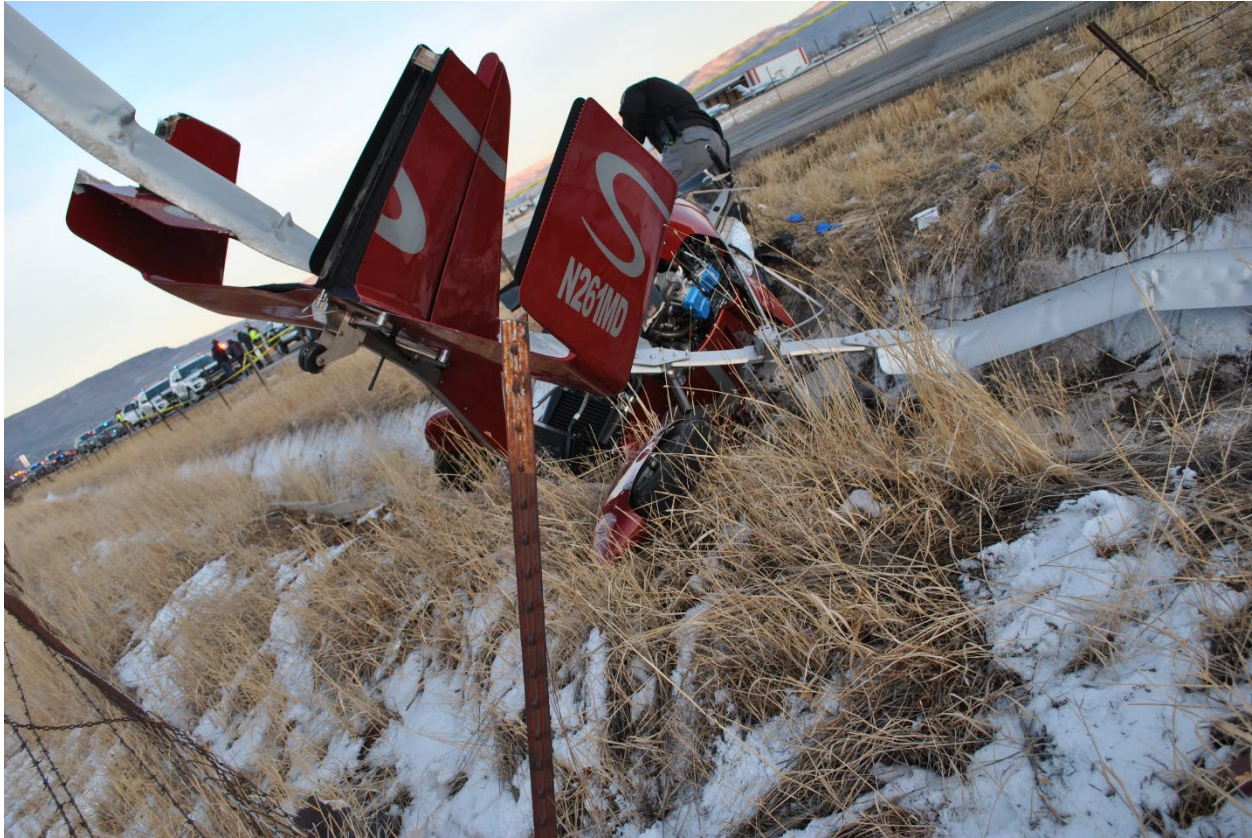
Figure 4. Right-rear view. Photo Sheriff's Department.

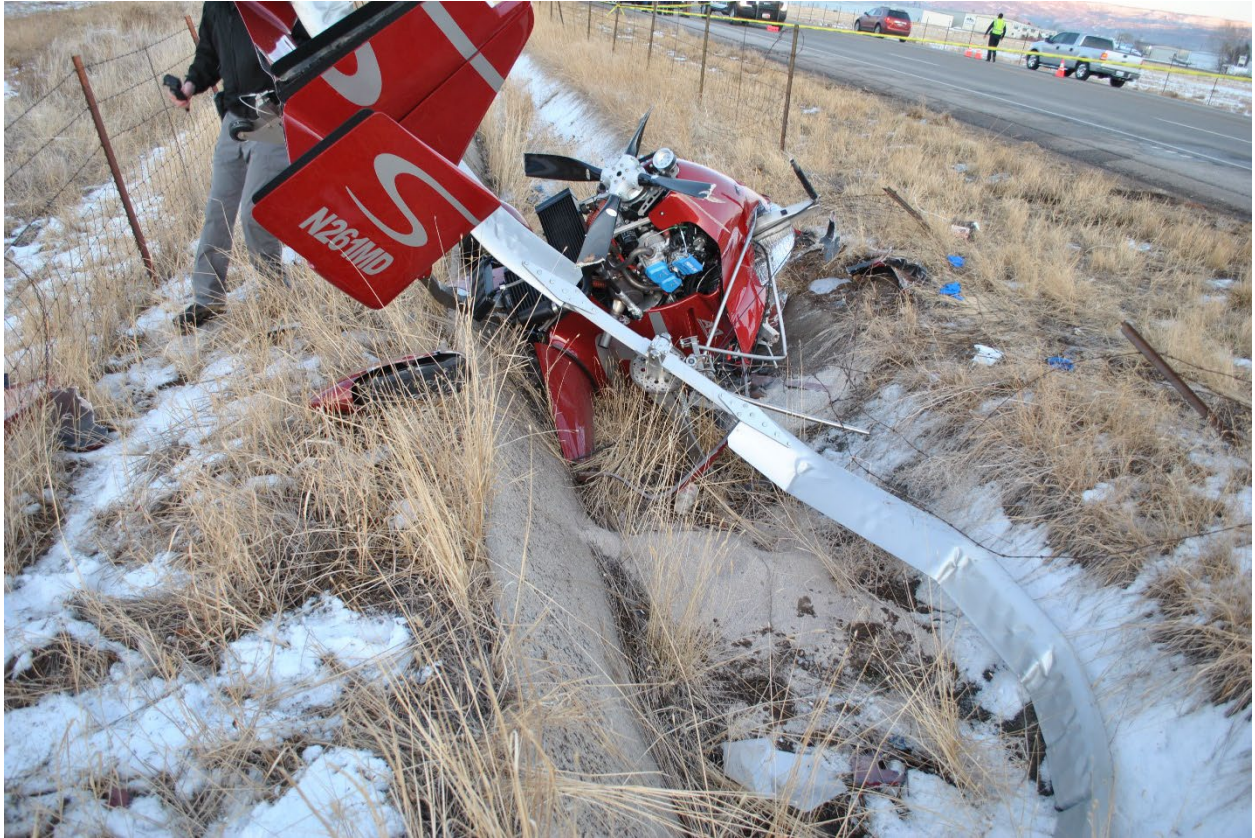
Figure 5. Right-side view. Photo Sheriff's Department.

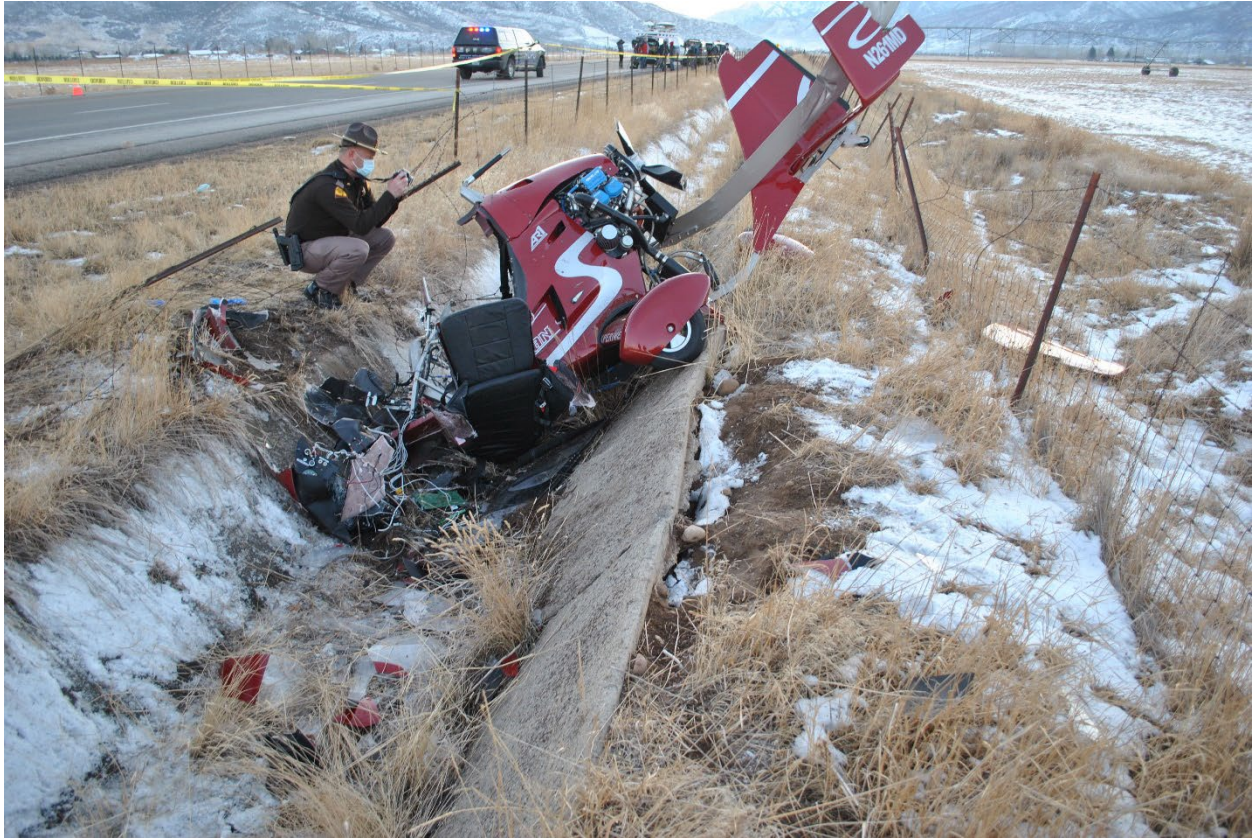
Figure 6. Left-side view. Photo Sheriff's Department.

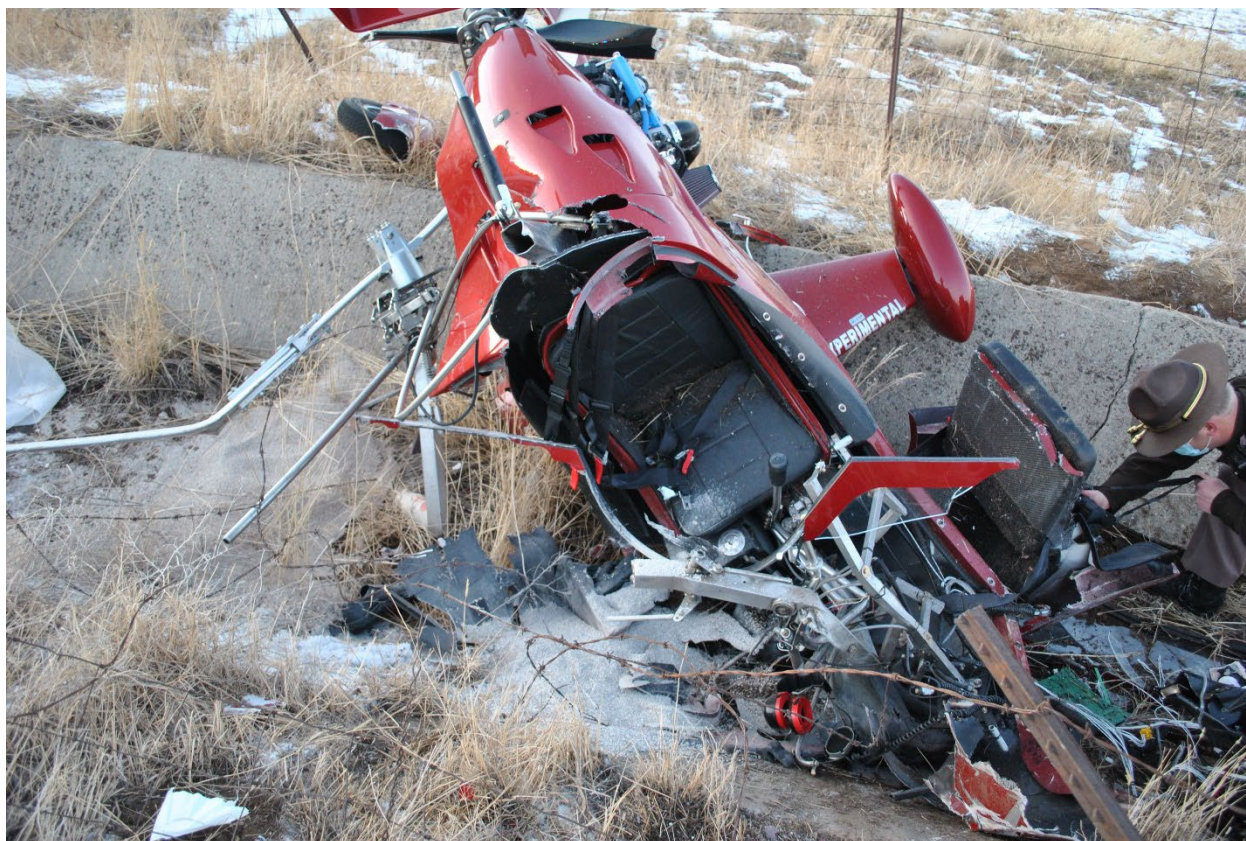
Figure 7. Front View. Photo Sheriff's Department.

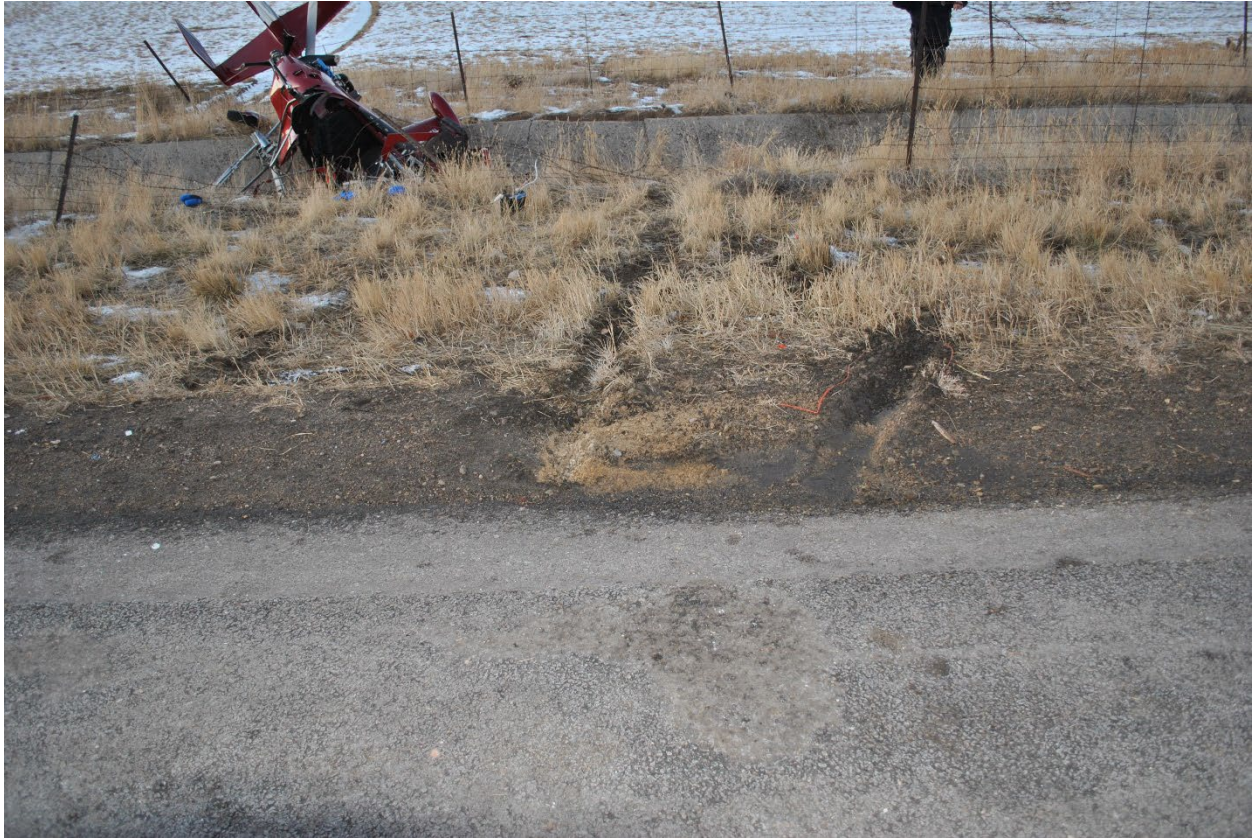
Gouge marks on the soil, immediately in front of the gyroplane was the first point of impact. Wire fencing was pulled from its supports and carried into the ditch by the fuselage. The cabin area was heavily damaged consistent with a nose down impact. The right side of the fuselage exhibited more damage than the left, with fracturing and separating of the composite fuselage material extending beyond the aft cabin area. The left side of the fuselage exhibited fracturing and separation of composite material extending back to about the rear of the front seat. The lower fuselage was substantially damaged with fragmentation and separation of composite material extending back to about the mid-cabin area.

Figure 8. Front view showing gouges in the soil near road. Photo Sheriff's Department.

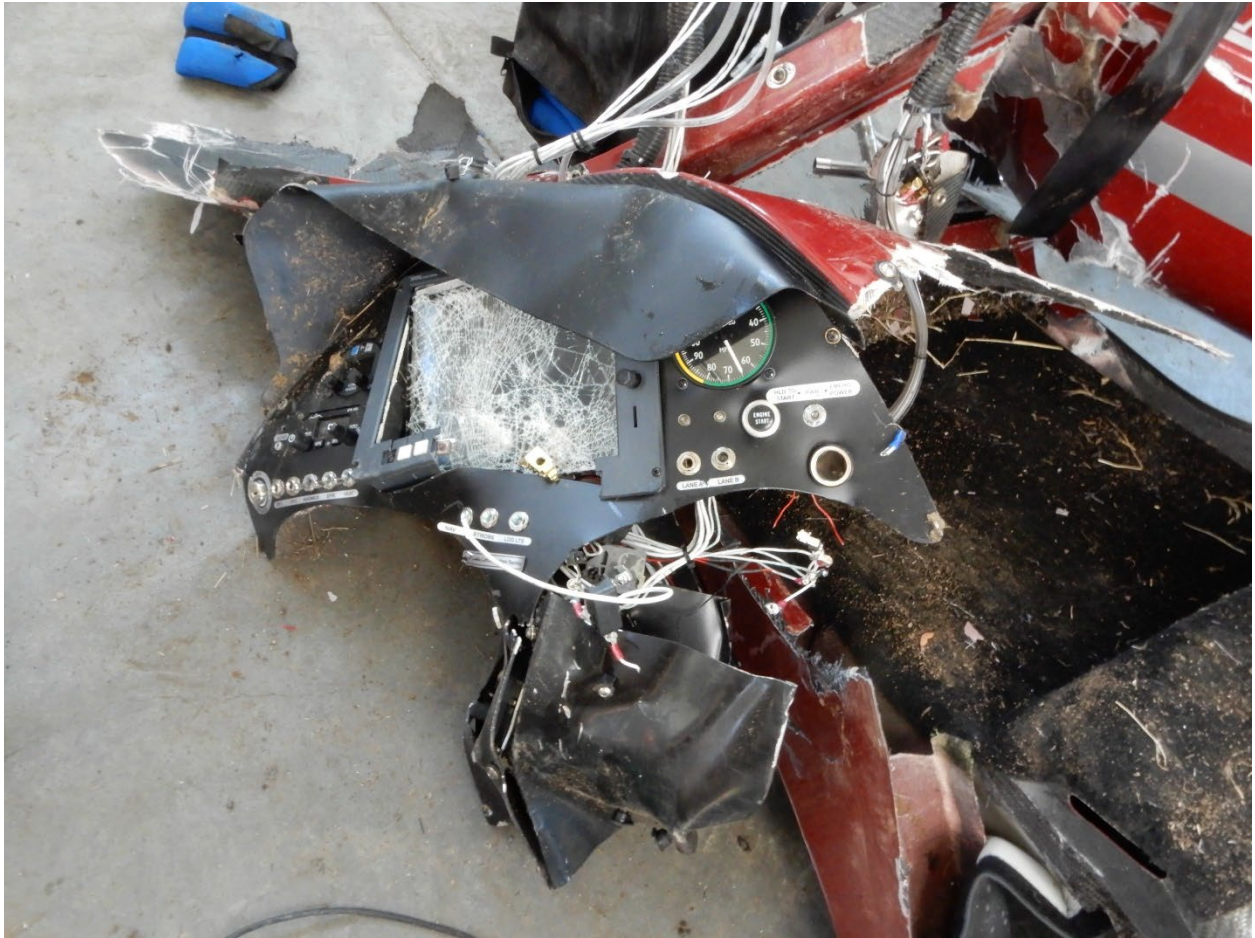
The instrument panel for the front seat partially separated from the cabin and remained attached by wires. The back of the multifunction display separated from the instrument panel and was shipped to the NTSB recorder's laboratory for download. Post-accident examination of the MFD revealed no usable data.

Figure 9. Front seat instrument panel.

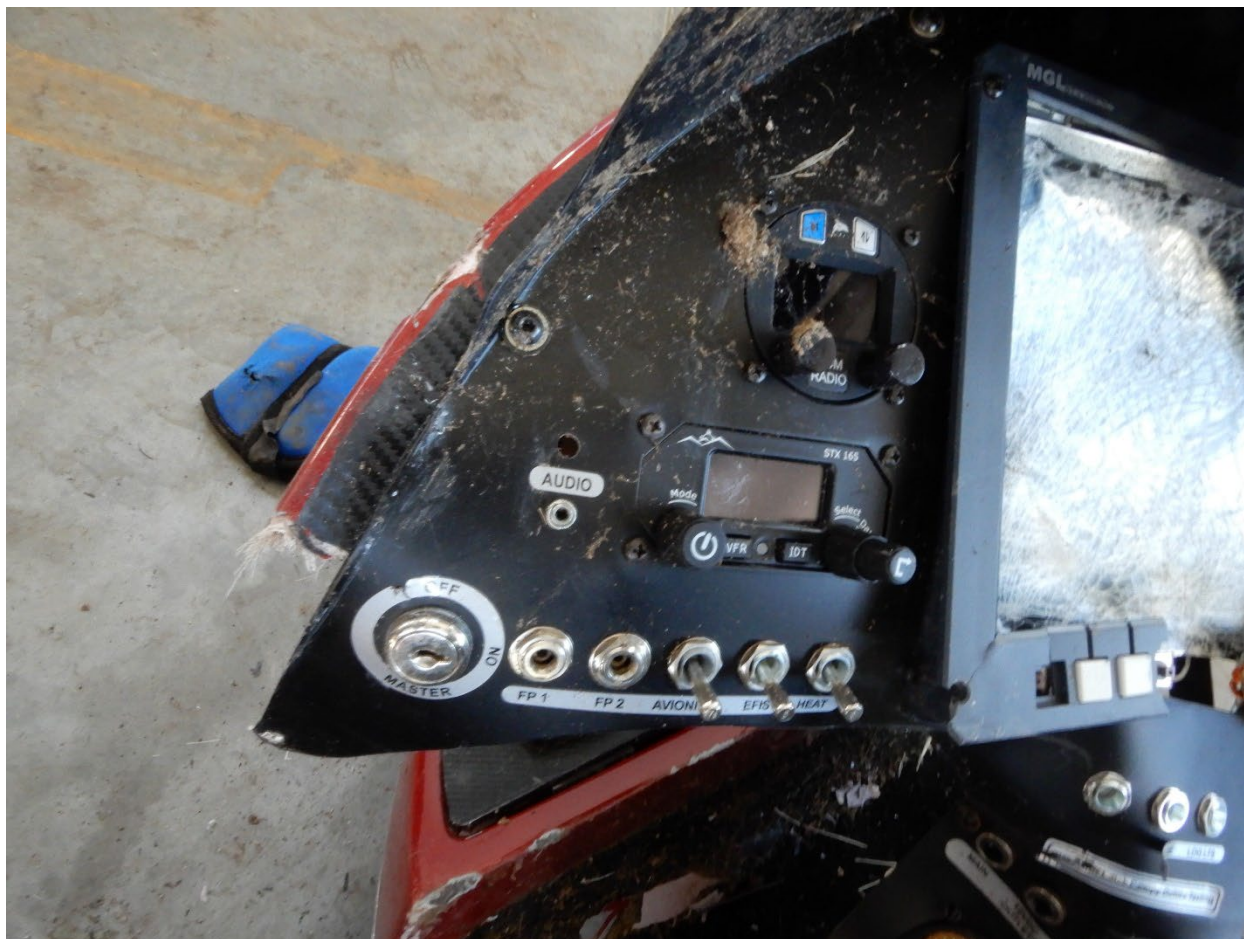
Figure 10. Left-side of the front-seat instrument panel.

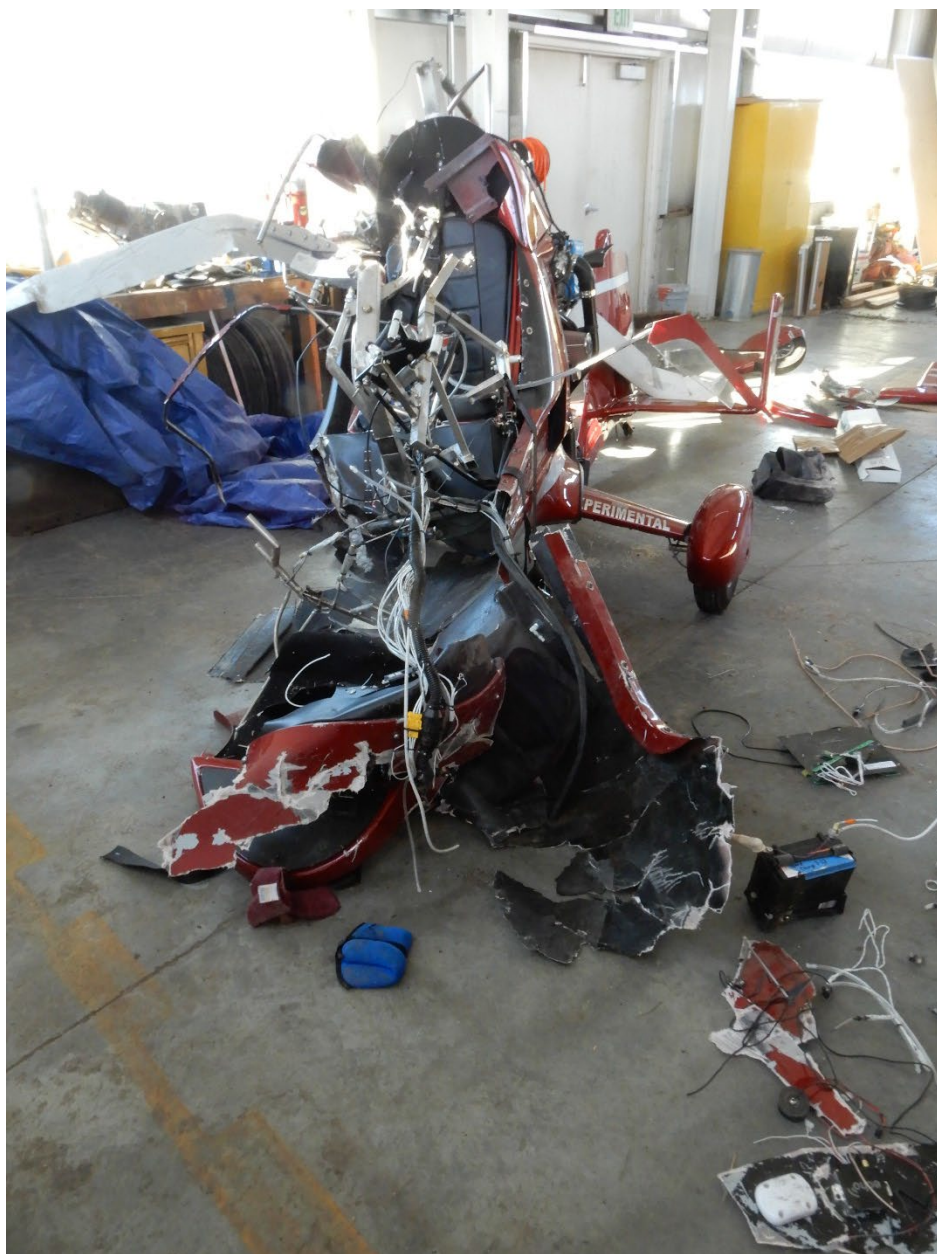
Figure 11. Front view while at the recovery site.

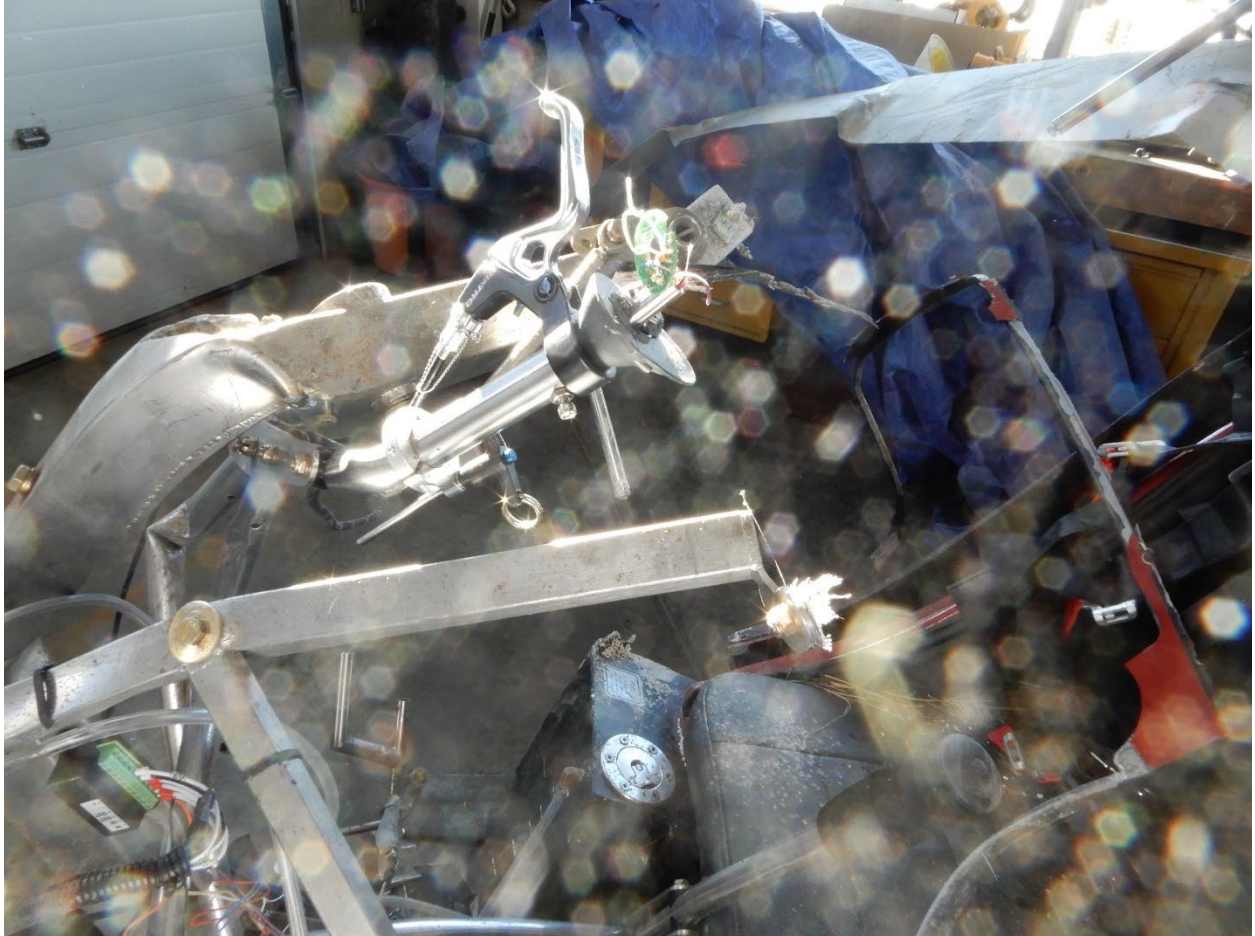
Control stick continuity was confirmed from the control sticks to the control torque tubes.

Figure 12. Front seat control stick.

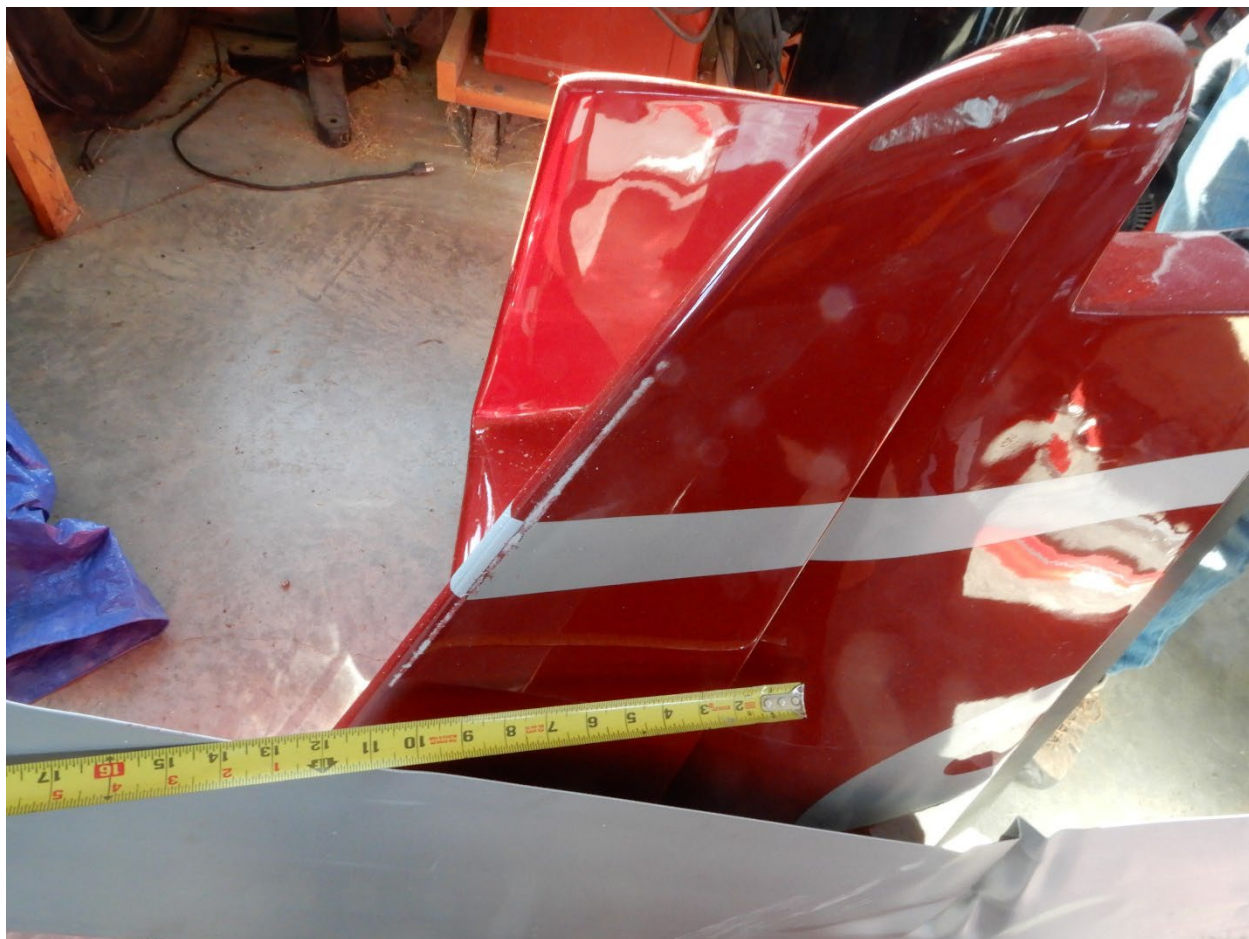
Empennage. The empennage remained attached to the fuselage, and consisted of a left and right horizontal stabilizer, a large two-piece center vertical stabilizer, two smaller left and right vertical stabilizers, and a large rudder. The left and right horizontal stabilizers exhibited minor damage with splits, cracking and deformation throughout. The right vertical stabilizer exhibited minor damage. The left vertical stabilizer exhibited substantial damage with a large section of the upper trailing edge separated, consistent with contact from the rotor system. The center vertical stabilizer exhibited substantial damage with separation of composite material along the leading edge. The top of the vertical stabilizer exhibited a loss of material and paint consistent with contact from the rotor system. The rudder separated from the center vertical stabilizer and was located near the wreckage. The rudder exhibited substantial damage with multiple cracks on the starboard side. The port side of the rudder exhibited minor cracks. The trim tab remained attached to the rudder.

Figure 13. Center vertical stabilizer showing damage to the leading edge.

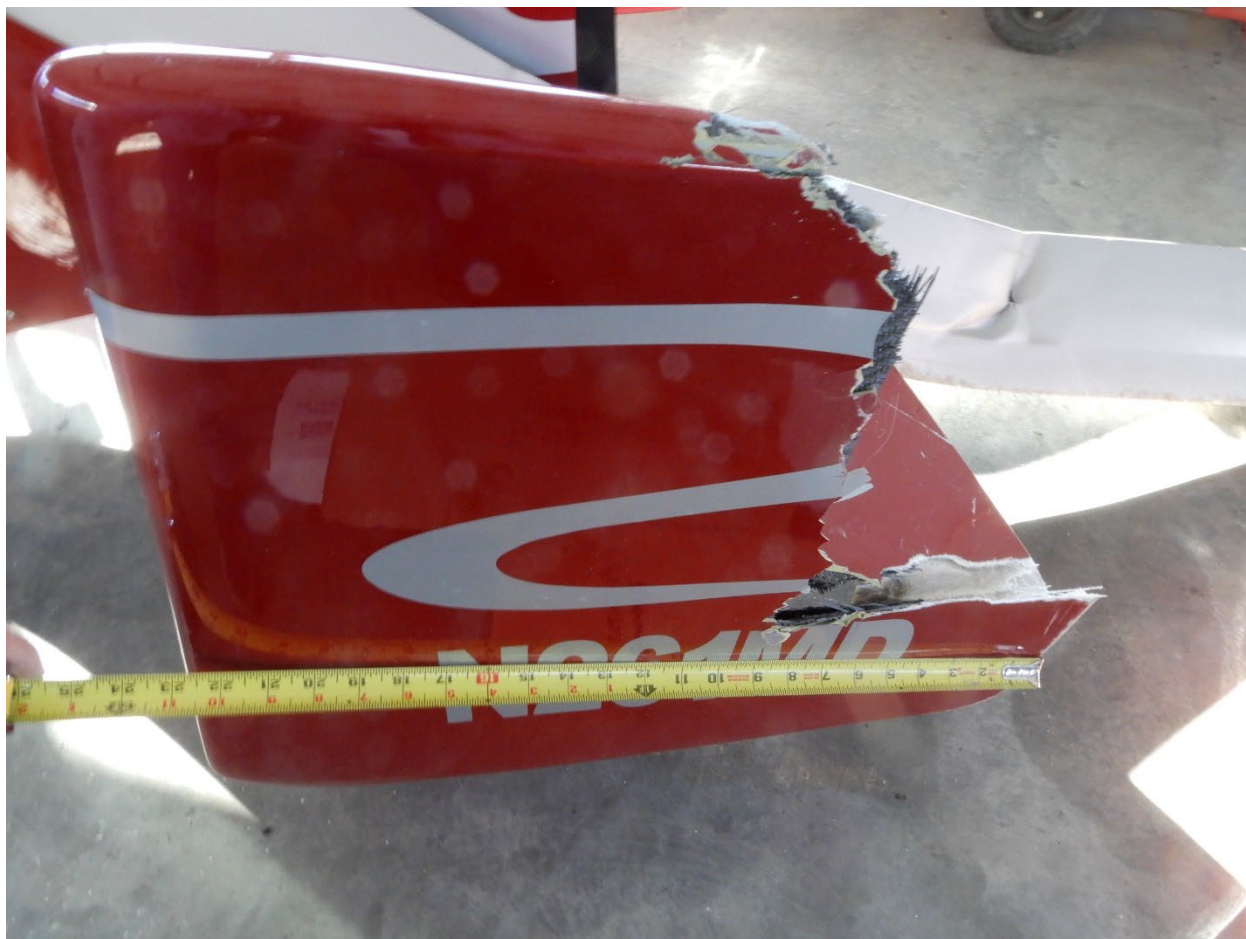
Figure 14. Left vertical stabilizer, showing damaged aft section.

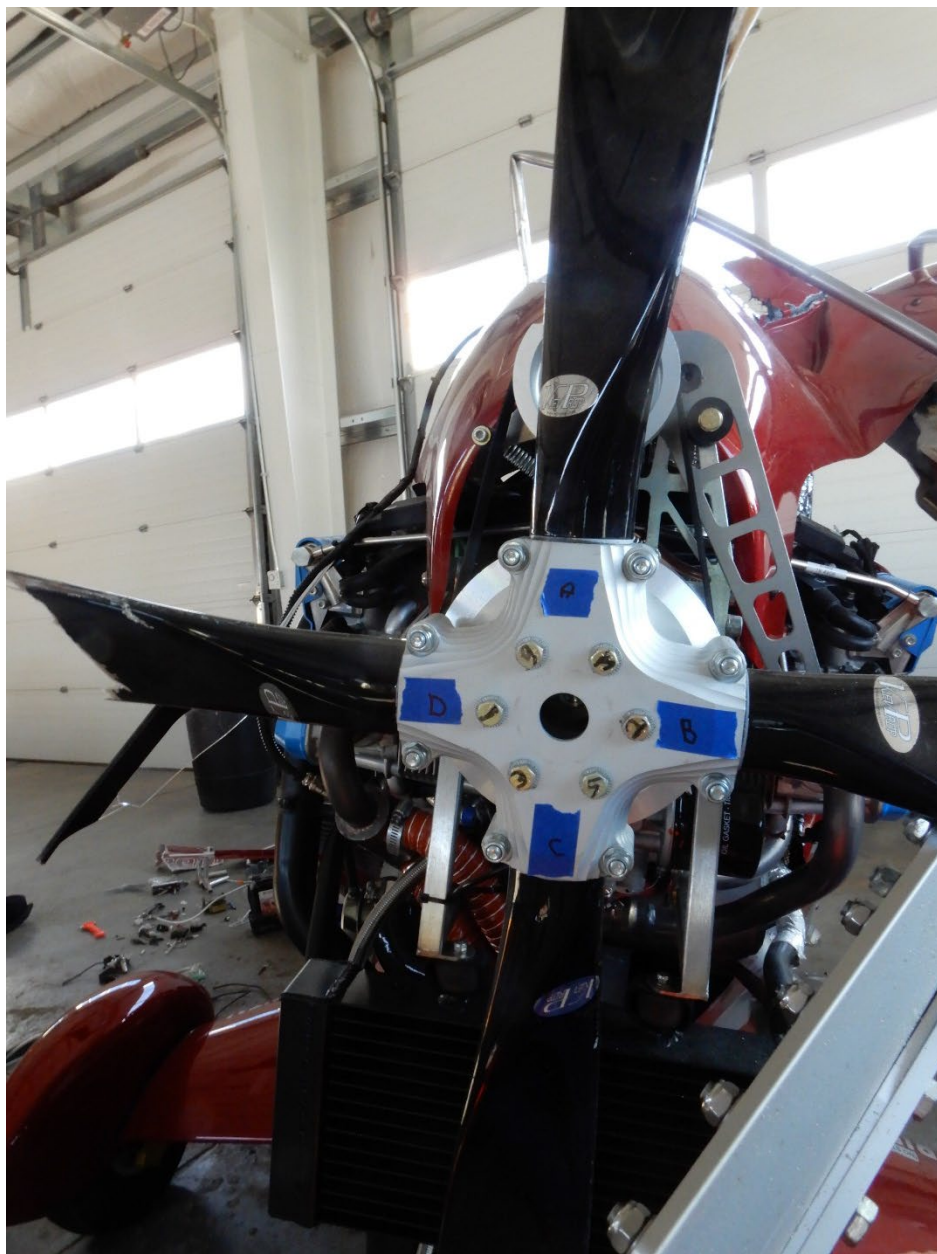
Propeller. The propeller consisted of four composite propeller blades and an aluminum hub. The propeller blades were identified as A, B, C, and D. The propeller hub remained attached to the propeller flange, which remained attached to the engine. All four propeller blades separated from the hub and were in the debris area. All breaks in the propeller blades were clean, showing no sign of contact with soil or vegetation. All separated propeller tips were recovered, and all tips exhibited minor damage with no tips showing contact with an object. This is consistent with the propeller being struck by an object inboard of the tips of the blade.

Propeller blade A. The shank and about 13 inches of the blade remained attached to the hub. The break ran chordwise about an 80° angle.

Propeller blade B. The shank and about 10.5 inches of the blade remained attached to the hub. The break ran chordwise about a 70° angle

Propeller Blade C. The shank and about 17 inches of the blade remained attached to the hub. The break ran about a 45° angle.

Propeller D. The shank and about 8 inches of the blade remained attached to the hub. The break ran chordwise about a 60° angle.

Figure 15. Propeller showing damaged blade shanks and the hub.

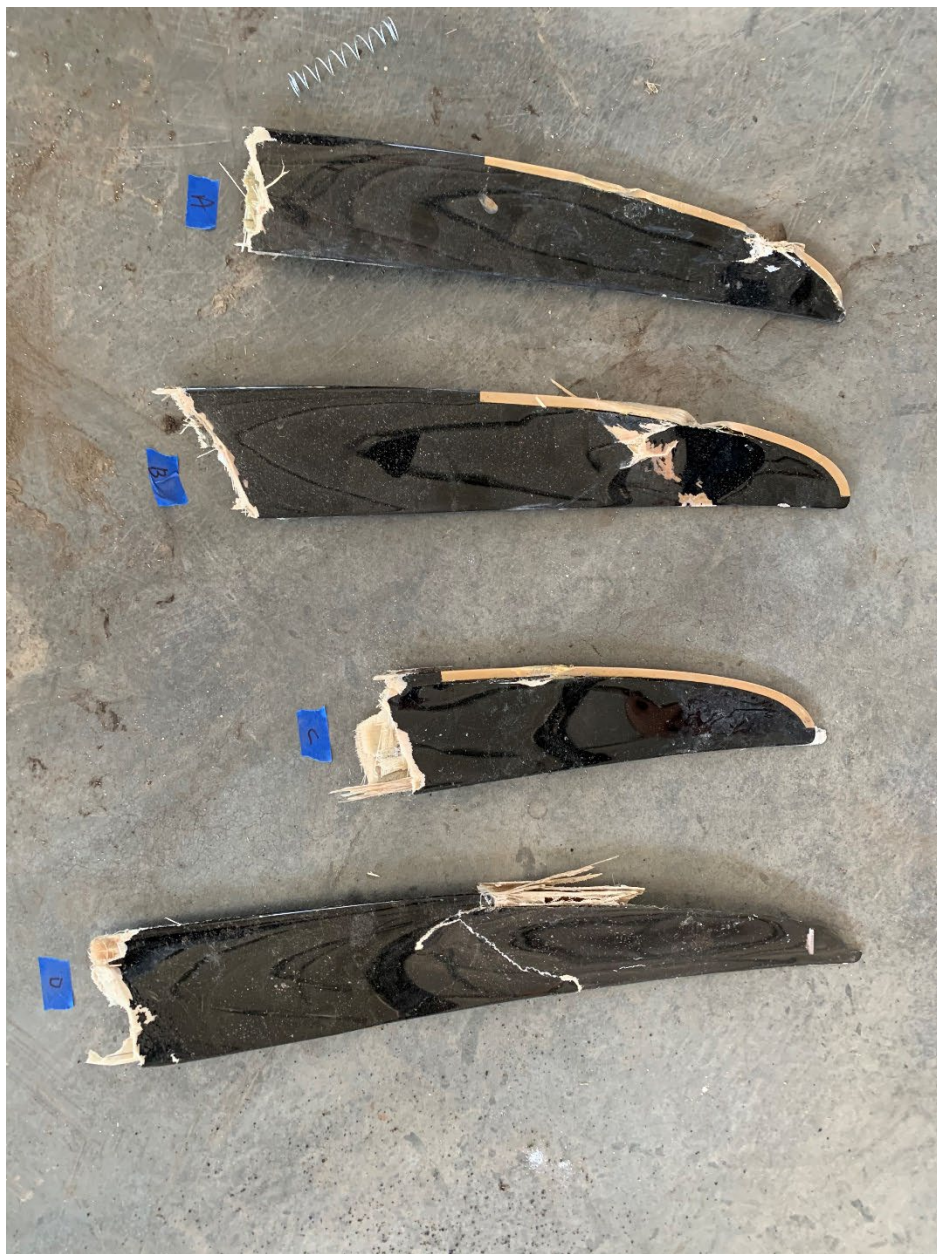
Figure 16. Propeller blade tips, showing minor damage at the tips.

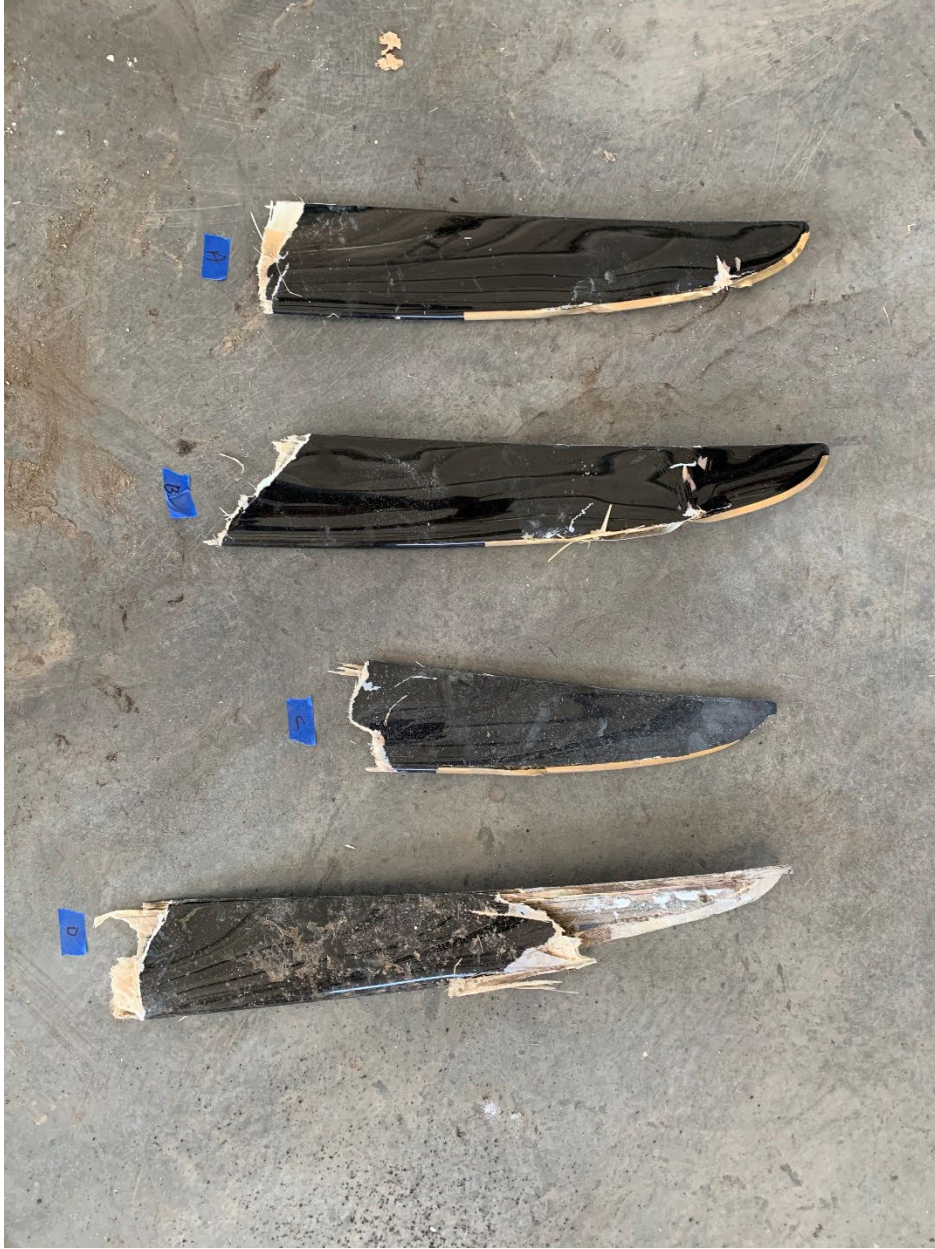
Figure 17. Propeller blade tips, other side, showing minor damage at the tips.

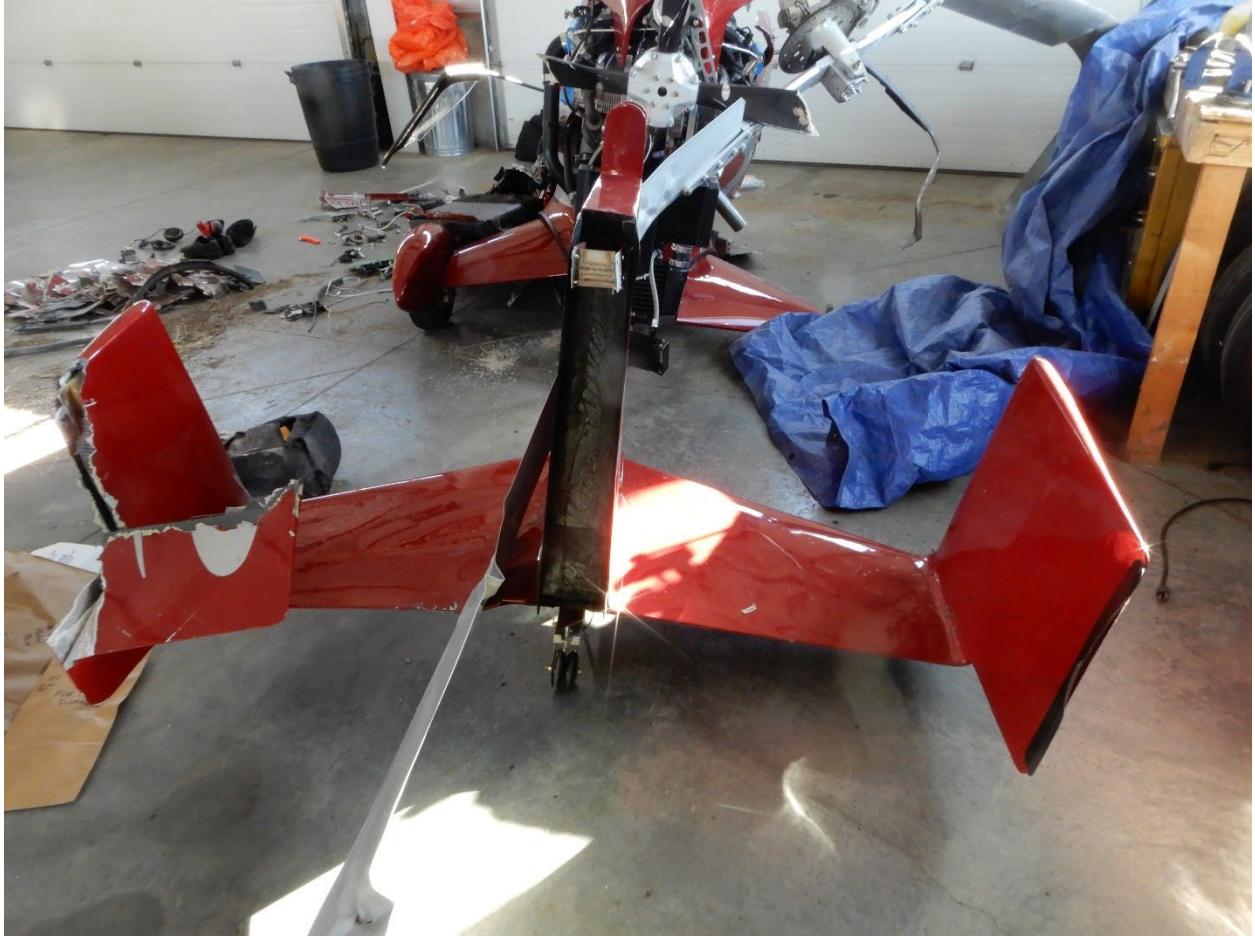
Figure 18. Aft view of the empennage.

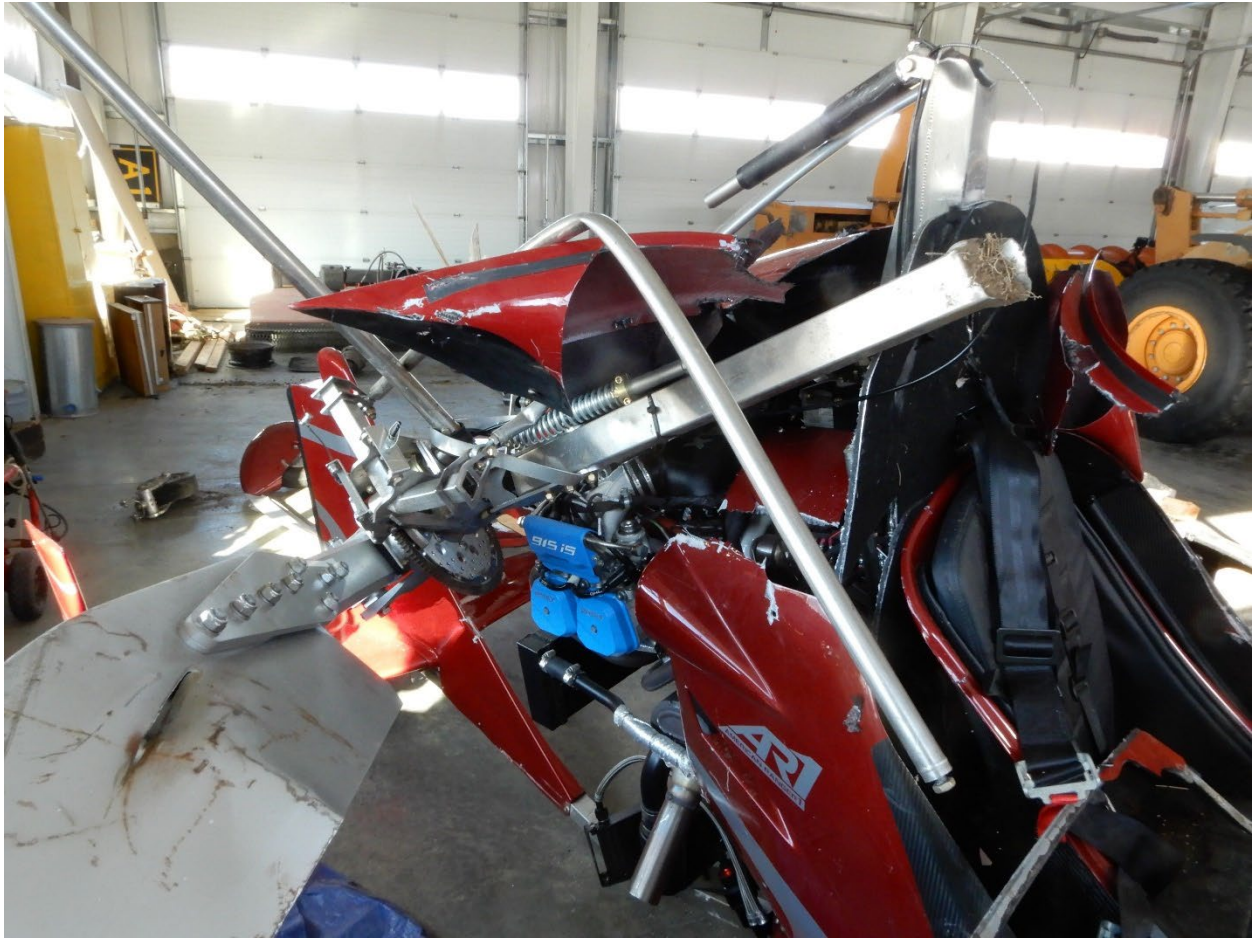
Rotor system. The two bladed rotor system remained attached to the rotor mast, and the mast separated from the fuselage. One rotor blade stopped adjacent to the left vertical stabilizer and is identified in this report as rotor blade #1. The other rotor blade stopped nearly over the cabin and is identified in this report as rotor blade #2.

Figure 19. Right-side view, showing the rotor mast separation point.
