## **NATIONAL TRANSPORTATION SAFETY BOARD**

# **AIRFRAME AND ENGINE EXAMINATION**

**WPR21LA070**

Location: Heber, Utah  
Date: December 16, 2020  
Aircraft: SilverLight Aviation AR-1  
NTSB IIC: Fabian Salazar

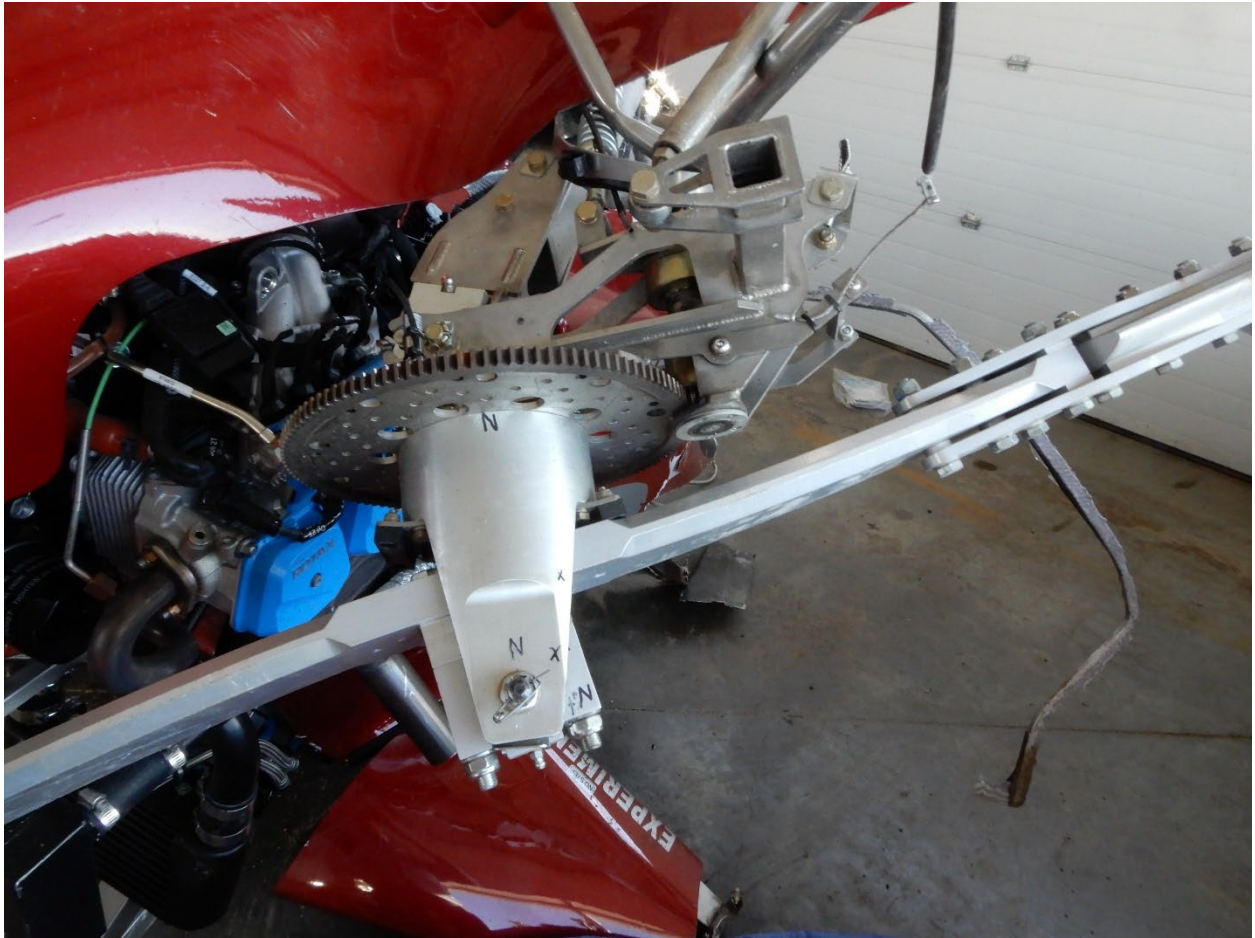
Figure 20. Rotor head.

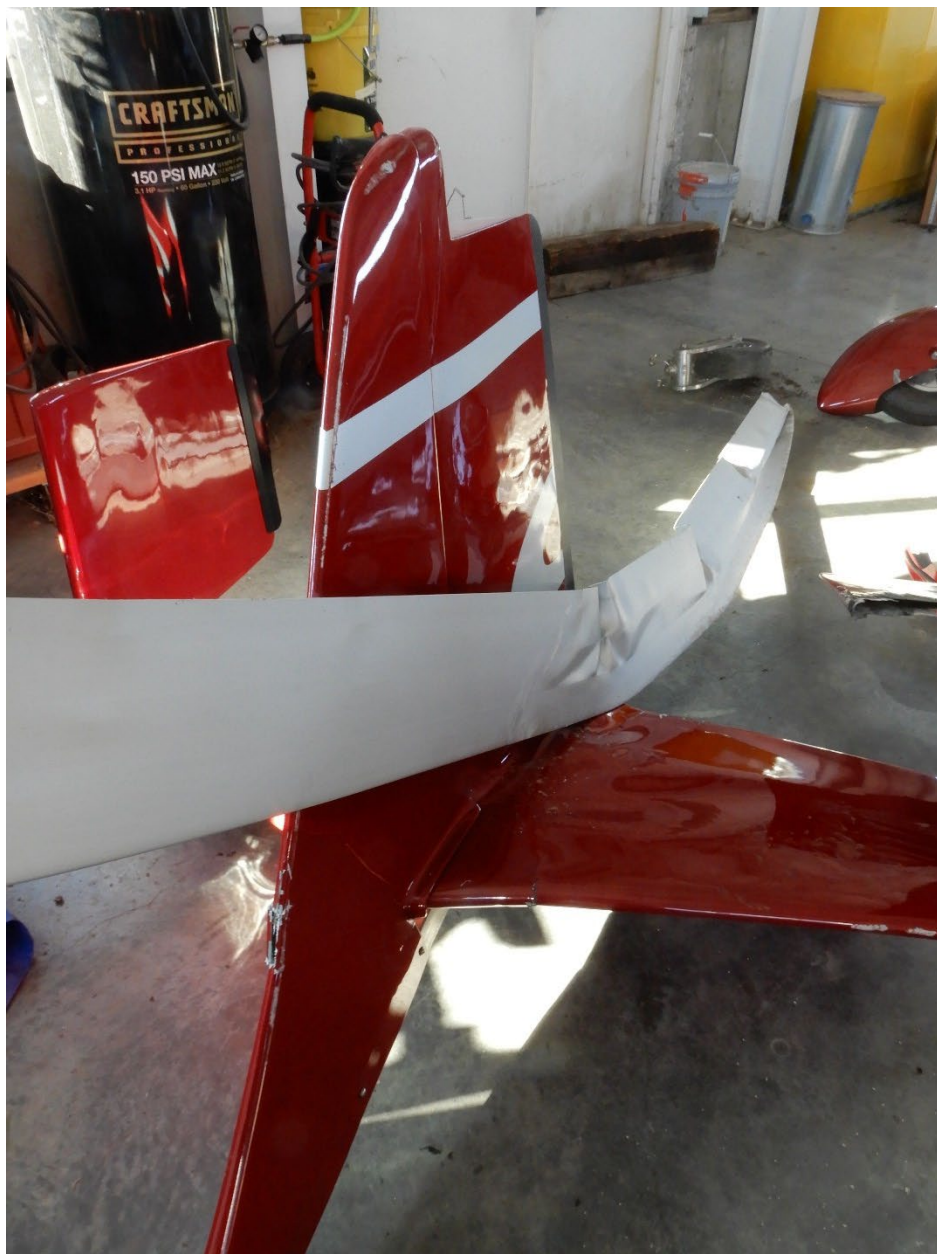
Rotor blade #1 exhibited chordwise bending aft (leading edge to trailing edge) with wrinkling of the blade aft of the spar. The blade also displaced upward spanwise bending mostly at the root of the blade. The tip of the #1 blade exhibited damage with a small section separated.

Figure 21. Rotor blade #1.

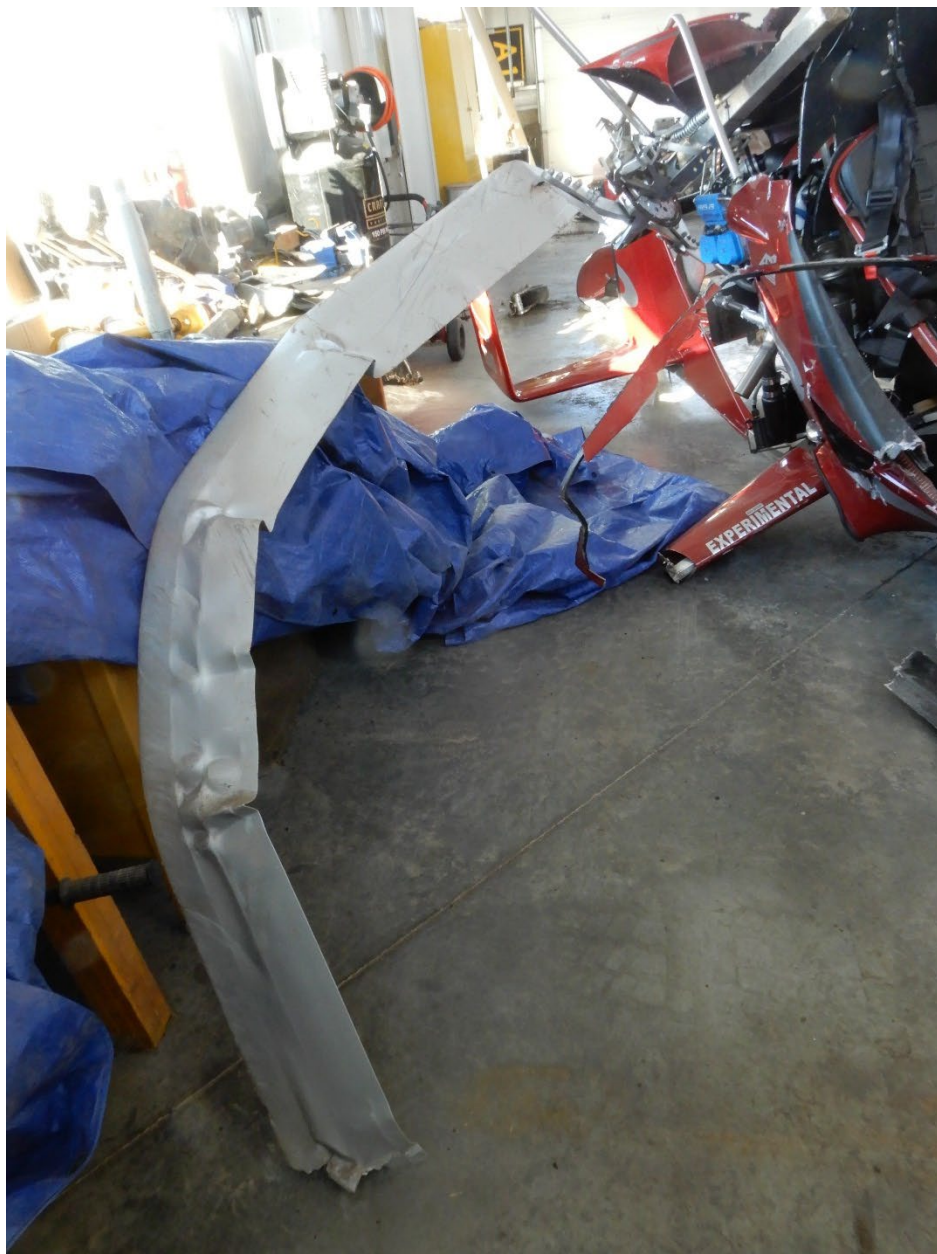
The #2 blade exhibited significantly more aft chordwise bending, than the #1 blade, and upward spanwise bending. A section beginning about 126 inches from the root, outboard, separated and was located in the debris area. Multiple dark scratches appeared on the underside of blade #2 about the 15-to-29-inch area. Multiple chordwise scratches were evident on the #2 leading edge with evidence of red paint transfer (or red gelcoat) in the same area, consistent with the red color of the fuselage.

Figure 22. Rotor Blade #2
