## INVESTIGATION SUPPLEMENTAL MATERIAL

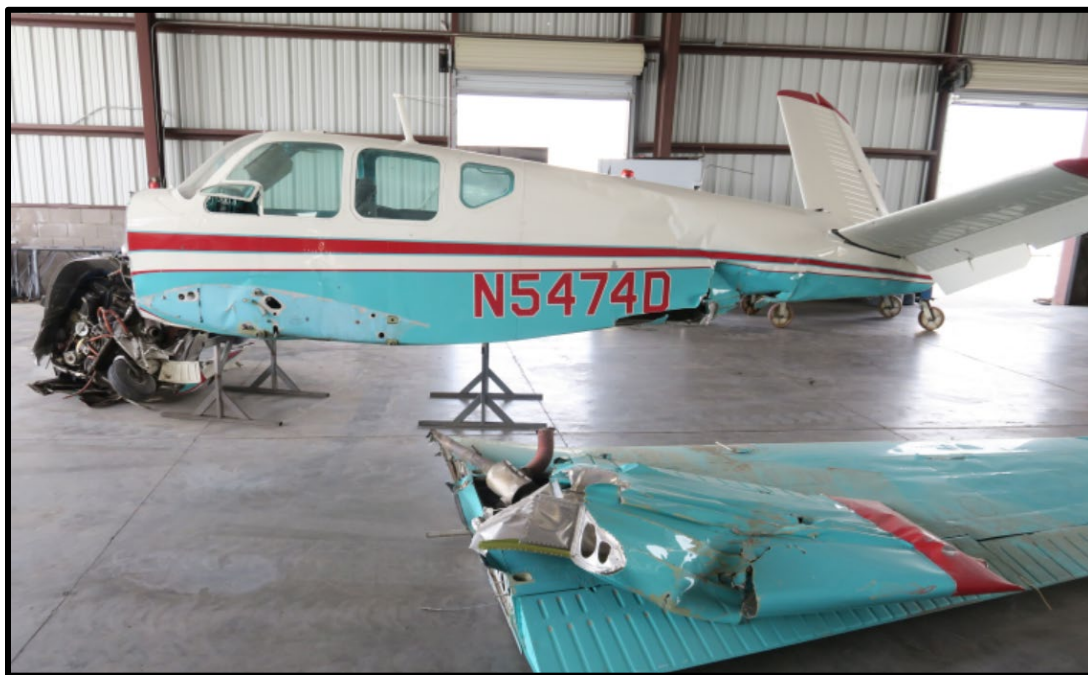
Figure 1: Wreckage

Investigators from the Safety Board and Textron Aviation examined the wreckage on April 26, 2022, at the facilities of Air Transport in Phoenix, Arizona.

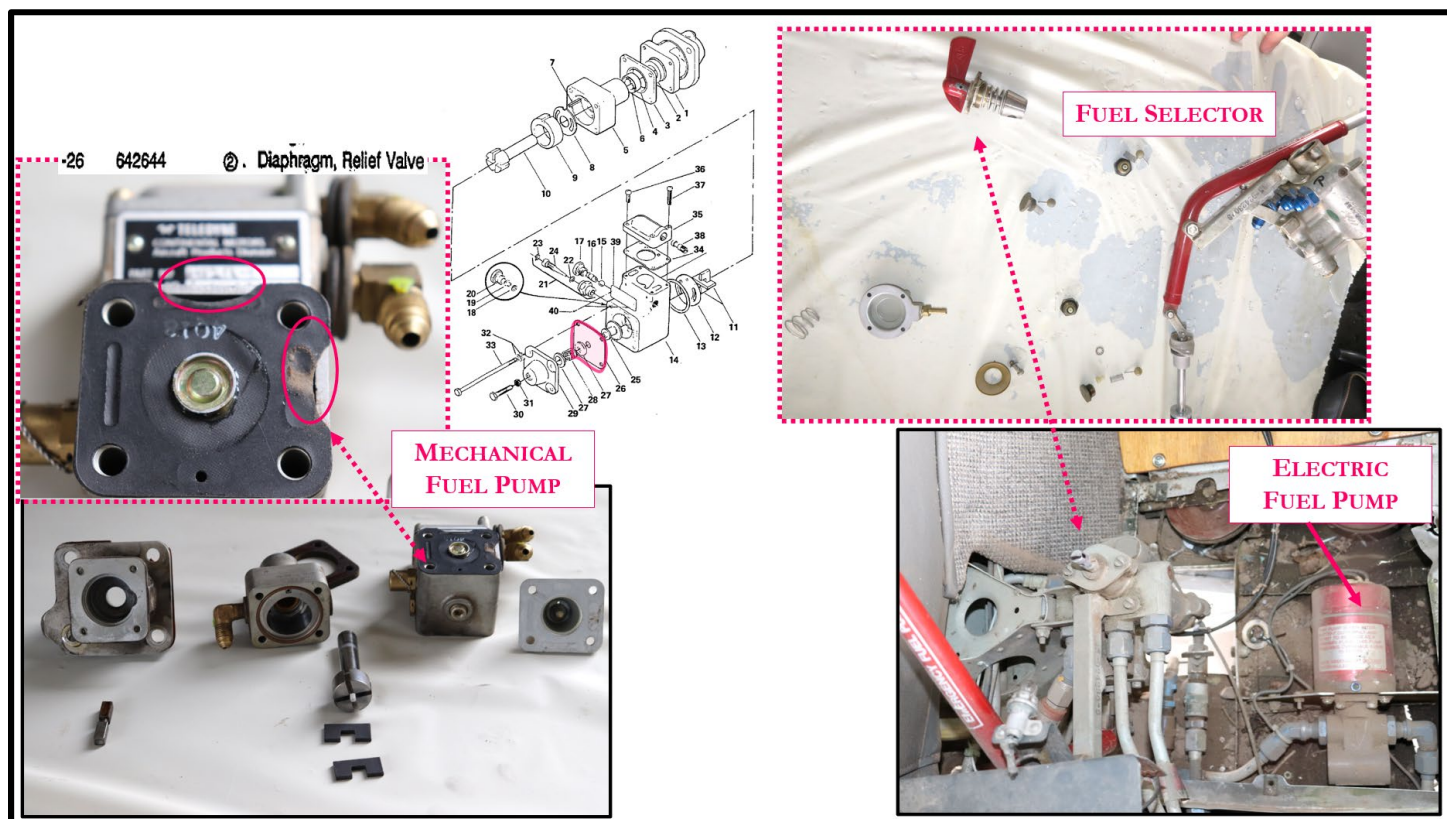
Figure 4: Fuel Pumps and Fuel Selector

system. The filter was disassembled and was clean with no debris noted. The mechanical fuel pump (p/n 646212-9) was disassembled and was found intact; the carbon vanes moved freely and light scoring was observed on cavity walls. The diaphragm appeared scalloped in the body orifice area; the cover assembly likely covered those orifices and would not have resulted in that areas so this likely would have interfered. The fuel servo had both the mixture and throttle cables attached; no anomalies were found. The fuel manifold was disassembled, revealing a pliable diaphragm that was intact.
