## N737NB Lycoming field notes

The airplane was recovered to a secure facility at the Palm Springs Airport, where an examination was conducted April 13, 2021.

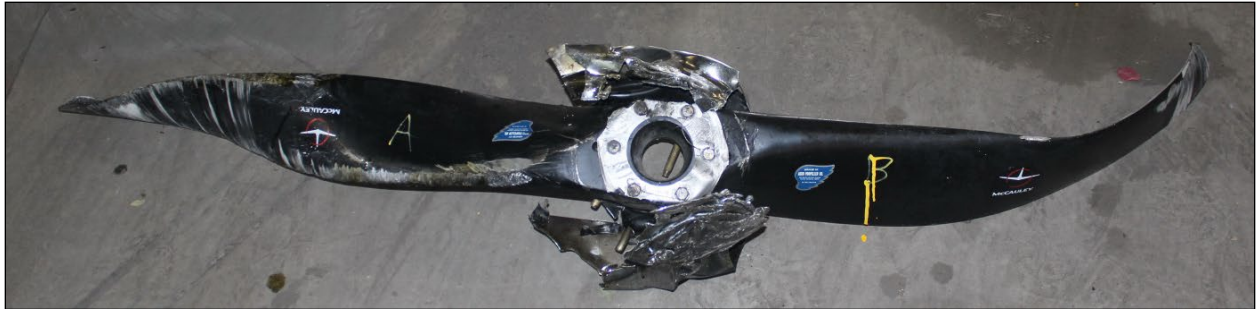
The metal two bladed fixed pitch propeller was displaced from the crankshaft flange at the mechanical attachment area of the hub. The fracture surfaces exhibited signatures consistent with overload due to the absorption of rotational energy.

The propeller blades remained attached to the propeller hub. The propeller blades displayed leading edge gouging, torsional twisting, chordwise striations across the cambered surface and trailing edge "S" bending. The signatures were consistent with the absorption of rotational forces applied at the crankshaft at the time of impact.

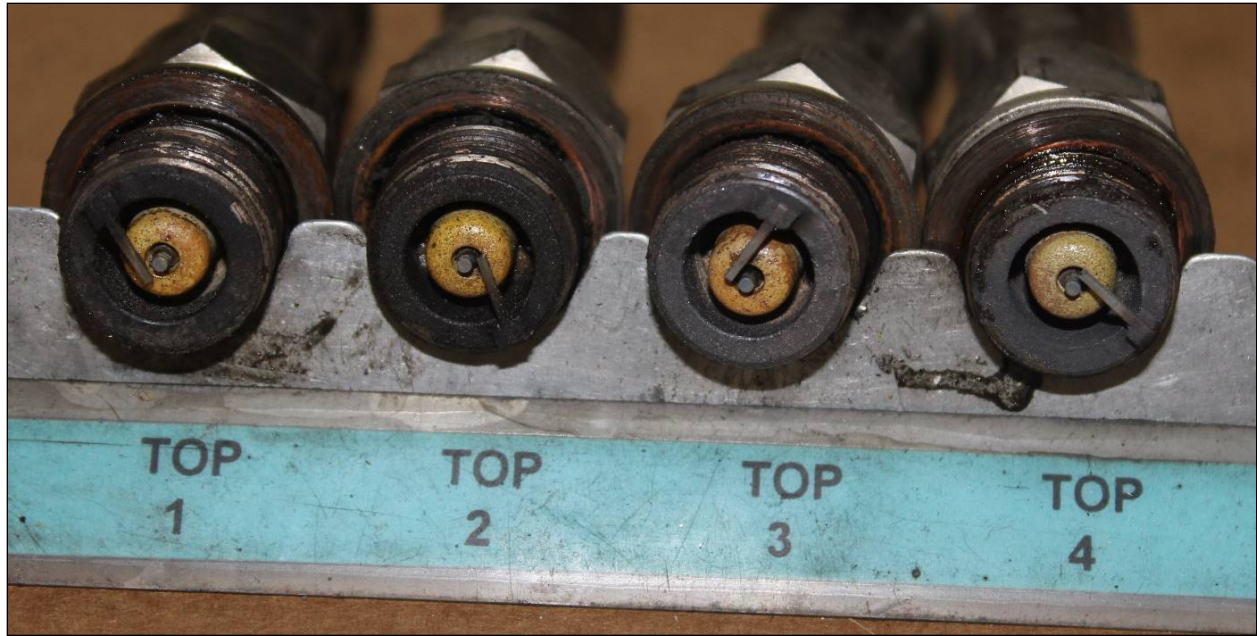
The top spark plugs were removed, examined and photographed. The vacuum pump was removed and the crankshaft was rotated by hand through the drive pad utilizing a drive tool. The crankshaft was free to rotate in both directions. "Thumb" compression was observed in proper order on all four cylinders. The complete valve train was observed to operate in proper order and appeared to be free of any pre-mishap mechanical malfunction. Normal "lift action" was observed at each exhaust rocker assembly; however, the intake valve rocker at each cylinder exhibited diminished movement estimated at 60% less than normal. Clean, uncontaminated oil was observed at all four rockerbox areas. Mechanical continuity was established throughout the rotating group, valve train and accessory section during hand rotation of the crankshaft. The combustion chamber of each cylinder was examined through the spark plug holes utilizing a lighted borescope. The combustion chambers and bottom spark plug electrodes remained mechanically undamaged and there was no evidence of foreign object ingestion or detonation. The valves were intact and undamaged. There was no evidence of valve to piston face contact observed. The gas path and combustion signatures observed at the spark plugs, combustion chambers and exhaust system components displayed coloration consistent with normal operation. There was no oil residue observed in the exhaust system gas path. The exhaust system and muffler were found free of obstructions.

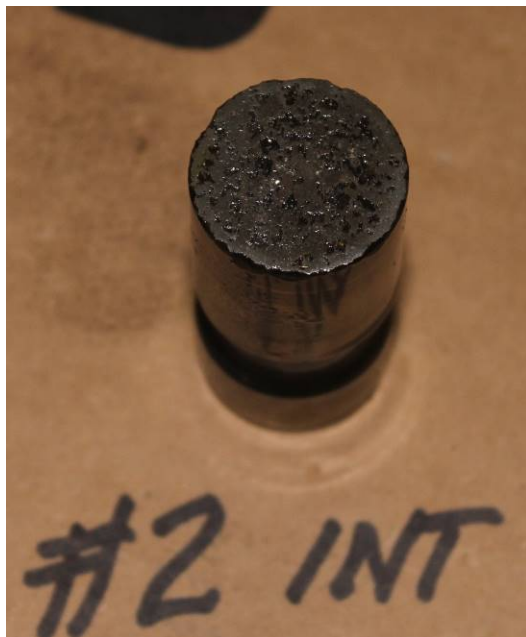
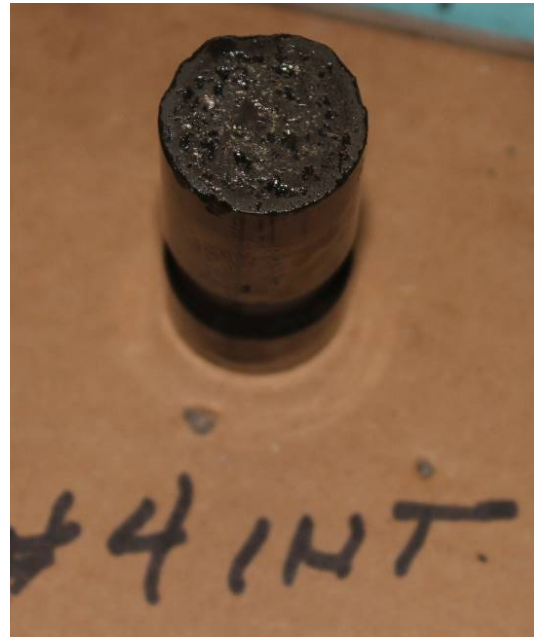
To facilitate further internal examination, holes were drilled through the top of the engine case material in-line with the rotational plane of each connecting rod at cylinder one and three. A lighted borescope was inserted into the hole to visualize the intake camlobes and tappets. The intake lobes characteristic elliptical shape was significantly diminished at each intake valves shared lobe. The intake tappets exhibited severe spalling. The tappets from cylinder two and four were removed for further examination, which found chipped edges and missing material.

Lycoming Engines Mandatory Service Bulletin SB301B, dated February 18, 1977 provides guidance for maintenance procedures and service limitations for valves. In particular Paragraph 1, (b) states "Rotate the engine by hand and check to determine that all cylinders have normal lift and that rockers arms operate normally" a 400-hour inspection interval.

Additionally, the Lycoming O-320-H series engines require the use of an oil additive LW-16702, IAW AD 80-04-03 R2, Lycoming MSB 446E that have anti-wear additive which reduces cam wear and tappet spalling. NE-06-31R5 dated October 19, 2011 provides for an Alternate Means of Compliance (AMOC) to this AD.
