**NATIONAL TRANSPORTATION SAFETY BOARD  
Office of Aviation Safety  
Washington, DC 20594**

**SUMMARY OF AIRFRAME AND ENGINE EXAMINATION**

**WPR21LA086**

Location: Spanish fork, Utah  
Date: 1/13/2021  
Time: 1315 MDT  
Aircraft: [Hughes 269C (S/N 170570) N7480F]

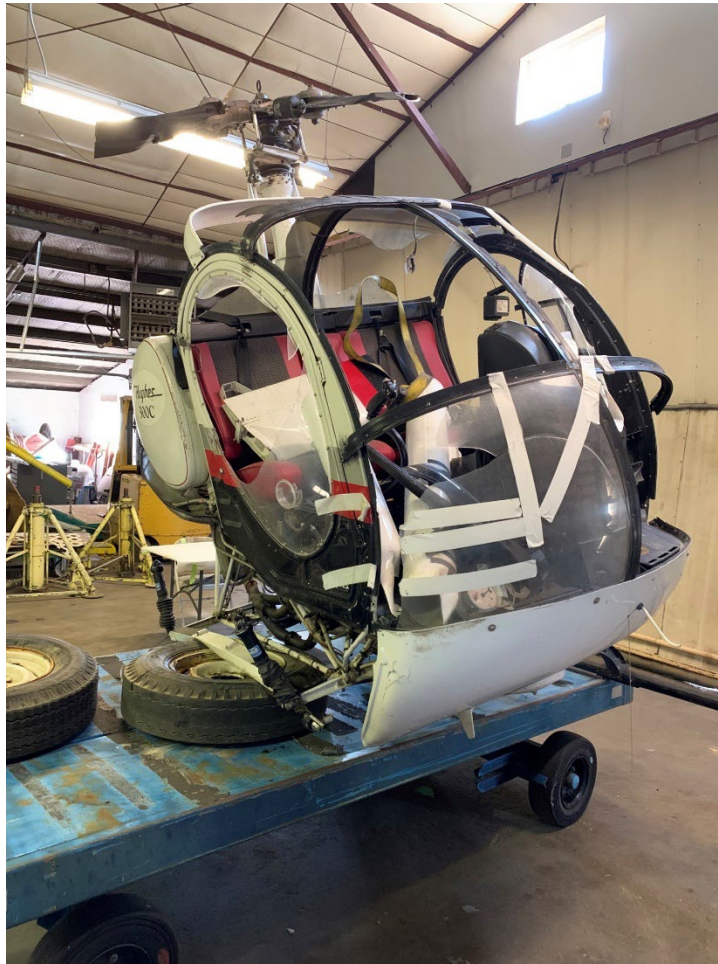
Figure 1, Helicopter on Trailer

The helicopter cockpit, main rotor mast and rotorhead, and engine were secured upright to a trailer. The three main rotor blades had been cut and removed about 18 inches outboard of the hub and laid aside for inspection. One main rotor blade was bent at mid-span and about 12 inches inboard of the blade tip and showed nicks in the leading edge and scrapes across the top and bottom blade faces. The tail boom was sectioned into three pieces. One section showed an angular crush and cut where the main rotor blade made contact. The tail rotor and skid were separated at the gearbox. The tailrotor drive shaft turned freely, the control tube to the tail rotor was manipulated and moved the tail rotor pitch links properly. The right skid was broken at the right front leg. The remainder of the skid was removed. The right front cockpit Plexiglas and right cockpit door Plexiglas were broken out, cracked and fragmented. The left from cockpit Plexiglas was cracked and broken.

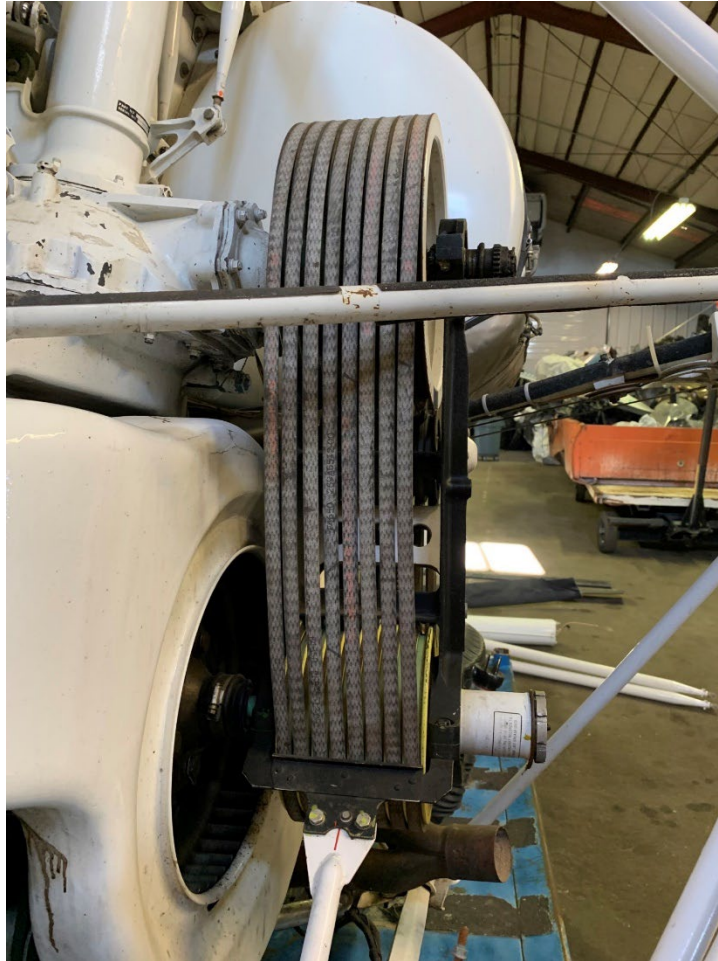
Figure 5, Drive Belts

All 8 drive belts were intact and attached to the engine drive pulley to the rotor control pulley and Sprague clutch. Manipulation of the pulleys turned the main rotor and the tail rotor drive shaft. The 8 belts were marked with a "V" and cut so that the engine could be run without manipulation of the main and tail rotor drives.

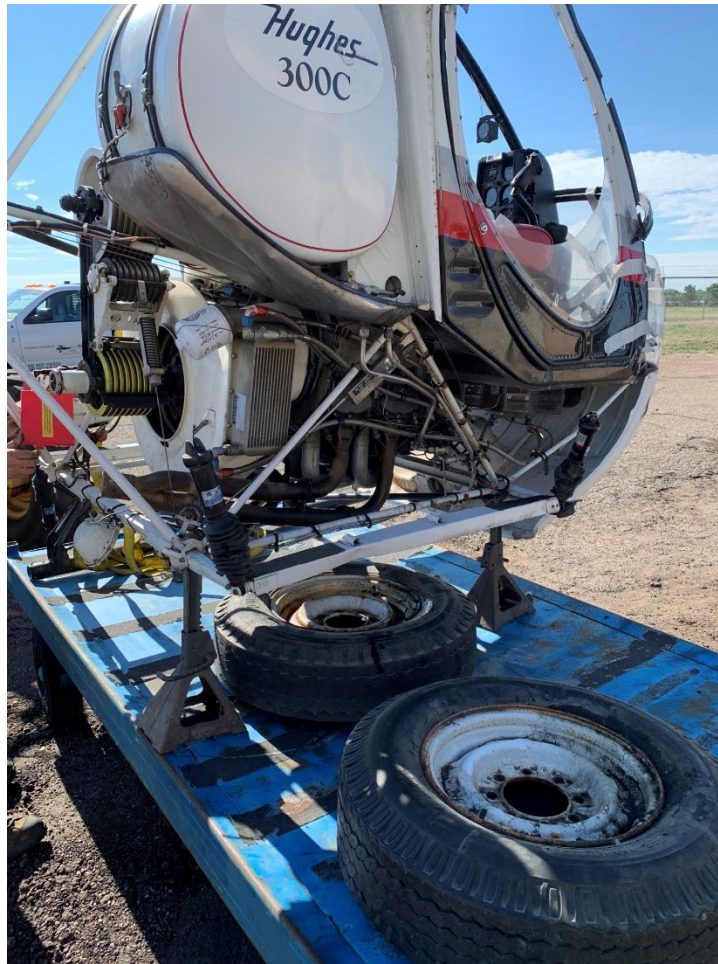
Figure 6, Helicopter Strapped to Trailer for Engine Run

The helicopter and trailer were removed to the ramp. The helicopter was lifted so that jacks could be placed on the right side where the right skid would have been to level the helicopter. The helicopter was then strapped to the trailer to secure it for the engine run.

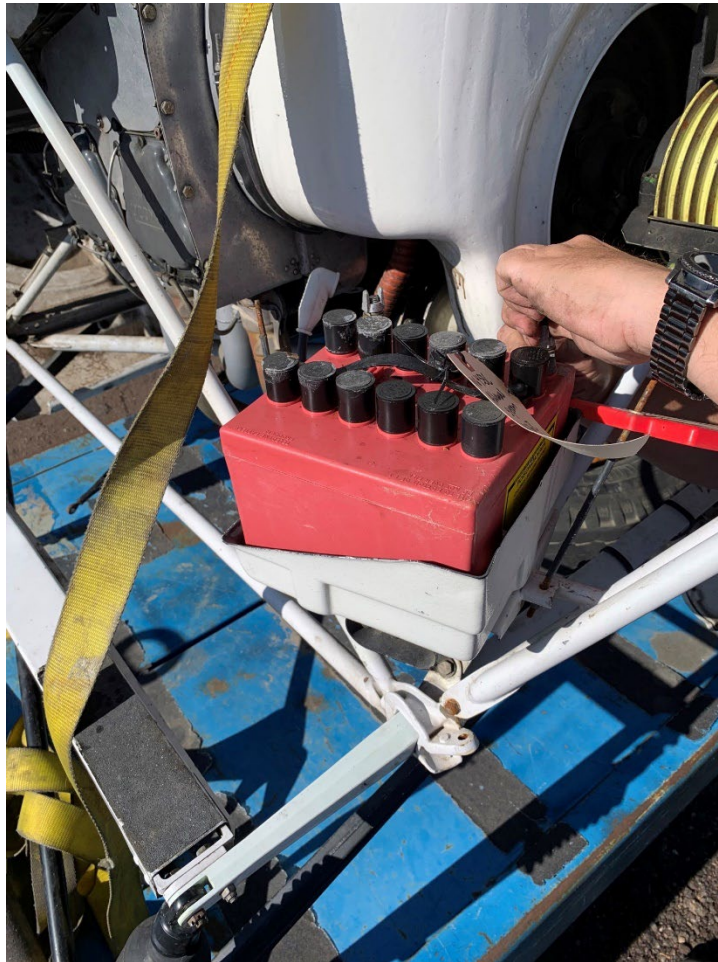
Figure 7, Installed 24-Volt Battery

A 24-volt battery was installed, and 5 gallons of fuel were added to the fuel tank. No other preparatory action was done.
