## **NATIONAL TRANSPORTATION SAFETY BOARD**

# **ENGINE EXAMINATION SUMMARY REPORT**

**WPR20L094**

Location: Eagle Point, OR  
Date: Jan 21, 2021  
Aircraft: N322TR  
NTSB IIC: James Bledsoe

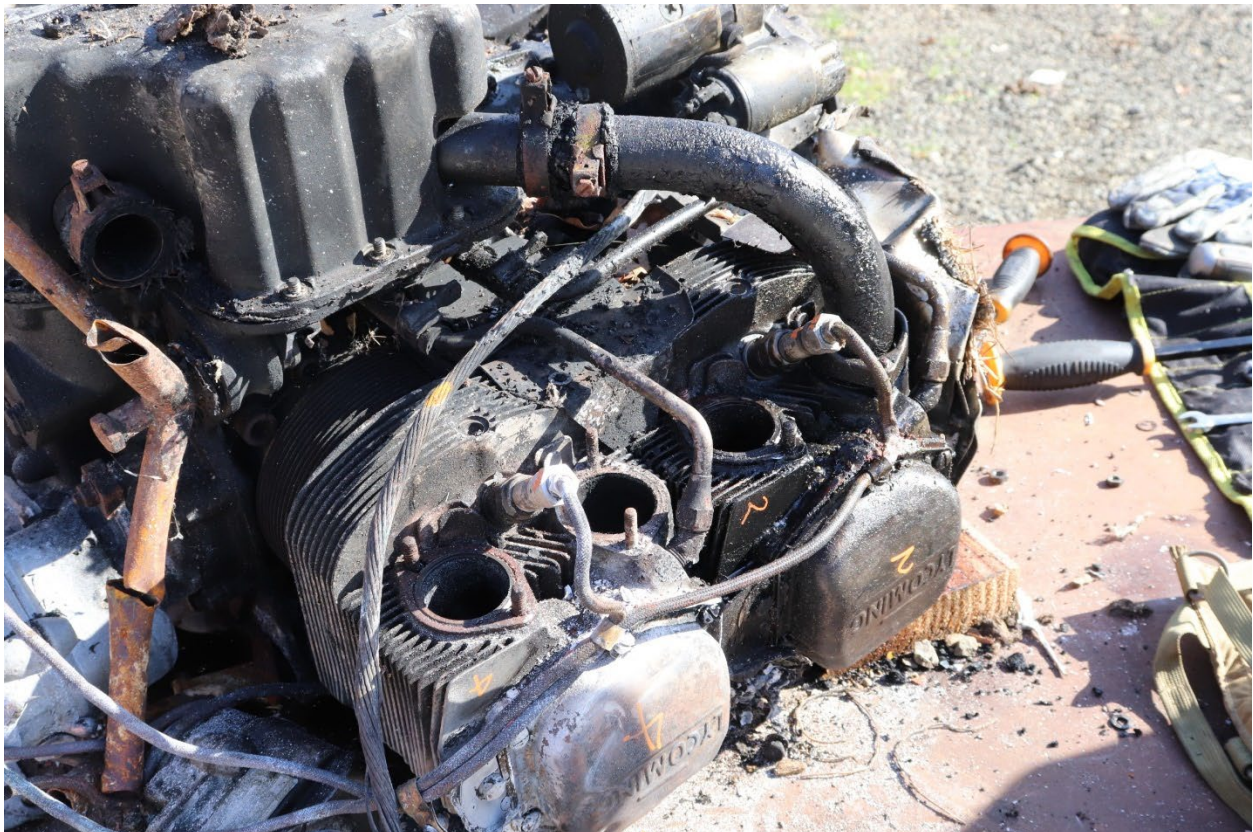
Figure 1- Intake manifold

The intake manifold was intact and visually inspected prior to removal. Minimal impact damage to the intake was present but moderate thermal damage was present with the system attached to the manifold.

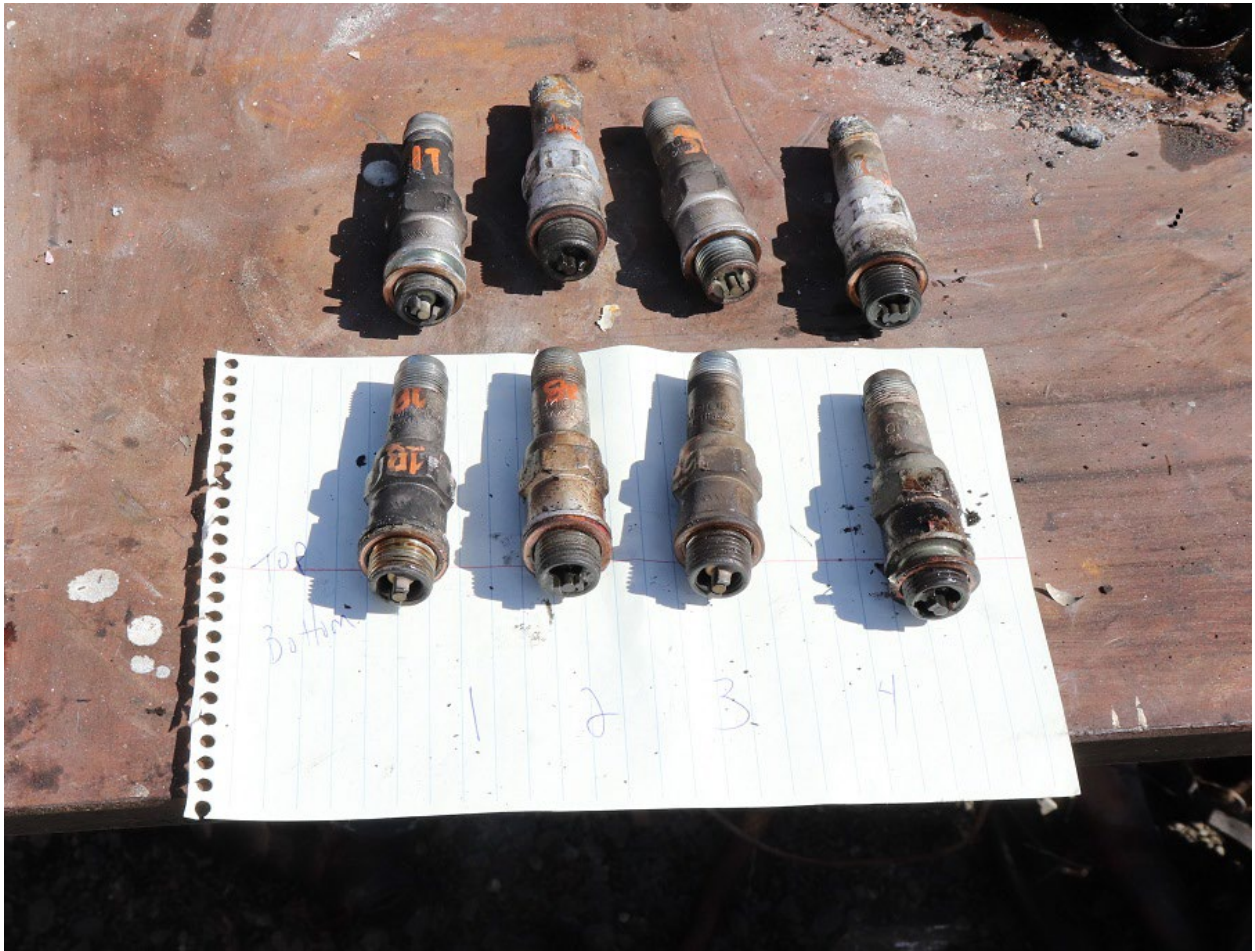
Figure 2-Spark Plugs

All spark plugs were removed and inspected. The leads on the aft cylinders showed signs of thermal damage. Cylinders 1 and 3 bottom leads were attached to left magneto. #1 top lead was attached to magneto. The no. 3 top lead was severed from tension overload consistent with impact damage. No. 2 lead bottom was attached to the right magneto. The number 4 bottom lead was attached to the right magneto. The no. 2 top lead was severed and showed signs of thermal damage. The number 4 top lead

was connected to the right magneto.

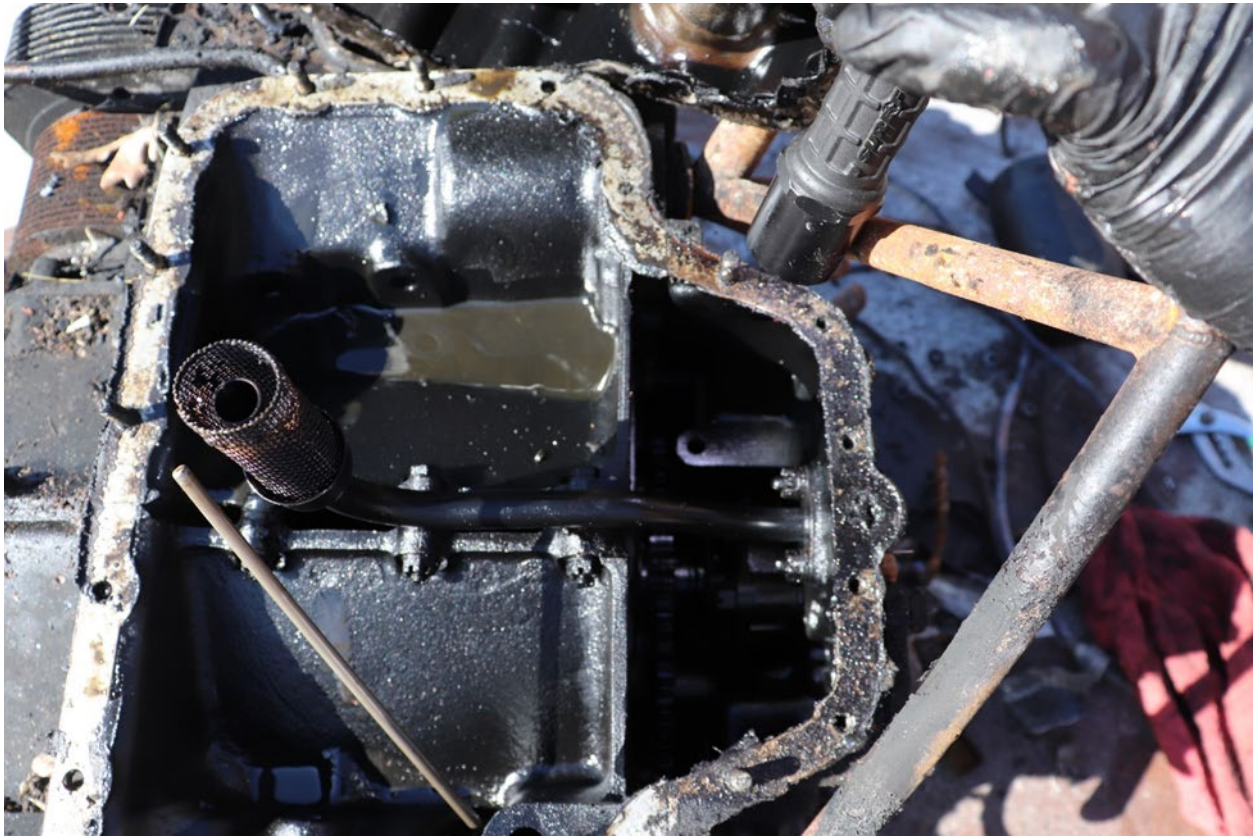
*Figure 3-Crankcase*

**Crankcase** was free of holes, cracks, or discoloration. Oil pan was removed, and residual oil appeared normal. No metal shavings or fragments were present. The filter screen was removed and showed no

debris.

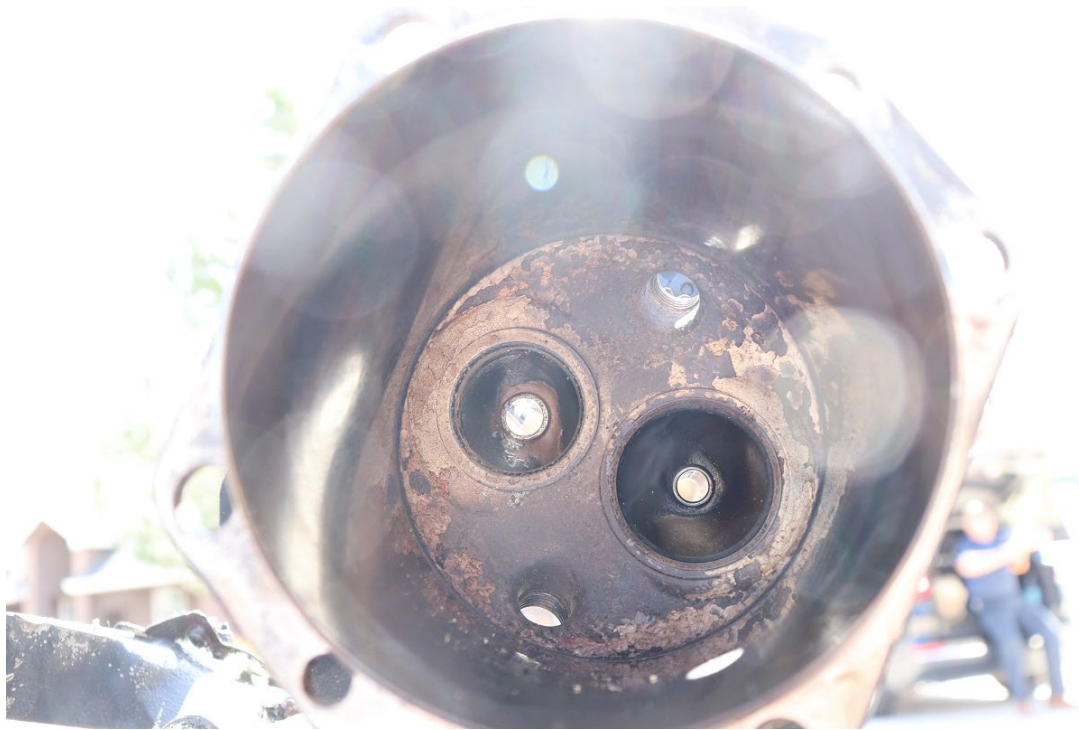
*Figure 5- Cylinder 1*

Oily components were noted most likely from storage. No signs of valve to piston contact. No cracks or deformation. No discoloration. Cylinder walls normal. Carbon buildup on piston top and upper part of cylinder near valve housing. No signs of detonation or pre ignition.
