## **NATIONAL TRANSPORTATION SAFETY BOARD**

### **COMPONENT EXAMINATION SUMMARY**

**WPR21LA098**

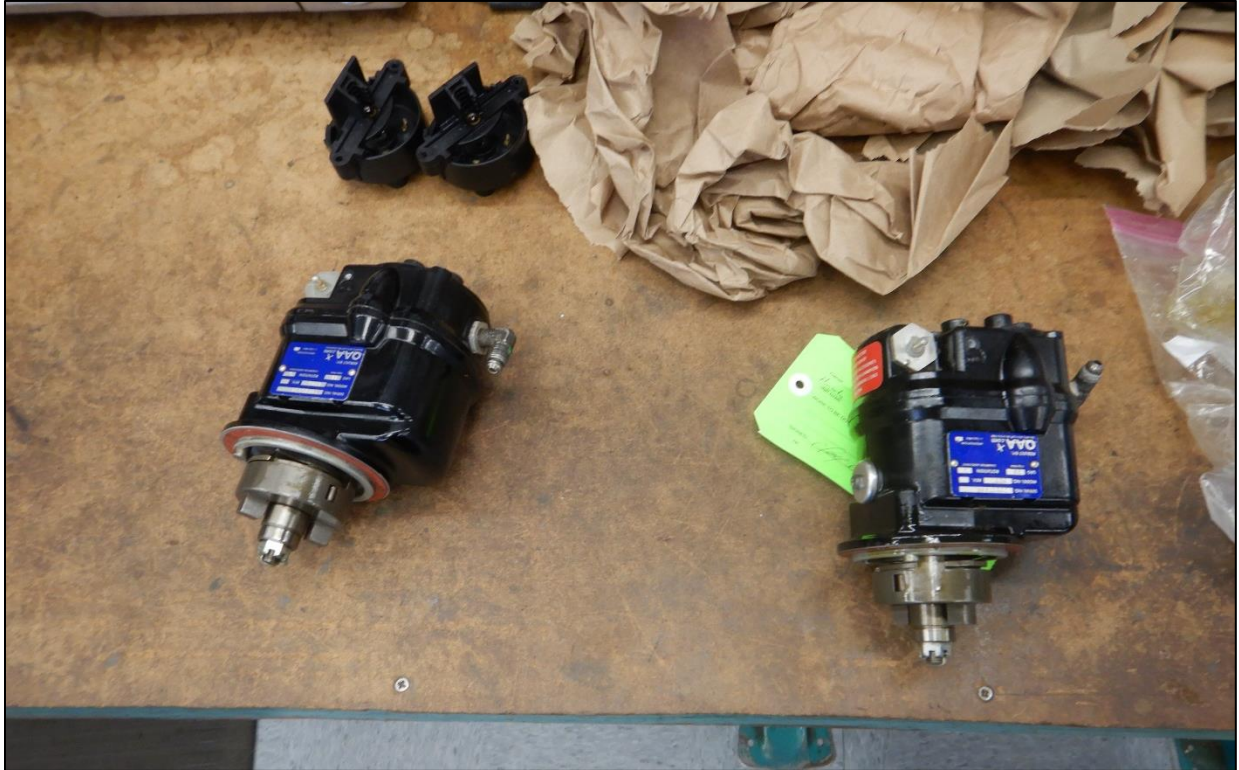
Figure 1-Magnetos.

The magnetos were examined, and the exterior surfaces were undamaged. The original magneto 'Slick' data tag had been removed and a Quality Aircraft Accessories (QAA) data tag installed. The magneto drives were rotated by hand and some resistance was noted. The magnetos were setup on a bench with a slaved ignition lead assembly. No spark was produced from either magneto.

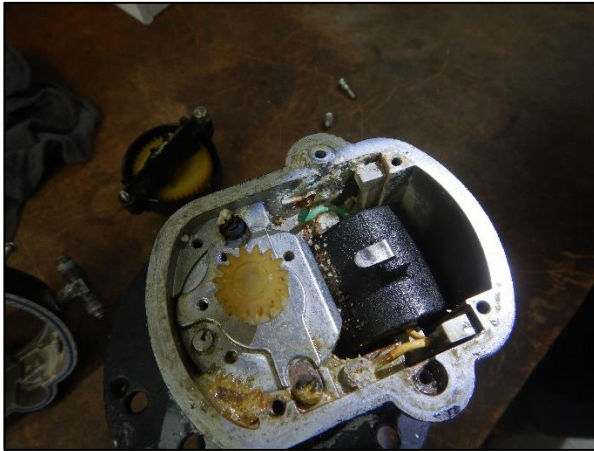
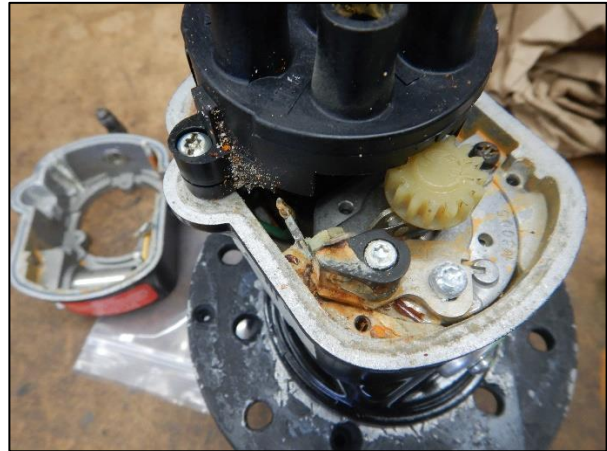
The magnetos were disassembled, and corrosion and rust were noted on the interior surfaces and interior components.

**Figure 2-Magneto's internal surfaces.**

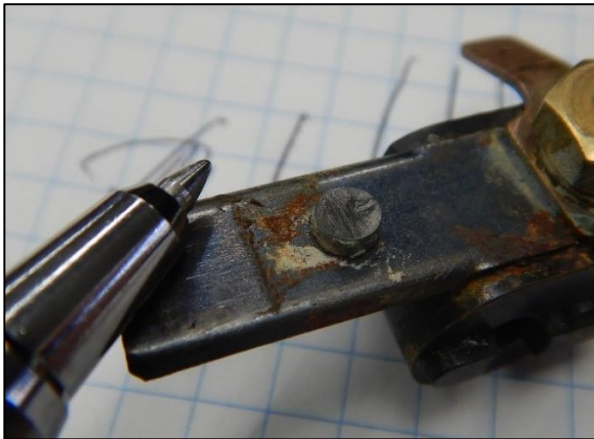
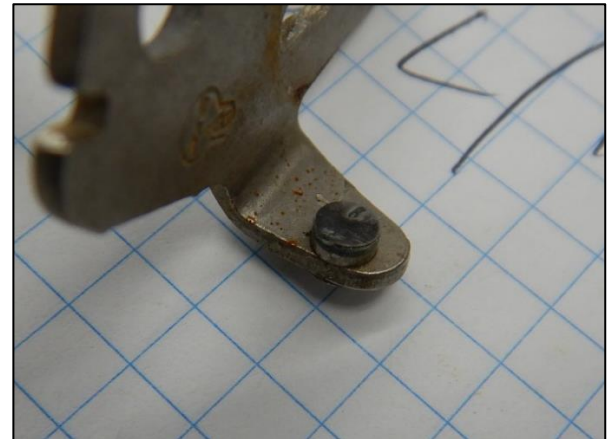
The points were removed from the magnetos, and corrosion was noted on the contact surfaces. Sandpaper was used to remove the corrosion from both sets of points. Deformities such as deterioration and buildup of the contact surfaces were visible. (See figures 3 and 4.)

**Figure 3-Left magneto point contact surfaces.**

**Deformatiy**

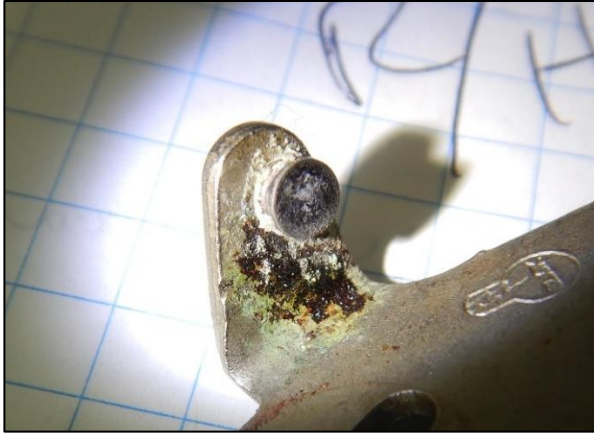
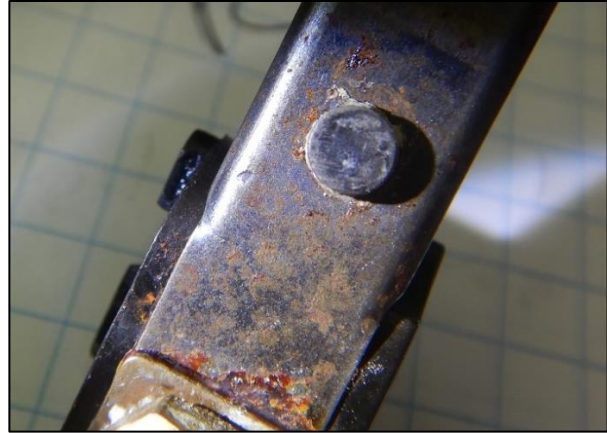
**Figure 4-Right magneto point contact surfaces.**
